# Stage 1: Tier 2 Site Investigation GQRA

Project Reference: P24.118.GQRA  
9 Cranbury Place

Roath Construction Ltd

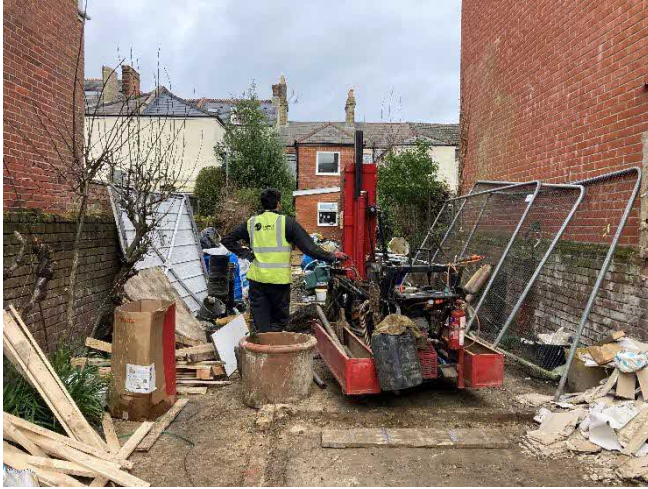
Project:	9 Cranbury Place	Title:	Site Photographs
Job Number:	P24.118	5. WS1 6. WS1 GL-1.00m 7. WS1 spoil 8. WS1 1.00-4.60m

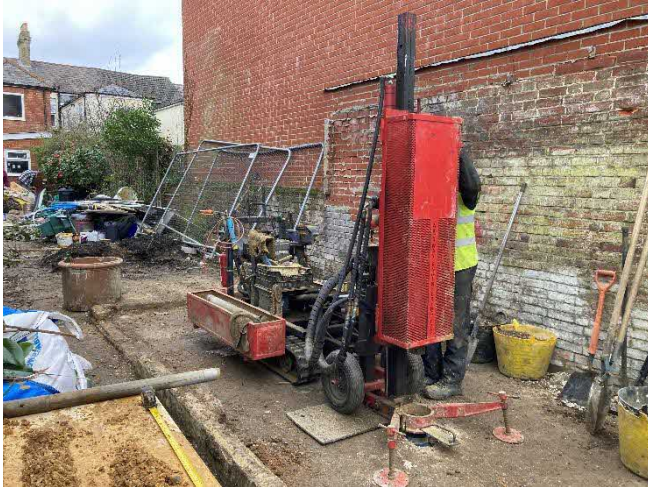
Project:	9 Cranbury Place	Title:	Site Photographs
Job Number:	P24.118	9. WS2 10. WS2 GL-1.00m 11. WS2 spoil 12. WS2 1.00-3.70m

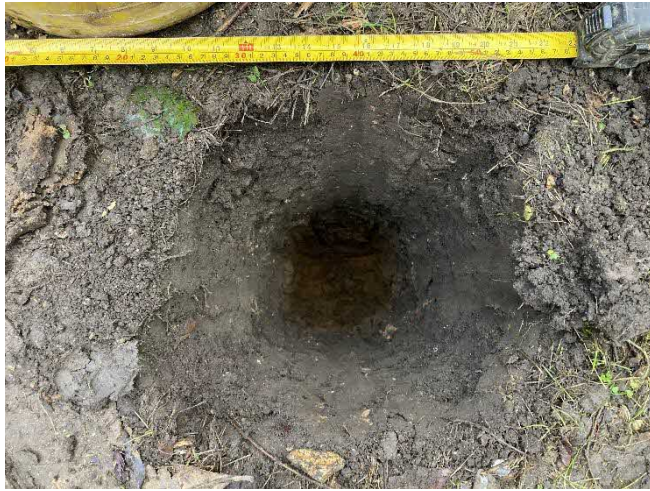
Project:	9 Cranbury Place		Title:	Site Photographs
Job Number:	P24.118	13. TP1 14. TP1 GL-1.00m

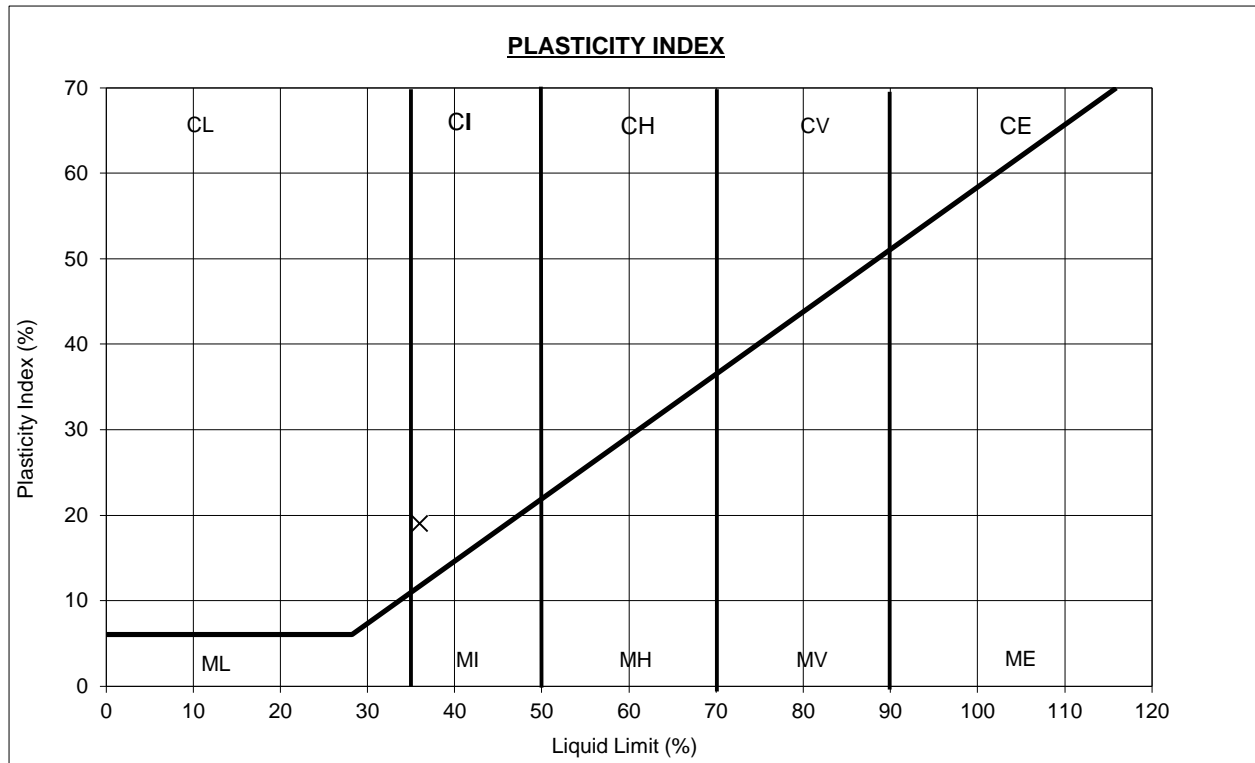
Site Name	9 Cranbury Place		
Project No.	P24.118	Client	Impact Geotechnical
Soil Description	Brown and orangish brown slightly sandy slightly gravelly silty CLAY (gravel is fm and sub-angular to sub-rounded)

NATURAL MOISTURE CONTENT	21	%
% PASSING 425µm SIEVE	94	%
LIQUID LIMIT	36	%
PLASTIC LIMIT	17	%
PLASTICITY INDEX	19	%
