Riverside Gardens CSO

Arboricultural Report

April 2024

Document reference: YW24J213-MMB-00-ZZ-DOC-Z-0100

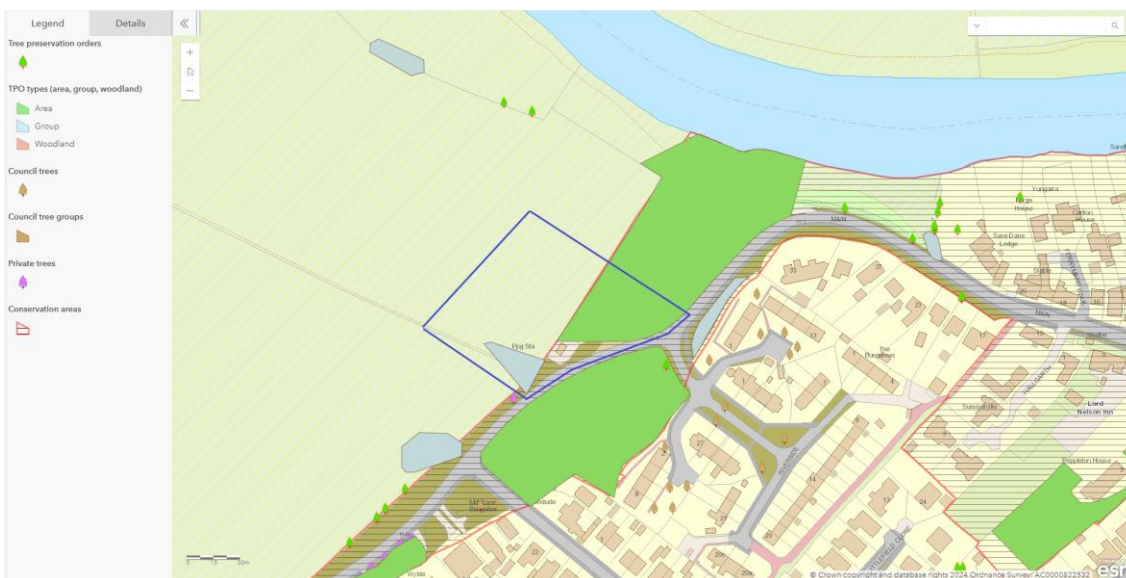
Figure 2.1: Screenshot showing the approximate area of interest (blue line) and associated designations, including the Nether Poppleton Conservation Area (hashed polygon), group TPO 1/1970-G3 (grey polygon), and Area TPO 1/1970-A4 (green polygon).

Any works required to the trees protected by these designations will require permission from CYC prior to construction commencing. It should be noted that an exemption exists where tree work is necessary to implement an approved planning permission.

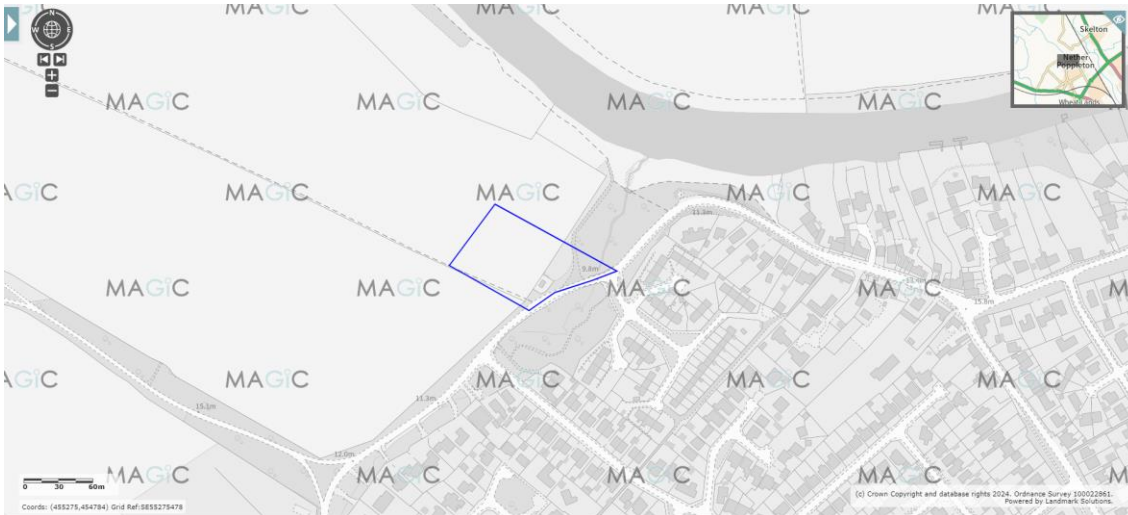
Figure E.1: Screenshot showing no ancient woodlands within the vicinity of the approximate area of interest (blue line).

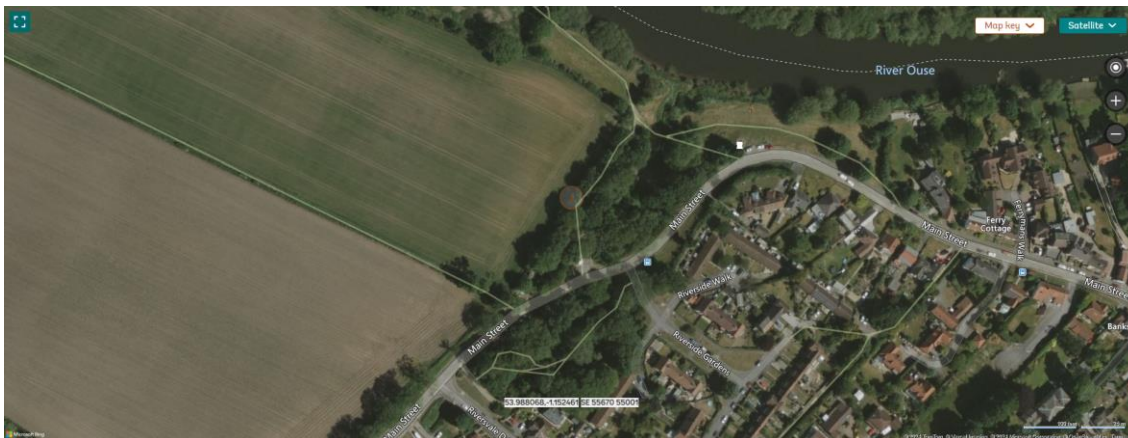
Figure E.2: Screenshot showing no ancient, veteran, or notable trees recorded on or adjacent to the approximate area of interest (red crosshairs, centre of image).

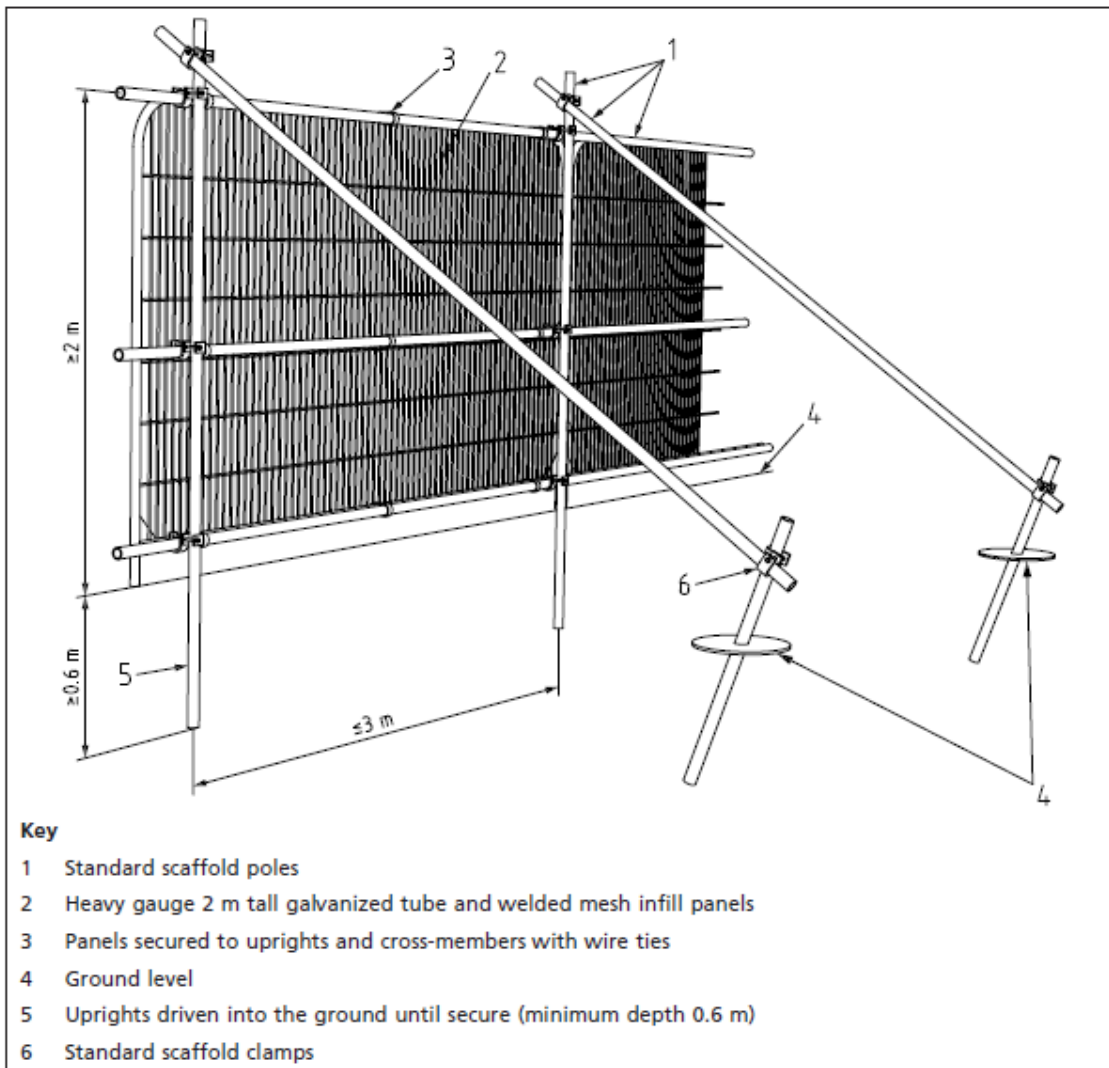
Figure F.1: Extract from BS5837:2012 Default specification for protection barrier.

Figures F.1, F.2, and F.2 provide an illustrated specification of the tree protection barriers and a written specification of the ground protection measures, as recommended in BS 5837:2012.

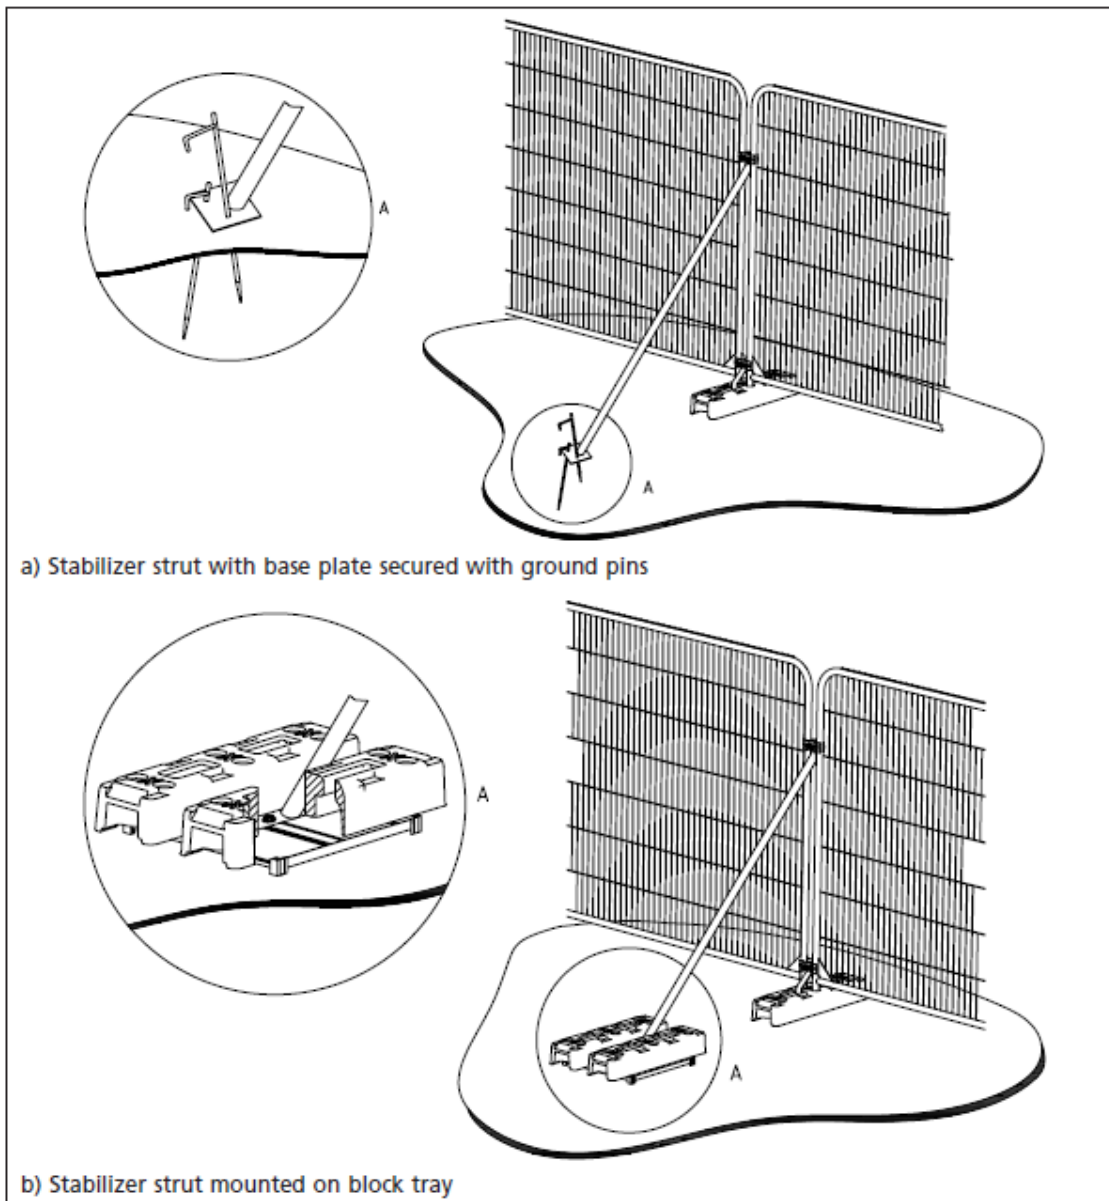
Figure F.2: Extract from BS5837:2012 Examples of ground stabilising systems.
