Preliminary Bat Roost Assessment	
For:	GR Planning and Architectural Design Ltd
Site:	Land Rear of 48 Retford Road, Blyth, Worksop, S81 8HB
Report Date:	18 th March 2024
Report Reference:	SQ-1719

Client:	GR Planning and Architectural Design Ltd
Site Name:	Land Rear of 48 Retford Road, Blyth, Worksop, S81 8HB
Central Grid Reference:	SK 62916 86888
Report:	Preliminary Bat Roost Assessment
Date of survey:	15 th March 2024
Surveyed by:	Natasha Estrada BSc (hons), MRes, MCIEEM <i>Natural England Bat Licence: 2015-12231-CLS-CLS</i>

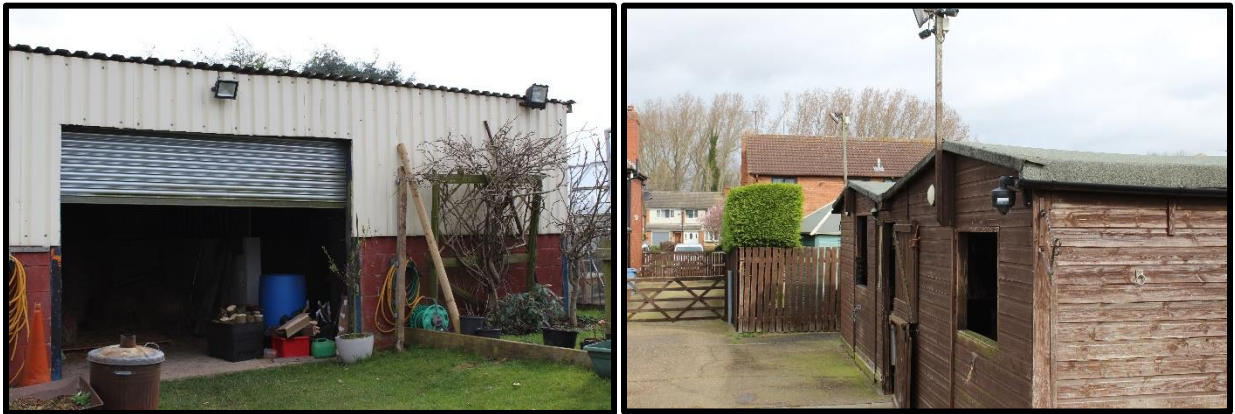
Figure 2: Barns within the site

4.1.1 The site at the rear of 48 Retford Road, comprised of two barns; the northernmost barn, a stable block comprises wooden walls and a bitumen lined roof, with the southern barn comprising of a breezeblock base and corrugated metal walls and roof covering.

4.1.2 **Metal Barn:** The southern barn within the site, comprised of a red breezeblock base which extended approximately a meter from the ground. Corrugated metal then continued to form the main construction of the barn on all elevations including the roof.

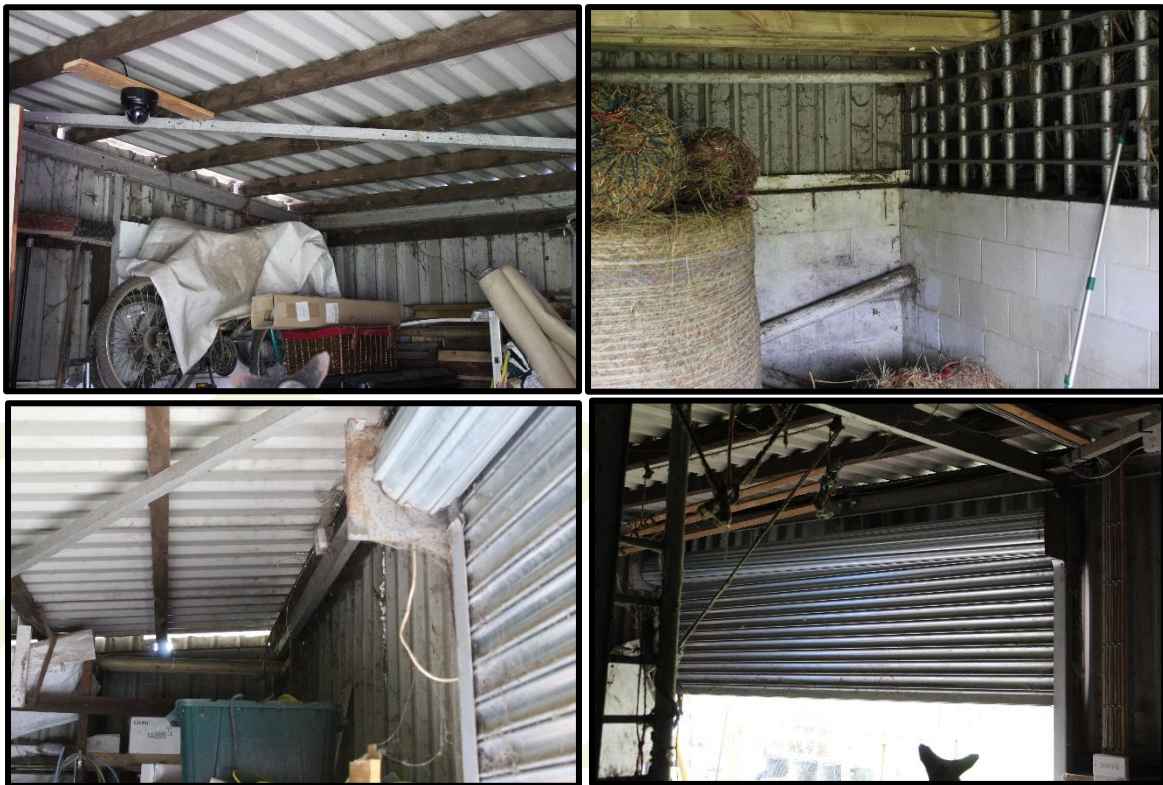
Figure 3: Metal Barn

- 4.1.3 A flat corrugated metal roof was present, which displayed a small gap between the roofing metal and the metal at the top of the barn walls, which recorded suitable gaps in which, access could be gained to the internals by bats and breeding birds. However, given the exposed edges of the metal, this feature is deemed suboptimal for bat access and egress.

- 4.1.4 Two external lights were mounted on the western elevation of the barn. These were confirmed as being motion sensor operated lighting and were functional at the time of survey, likely resulting in splay across the western aspect and beyond.

- 4.1.5 A large metal roller door was recorded on the western elevation of the metal barn, which was open during the survey to permit internal inspection. However, it was confirmed by the landowner, that the door remains closed at all times during evening hours. When closed, the door is well sealed and offers no access potential to either breeding birds or bats.

- 4.1.6 The internals of the metal barn were surveyed in full. The barn was recorded as being used for storage, with multiple items recorded. All accessible items and areas were inspected using a high-powered torch to inspect for field signs pertaining to bats. The wooden roofing beams were recorded as running flush to the corrugated sheeting and all areas of blockwork were recorded as sealed offering no roost suitability.

- 4.1.7 No field sign evidence in relation to bats was recorded within any section of the barn. Furthermore, the barn recorded hostile construction materials which were deemed sub-optimal for bats to utilise. No potential roosting features were recorded. It was also noted rats had at some point had been

using the interior of the barn, the presence of which could provide an elevated predation risk to any bats in situ. The metal barn recorded no evidence of historical or active breeding birds.

4.1.8 For the purpose of this assessment, when considering the construction of the barn and lack of suitable roosting features, the metal barn recorded within the site was deemed to provide negligible roosting potential for roosting bats. No further assessment is deemed necessary at this juncture.

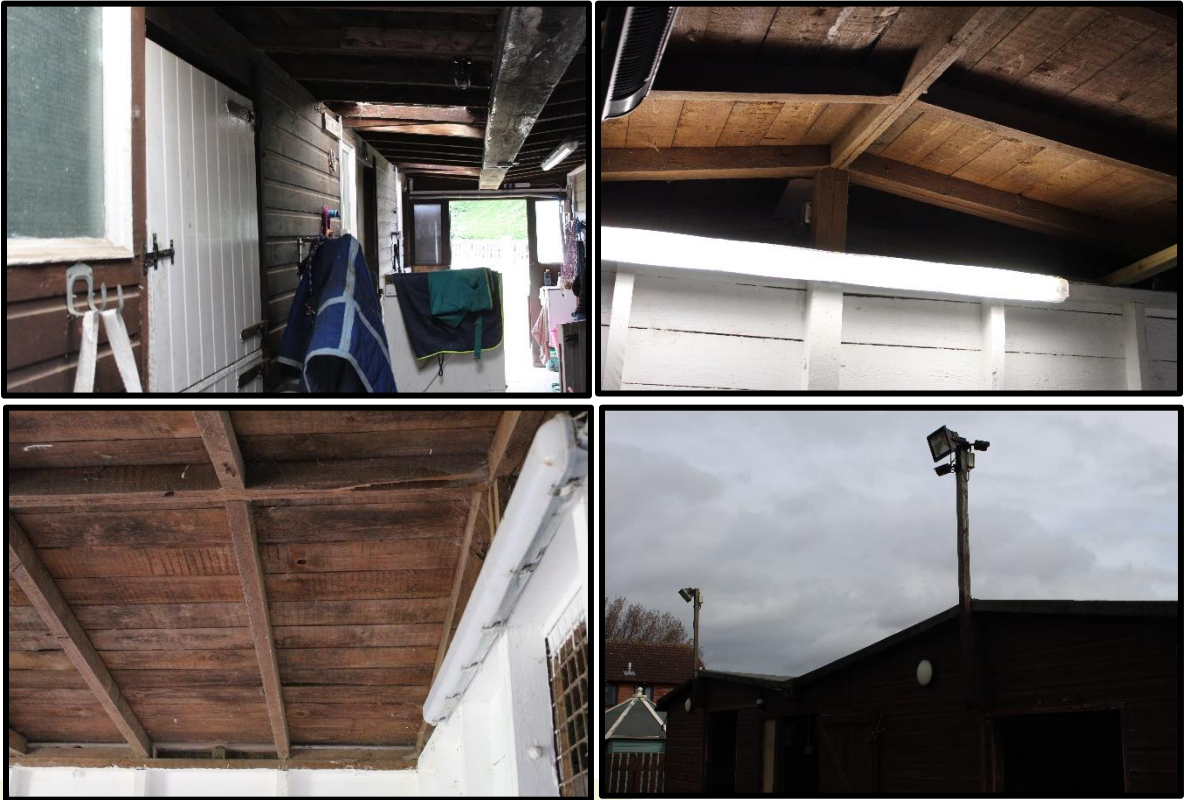
Figure 4: Wooden Barn

4.1.9 Stable **Block:** A second barn was recorded within the site, comprising of wooden walls, wooden roof with bitumen lining and windows which were recorded as being intact.

4.1.10 The walls of the barn were recorded as being in good condition, with no damage recorded within any section of the lapped timber. The walls were inspected for fields signs pertaining to bats; however, none were recorded.

- 4.1.11 The roof recorded a double pitch profile with bitumen lining. The lining was intact throughout and tacked to the wood beneath. The roof was recorded in good condition with no warping of the bitumen or wood recorded.

- 4.1.12 Two external lights were recorded on the western elevation of the barn which were confirmed as being on at all times during the evening for security purposes. This was deemed to provide a limiting factor for bats in relation to utilisation of the site given the luminaire type.

- 4.1.13 The internals of the barn were inspected in full and were recorded as being in use as a stable for equine livestock and equipment. No suitable features which bats could utilise were recorded within the wooden barn. The wooden ceiling was entirely intact with wooden beams and ridge beam running flush to the wood. Some partitions between adjacent stalls were recorded as being blocked with mesh preventing access. Furthermore, lighting within the stable block is present and given the nature of the structures use, is likely to be on during evening hours. No field sign evidence pertaining to bats was recorded within any section of the stable block.

- 4.1.14 For the purpose of this assessment, when considering the stable block and lack of suitable roosting features, it was recorded as providing negligible roost suitability when assessed by two licensed ecologists. No further assessment is deemed necessary at this juncture.

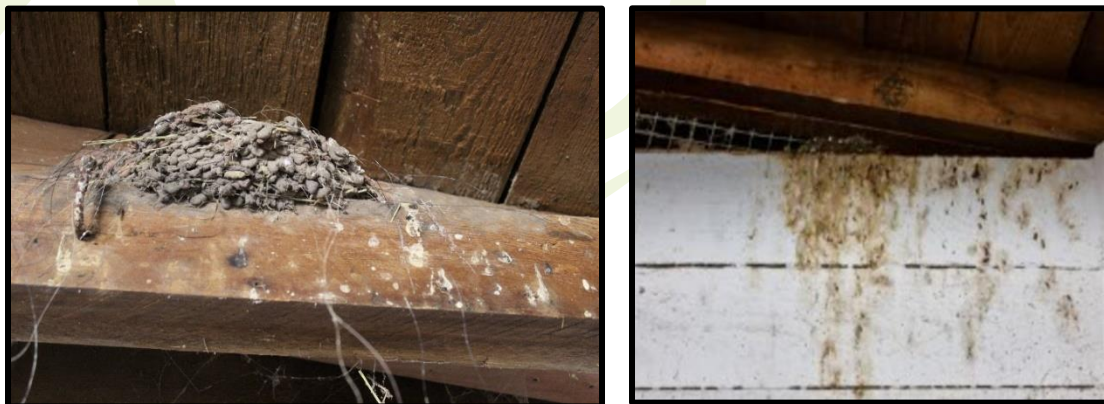
Figure 5: Swallow Nest

- 4.1.15 Two nests were recorded internally within the stable block, identified as swallow. The nests were inactive and appeared to be defunct due to signs of damage. Further recommendations have been made herein.

5.1.2 The wooden stable block within the site, recorded historical evidence of nesting birds, namely, swallow with the presence of two swallow nests. Recommendations for precautionary methods are provided within the conclusion of this report.

6.2.2 It is recommended, where feasible, works on the building should be undertaken outside the breeding bird season to avoid potential impacts towards breeding birds. The breeding bird season typically runs from March to September, inclusive.

6.2.3 Should these timings not be feasible, then precautionary working methods to mitigate potential impacts towards birds using the structure are recommended. If any evidence of nests, building as nests, breeding, or attempting to breed, then works should cease and a suitably qualified ecologist consulted. Works should not resume until an ecologist has given the go ahead for works to proceed.

6.2.4 Post development, artificial nest boxes for Swallow should be incorporated within the scheme design to ensure continued nesting sites for the species within the plot.
