Former Colchester Institute, Church Road, Clacton-on-Sea, Essex -**Report Title:**

Historic Environment Desk-Based Assessment

Report Ref: 22672

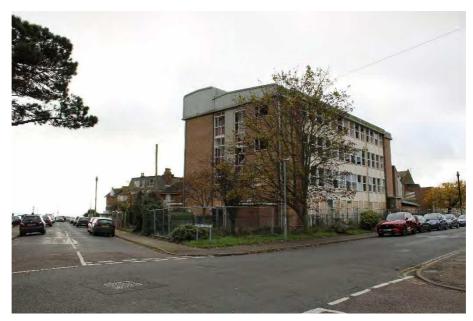
Plate 1. View towards the Site from the north east

1.2.3 The current character and appearance of the Site is characterised by the former college building, surrounded by amenity grass with car parking to the rear. The Site closed as a college in 2020 and has been remained vacant. Heras fencing encloses the Site.

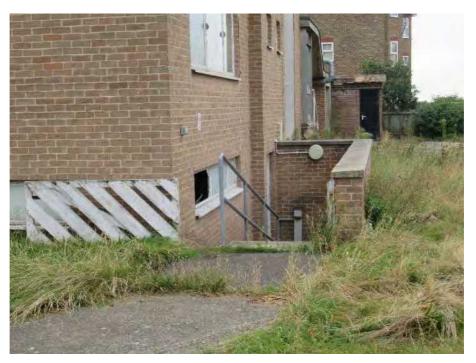
Plate 3. View of basement level

3.4.2 Although details associated with the construction of the existing building within the Site are currently unknown, the site visit indicated that it does comprise a basement level (Plate 3).

3.4.3 The baseline presented in this section indicates that the Site has been subject to significant disturbance/impact. The work at the end of the twentieth/early twenty-first century is likely to have substantially truncated or destroyed any buried archaeological resource within its footprint.

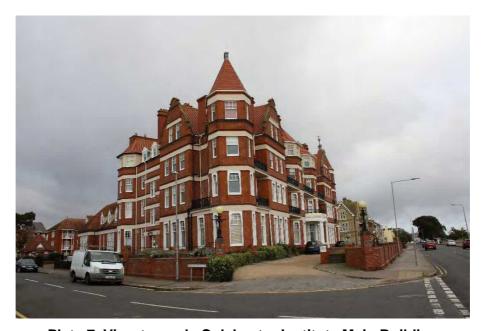
Plate 7. View towards Colchester Institute Main Building

4.3.1 The Colchester Institute Main Building is a Grade II Listed Building dating from 1892-1897 and was built as the Grand Hotel by A.J. Gale and N.T. Farthing of Smith, Son and Gale, for Henry Grant (NHLE: 1380565; Plate 7). Built during the expansion and development of Clacton-on-Sea as a seaside town, it was converted to a teacher training college in 1950. It has since been converted to residential accommodation (i.e. flats).

4.3.2 The building has a steel box frame construction with red brick curtain walls and machine tiled roof.

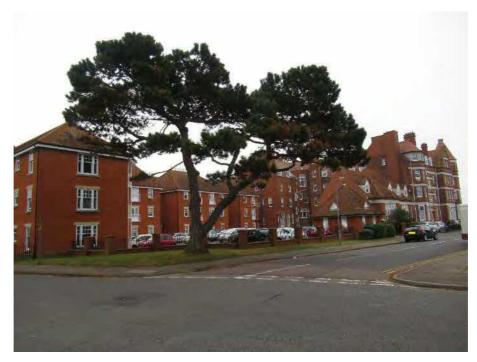
Plate 12. View of later development in the grounds of Colchester Institute Main Building

- 4.3.8 From the mid-twentieth century onwards the Listed Building formed part of the St Osyth's Training College. Historic mapping indicates that associated built form was located within the immediate environs. Like Colchester Institute Main Building many have since been removed or converted for residential use. Although some of these buildings remain located within the setting of the Listed Building, their former function and association with each other is not apparent within the landscape today. This can therefore be best understood and appreciated on historic documentary and cartographic sources and the buildings are not considered to contribute to why Colchester Institute Main Building is of heritage significance.

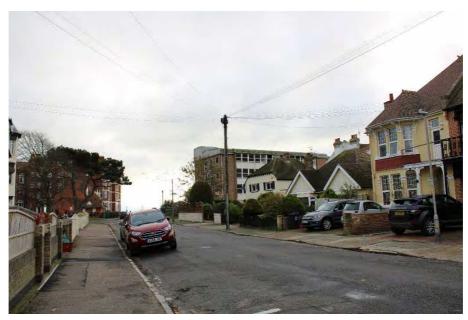
Plate 15. View from Thoroughgood Road encompassing the Site and Colchester Institute Main Building

- 4.3.13 Whilst a level of intervisibility is afforded from the junction between Thoroughgood Road and Church Road (Plate 15) and between Thoroughgood Road and Marine Parade East (Plate 16), the Site appears derelict and of poor visual interest in such views. The Site does not feature in views from the principal (south east) elevation of the Listed Building.
