## Phase 1 bat and nesting bird survey report

**Site:** Subway at A30 Services,  
Altarnun,  
Cornwall,  
PL15 7RR

**Report**  
**prepared by:** Richard Bates, ACIEEM, BSc(Hons).

**March 2024**

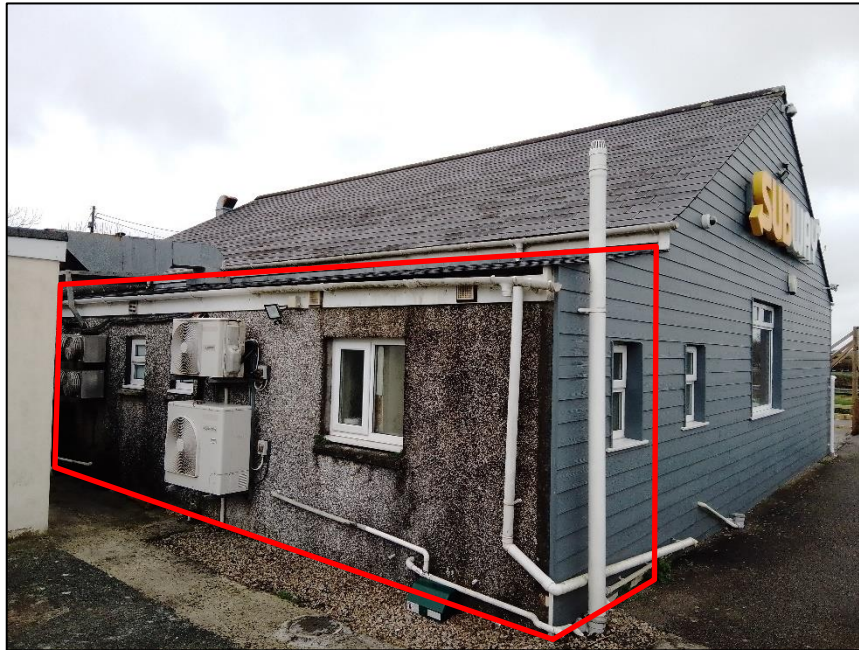
*Photograph 1– View of the south aspect where the extension is located.*

- The building is a single storey commercial property with a pitched roof and a two part single storey extension.
- The roof of the building has flat fibreboard tiles that are in very good condition. No gaps were noted beneath the tiles.

- Concrete ridge tiles are present and in good condition. No suitable gaps were noted beneath the ridges.
- Wooden/plastic weatherboarding is present on the east gable end. This is in good condition; individual knotholes were noted in the boards but these are small and located outside of the proposed work area. The boards that are located on the east side of the extension are well sealed with no gaps.

- uPVC guttering is present and in good condition. No gaps were noted behind the guttering.
- uPVC windows and doors are present on all aspects. These are well fitted with no gaps around frames.

- The extension has a smaller, mono-pitched fibreboard tile roof and a larger flat bituminous felt roof. Both sections of roof are in good condition with no gaps beneath tiles or the edges of the felt.

- The mono-pitched roof section of the extension is sealed to the main building with lead flashing. This is in very good condition no gaps beneath the lead.

- uPVC bargeboards are present on the south side of the building. One short area of gaps was noted beneath the west end of the building but could be closely inspected from ground level. The gaps were found to be completely cobwebbed over with no signs of use by bats.
- The edge roof tiles are well sealed to the weatherboarding. No suitable gaps were noted.
- A full survey of the exterior recorded **negligible** potential for bats. The building extension has no internal spaces and as such has no internal potential for bats.

- All roof tiles affected by the development will be removed by lifting them from the battens or ridge. The tiles will not be slid from the roof as this can cause accidentally crushing injuries if bats are present. The reverse side of all tiles will be inspected to ensure no bats are present. Should bats be encountered during this process, all work will cease immediately and a licensed ecologist will be consulted.

- All guttering, bargeboards and weatherboarding will be carefully lifted away from the building using hand tools. The reverse side of all these features will be checked to ensure no bats are present before being lowered to ground level.

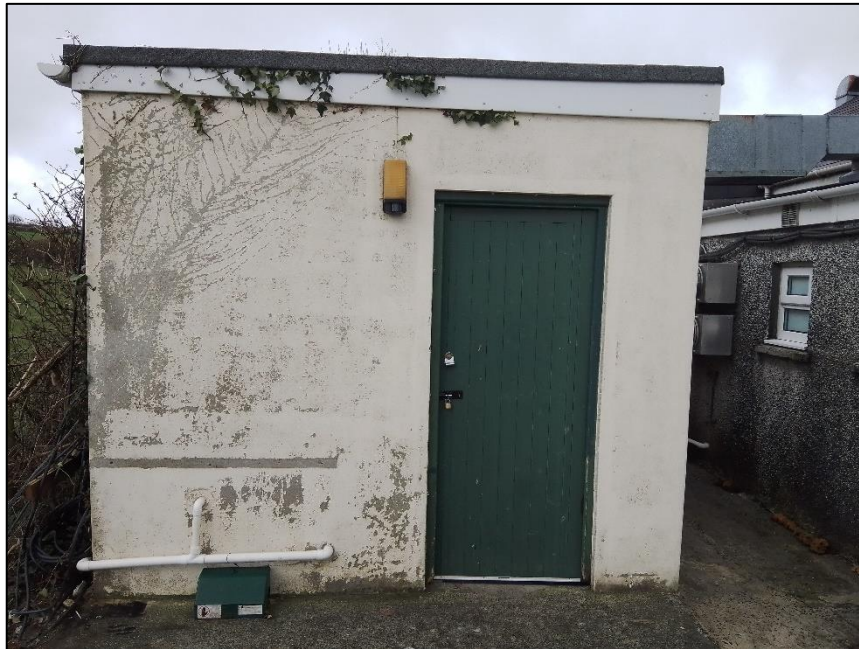
*Photograph 1– View of the east aspect of the utility outbuilding.*

- The building is a small, single storey breezeblock utility outbuilding with a bituminous felt roof. The walls are rendered on all aspects.
- The felt roof is well fitted with no gaps beneath the edges.

- uPVC bargeboards are present on the building. These are well fitted with no gaps beneath them.
- One wooden door is present. This is well fitted with no gaps around the edges.

- Dense bushy vegetation is present across the whole of the south aspect of the building. This has no potential to support roosting bats but has potential to support nesting birds. **Recommendations have been included in section 5** regarding nesting birds.

- The building has no internal void spaces and is fully tiled as a shower facility. It is currently disused but has many stored items inside. These could be closely inspected – no evidence of bats was found inside and **negligible** potential for roosting was noted internally.

- A full survey of the exterior recorded **negligible** potential for bats.

- Where possible, clearance of the vegetation will commence outside of the bird nesting season (March – August). If works cannot commence in the timeframe detailed above, a search of the vegetation for nesting birds will be undertaken by an ecologist immediately prior to work commencing.
- Should nesting birds be recorded, a 3m buffer zone will be established around the nest and work in that area will cease until the fledglings have left the nest.
- Arrangements for replacement nesting opportunities will be provided as part of the development (see section 5.3 below).

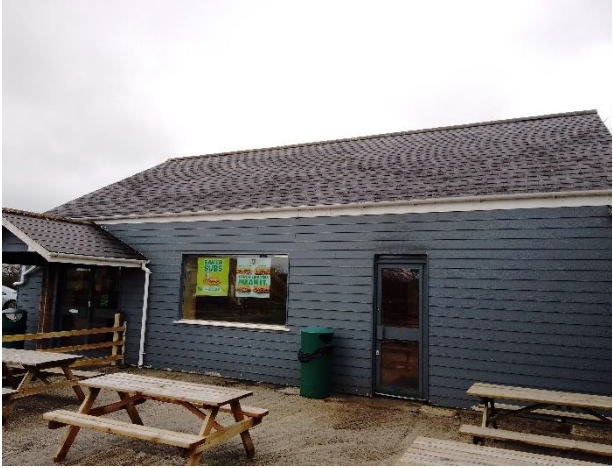
*Photograph 1 – View of the north aspect of the building.*

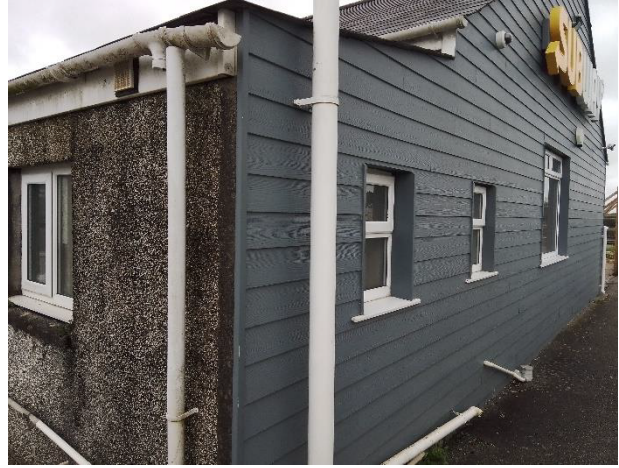
*Photograph 2 – Closer view of the extension to be removed.*

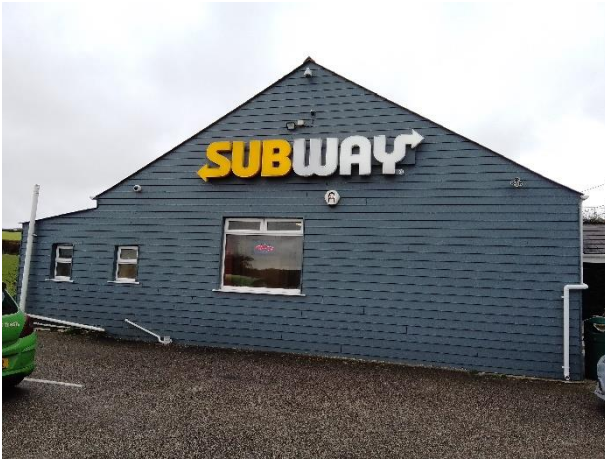
*Photograph 3 – View of the east aspect.*

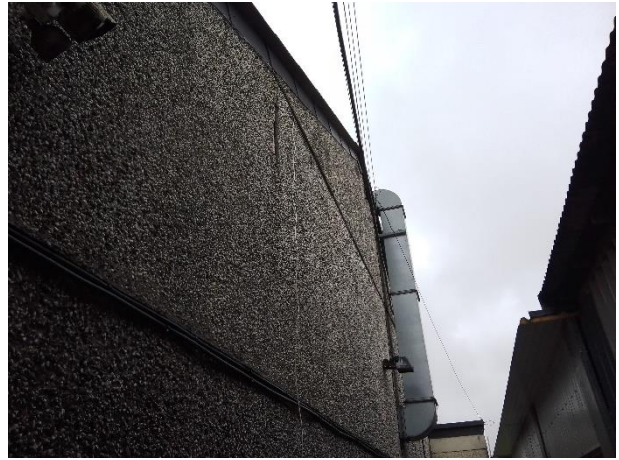
*Photograph 4 – View of the west aspect.*

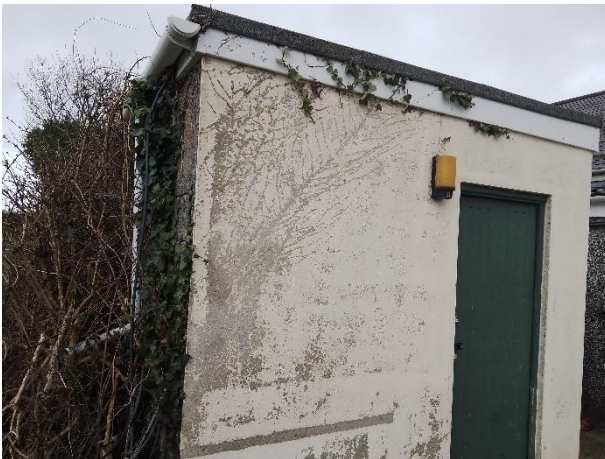
*Photograph 3 – View of the south aspect of utility building showing vegetation.*

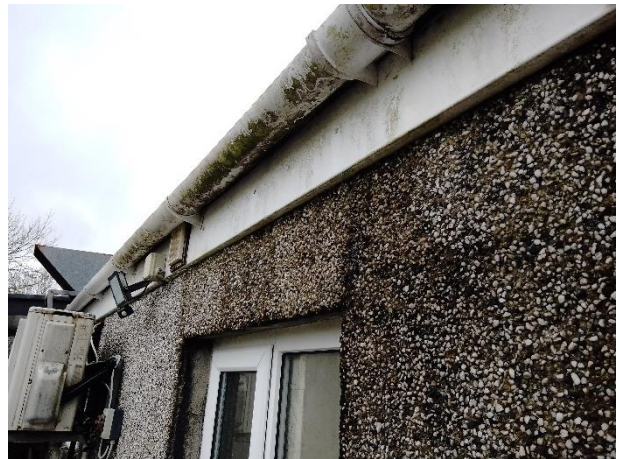
*Photograph 4 – View of the mostly well sealed bargeboards.*

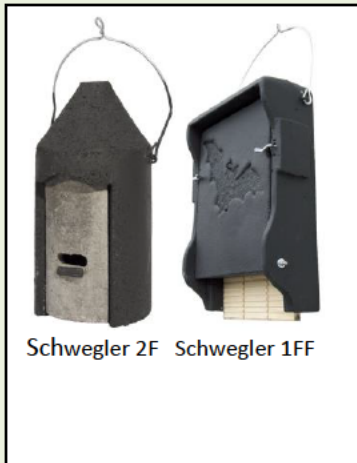
Schwegler 2F Schwegler 1FF

Examples of tree or wall mounted bat boxes. Box should comprise one Schwegler 2F or Schwegler 1FF bat box to provide suitable roosting site for multiple bat species.

For either design, box should be located a minimum of 3m from ground level and with a clear, uncluttered flight path to the box entrances. **Boxes must not be illuminated from any nearby artificial lighting.**

- One Schwegler 2F or 1FF bat box or, if compatible with the new building, one Schwegler bat tube will be installed at the site. If a bat box is included this will be installed on an external wall or suitable mature tree. The box/tube will be positioned a minimum of 3m from ground level in a sheltered

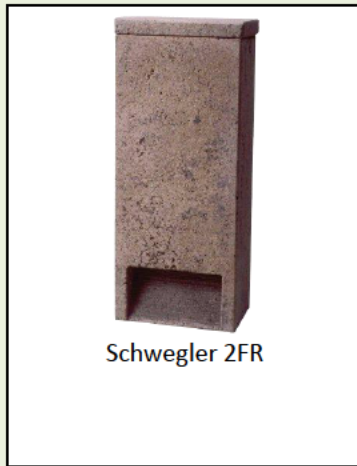
Example of Schwegler 2FR bat tube, designed to be incorporated into wall. To be installed on south or east aspect for protection from prevailing wind. Requires no maintenance and can be painted/rendered.

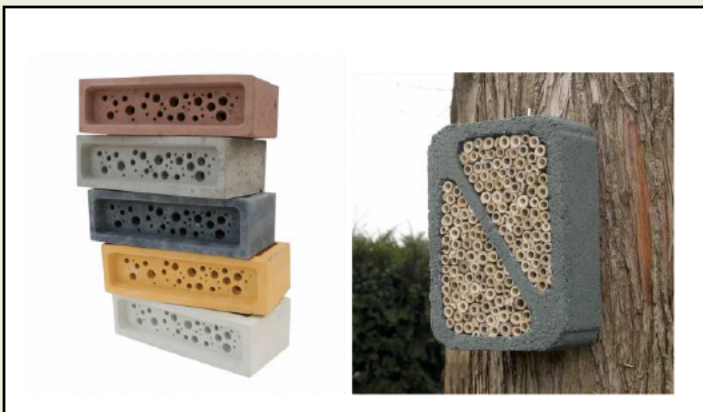
Example of 'bee bricks' that can be incorporated into new buildings or stand-alone insect houses. Either design should be installed at a minimum of 1m from ground level, preferably on south facing wall for warmth.

- Provision should be made for pollinating insects on site. A number of commercial products are available to 'house' important pollinators such as solitary bee and solitary wasp species. A minimum of one suitable product should be included to provide nesting opportunities. These may be free standing, attached to trees or installed on buildings. The provision of nesting opportunities for pollinators will be of benefit to a range of important insect species, the plants they pollinate and the mammals and birds that prey on them.

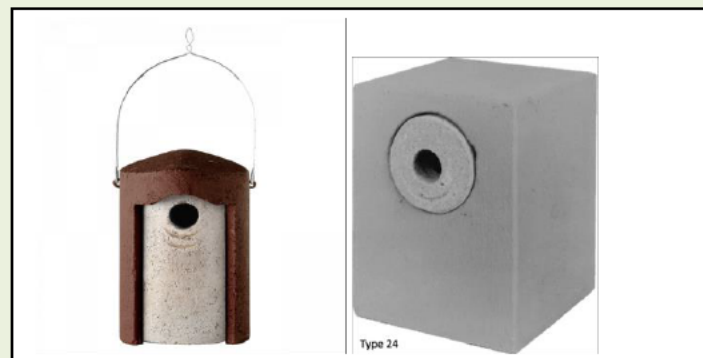
Type 24

Example of a suitable wall/tree mounted bird box and a Schwegler bird brick, to be installed in a sheltered location out of the prevailing wind. Not to be installed in south facing locations to prevent overheating of eggs or chicks.

- A minimum of one Schwegler brick nest boxes, or other suitable tree/building mounted bird box, should be installed at the site. The box will be positioned as high as possible on the wall or tree, a minimum of 3m from ground level. The boxes should also be located on a north facing aspect out of the prevailing wind and strong sunlight. The addition of bird boxes will provide nesting opportunities for common bird species.
