Grandpont House, Abingdon Road, Oxford

Heritage Impact Assessment for Mr Xavier Bosch

March 2024

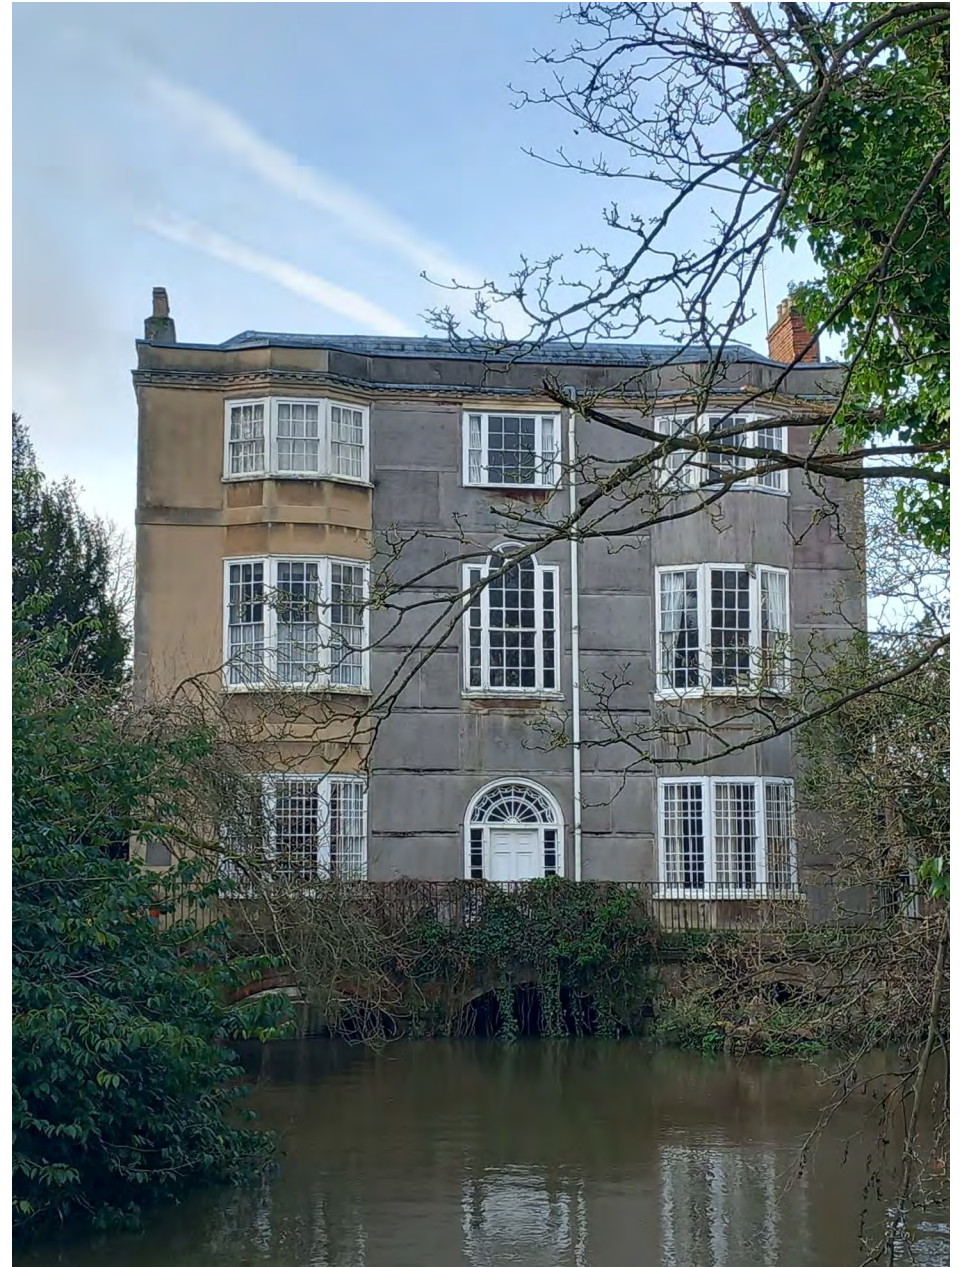
2.6 The east front of the east wing, showing the arches on which the house is built across the Isis (DIA)

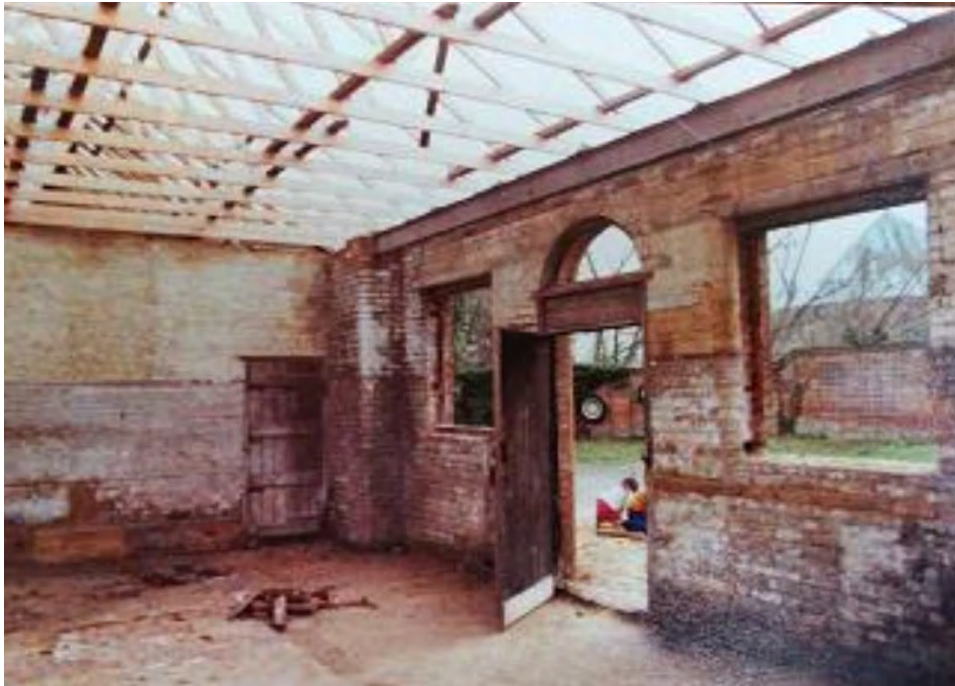
2.23 Replacement of the stable block roof from the central bay, c.1976 (Grandpont House archives)

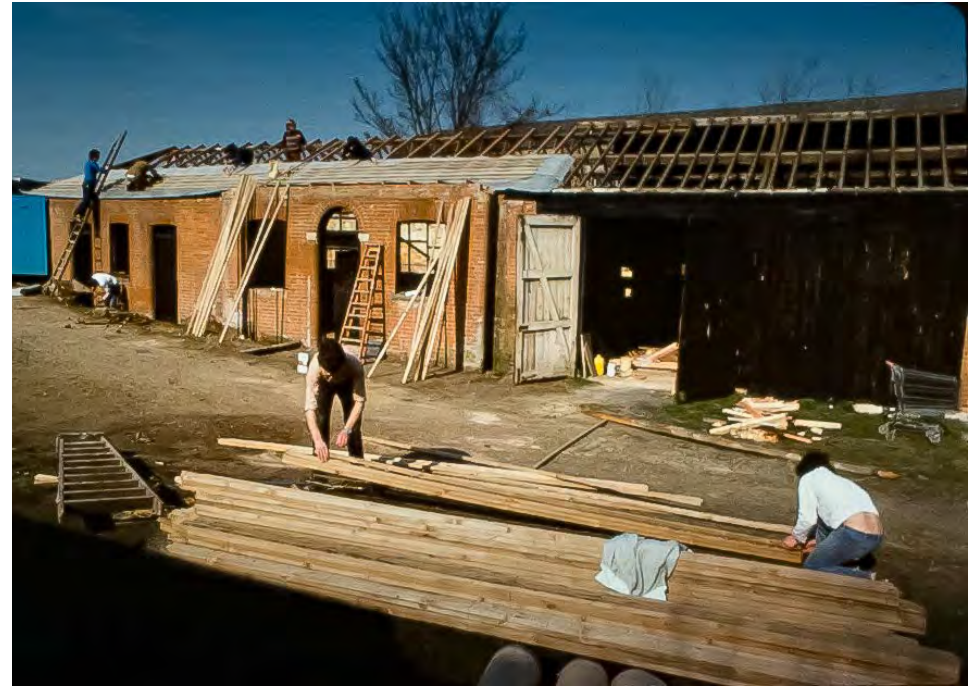
2.24 Replacement of the stable and coach house roof, c.1976 (Grandpont House archives)

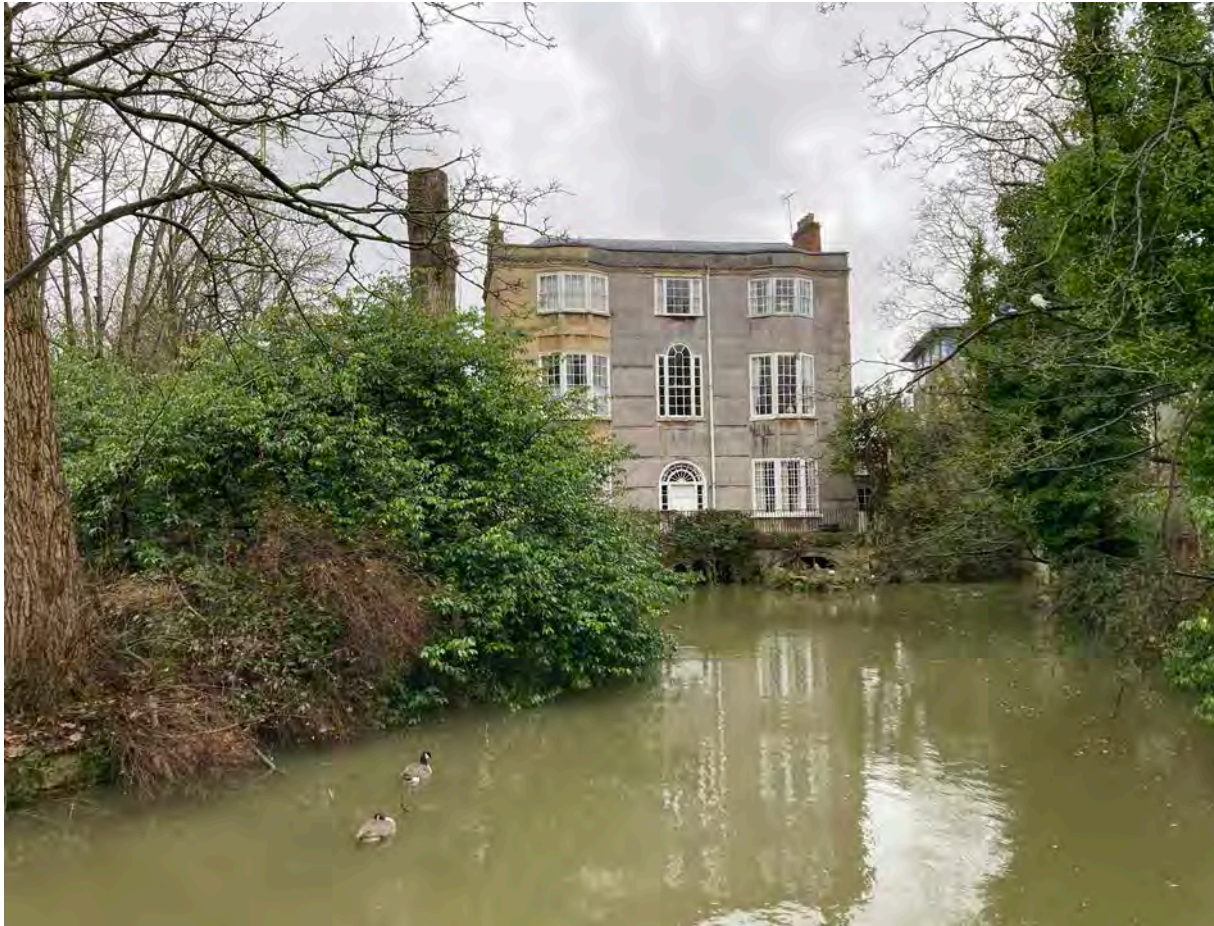
3.1 *The east facade of the main house seen from the river bank of the Thames*

The house was designed to face the Thames and to be seen from it, although as the trees have matured the view of the house is partially obscured. **[Plate 3.1]**. The eastern part of the setting comprises the Thames, the Hogacre Ditch and parts of the landscaped garden. A stream divides the west part of the site into two elements: the garden to the south and the courtyard and out-buildings to the north. **[Plate 3.2]**. The garden features a large number of mature trees, with a lawn in its centre. On the north side the site is bounded by another stream. The courtyard is used for car parking and has a gravel surface on its north side, and a lawn to the south. Behind the south wall of the courtyard is a path leading from Abingdon Road to the rear of the house.

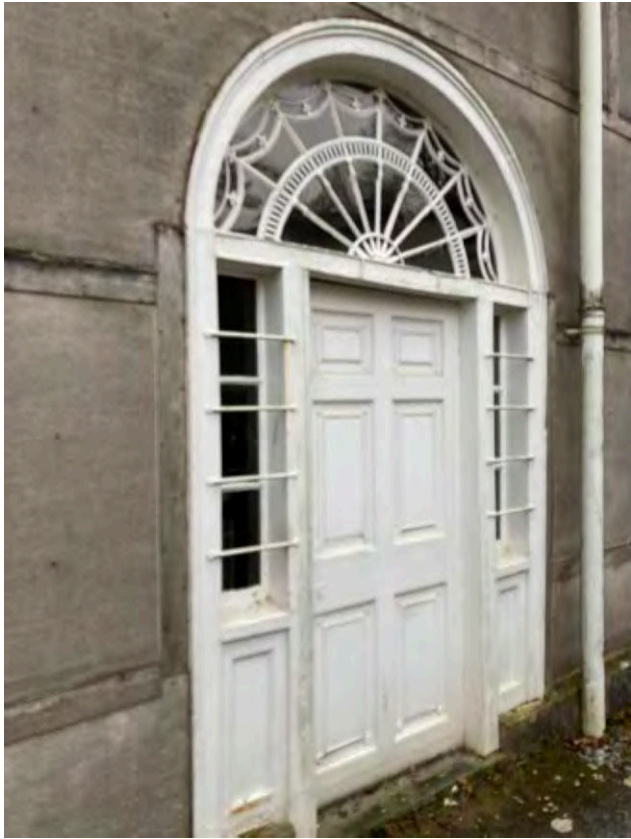
3.4 *The front entrance*

The front elevation is a timber framed facade covered in render, which is channelled to make it appear ashlar like, and where the render has failed (on about two thirds of the facade), plywood has been used as a cladding. The date of the render is unknown. There are horizontal projecting bands at the first floor and second floor levels. It is a symmetrical composition with a central entrance door at ground floor level. Above the entrance is a Palladian (Venetian/Serlian) window at first floor level. At second floor level there is a square window opening with two 6 pane sashes, with side lights with two 2 pane sashes. These central windows light the main staircase. **[Plates 3.1 and 3.4].**

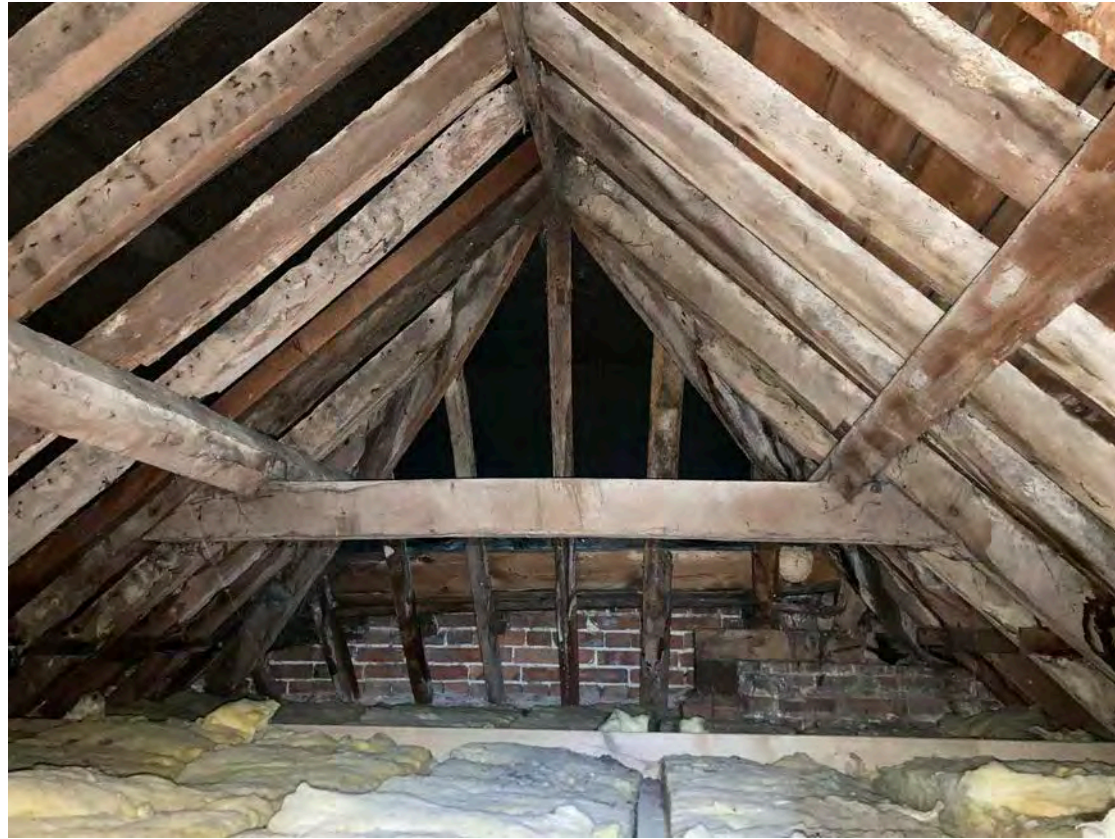
3.8 The interior of the western roof of the east wing looking east

There are two shallow pitched, covered with Spanish slates (installed in the 1980's ?), hipped roofs with their ridges running parallel to the front and rear facades. These are set behind the parapets. These are clasped purlin roofs with substantial rafters and a ridge board. This is consistent with a date of 1785. **[Plate 3.8].**

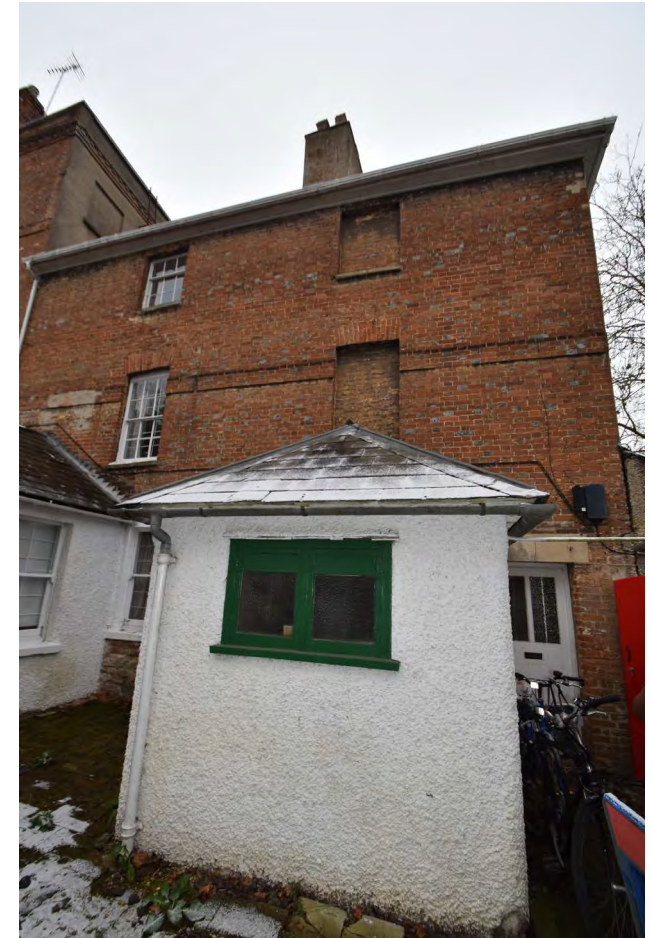
3.15 The north wall of the larder

This extension has three facades, covered with rough cast render (dating from 1911). The east and west are blind walls and the north wall has a single window, comprising two fixed timber sashes. The ridge of the slate covered roof runs north-south and it is hipped at the north end. There is an eaves gutter running around the extension. **[Plate 3.15]**.

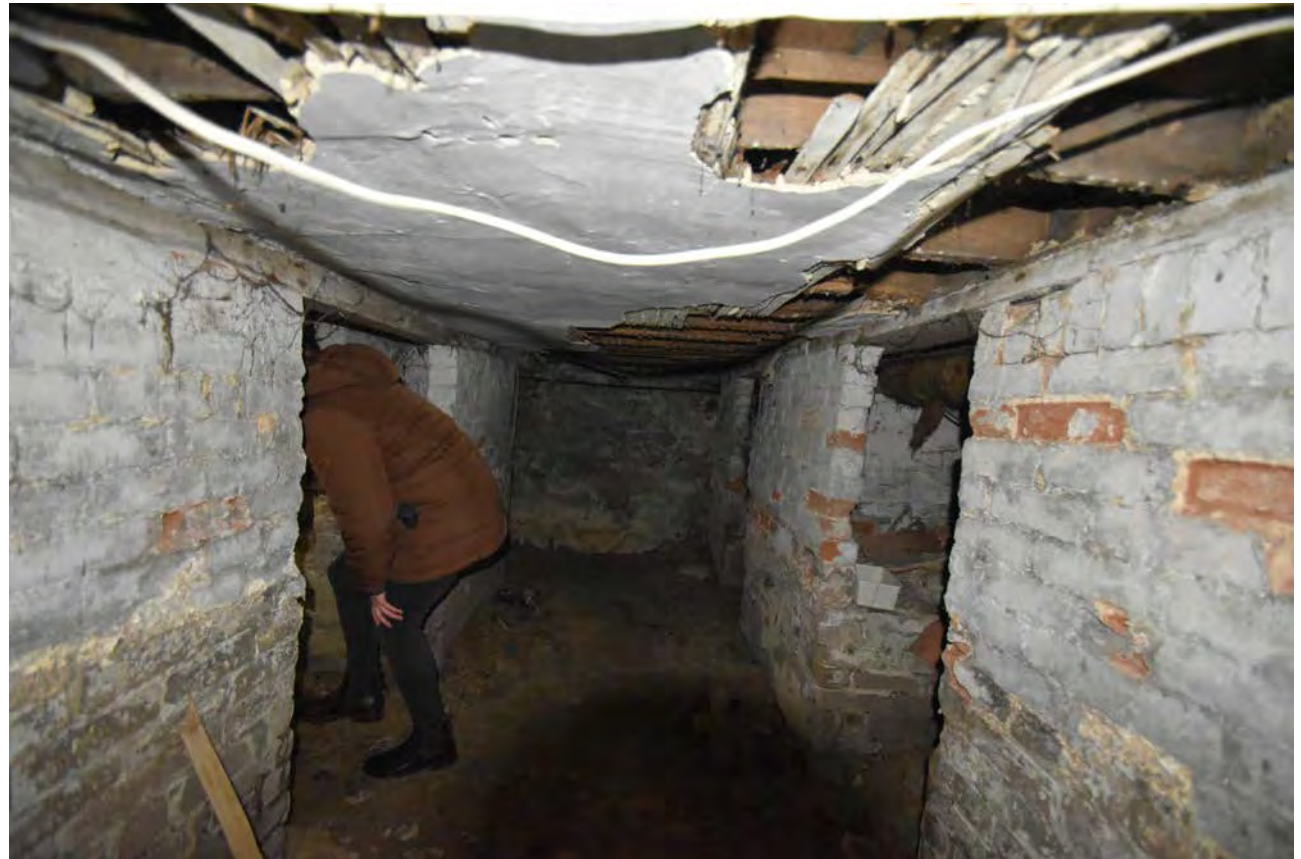
It has a very low floor to ceiling height. There are signs that it once had a lath and plaster ceiling. There is a central corridor with small brick built spaces to the north and south, which may have been for storage, such as wine. The openings to these spaces have timber lintels over them. **[Plate 3.21]** The north wall is made of rubble stone and there is wide brick arch on the south side of the wall, towards its western end.

3.21 *The basement at the north end of the house, looking east*

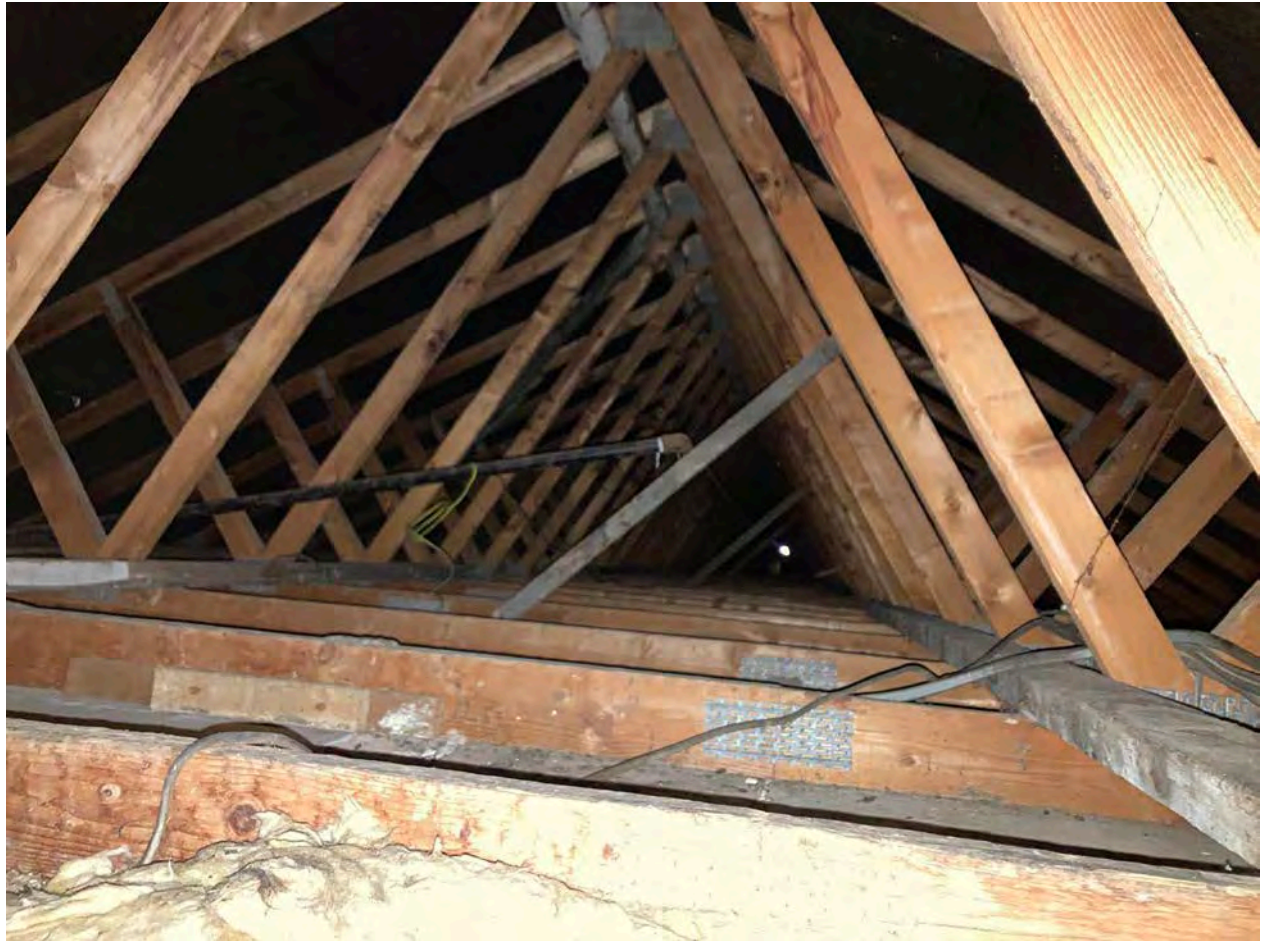
3.47 *The modern roof of the outbuildings*

This appears to be a wholly modern roof structure. The rafters are supported by struts from the base of a central A frame. [Plate 3.47].

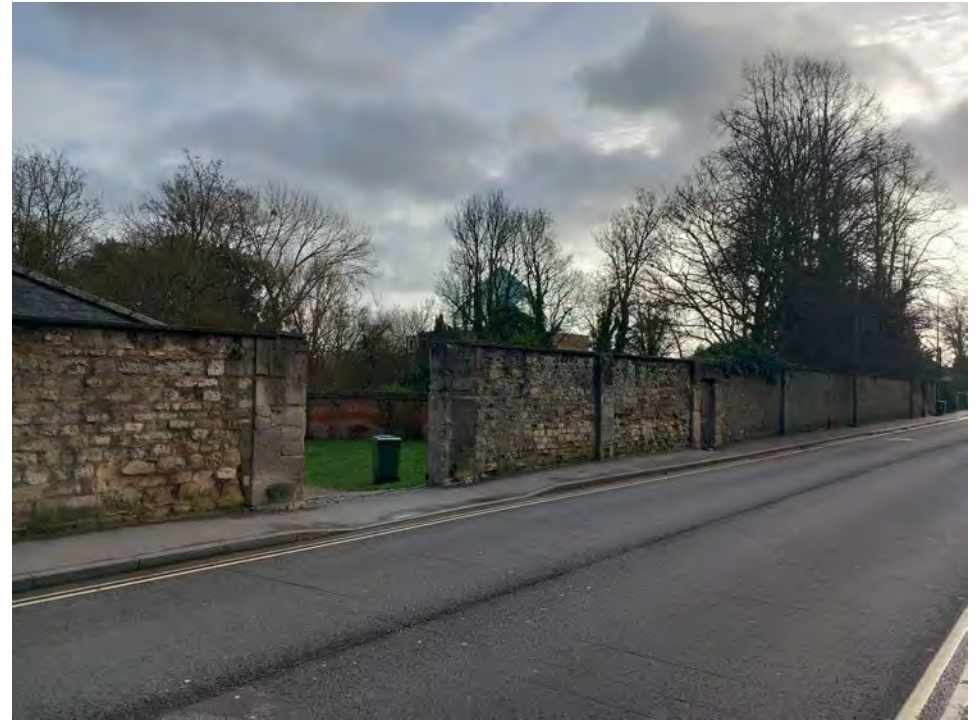
3.50 *The garden wall on Abingdon Road. The entrance to the courtyard is on the left, and the pedestrian entrance on the right.*

coursed stone. The entrances have substantial piers and the pedestrian entrance, with a six panelled door, in poor condition, has a heavy lintel over it. [Plate 3.50].

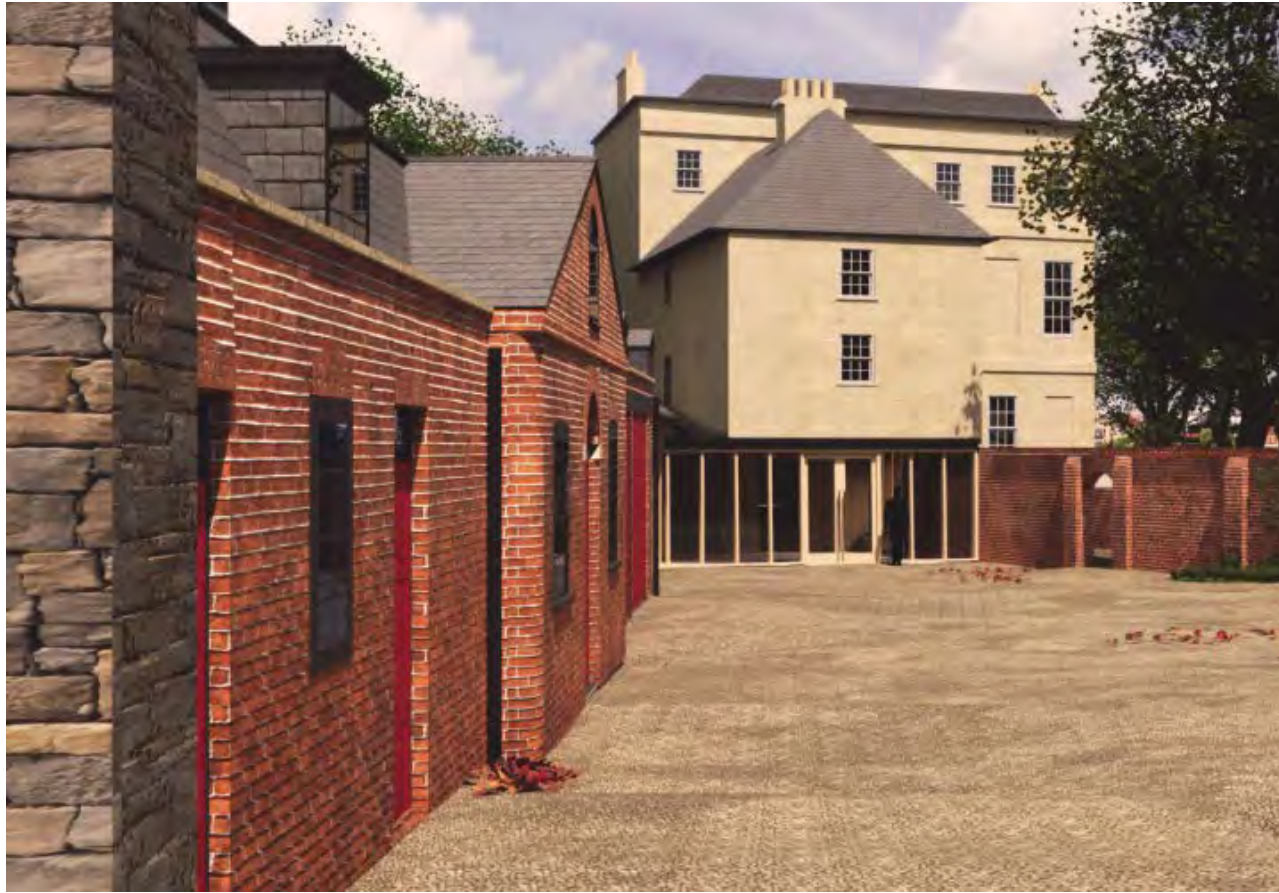
5.1 View of the stables (left) and the new entrance to the house (right) (Studio Stassano)

The front and rear facades are retained along with the main structural internal walls. The ground floor is lowered and the modern roof is replaced by a traditional mansard roof to provide a new floor of accommodation. There will be small projecting traditional dormers in the roof slopes. The missing central gable end on the south facade is reinstated.

The works will not result in harm to the significance of the out-buildings, or the setting of the house. The demolition of the modern roof does not result in the loss of any historic fabric and the proposed mansard roof will be of an appropriate form of extension. The new windows on the north wall will improve its appearance. The reinstatement of the gable is a significant heritage benefit. **[Plate 5.1].**

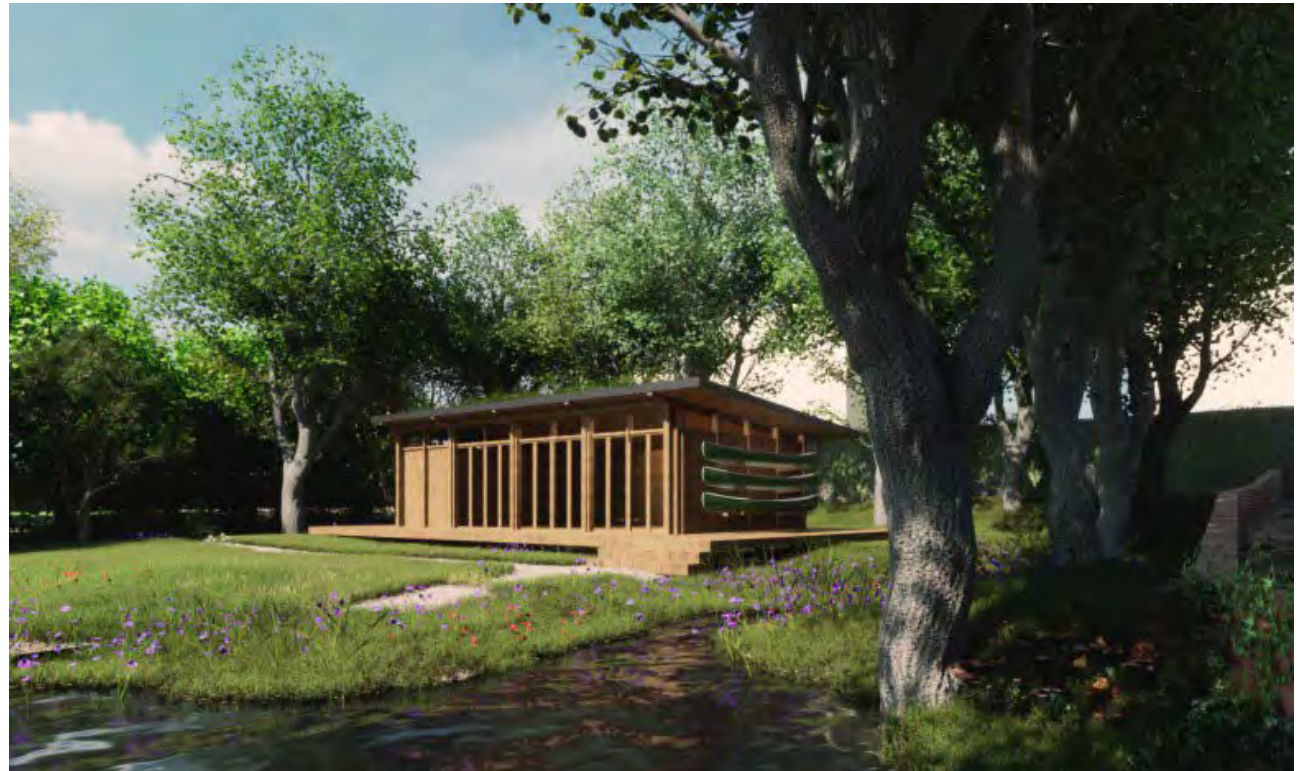
5.3 The proposed boathouse (Studio Stassano)

The proposed building is modest in size, of high design quality, and set well away from the house so that it will not have a harmful impact on the significance of the house or its setting. Neither will it harm to setting of the listed garden wall and the scheduled monument to the west. [Plate 5.3].
