Coal Mining Risk Assessment

1 Douglas Crescent

Report No. A5838/24/CMRA

Report Title:	1 Douglas Crescent, Bonnyrigg, Midlothian Coal Mining Risk Assessment		
Report Reference:	A5838/24/CMRA		
Client:	Esk Homes Ltd		
Issue Date:	11th February 2024		
Drafted By:	M Coleman		
Reviewed By:	A Czarnecki BSc (Hons) FGS, CGeol		
Authorised By:	A Czarnecki BSc (Hons) FGS, CGeol

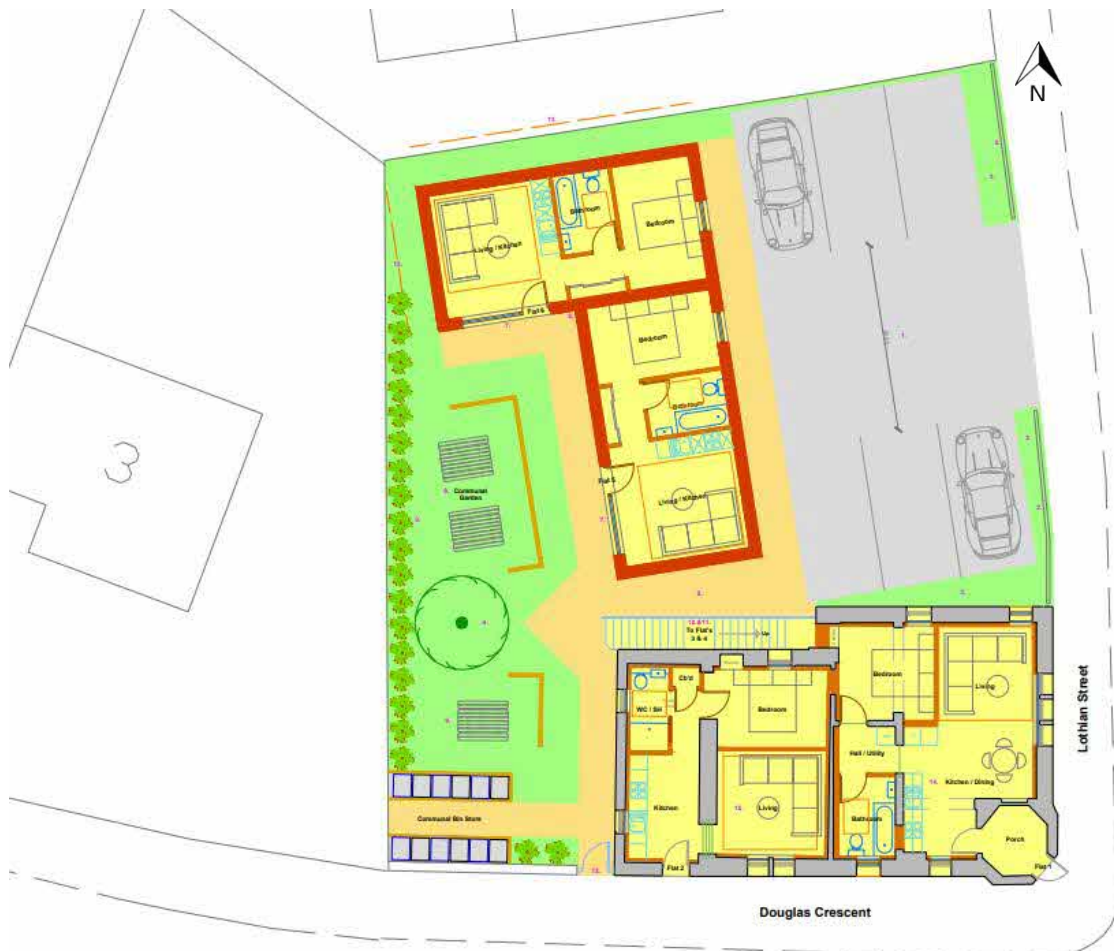
Figure 1: Proposed Development Plan

- 1.1 Earth Environmental & Geotechnical Ltd has been commissioned by Lothian Built Environmental Services on behalf of Esk Homes Ltd (the Client) to undertake a Coal Mining Risk Assessment at The Orchard Centre, 1 Douglas Crescent, Bonnyrigg, Midlothian.
- 1.2 It is understood that the Client intends to convert an existing structure and construct six 1no. bed flats with associated car spacing pedestrian access and landscaping.
- 1.3 A communal bin store and communal garden have also been proposed.
- 1.4 Vehicle access will be gained from Douglas Crescent and/or Lothian Street, Bonnyrigg.
- 1.5 A proposed development plan has been provided and is shown as Figure 1.
