Phase 1 GeoEnvironmental Desk Study

1 Douglas Crescent

Bonnyrigg

Report No. A5838/23

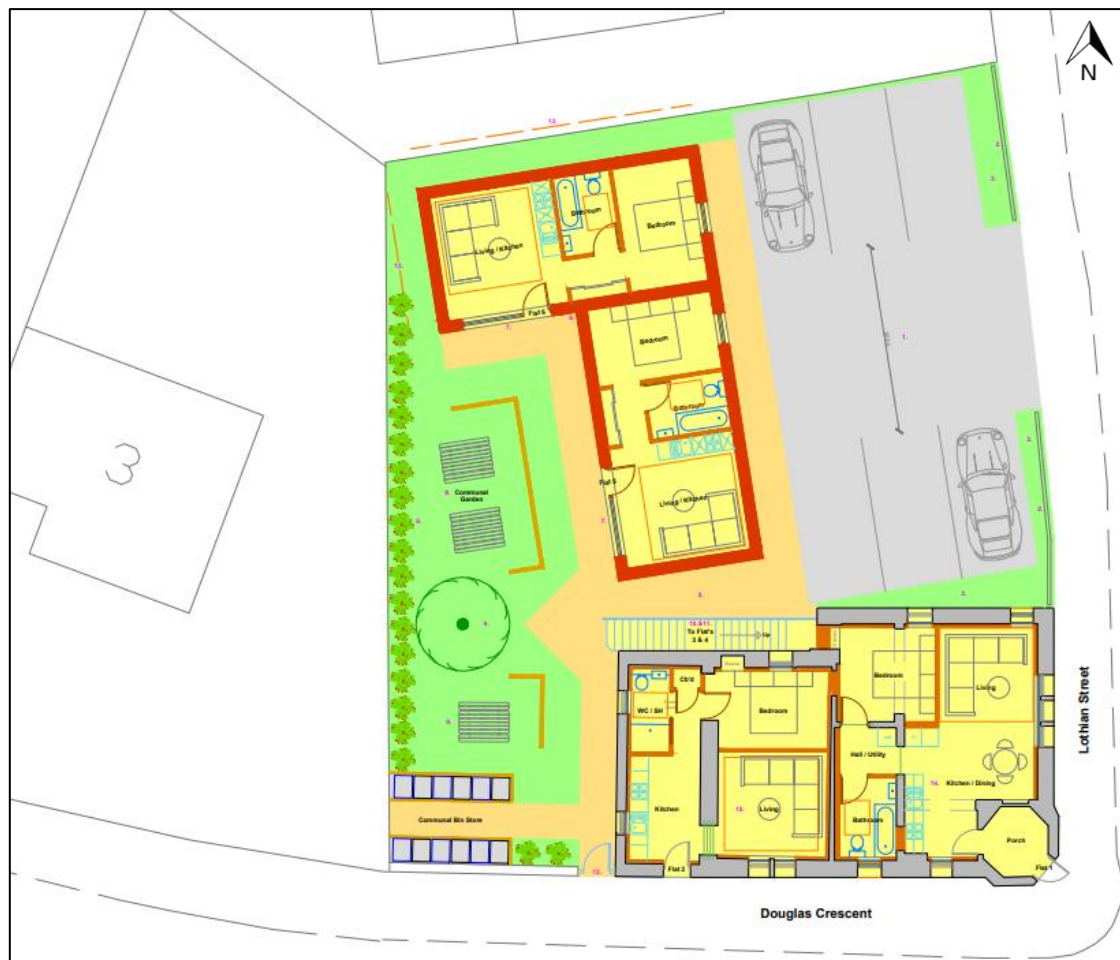
Figure 1 Proposed Development Plan

- 1.1 Earth Environmental & Geotechnical Ltd has been commissioned by Lothian Built Environmental Services on behalf of Esk Homes Ltd (the Client) to undertake a Phase I GeoEnvironmental Desk Study for the proposed development at The Orchard Centre, 1 Douglas Crescent, Bonnyrigg, Midlothian.
- 1.2 It is understood that the Client intends to convert an existing structure and construct six 1 no. bed flats with associated car spacing pedestrian access and landscaping.
- 1.3 A communal bin store and communal garden have also been proposed.
- 1.4 Vehicle access will be gained from Douglas Crescent and/or Lothian Street, Bonnyrigg.
- 1.5 A proposed development plan has been provided and is shown in Figure 1.

- 5.4 The PCM/PRA is based on a proposed residential end use.

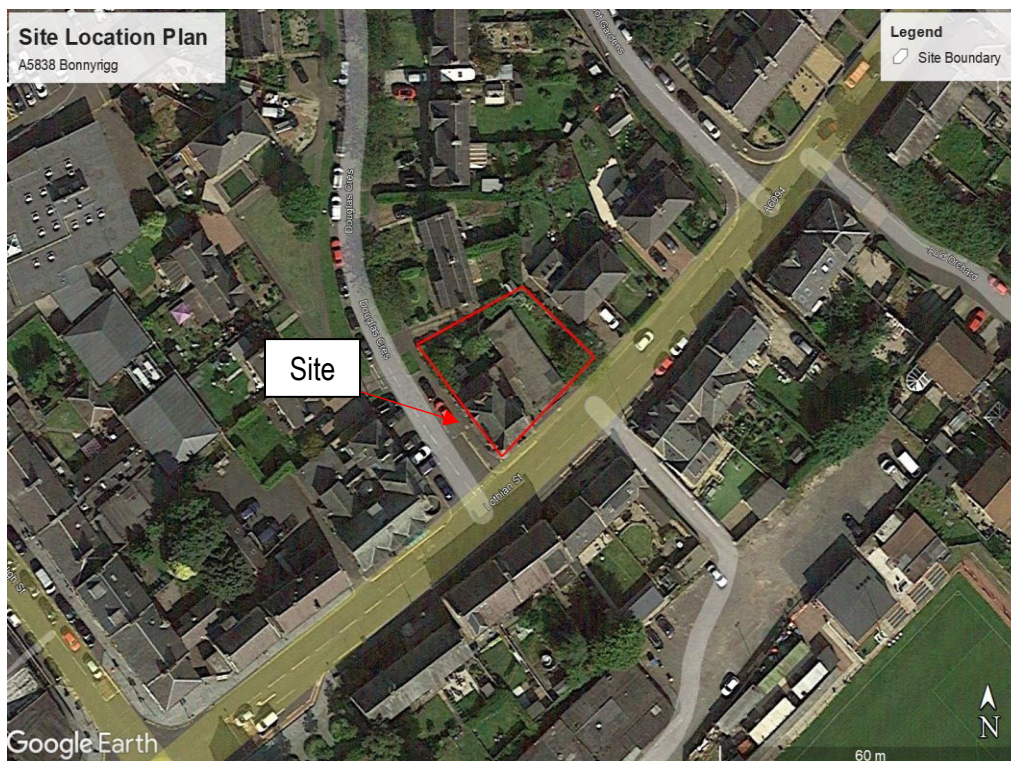
Figure 2 Site Location Plan

- 2.1 The site (0.05 hectares) is located on the corner of Douglas Crescent and Lothian Street, Bonnyrigg, Midlothian, EH19 2DF. The site is situated approximately 80m northwest of Bonnyrigg Rose Football Club.

- 2.8 A location plan is shown below as Figure 2.

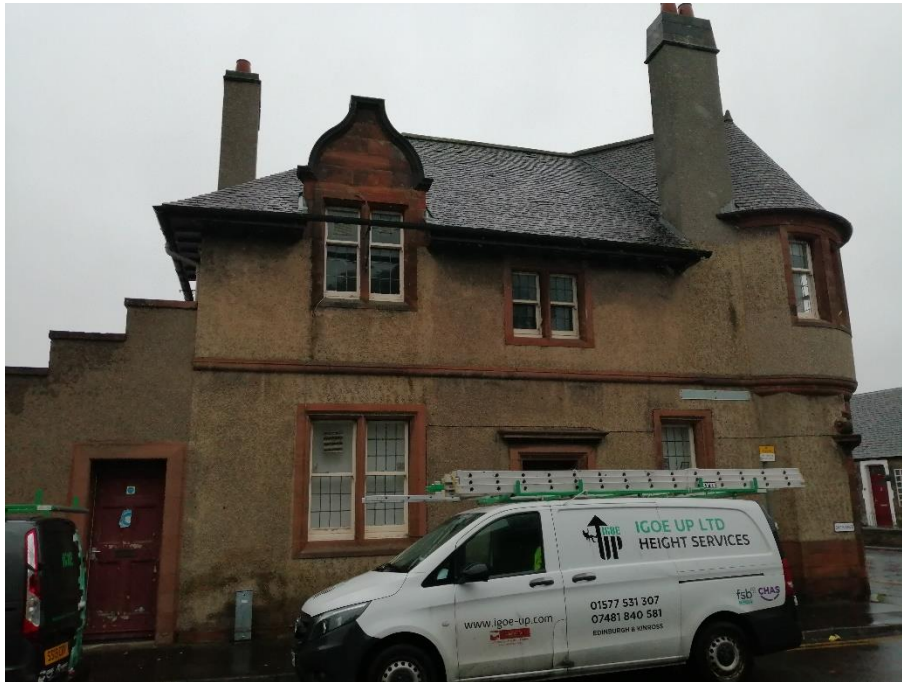
Figure 3 Site Photograph

- 2.2 The approximate National Grid Reference for the centre of the site is NT 30985 65251 (X:330985 Y: 665251).
- 2.3 The site is a rectangular shaped parcel of land which comprises of an existing structure (The Orchard Centre) and soft landscaped areas. The maximum dimensions of the site are 24m east to west and 25m north to south.

- 2.4 The Orchard Centre is a resource centre which provides community-based support across Midlothian, the building also includes a cafe.
- 2.5 The west of the site is adjacent to Douglas Crescent, the south of the site is adjacent to Lothian Street.

- 2.6 The northern and eastern boundaries are adjacent to residential dwellings which are demarcated by a wooden fence.
- 2.7 The general surrounding area comprises of residential dwellings within an urban setting. Bonnyrigg Rose Football Club is 80m southeast of the southern boundary of the site.

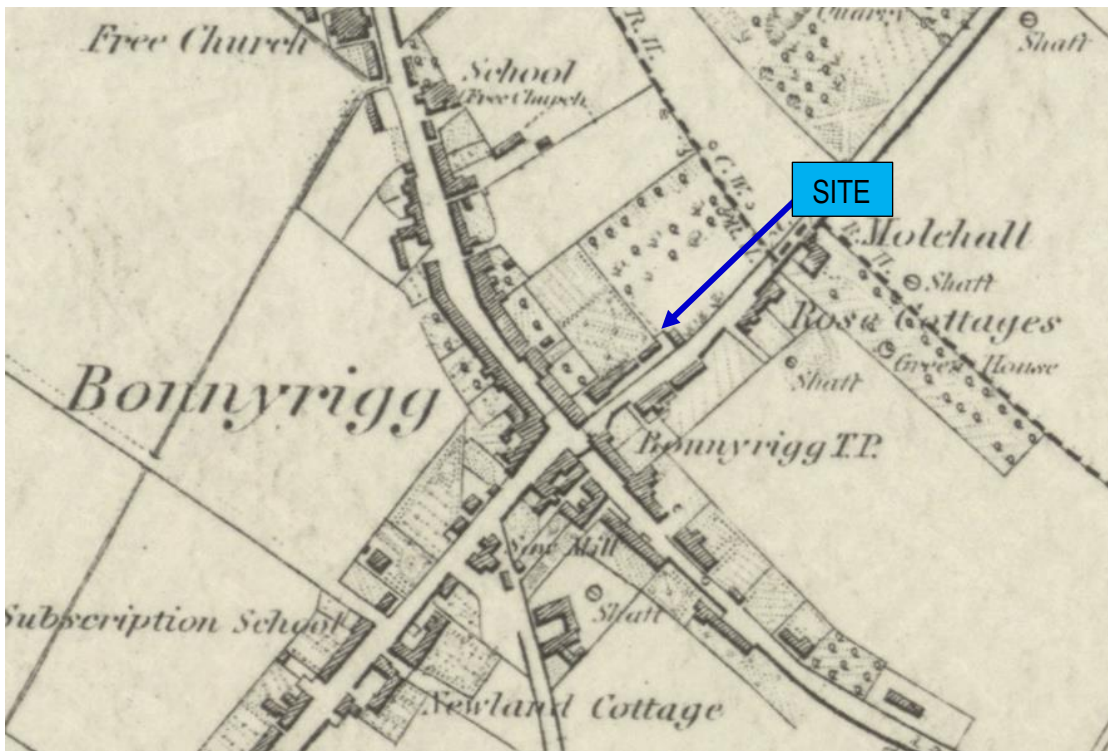
Figure 4 OS Map Extract 1854

Date	On-Site History	Surrounding Land Use History
1854, 1:10,560 1885, 1:63,360	There are structures located on site.	<p>There is a school located 195m north of the site.</p> <p>There is a sawmill located 90m southwest of the site.</p> <p>There is a church located 215m north of the site.</p> <p>There are shafts located 39m south of the site and several more shafts within 500m of the site.</p> <p>There is a sandstone quarry located 286m northeast of the site.</p> <p>There are several other quarries located within 750m of the site.</p> <p>There is a railway line located 400m north of the site.</p> <p>There are several refuse heaps within 500m south of the site.</p> <p>The surrounding area generally comprises of agricultural land.</p>
1894 1:25,000 1895, 1906 1:10,560	Structures have been demolished; site is now unoccupied.	<p>A quarry is located 270m northwest of the site.</p> <p>There is a police station located 250m west of the site.</p> <p>There has been increased residential development within 250m of the site.</p> <p>There has been significant infrastructural change such as roads around the area.</p>

- 5.5 Historically the site has seen structures present on the site from historical records dating back to 1854.
- 5.6 The site appears to have been a government building since its construction in the early 1900's with the plot lying empty until they added the prefabricated timber clad flat roofed extension on.
- 5.7 The immediate surrounding area in 1940's seen significant infrastructure change comprising new roads, including Douglas Crescent and part of the current existing structure. The date of the extension to The Orchard centre is unknown however it can be approximated at around the 1960's.
