Document: Remediation Verification Report

Project: Needham Market Quarry

Reference No.: GN17820_RV40

REMEDIATION VERIFICATION REPORT
FOR REMEDIAL ACTIVITY
AT
NEEDHAM MARKET QUARRY (Plots 87-89)

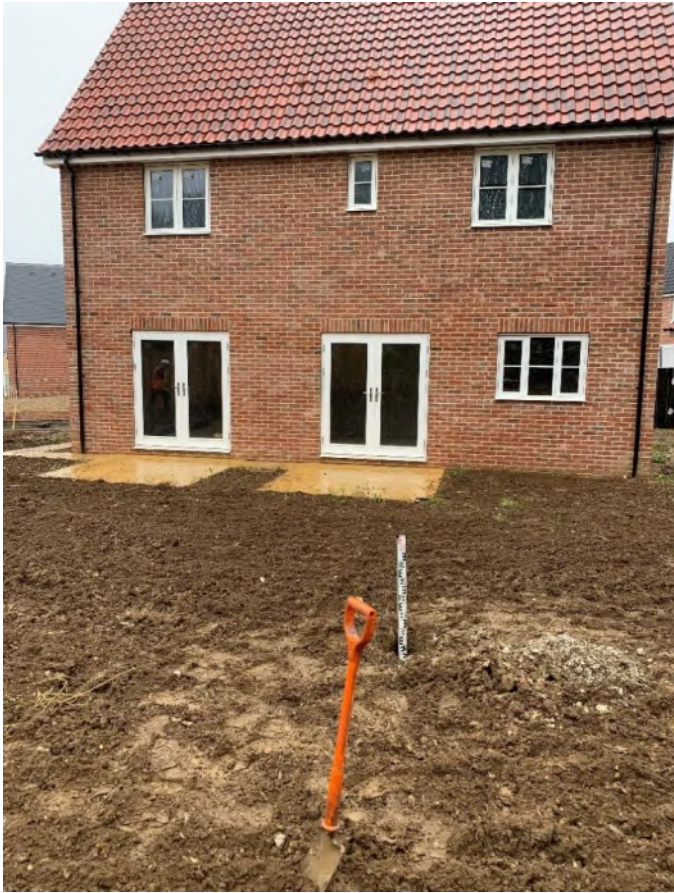
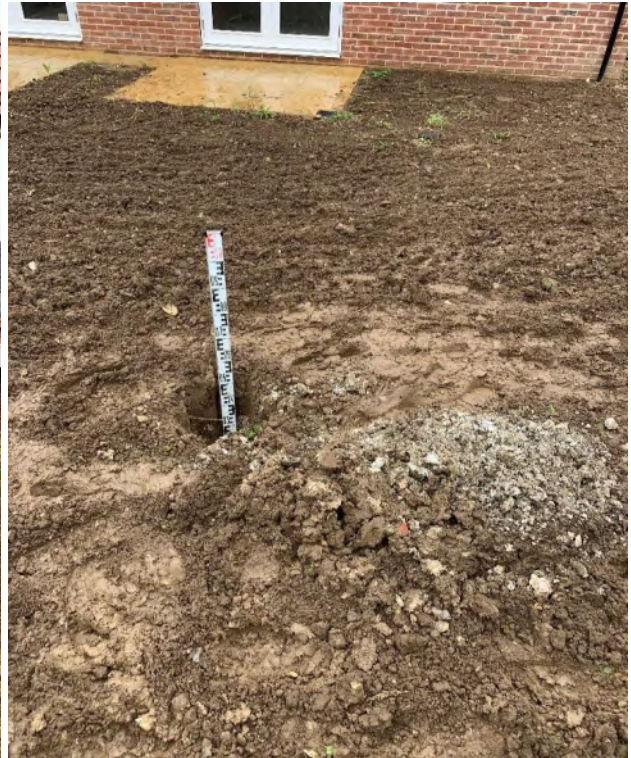
Photographs 1-2, taken on the 01st September 2023 showing examples of hand dug trial pits and the nature of the subsoil and topsoil within the soft landscaping of plot 88 (back garden).

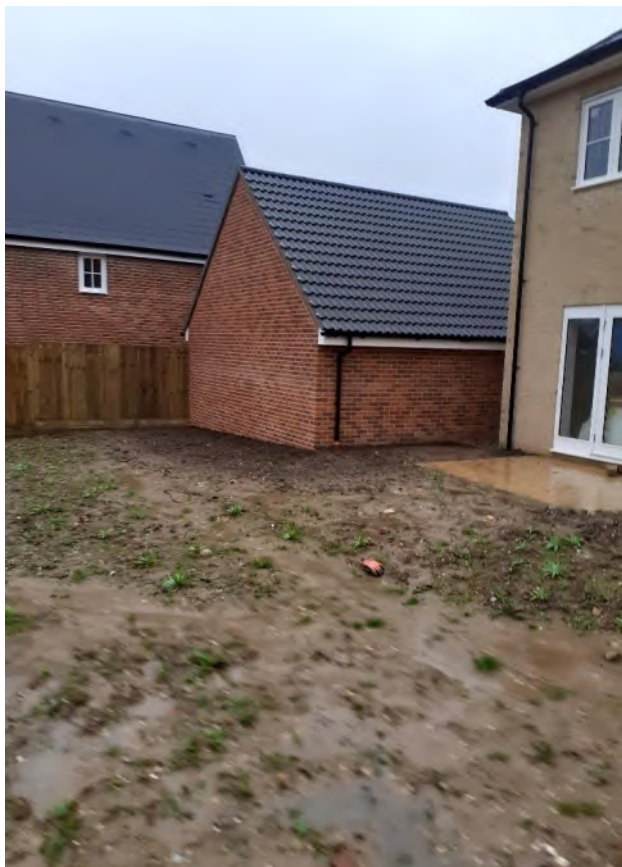
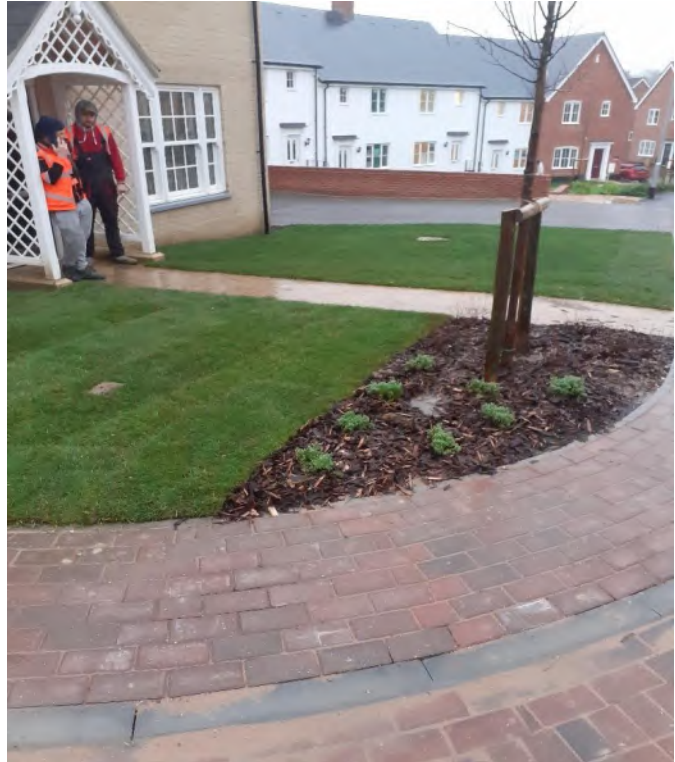
Client Supplied Photographs 3-4, taken on the 22nd January 2024 showing topsoil placement within the front and back garden of plots 89.

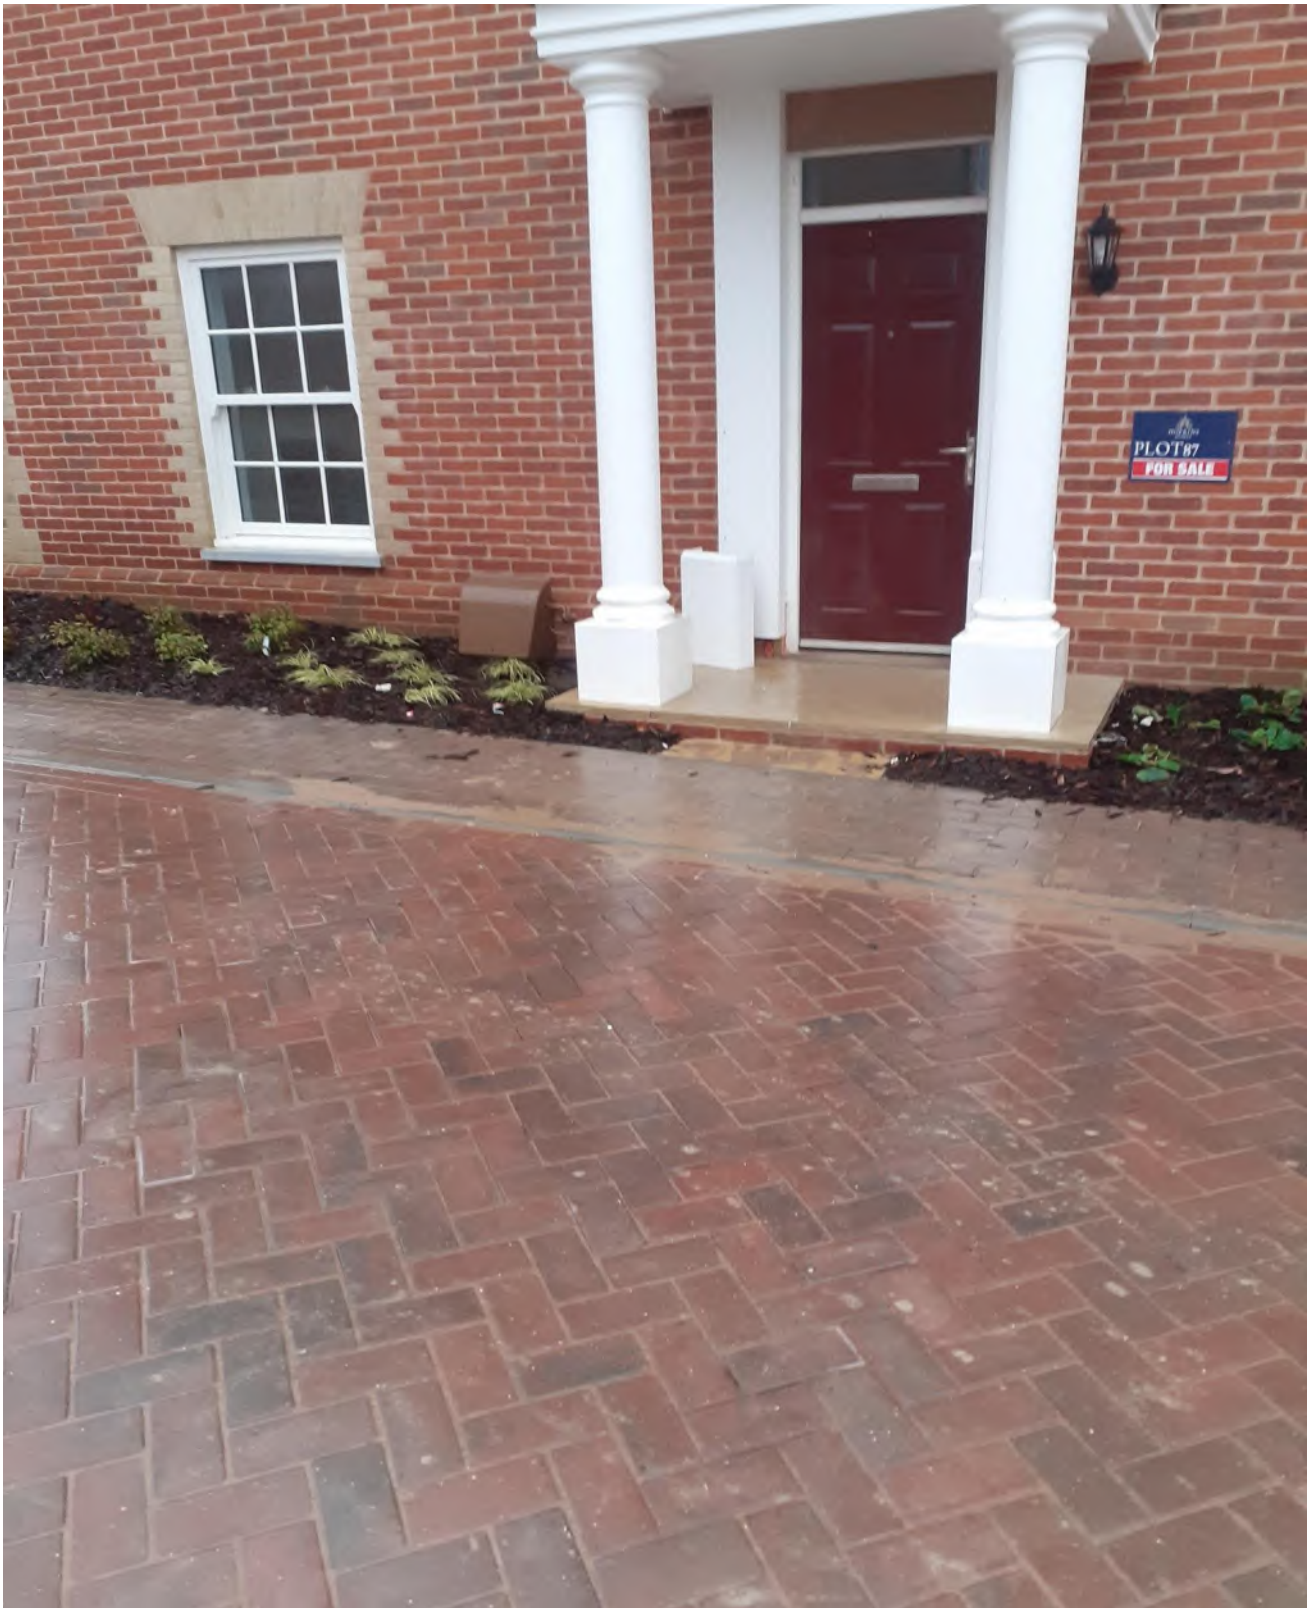
Client Supplied Photographs 5, taken on the 22nd January 2024 showing the front garden of plot 87.
