Document: Remediation Verification Report

Project: Needham Market Quarry

Reference No.: GN17820_RV42

REMEDATION VERIFICATION REPORT
FOR REMEDIAL ACTIVITY
AT
NEEDHAM MARKET QUARRY (Plots 104-108)

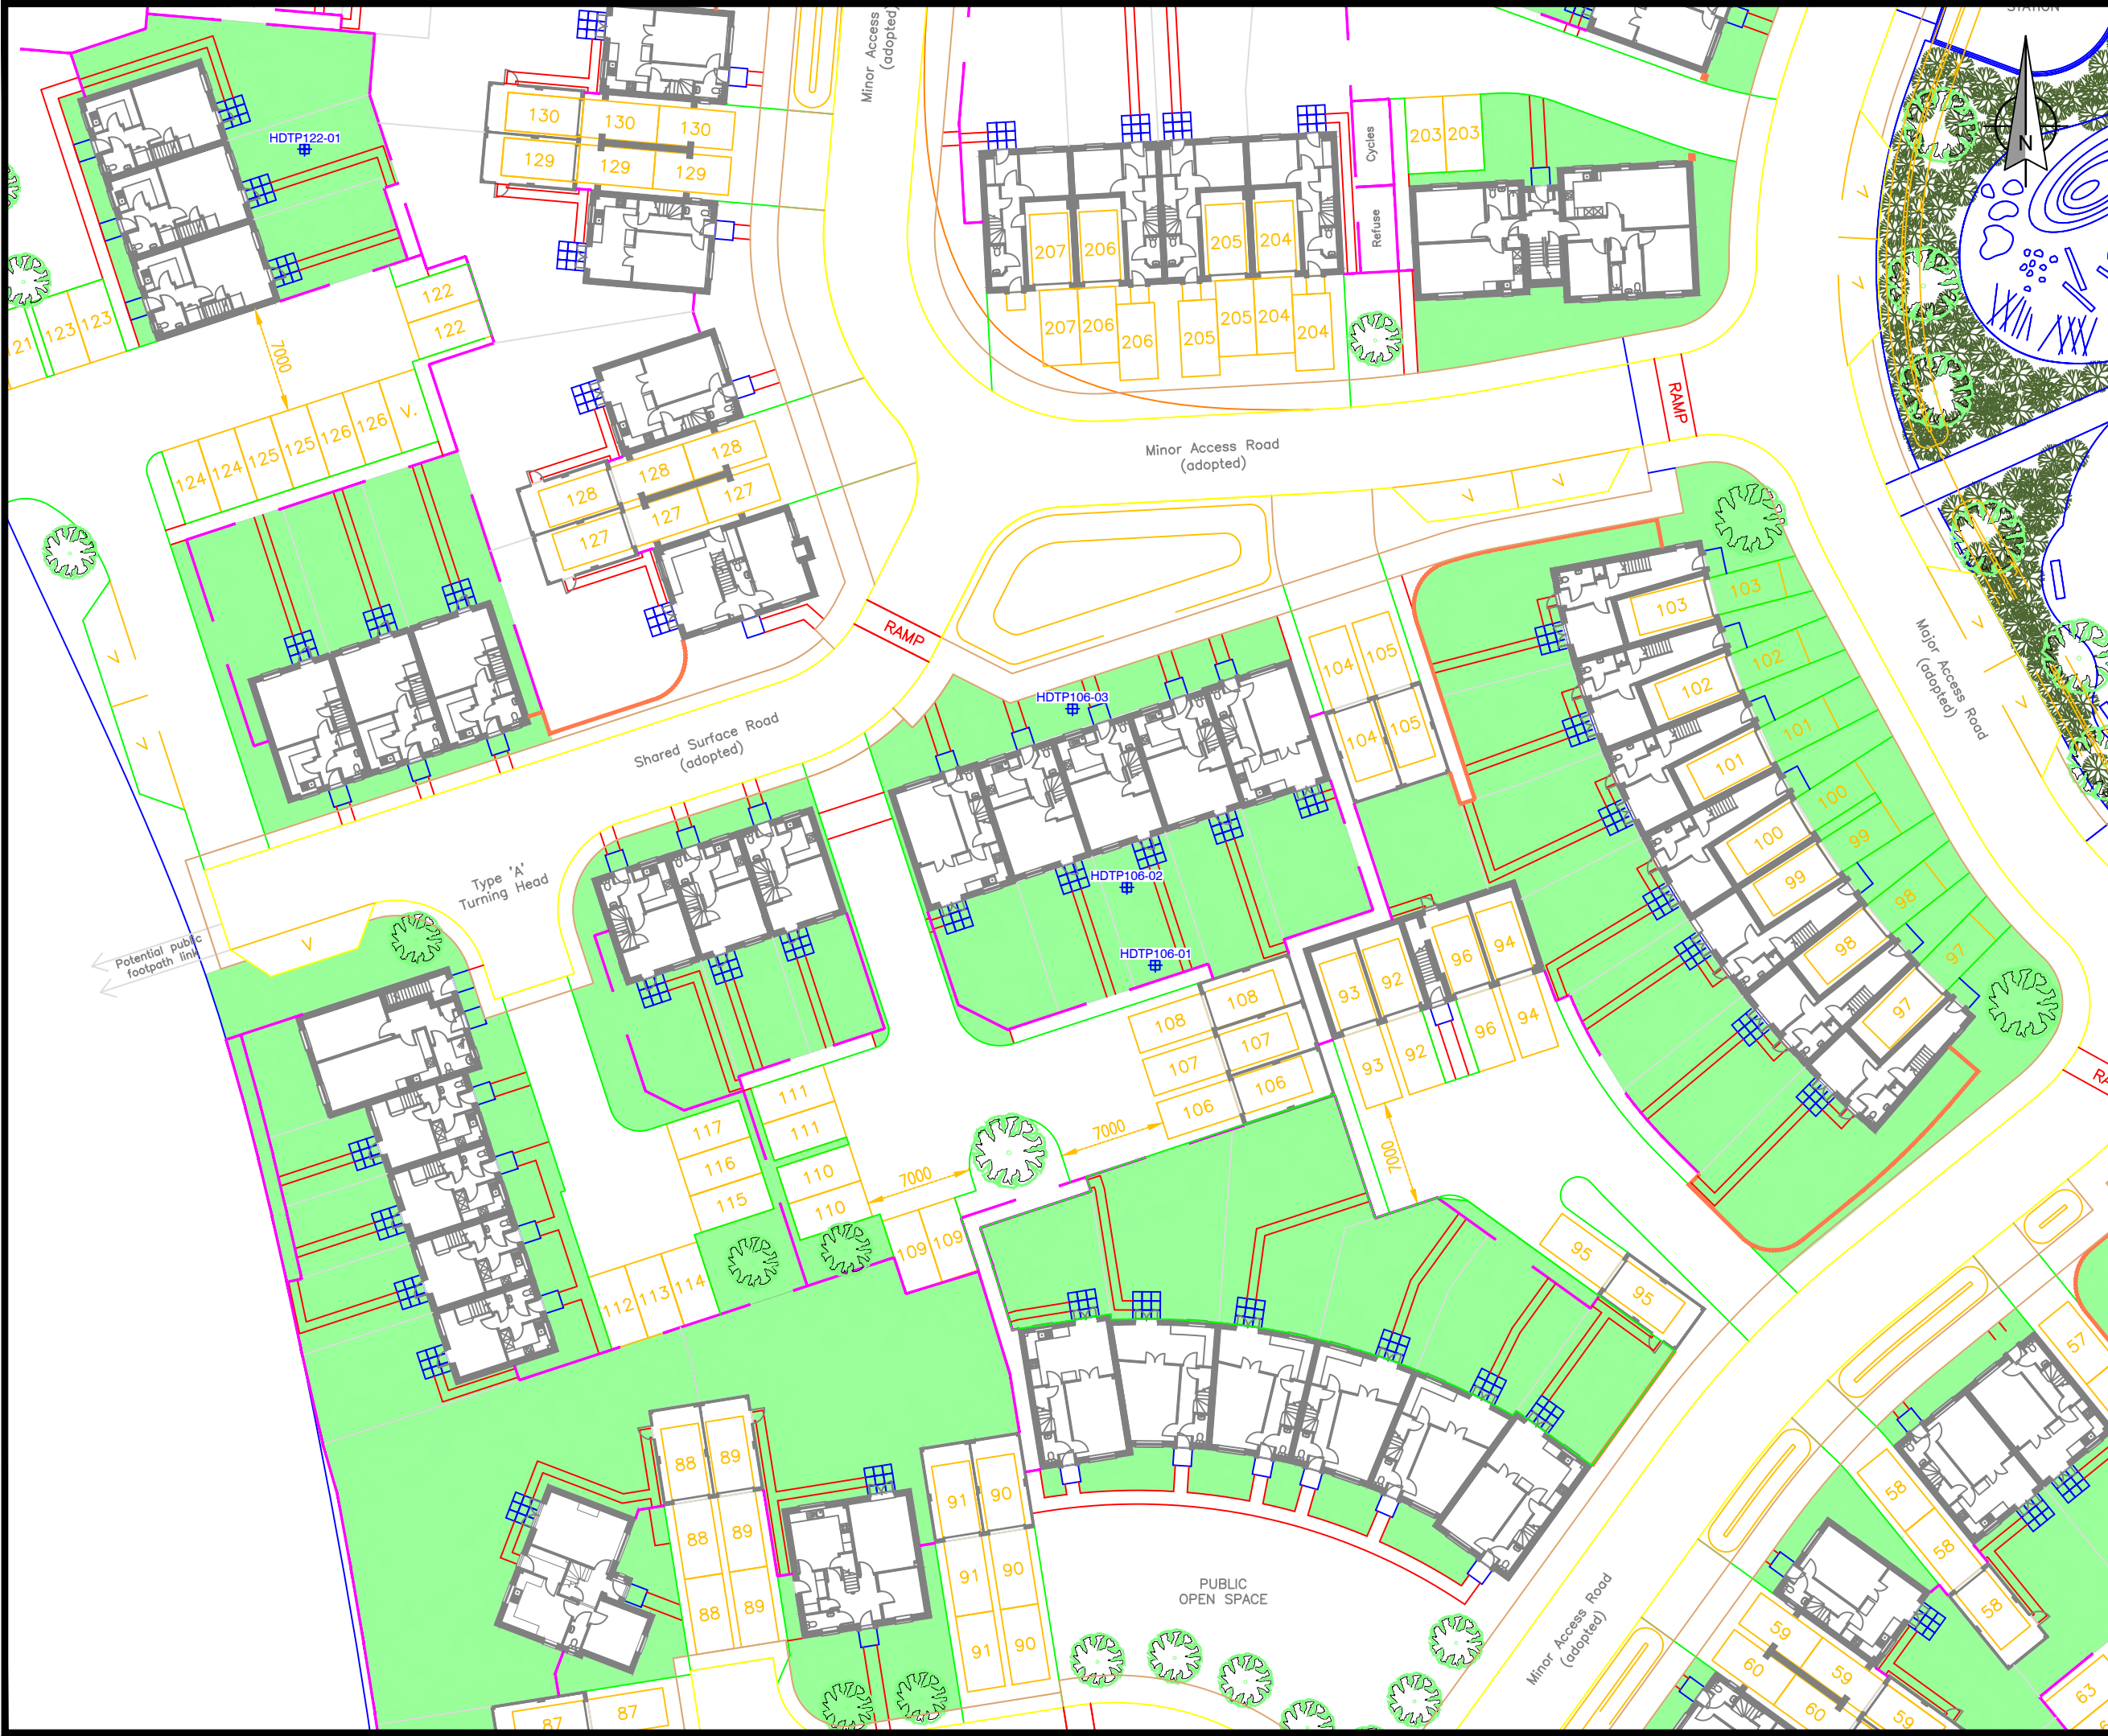
- HDTP90-01 Hand Dug Trial Pit
- Acceptable Cover System

Client: Hopkins Homes Ltd
Project: Needham Market Quarry
Job No: GN17820 **Date:** March 2024
Drawing Title: Fieldwork Location Plan - Plot 104-108
Drawing No: GN17820 - DR502ar
Scale: 1:400 @ A3
Drawn by: RW **Checked by:** CD
Eastings: 609375 **Norings:** 254040

The fieldwork locations are shown on drawings GN17820-DR502ar included within the appendix. Hand excavated trial pits were undertaken to record the thickness and physical descriptions of the materials present and to confirm material suitability.

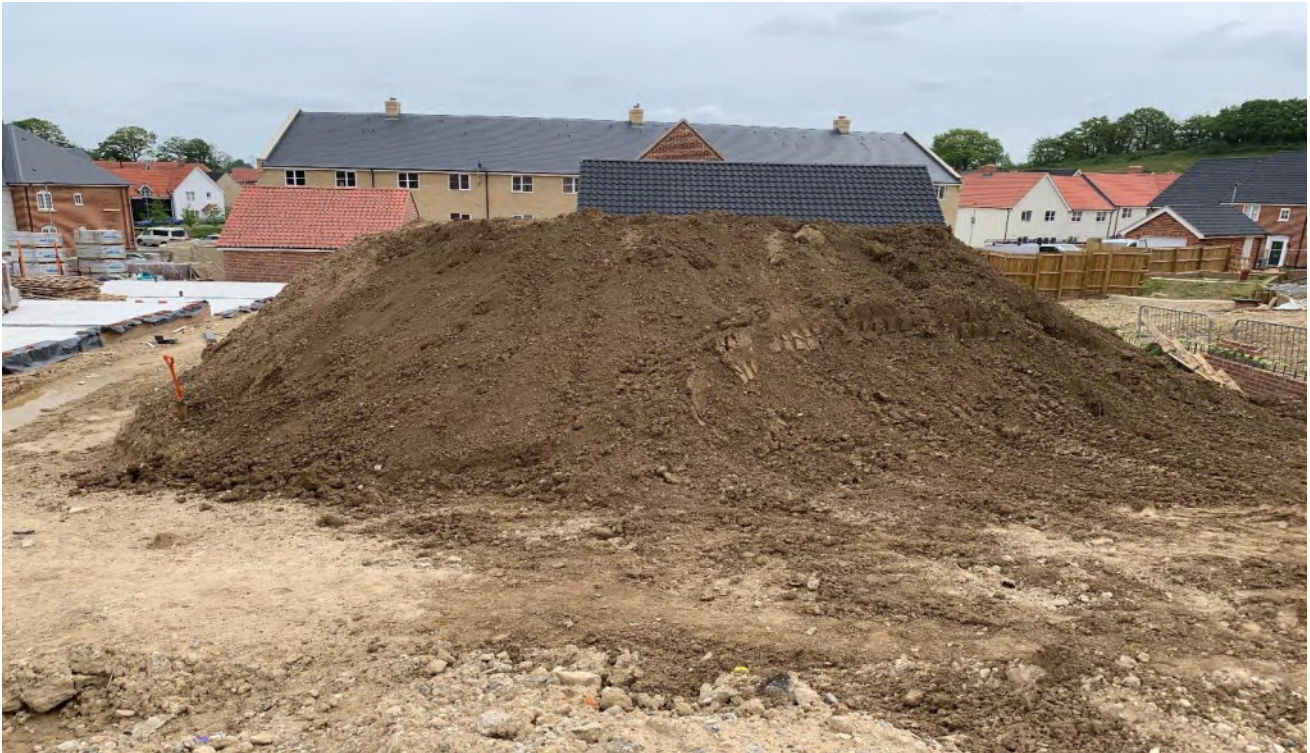
Photograph 1, taken on the 19th May 2023 showing stockpile TS1 within the future plots of 104-108. Photograph taken looking towards the East.

HGE were made aware that topsoil stockpile S02 had been used and that a new topsoil stockpile (TS1) had been created during onsite earthworks undertaken at the beginning of 2023. Testing was therefore required to confirm the suitability for site use. The stockpile of site won topsoil had been placed within the development area of plots 104-108. An HGE engineer visited site on 19th May 2023 to visually assess the stockpile and to collect representative soil samples for chemical analysis at an appropriately accredited laboratory (to confirm material suitability). On visual inspection the material was deemed physically suitable for use as a topsoil, as the soil appeared to be an appropriate consistency for use in garden areas. The material within TS1 was described as dark brown slightly gravelly silty fine to medium SAND. Gravel is sub-angular to sub-rounded fine to coarse flint with occasional chalk and rare brick. A total of five samples were submitted to a laboratory in May 2023 for testing of a general suite of contaminants and an asbestos screen. No asbestos was detected, and the levels of all other contaminants were below the site criteria. The results of the chemical analysis are appended to this report (test report ref.: 23-16989-1, dated 09th June 2023).

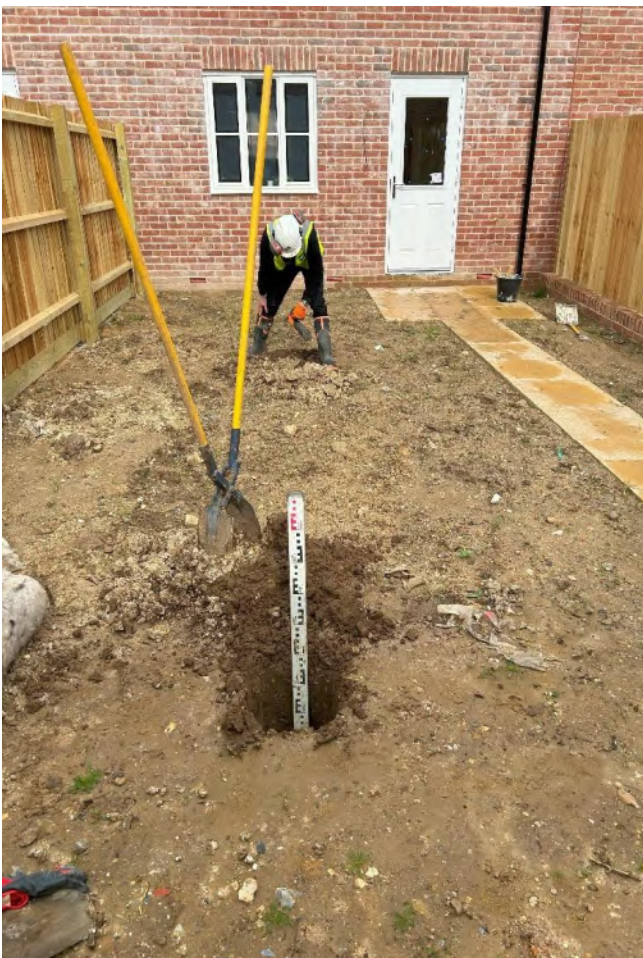
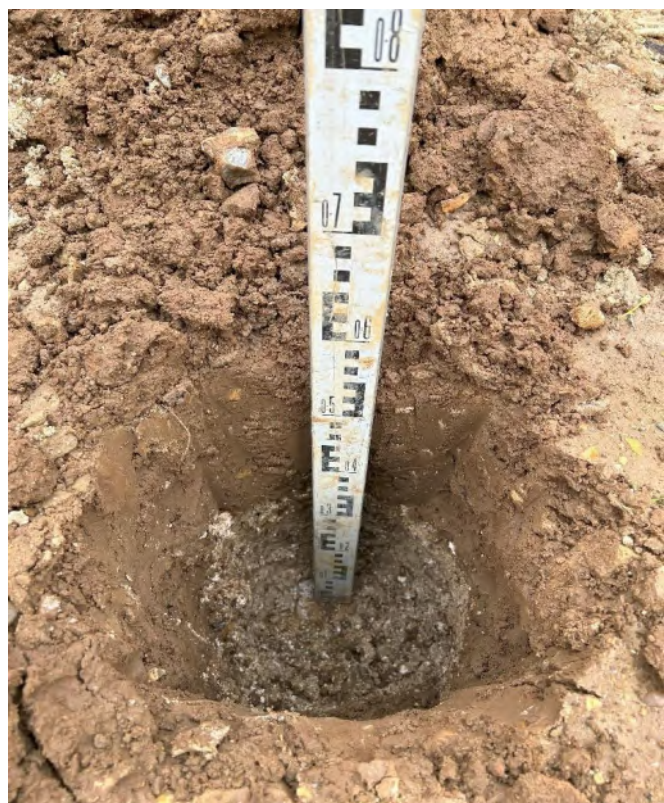
Photographs 2-3, taken on the 20th March 2024 showing verification hand dug trial pits in rear garden of plot 106. Photographs taken looking towards the North.

The thickness of suitable soil was recorded to be at least 600mm within the trial pits completed.

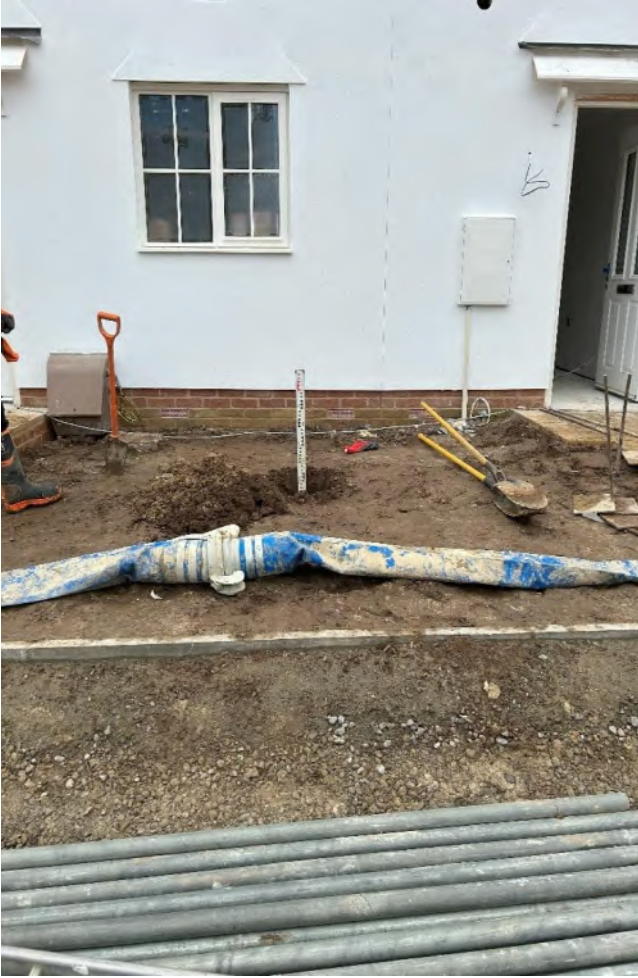
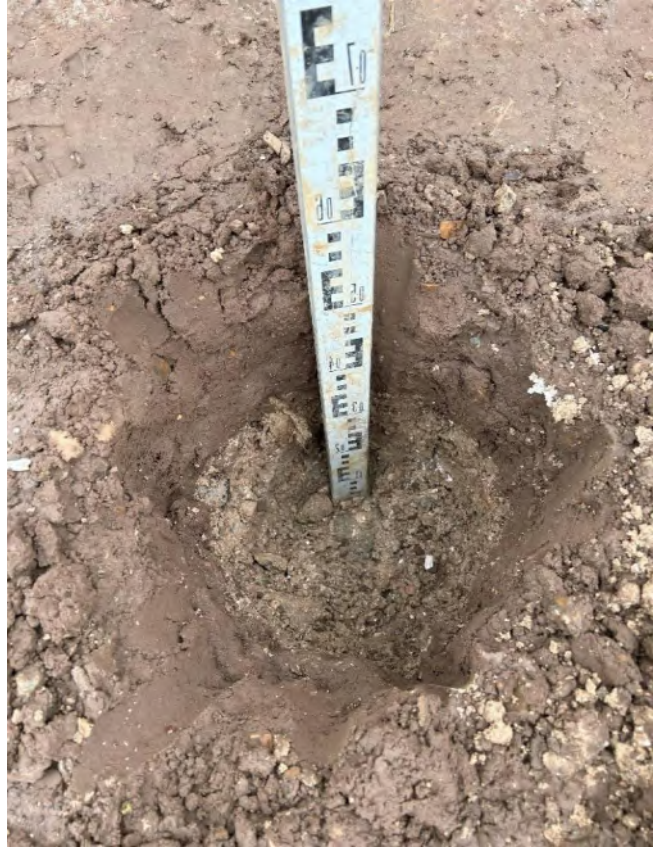
- MADE GROUND. Light brown slightly sandy gravelly CLAY. Gravel is sub-angular to rounded fine to coarse chalk, flint and rare brick. A cobble of concrete was identified at 0.6m within HDTP106-03.

Photographs 4-5, taken on the 20th March 2024 showing verification hand dug trial pit in front garden of plot 106 (HDTP106-03). Photographs taken looking towards the South.

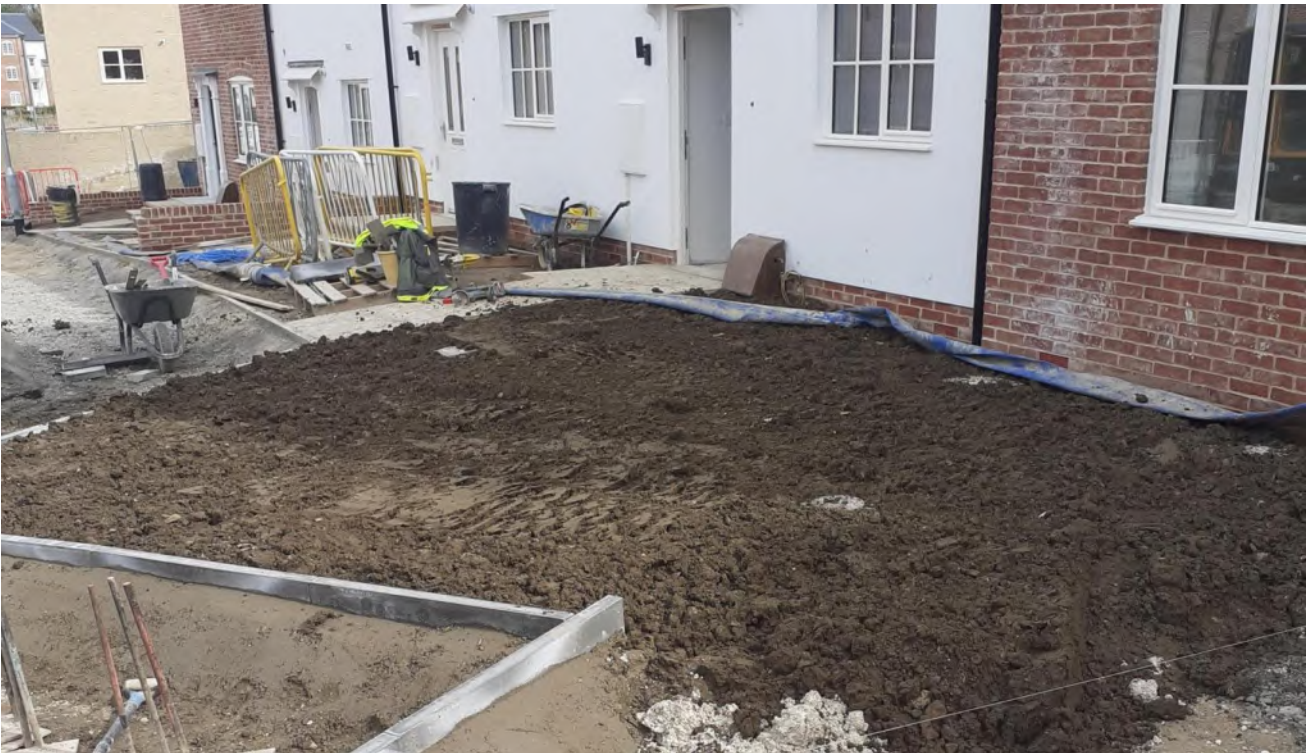
- Concrete edging was observed adjacent to footpaths and curb sides at approximately 45° angle.
- At the time of the site visit topsoil had not been placed within the front gardens of plots 107 and 108. However, since our site visit HH have provided photographs of the topsoil being placed within these plots, which have been reviewed and are deemed suitable.

Photograph 6, taken by the client on 12th April 2024 showing topsoil placement within the front gardens of plots 107 and 108. Photograph taken looking towards the Southeast.
