# **Historic Impact Assessment**

<u>Hidcote Manor Garden – Re-thatching of Thatched Barn</u>

Hidcote Manor Garden Hidcote Bartrim Chipping Campden Glos GL55 6LR

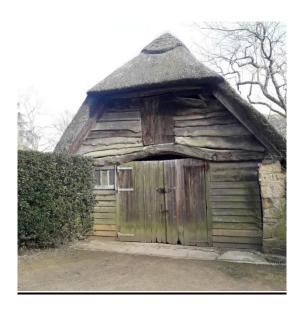
1. West Elevation

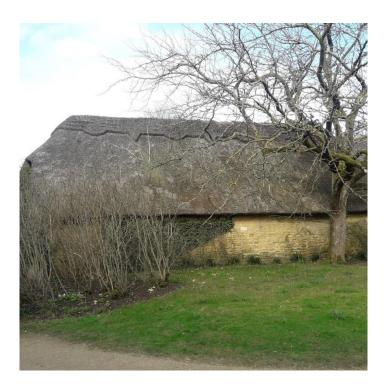
2. South Elevation, showing close proximity of Davidia tree

The barn is overhung by a large, mature *Davidia* tree which contributes to the damaging build-up of moss and localised destruction due to branch contact in windy weather. Whilst some very minor pruning of the tree is acceptable, this tree is a significant feature in its own right and major pruning could cause harm and is therefore unacceptable to the National Trust. There is a smaller *Prunus* tree on the north side of the building which also causes issues with moss build-up and branch damage. The roof is currently covered in chicken wire and this detail will be reinstated to provide some protection to the thatch from impact damage and birds (jackdaws are prevalent in the area).

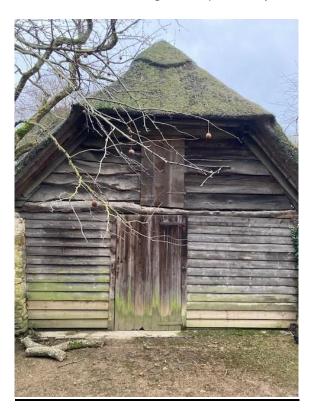
3. East Elevation

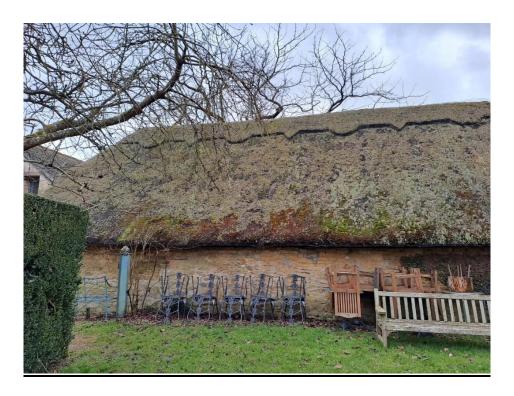
4. North Elevation, showing close proximity of Prunus tree

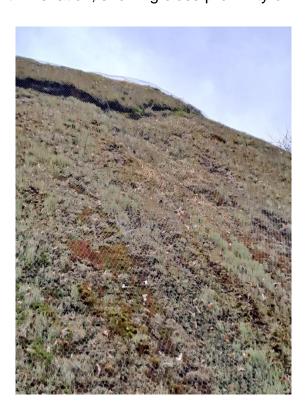
In 2022/23 plans were made to re-thatch the ridge and carry out patch repairs elsewhere on the roof. However, when the thatcher started work, he discovered that the condition of the existing thatch was much worse than first thought and a full re-thatch was recommended.

5. Close up of thatch condition

The main roof thatch will be replaced like-for-like with water reed. The block ridge will be renewed like-for-like with combed wheat reed, retaining the existing pattern of scallops and diamonds. Traditional wooden spars will be used to fix the layers of thatch in situ. The roof membrane will be replaced like-for-like.

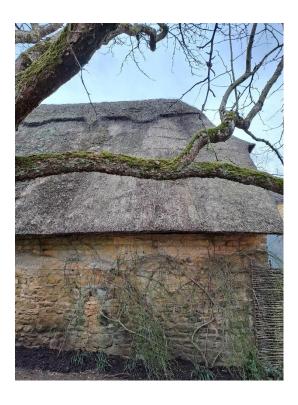
6. Eastern End of South Elevation

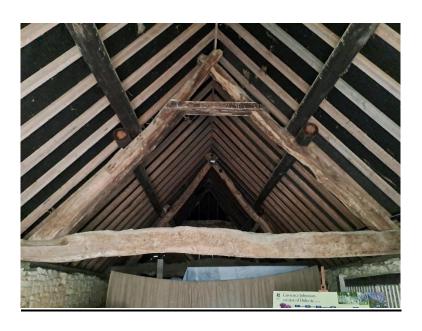
The Thatched Barn is a single storey building with a half-hipped roof supported above huge cross-beams (unusual curved-shaped tree trunks) spanning the space between the north and south walls, with trusses above. The purlins are relatively smooth, round-wood poles. The roof timbers have been substantially repaired and the rafters were replaced in the 1960s. Some beams are now supported on internal brick piers built inside the rubble walls. The main roof is thatched in water reed and the block ridge is thatched in combed wheat reed, incorporating scalloped and diamond shapes.

7. Internal view of roof timbers

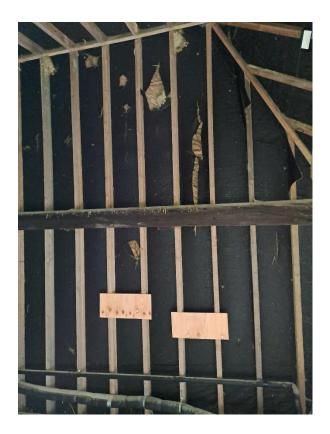
8. Torn traditional felt membrane

- Careful removal of the existing chicken wire and thatch;
- Replacement of the existing felt membrane, which is torn in numerous places, with new traditional felt membrane:
- Recovering of roof using new thatch to match the existing material and details;
- Installation of new chicken wire to protect the thatch
