Factual Geotechnical Site Investigation Report

Culls Farm,
Dean Street,
Maidstone,
ME15 0PS

Culls Development Ltd

Ref: 5750 23 03 06 Rpt 01 Rev B RC NS

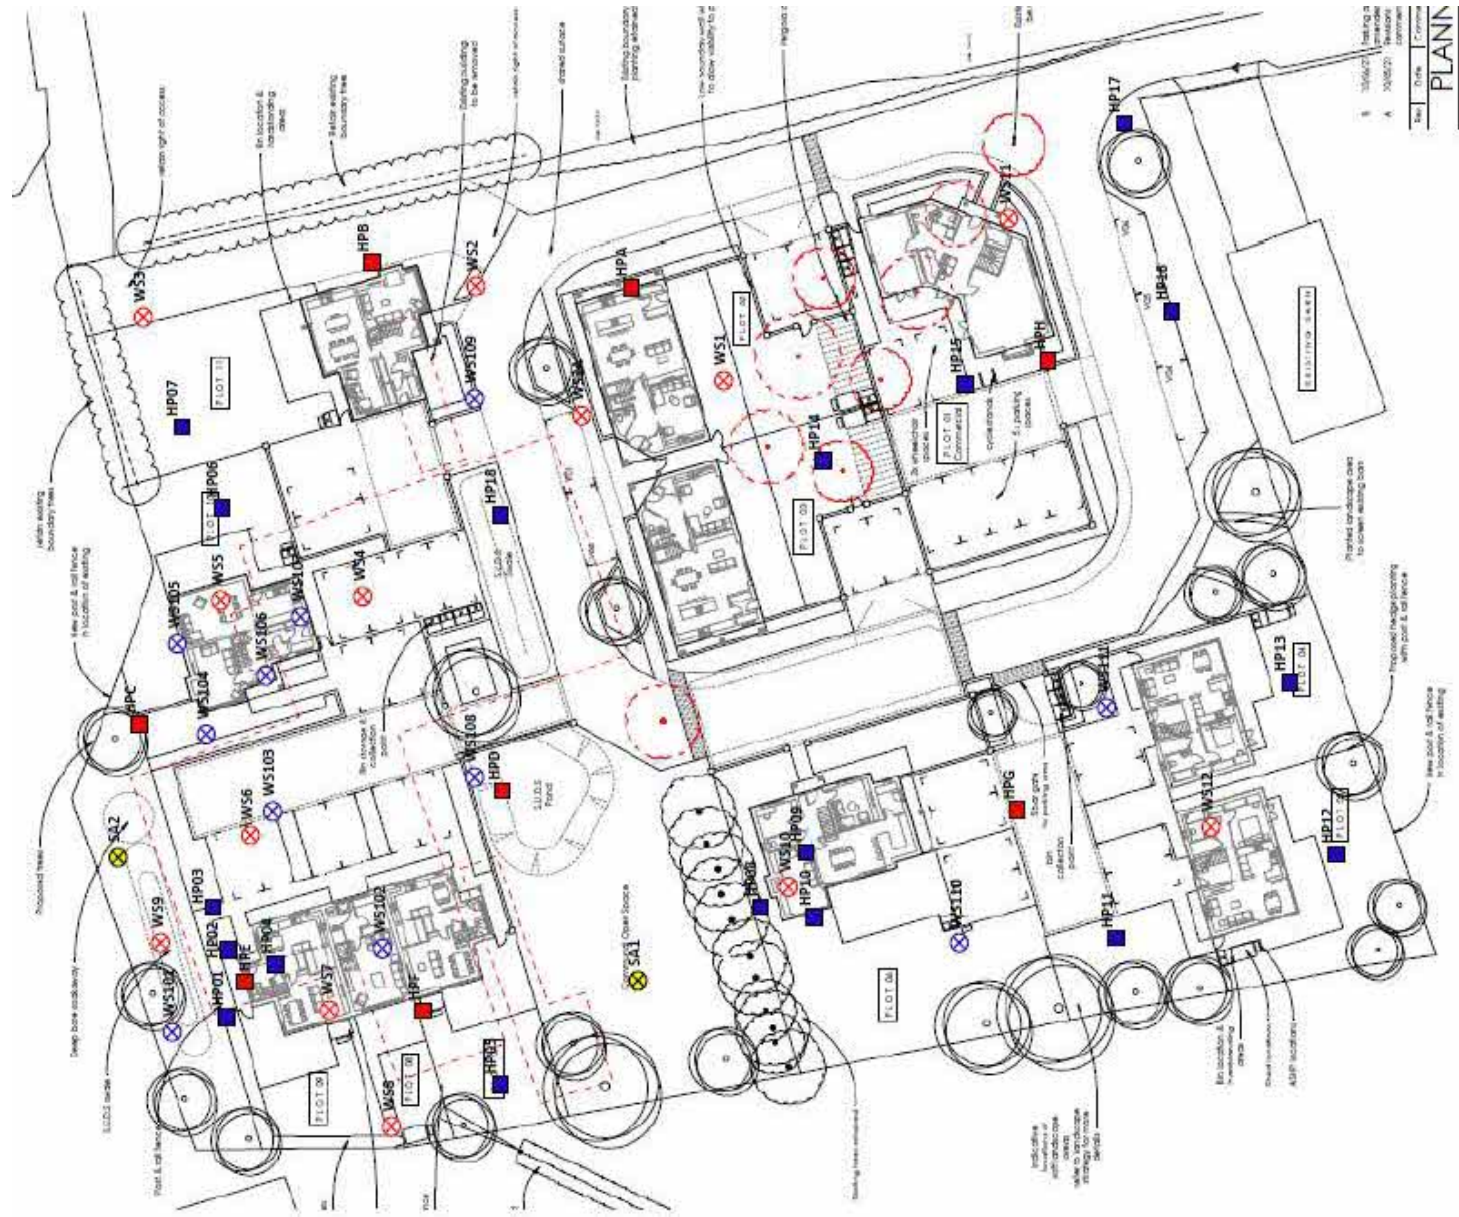
4.3 Exploratory hole locations were positioned to provide good general coverage across the site and to investigate ground conditions within the vicinity of the proposed development. Exploratory hole locations were agreed with the Client. (Appendix A - Figure 4 Exploratory Hole Location Plan).

- Previous Boreholes
- Previous Handpits
- Current SI Boreholes
- Current SI Handpits
- Borehole Soakaways

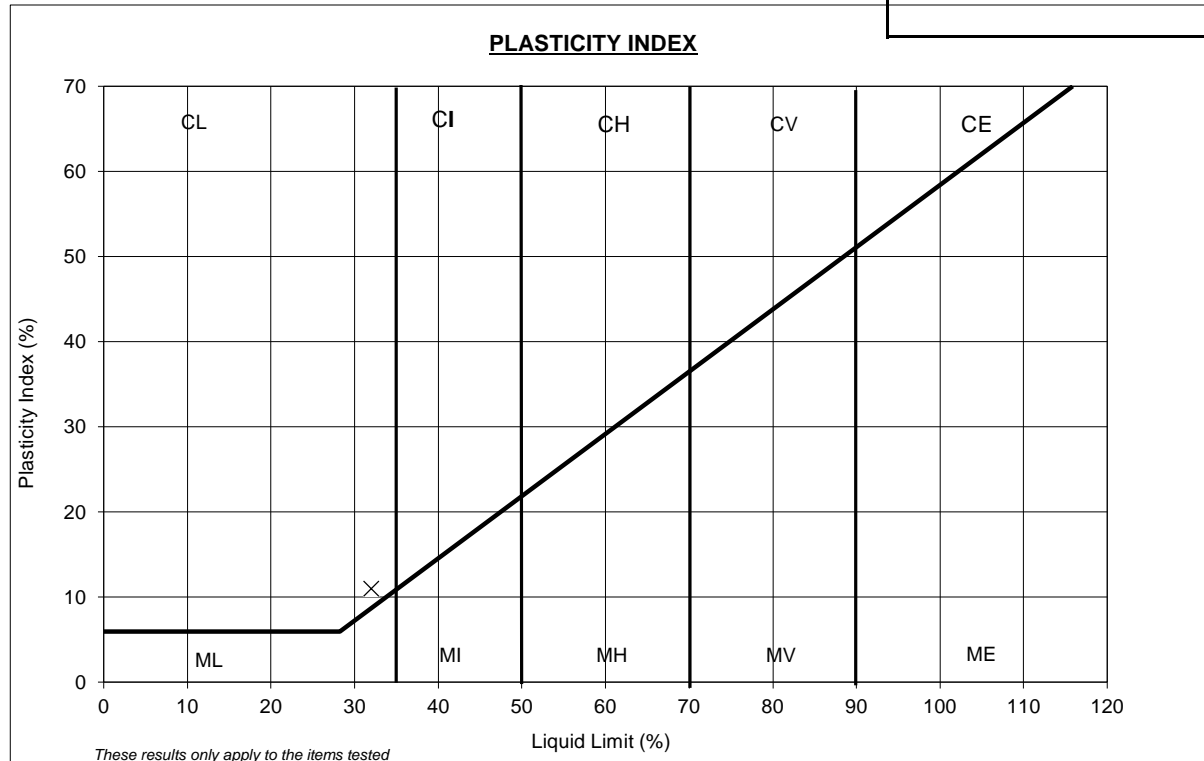
NATURAL MOISTURE CONTENT	21	%
% PASSING 425µm SIEVE	95	%
LIQUID LIMIT	32	%
PLASTIC LIMIT	21	%
PLASTICITY INDEX	11	%
