Arboricultural Survey - BS5837:2012

**St Paul's Church, Hadley Wood, Trust**

**St Paul's Church**

16 August 2023

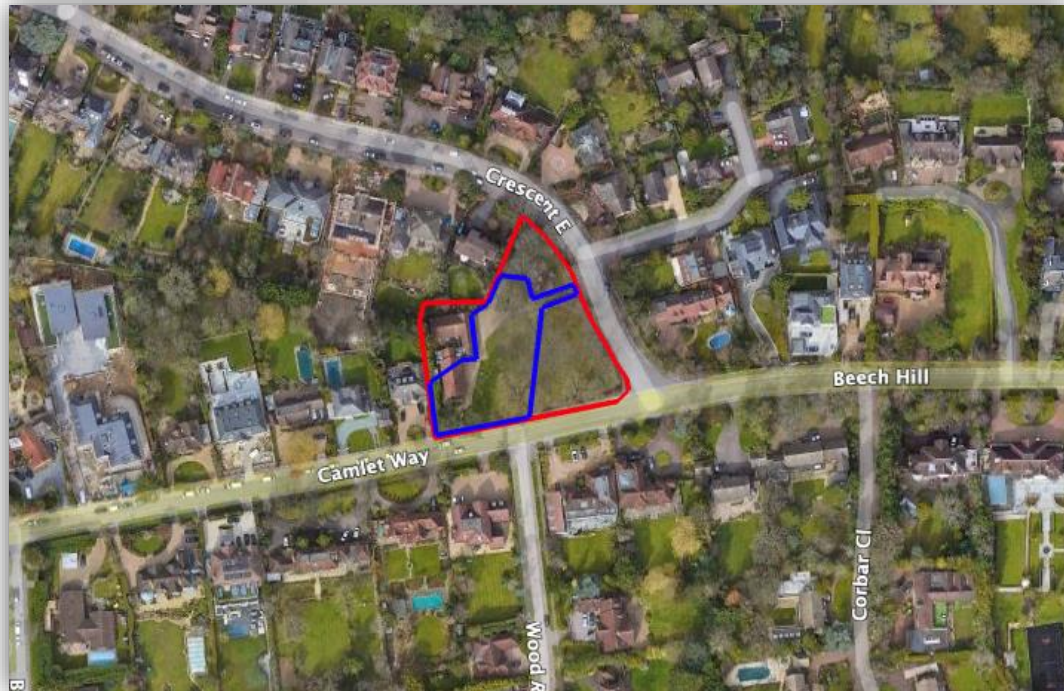
**Figure 2:** Aerial Image of the site with approximate red line boundary and with blue line denoting the area surveyed (Google Earth)

The site is situated in a residential area near the intersection of Camlet Way and Crescent East. The general aspect of the site is Southeast. The church is located on the western boundary, the rest of the property comprises of a large grass area with multiple mature trees, there is driveway access via Crescent East on the eastern boundary and pedestrian access on the south boundary.

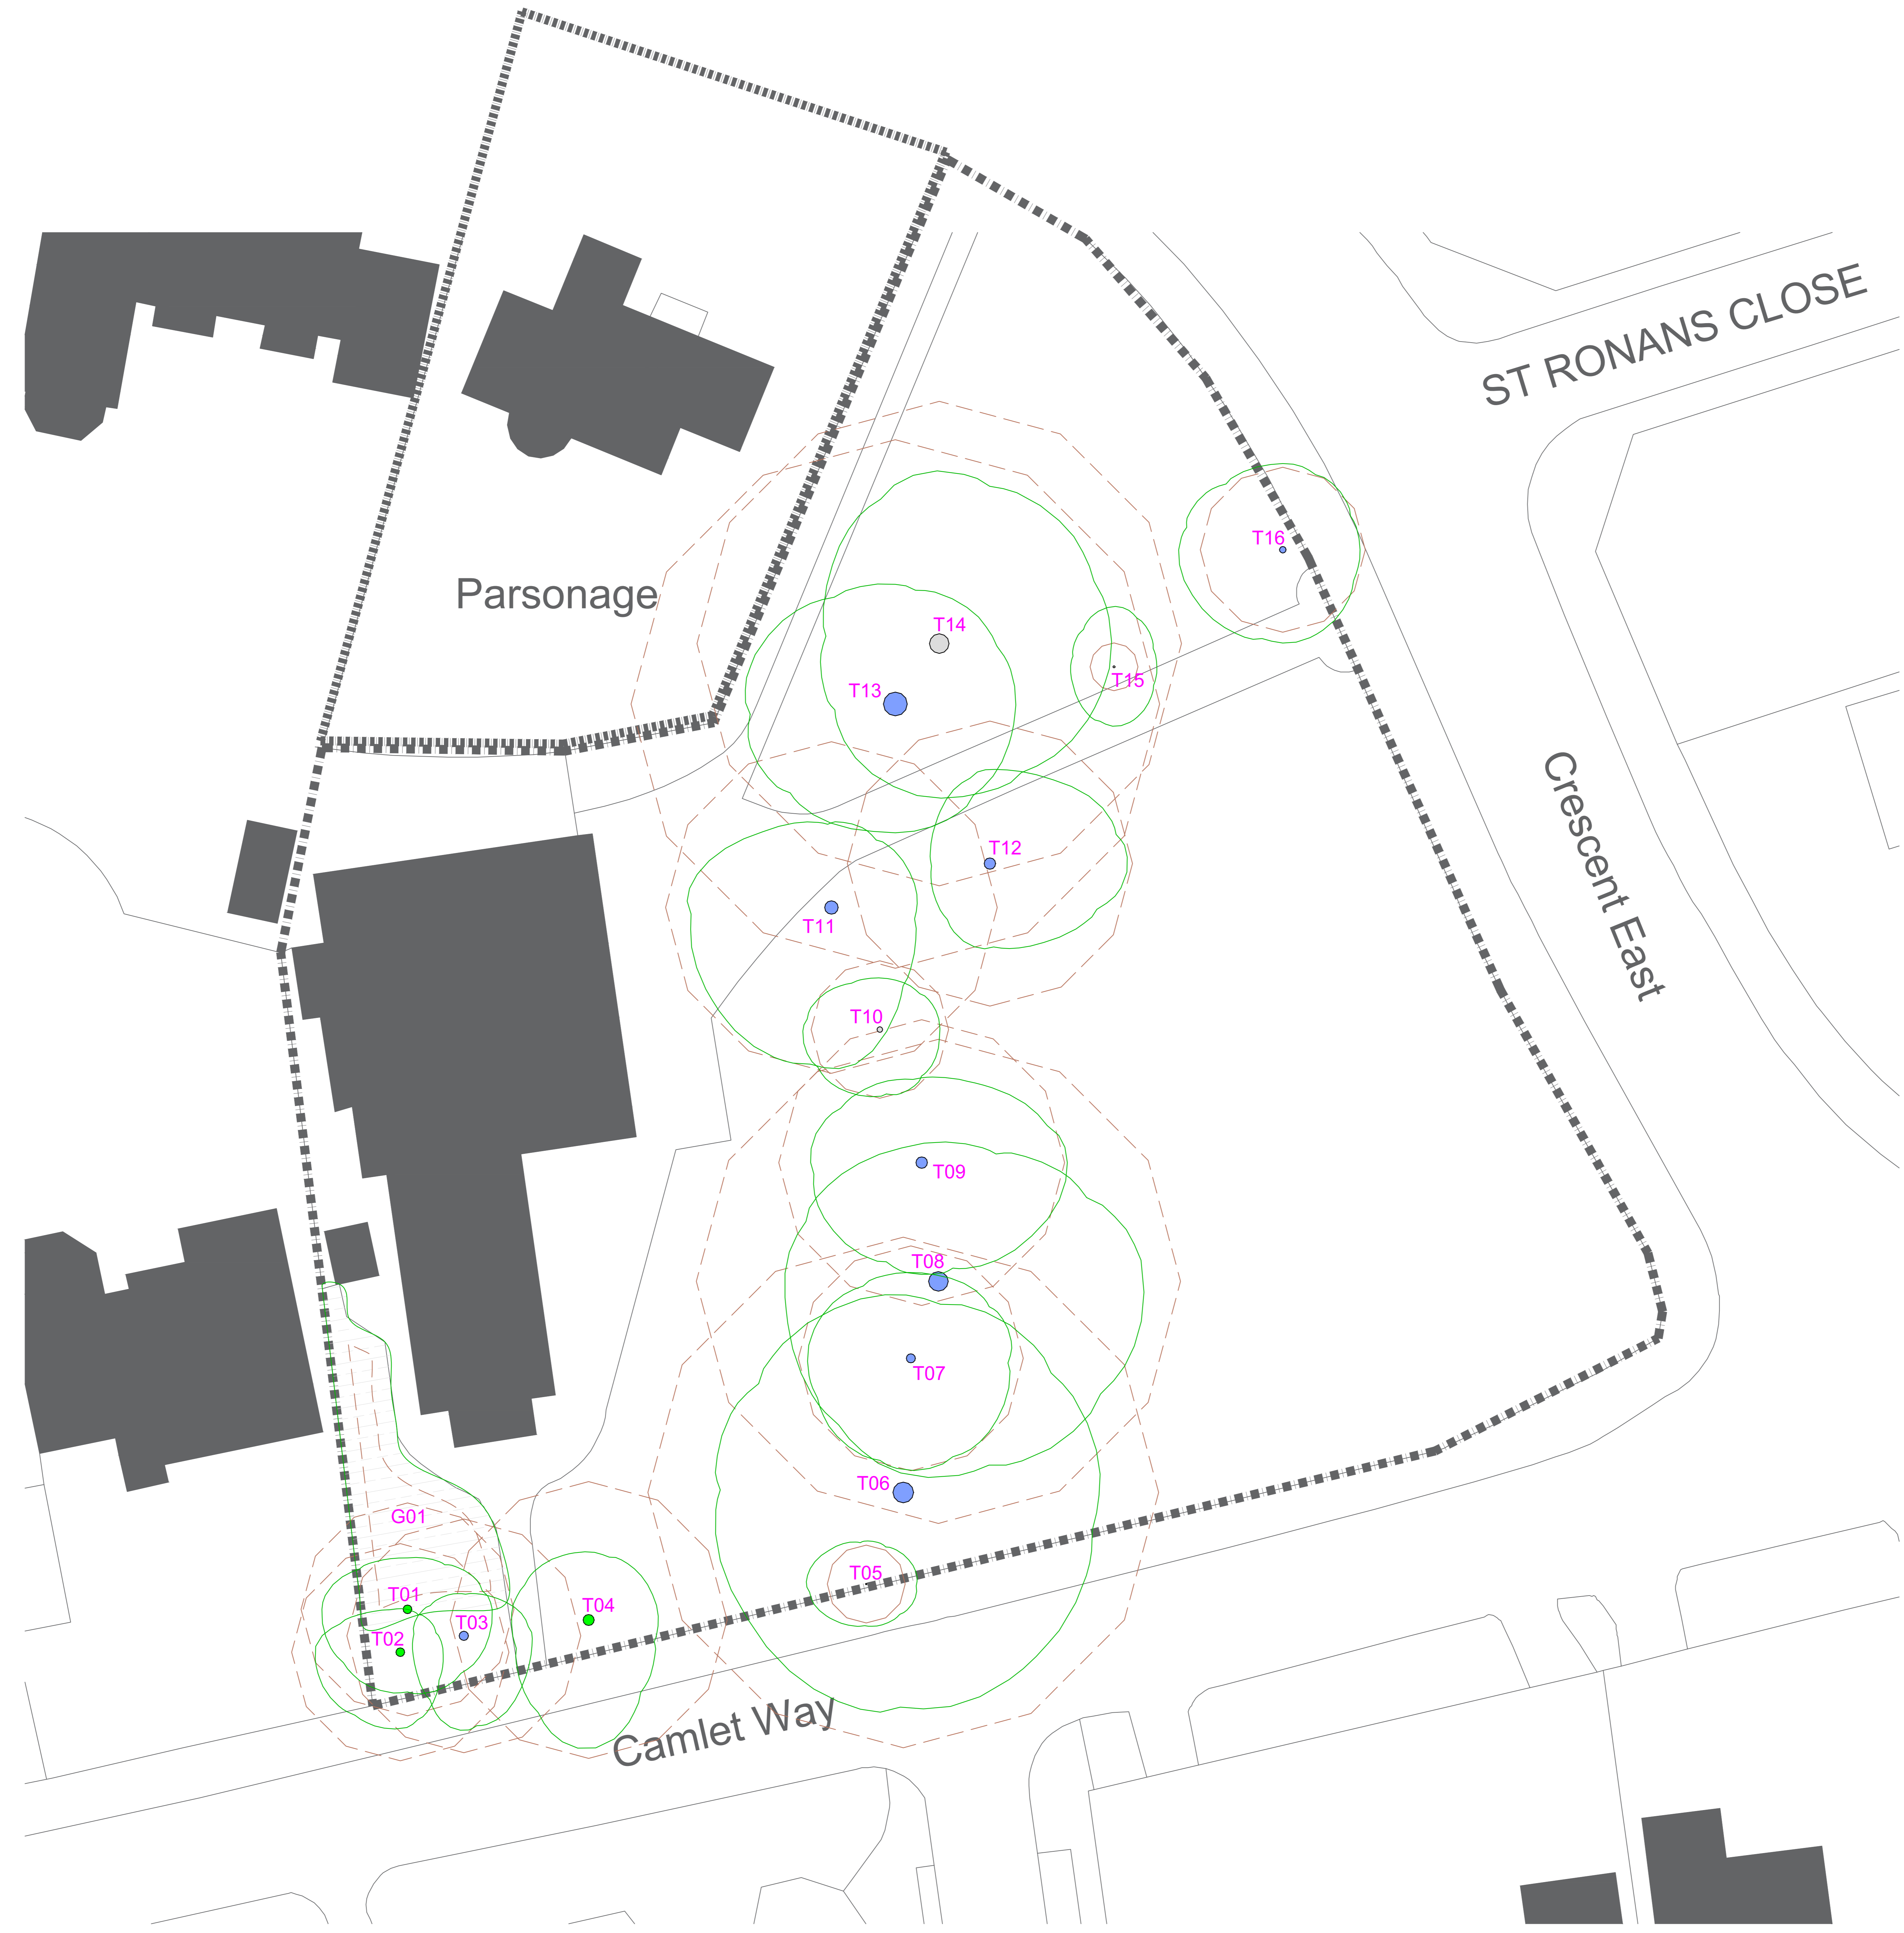
Drawing:  
**Tree Constraints Plan**

In order to avoid damage to the roots or rooting environment of retained trees, the Root Protection Areas (RPAs) should be plotted around each of the category A, B and C trees. This is a minimum area in m<sup>2</sup> which should be left undisturbed around each retained tree.

The calculated RPA is capped to 707m<sup>2</sup>, which is the equivalent to a circle with a radius of 15m. Where there appears to be restrictions to root growth the root protection area is reshaped to more accurately reflect the likely distribution of the roots.

We make the following recommendation to ensure that no conditions relating to arboriculture are attached to any planning consent secured: obtain and arboricultural report to include:

- a) An arboricultural impact assessment (AIA);
- b) An arboricultural method statement (AMS); and
- c) A tree protection plan (TPP).
