**Baseline Ecological Survey & Bat Survey
Hill Farmhouse – Hill Farm – Hockley Brook
Lane - Belbroughton
Worcestershire**

October 2023

BASELINE ECOLOGICAL SURVEY AND BAT SURVEY – HILL FARM – HOCKLEY BROOK LANE - BELBROUGHTON – WORCESTERSHIRE

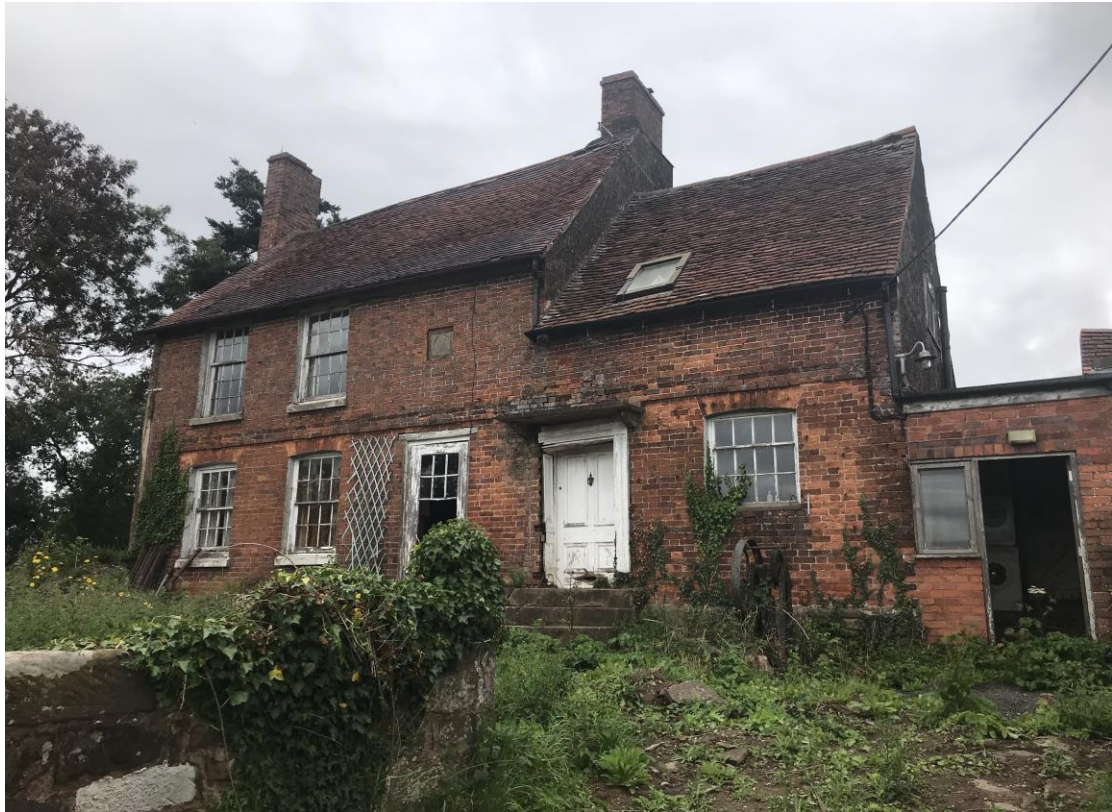
The farmhouse itself is brick with a tiled roof and in a very delapidated condition having not been occupied for 14 years. It was not safe to survey the farmhouse internally due to collapsed roof and ceilings.

PHOTO 1 – HILL FARMHOUSE FROM SOUTH-EAST

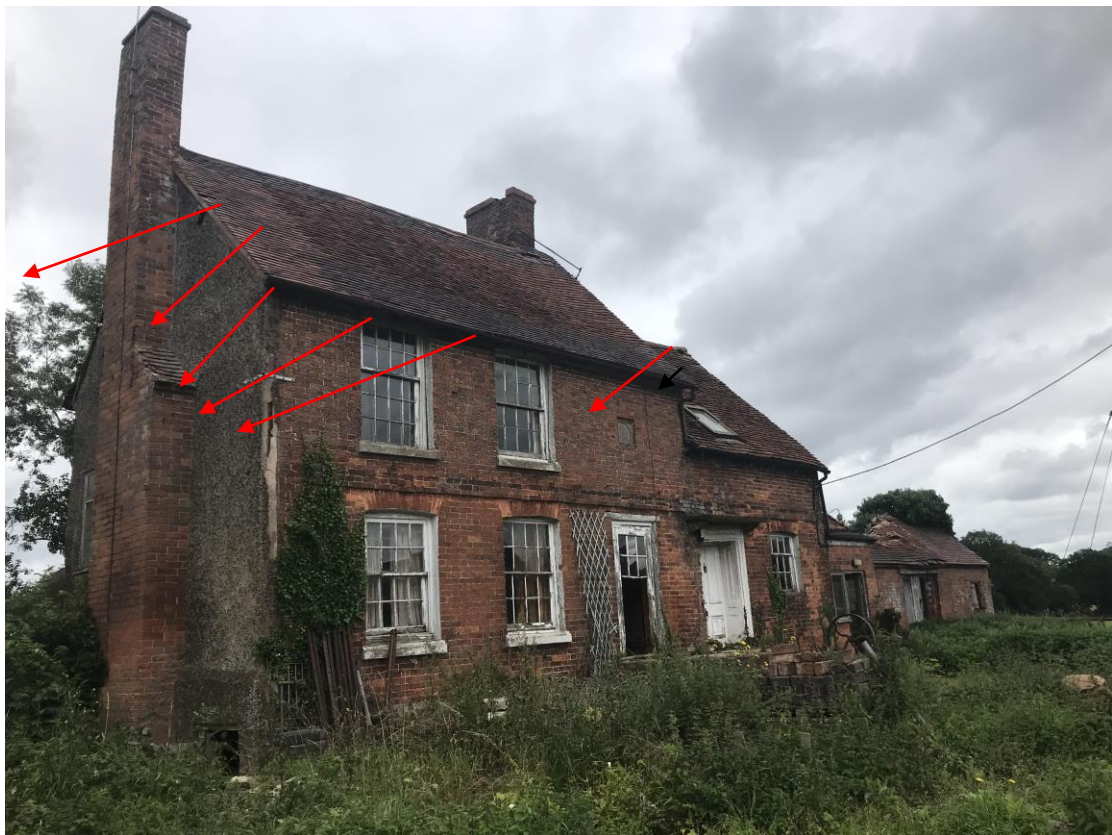
On the 15th of August 2023, 11 Soprano Pipistrelle bats were seen to emerge from under roof tiles in the locations shown on the photographs in appendix 2.

On the 30th of August 2023, 16 Soprano Pipistrelle bats emerged from under roof tiles and on the 13th of September 2023 16 Soprano Pipistrelle bats also emerged from under roof tiles in the locations shown on the photographs in appendix 2.

PHOTO 2 – HILL FARMHOUSE FROM SOUTH-WEST – SHOWING BAT EMERGENCES

6. In order that bats will be able to continue to use the building in the longer term it is recommended that 30 purpose designed bat access tiles are added to the north and south facing aspects of the building, particularly in locations where bats were previously found to be roosting. Advice should be sought by a licenced bat worker with regard to placement of these purpose designed tiles.

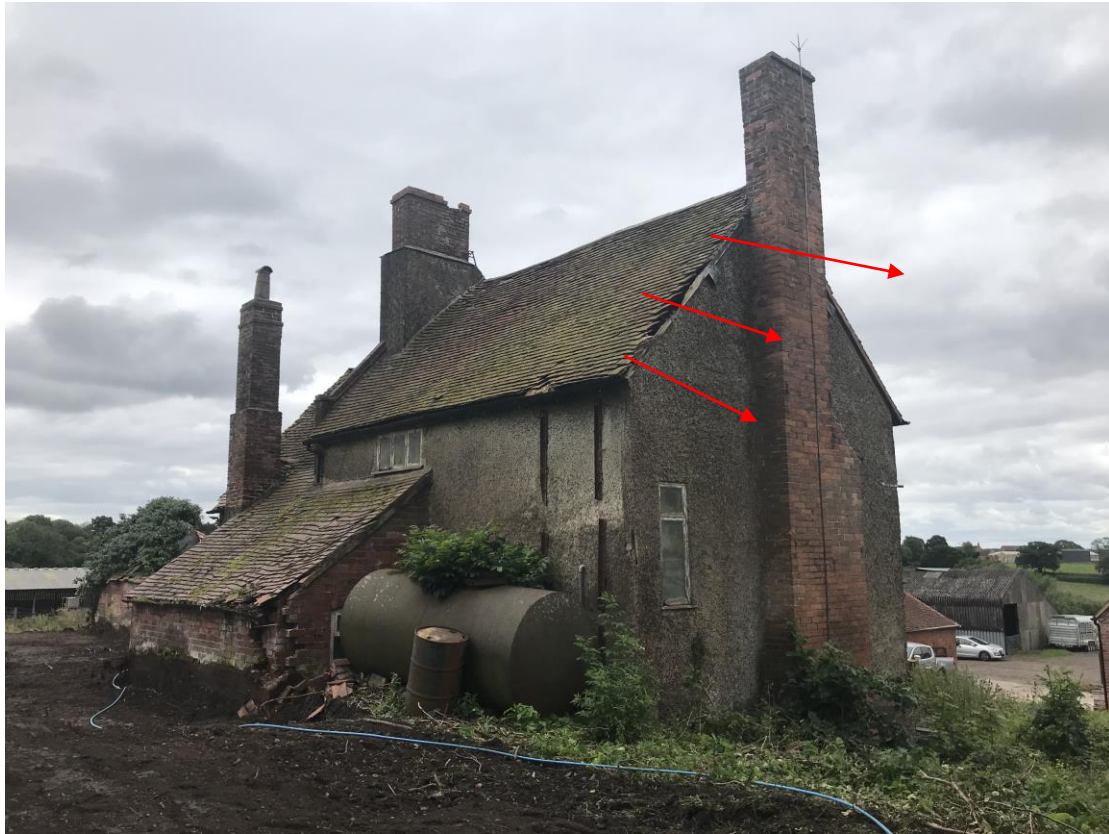
PHOTO 3 – FROM NORTH-WEST SHOWING BAT EMERGENCES

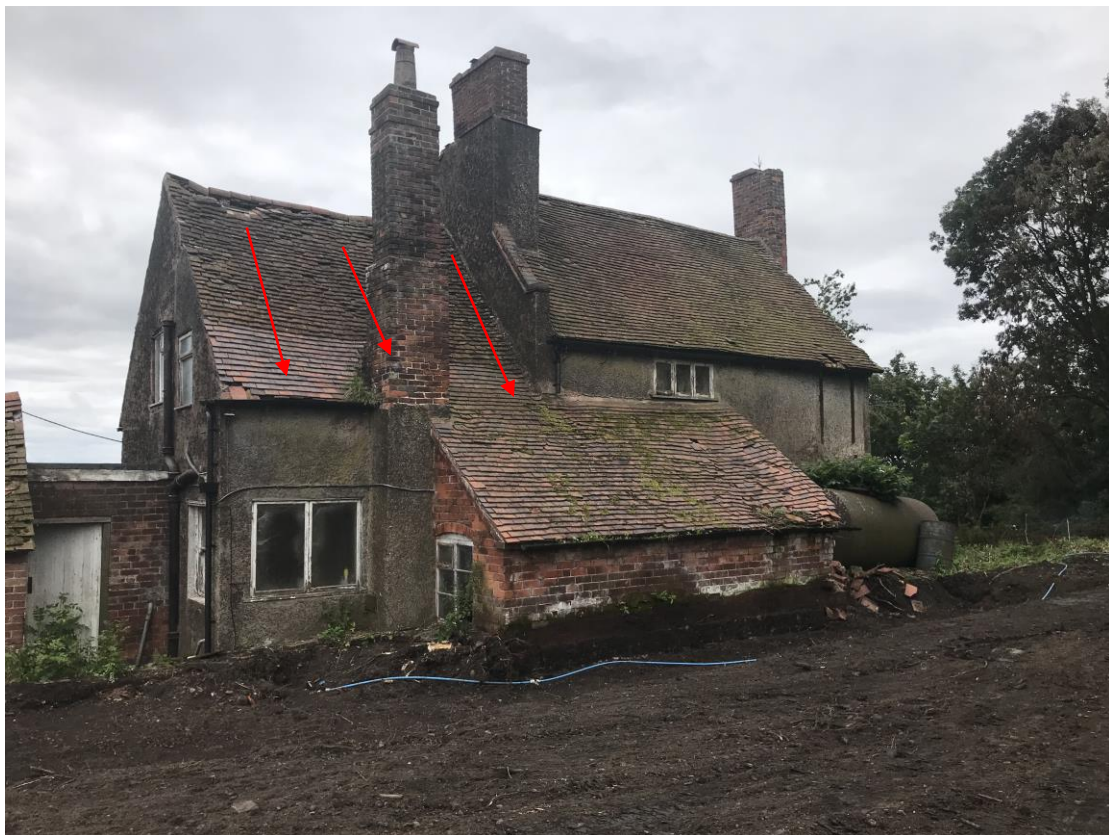
PHOTO 4 – FROM NORTH SHOWING BAT EMERGENCES

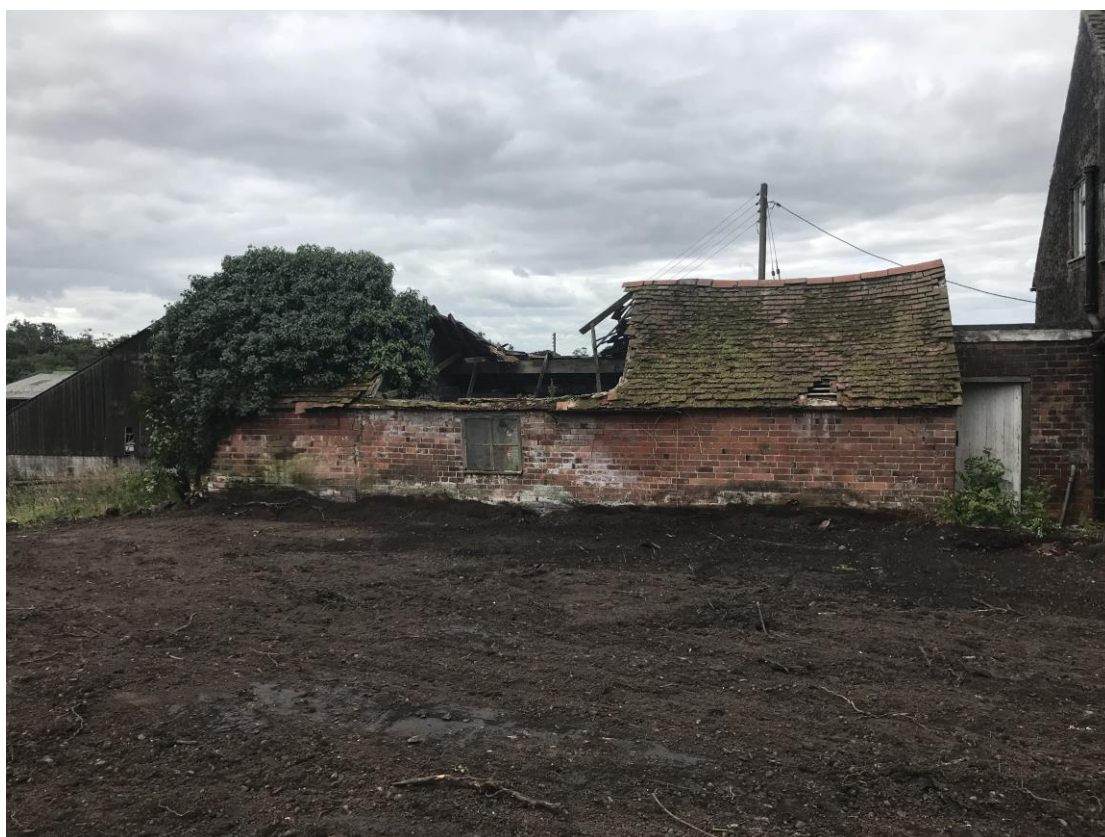
There is also an adjacent single storey outhouse also brick with a tiled roof. This also in a similarly delapidated condition, the roof having partially collapsed.

PHOTO 6 – ADJACENT OUTBUILDING WITH COLLAPSED ROOF FROM NORTH

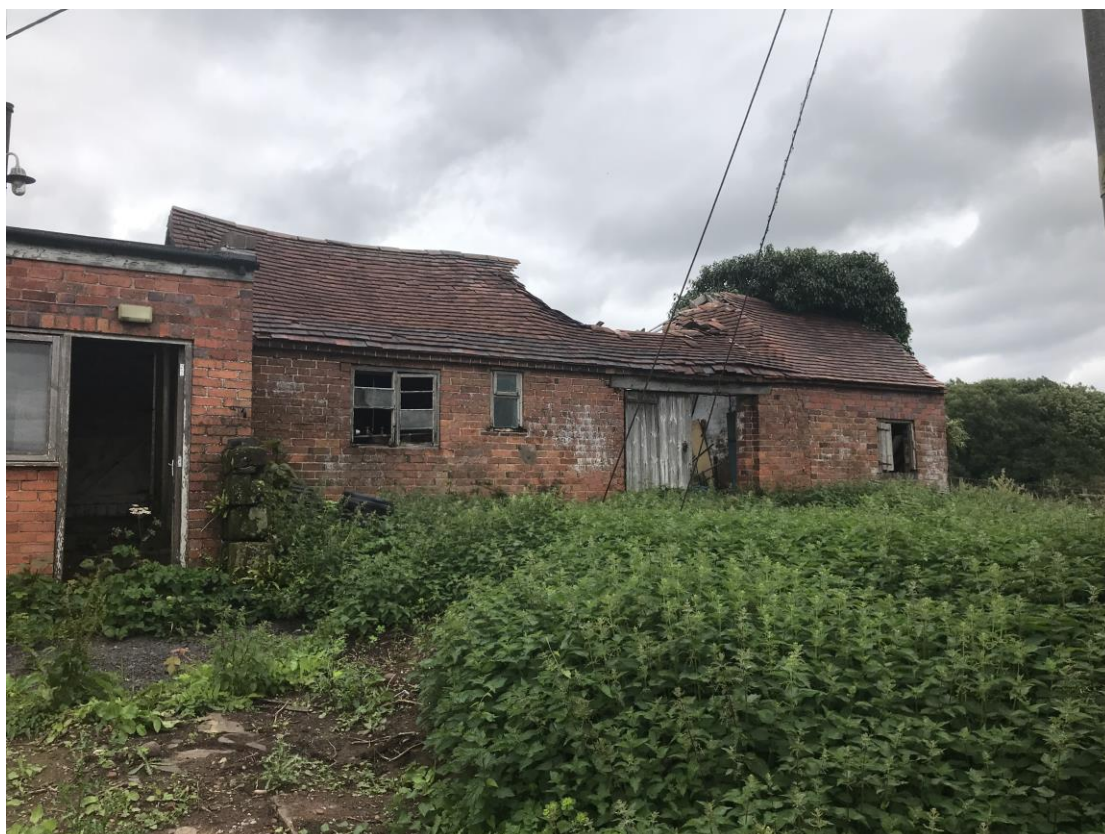
PHOTO 7 – ADJACENT OUTBUILDING WITH COLLAPSED ROOF FROM SOUTH

PHOTOS 9 & 10 – OUTBUILDING INTERNALLY

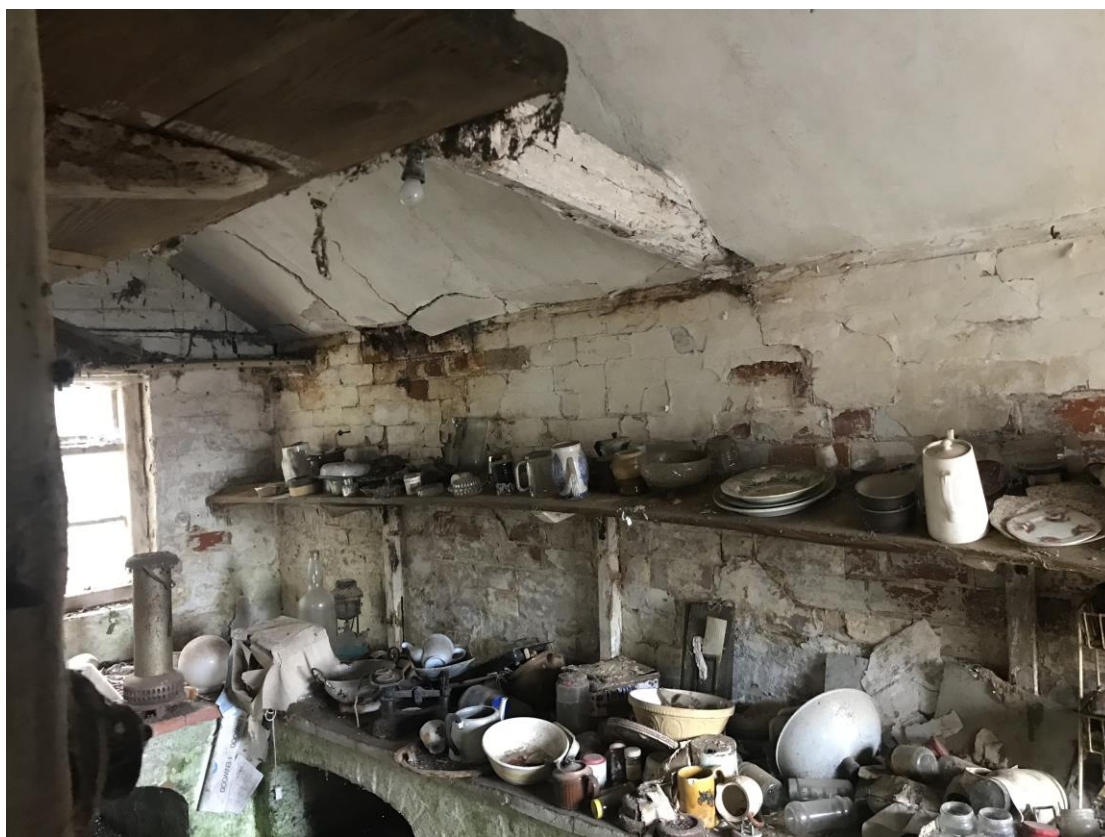
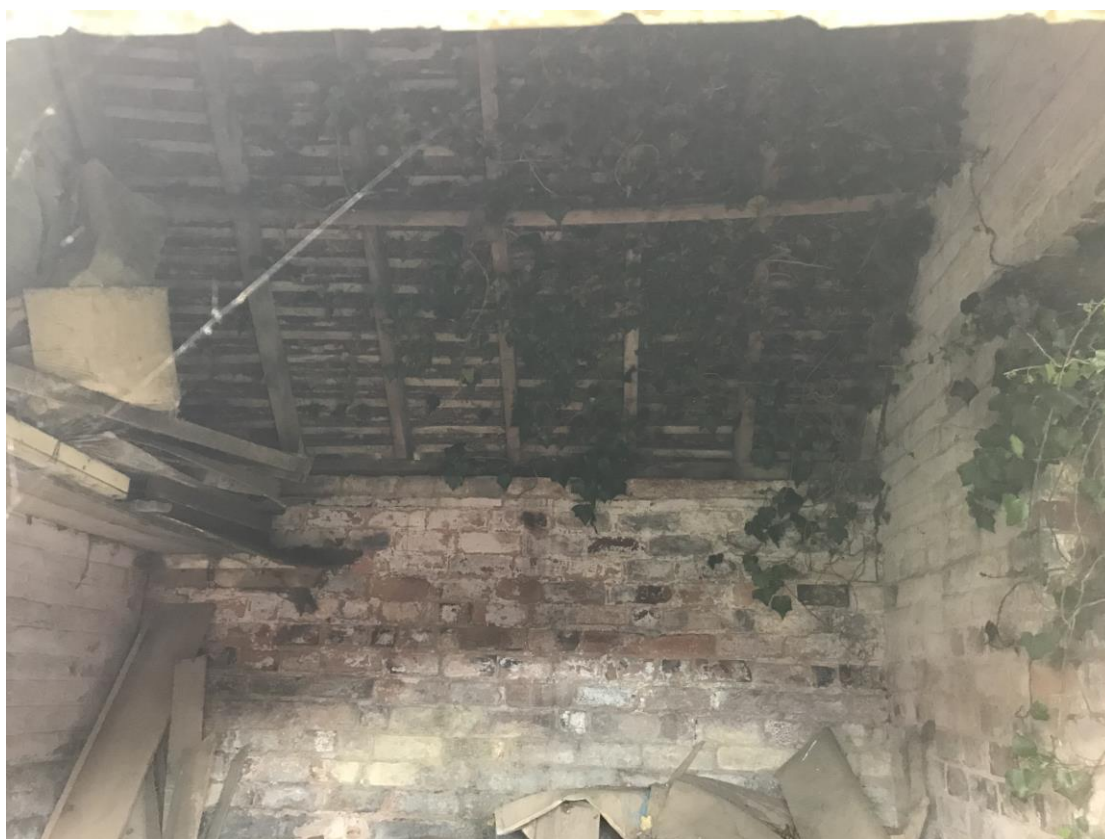
The property is brick with a tiled roof and is delapidated and in a poor state of repair having not been lived in for 14 years. Internally floors and ceilings are starting to collapse, meaning that internal survey work could not be carried out.

PHOTO 12 – OUTBUILDING INTERNALLY

PHOTO 13 – COLLAPSED CEILING AT TOP OF STAIRS – FARMHOUSE

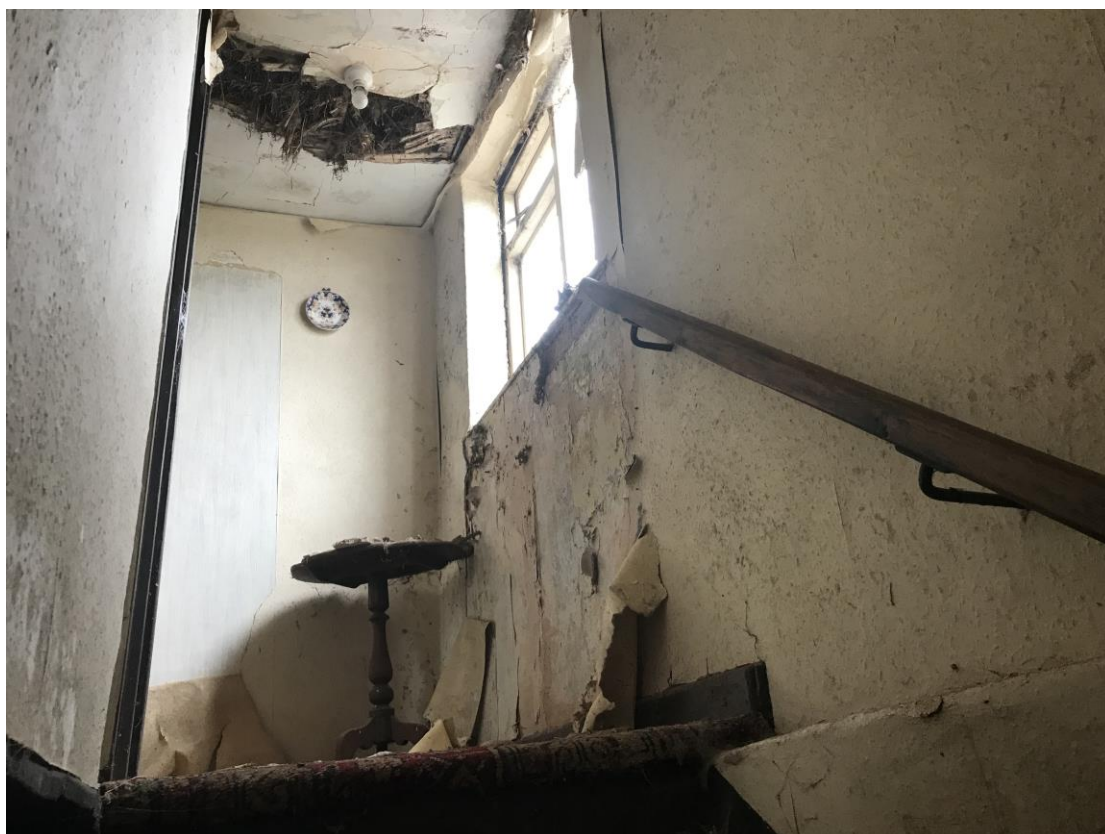
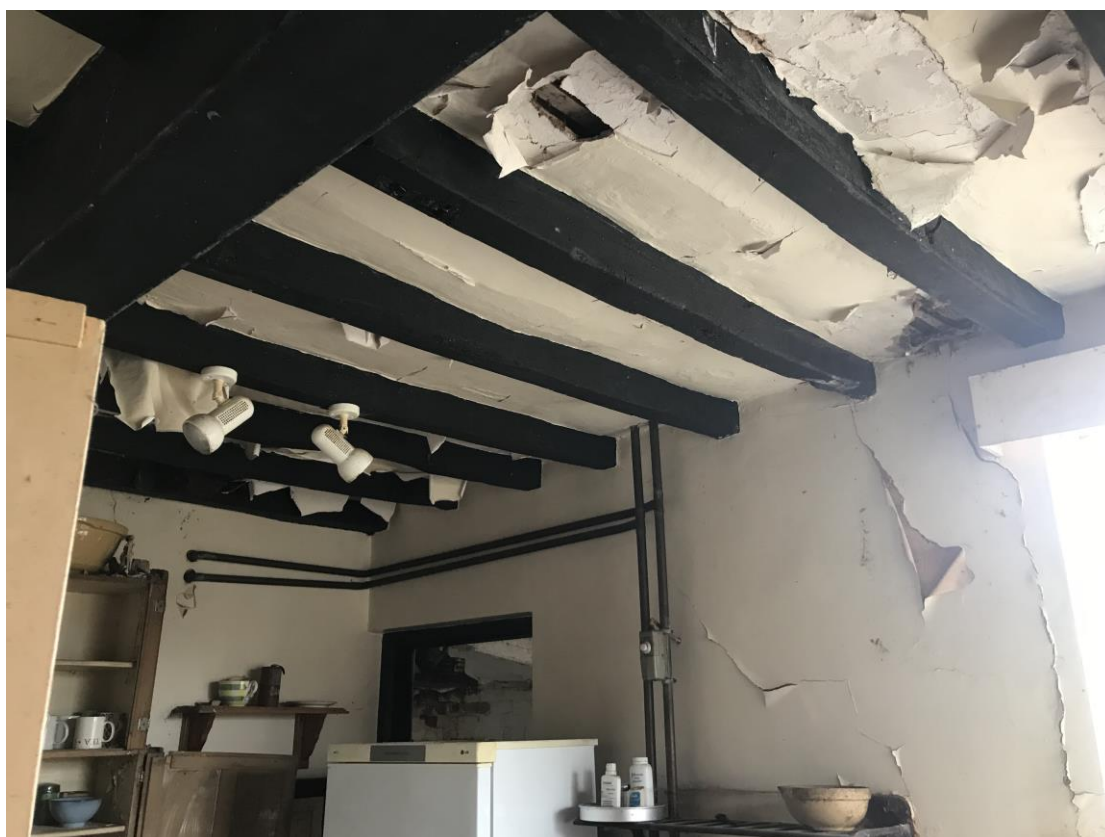
PHOTO 14 – KITCHEN WITH COLLAPSING CEILING

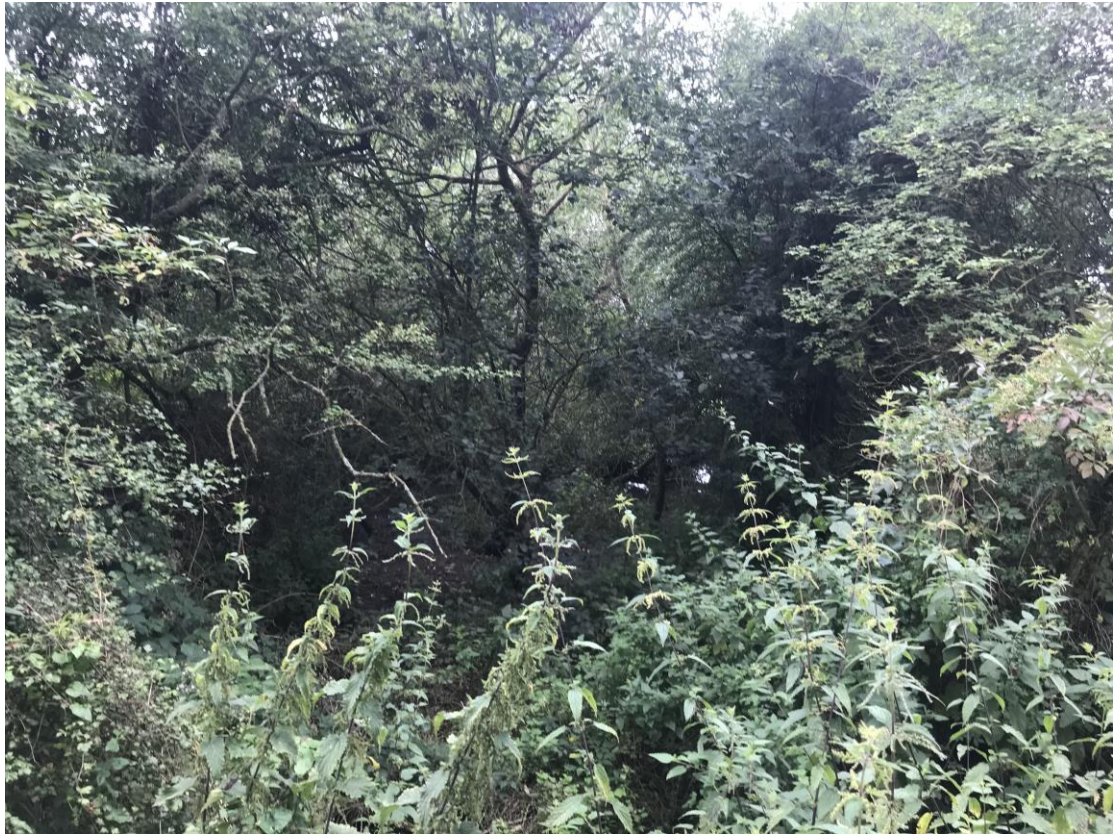
Approximately 200m to the south of the farmhouse is a small shaded pond surrounded by Crack Willow. It is approximately 20m x 5m in dimensions and 0.5m in depth at the time of survey. There is no marginal or aquatic vegetation.

This was assessed for its suitability for Great Crested Newts by using the Habitat Suitability Index and scored as below average in terms of its suitability.

PHOTO 15 – POND 1 – 200M TO SOUTH OF FARMHOUSE

11. Any rubble, earth, tiles, bricks or waste materials associated with the building process will be cleared off site or stored off the ground and not left lying around as GCN will be potentially attracted to such materials for shelter and hibernation.
12. It should be ensured that during all works, building materials are stored off the ground on palettes including, bricks, wood, tiles, cement, sand etc. This is because building materials are attractive to GCN who may use them for shelter and hibernation.
13. Grass around the construction area should be kept cut short in order to avoid attracting GCN to the building area.
