**An Archaeological Standing Building Survey  
& Heritage Impact Assessment**

**Hill Farm  
Belbroughton  
Stourbridge  
Worcestershire**

**March 2024**

**ABRS Project No 2023-HFBW**

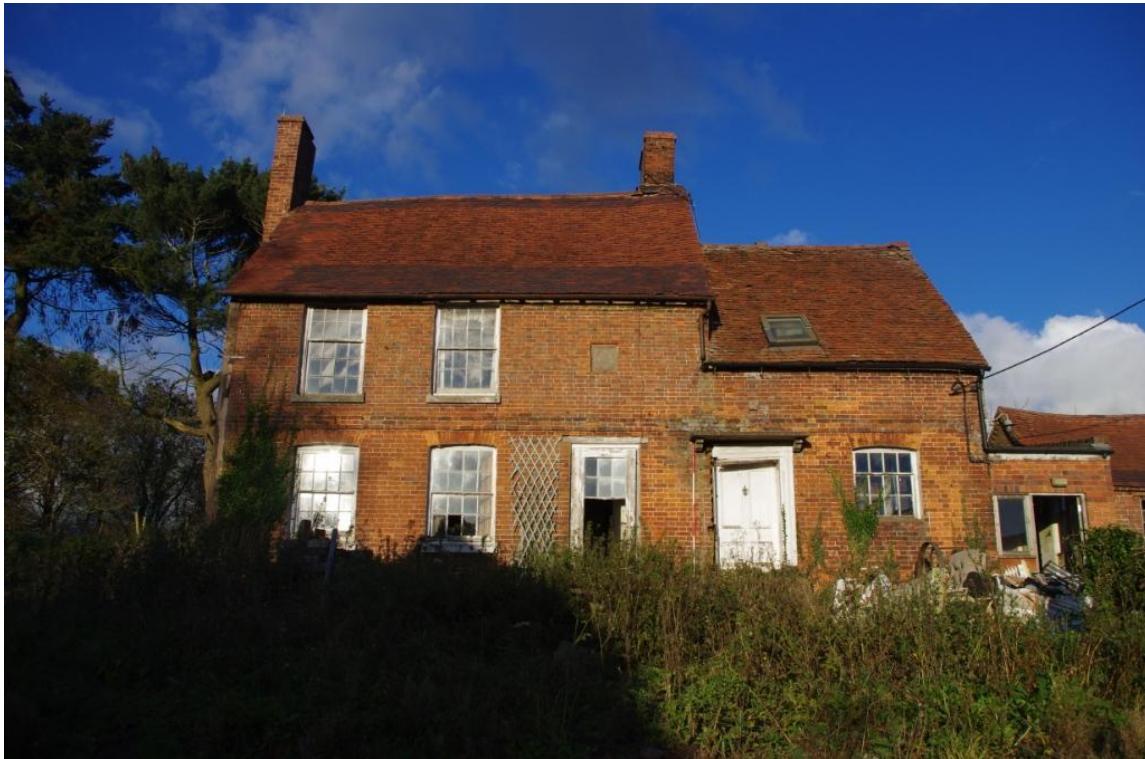
**Figure 10**  
Building A Principal Elevation, General View (Looking North East).

Building A Hill Farmhouse is a one and half and two storey, five bay brick built former farmhouse with a single storey three bay outbuilding to the south, both under plain tiles roofs forming the eastern range of a traditional “U” shaped farmyard. The principal two storey bay (*Figure 10*) to the north consists of three bays, to the south is the remains of a 20th century panelled door under a six light over door light, above which is a heavily weather date stone (*Figure 11*), the listed building description described it in 1986 as inscribed with “C/ FS/ 17?”. This may suggest an 18th century construction date, however the date stone is clearly recessed and may be earlier than the brickwork. Both northern bays have two ground and two first floor eight over eight light sashes with moulded architraves, the ground floor windows have cambered heads. The northernmost windows are modern reproduction. At first floor level is string course, there is the suggestion that this continues, in part on the southern bay.

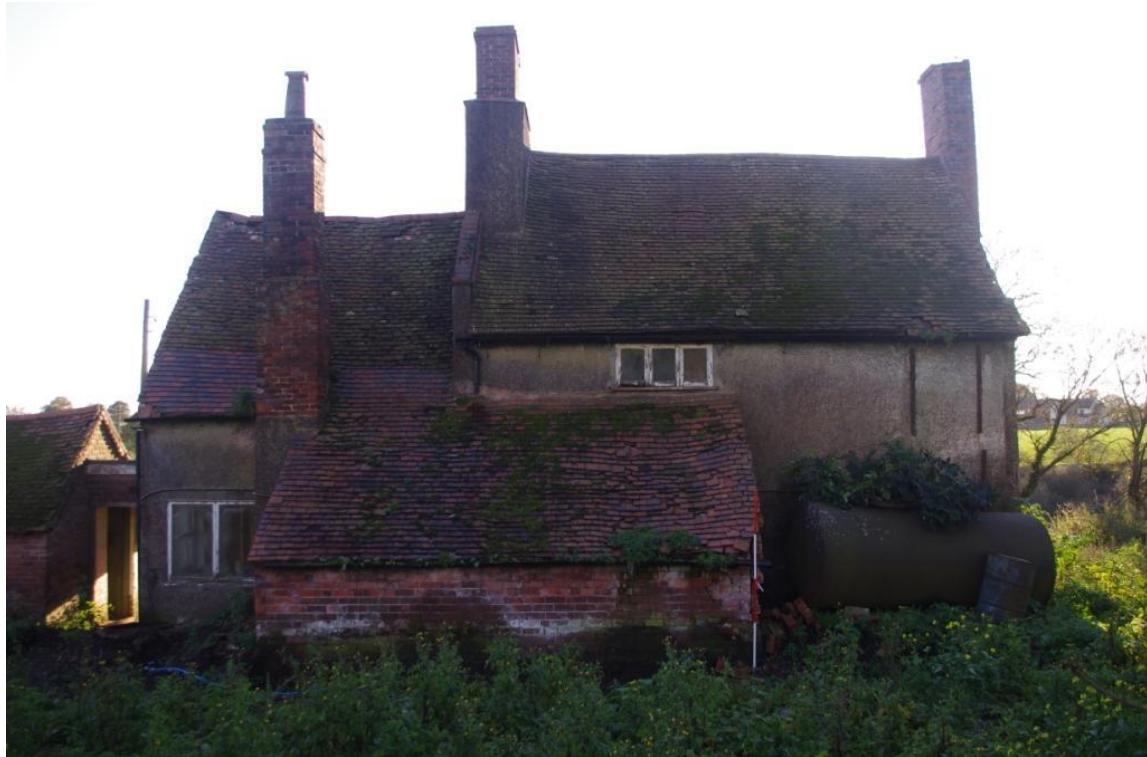
**Figure 12**  
Building A Rear Elevation, General View (Looking South West).

Both the rear elevation and both gables are rough cast rendered. Abutting the rear is a 19th century lean to under a plain tile roof, over which is a single window opening housing a modern timber casement, the dimensions of the opening suggest it too is modern (*Figure 12*). To the south of the lean to is external chimney stack, also 19th century in date. On the north east corner failed render has exposed a possible corner post (*Figure 13*), this may suggest a possible timber frame; there is a similar member on the north west corner.

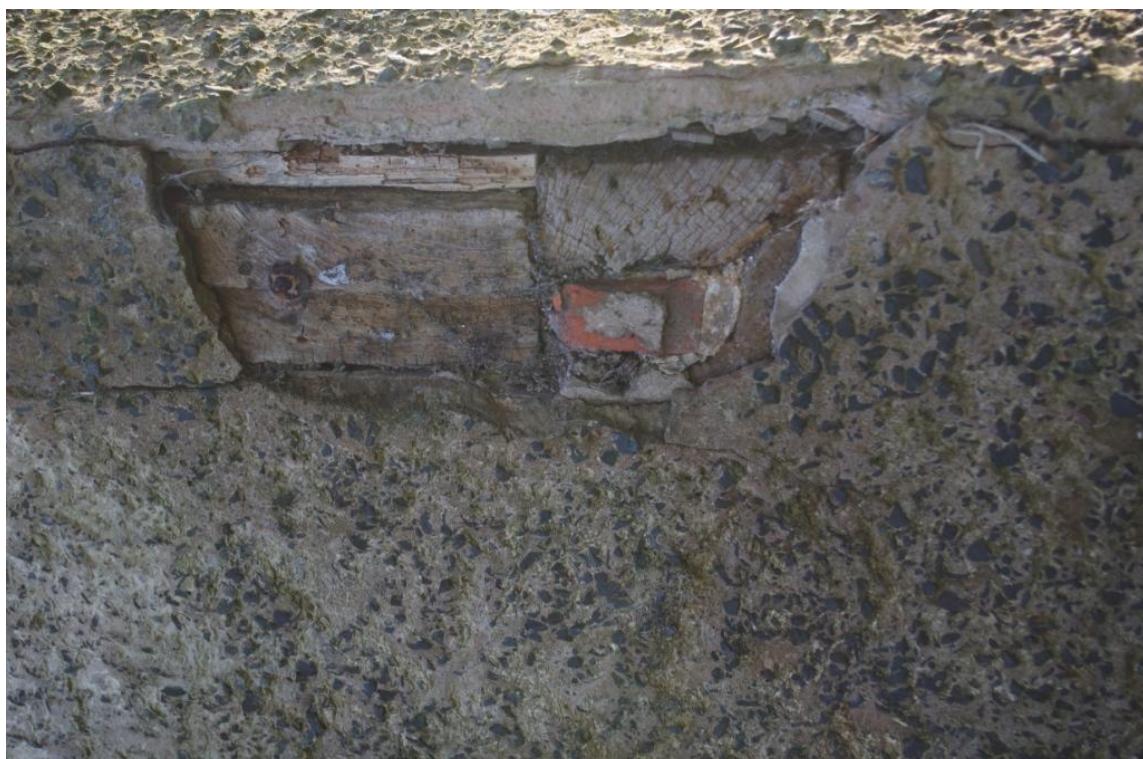
**Figure 13**  
Building A, Corner Post(?) on North  
East Corner (Looking South West).

There is possible evidence of a timber frame on the northernmost gable, this is far from certain and may represent a modern timber stop bead used to render that gable.

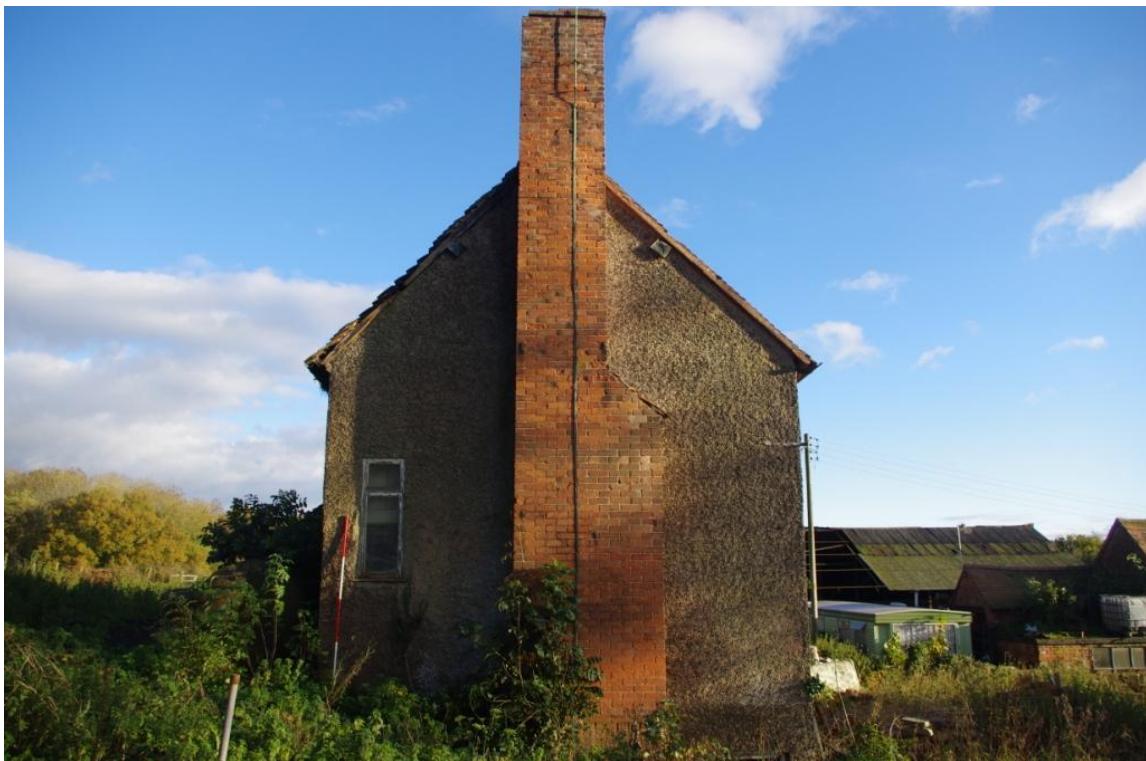
**Figure 14**  
Building A North West Facing Gable (Looking South East).

The north facing gable (*Figure 14*) has a central chimney stack, again later and an elongated window to the east, its dimensions are reminiscent of a stair window. The south facing gable (*Figure 15*) is largely concealed by the later outbuilding, but does house a central doorway on the ground floor as well irregular fenestration on the first floor which suggests the two openings are unlikely to be contemporary. Both windows are modern casements.

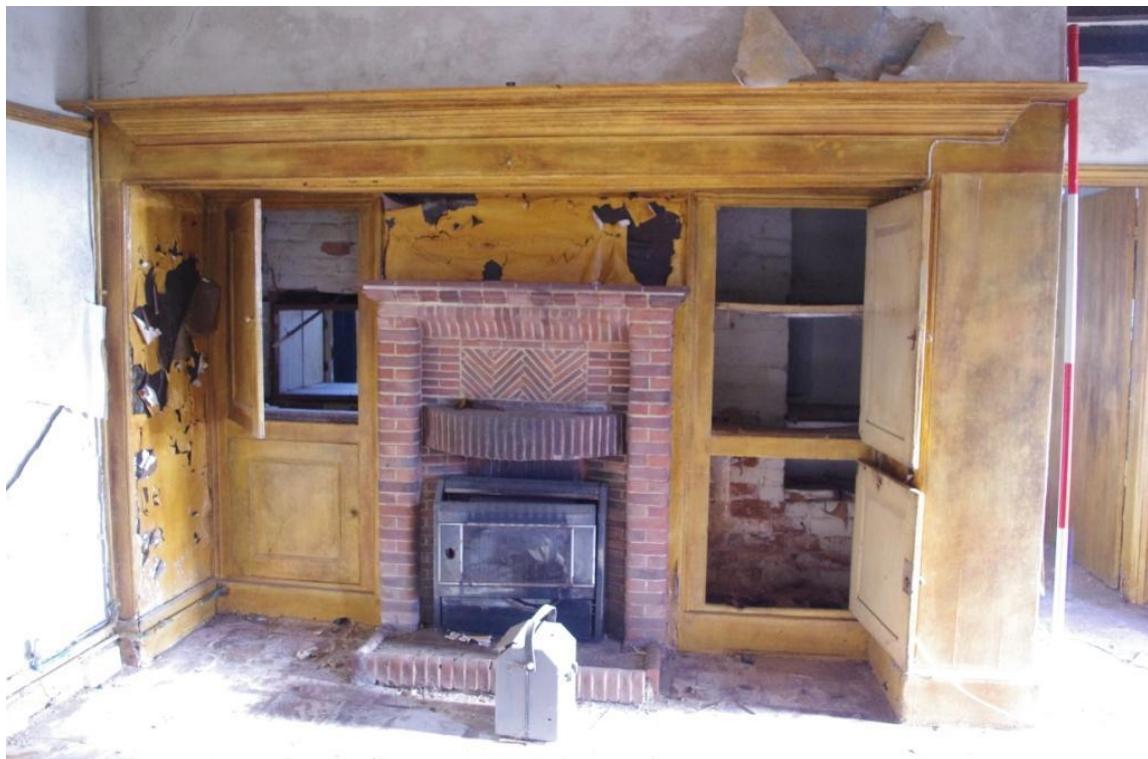
**Figure 16**  
Building A(3) Inglenook Fireplace (Looking East – South East).

The ground floor has an unusual plan-form; the central bay, (3) houses as a large inglenook fireplace in the south east corner (*Figure 16*), flanking the modern fireplace are two alcove cupboards, which are likely to have originally been spice or salt cupboards, which were normally located near the fire to prevent the contents from getting damp. Probate inventories suggest that by the late 17th century salt boxes were separate, moveable items. There is a chamfered and stopped timber overmantle. The step and runout stop dates between the late 16th and early 18th century, the moulded mantleshelf could, potentially be original as there are dated 17th century examples recorded, but in this case the moulding appears crisp and may be a 19th century replacement.

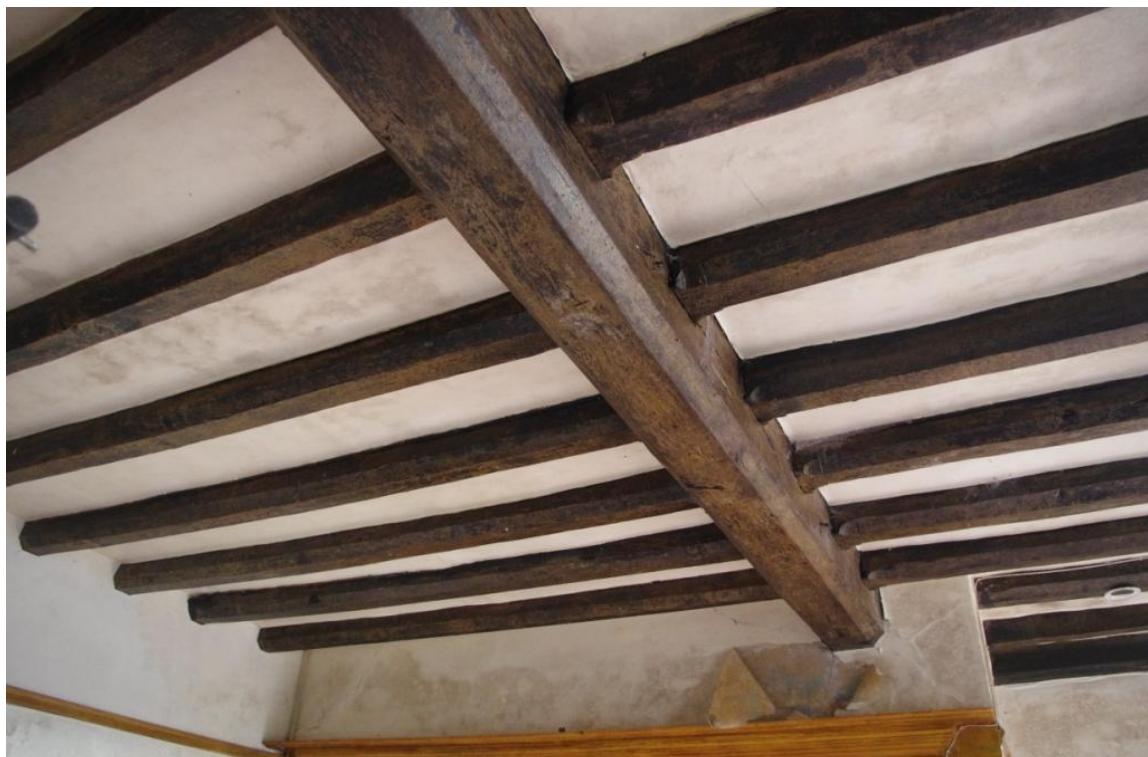
**Figure 17**  
Building A(3) Ceiling Structure (Looking East – South East).

The ceiling is carried on a single chamfered and stopped bridging beam with exposed joists (*Figure 17*), the beam is similarly stopped with a step and runout, so is likely to be contemporary with the fireplace, but in this case the step is much more pronounced (*Figure 18*). Interestingly, the joists are also chamfered and stopped, the use of chamfered and stopped joists is unusual, by the 16th century is largely limited to the wealthiest of houses. The listed building description, based upon an external examination only suggests an early to mid 18th century date, the joists may suggest an earlier core.

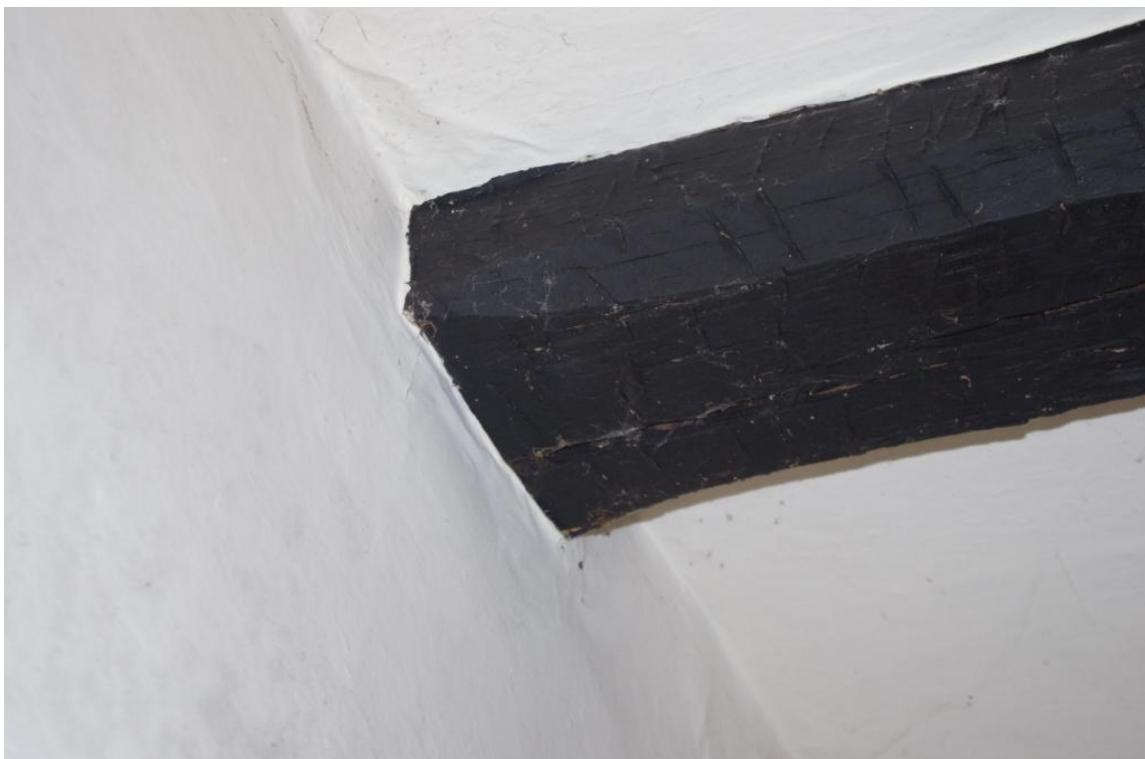
**Figure 19**  
Building A(11) Runout Stopped Collar Purlin (Looking North).

The central bay, (11) has a chimney breast in the south east corner, but no evidence of a fireplace. There is a chamfered and stopped collar purlin although the plain runout stop is difficult to date (*Figure 19*). There are wide, hardwood floorboards, wider boards tend to indicate an earlier date, are almost certainly pre 19th century.

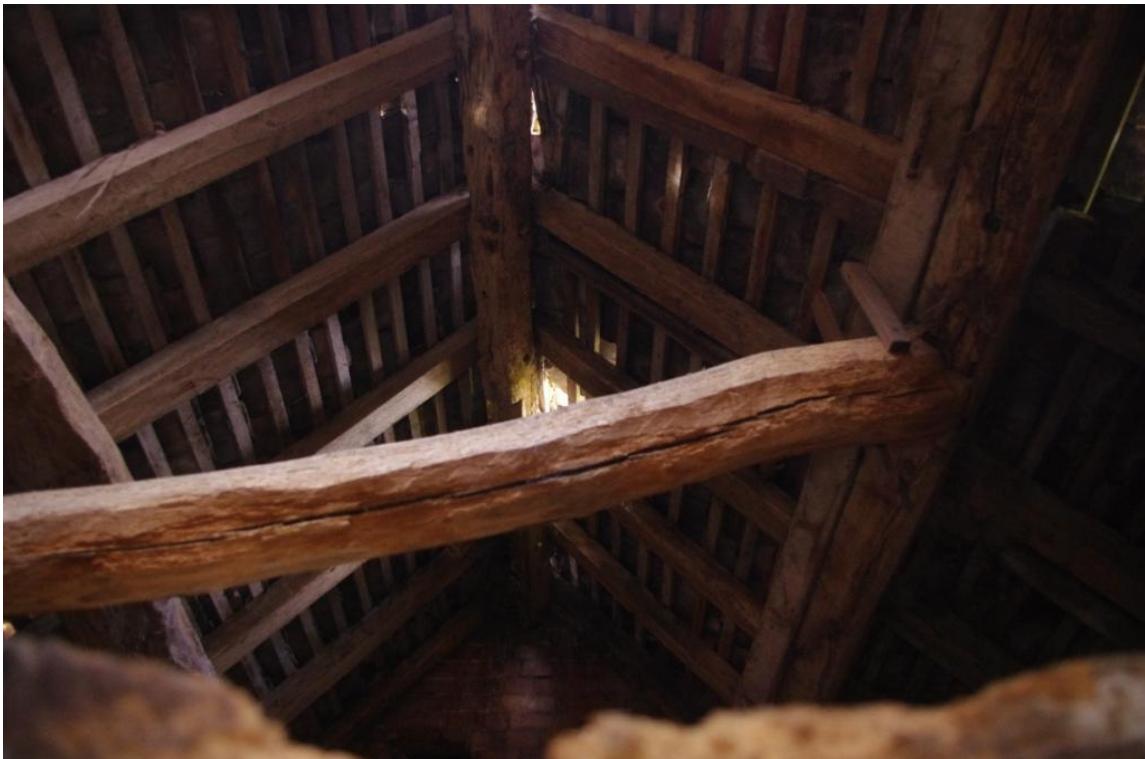
**Figure 20**  
Building A Limited View of Roof Structure (Looking North West).

There is a limited view of the roof space above the southernmost bay. The structure consists of common rafter roof with a ridge beam (*Figure 20*). The use of a heavy ridge beam confirms a pre 19th century date. The other members seen in the roof structure appear to be purlins, a collar beam and potentially another collar purlin, although the lack of access prevents a more detailed description.

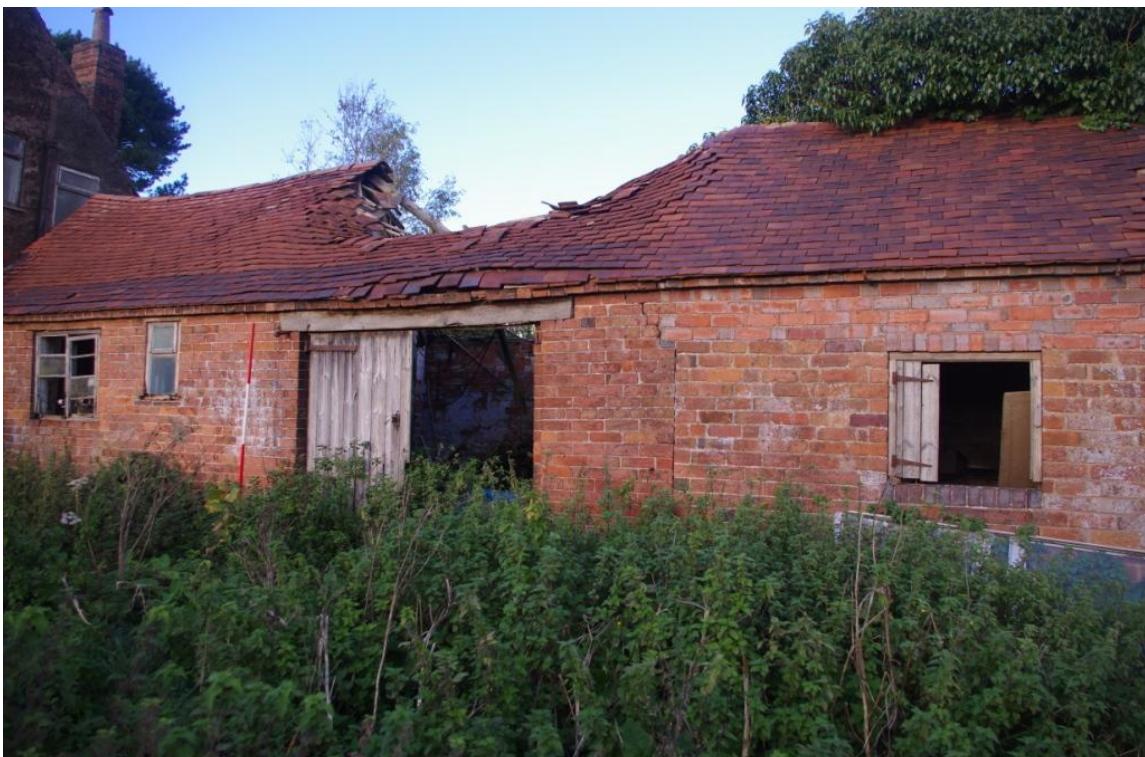
**Figure 21**  
Building B Principal Elevation (Looking West – North West).

The single storey three bay brick built building (*Figure 21*) is clearly later in date, the brick dimensions, 9inch x 3inch x 4inch, although not always an accurate aid to dating would suggest a mid to late 19th century construction date. There is a clear straight joint between the middle and southern bay indicating the southern bays is later still. The roof, although partially ruined is plain tiles.

The proposed works will see the taking down and rebuilding of building B for domestic use. It is likely that conservation and repair of this building in its current form would consist of considerable intervention where it would be uncertain as to the degree of existing historic fabric that could be viable and therefore retained, however, where possible retained material, most notably brick and tiles will be used, primarily on the principal elevation and roof to maintain the current, historic appearance of the outbuilding. This will result in the limited loss of historic fabric, which has again been mitigated through this programme of historic building inspection and recording in adherence to policy BDP20.18. It is proposed that the outbuilding is stepped forward, while its overall length is reduced to compensate. This will allow modern amenities within the proposed development without impacting upon the historic fabric of the listed building. Building B will remain clearly subservient to the farmhouse and remain identifiable as a former agricultural outbuilding, maintaining the rural and agricultural setting of the proposed development area.

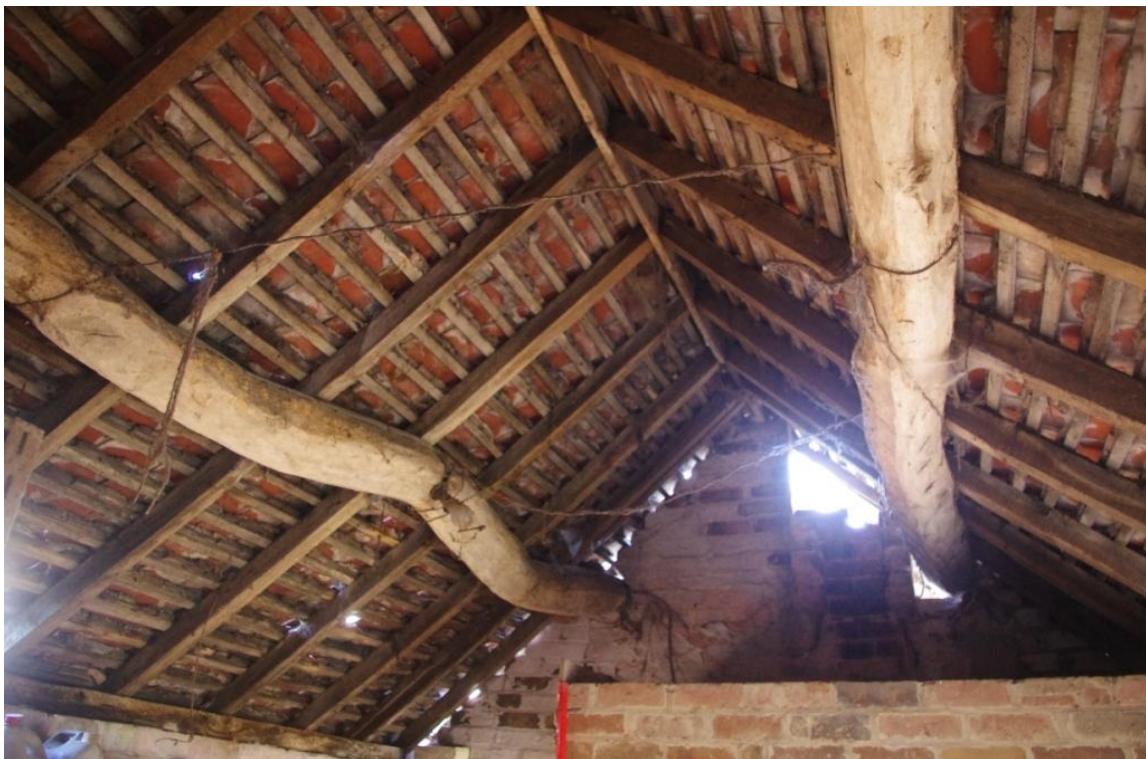
**Figure 22**  
Building B(1) Roof Structure (Looking East).

(1) consists of a single room with a recently inserted W.C in the south west corner. The common rafter roof is carried on two heavy, waney purlins (*Figure 22*) and the use of a ridge plank confirms the 19th century construction date.

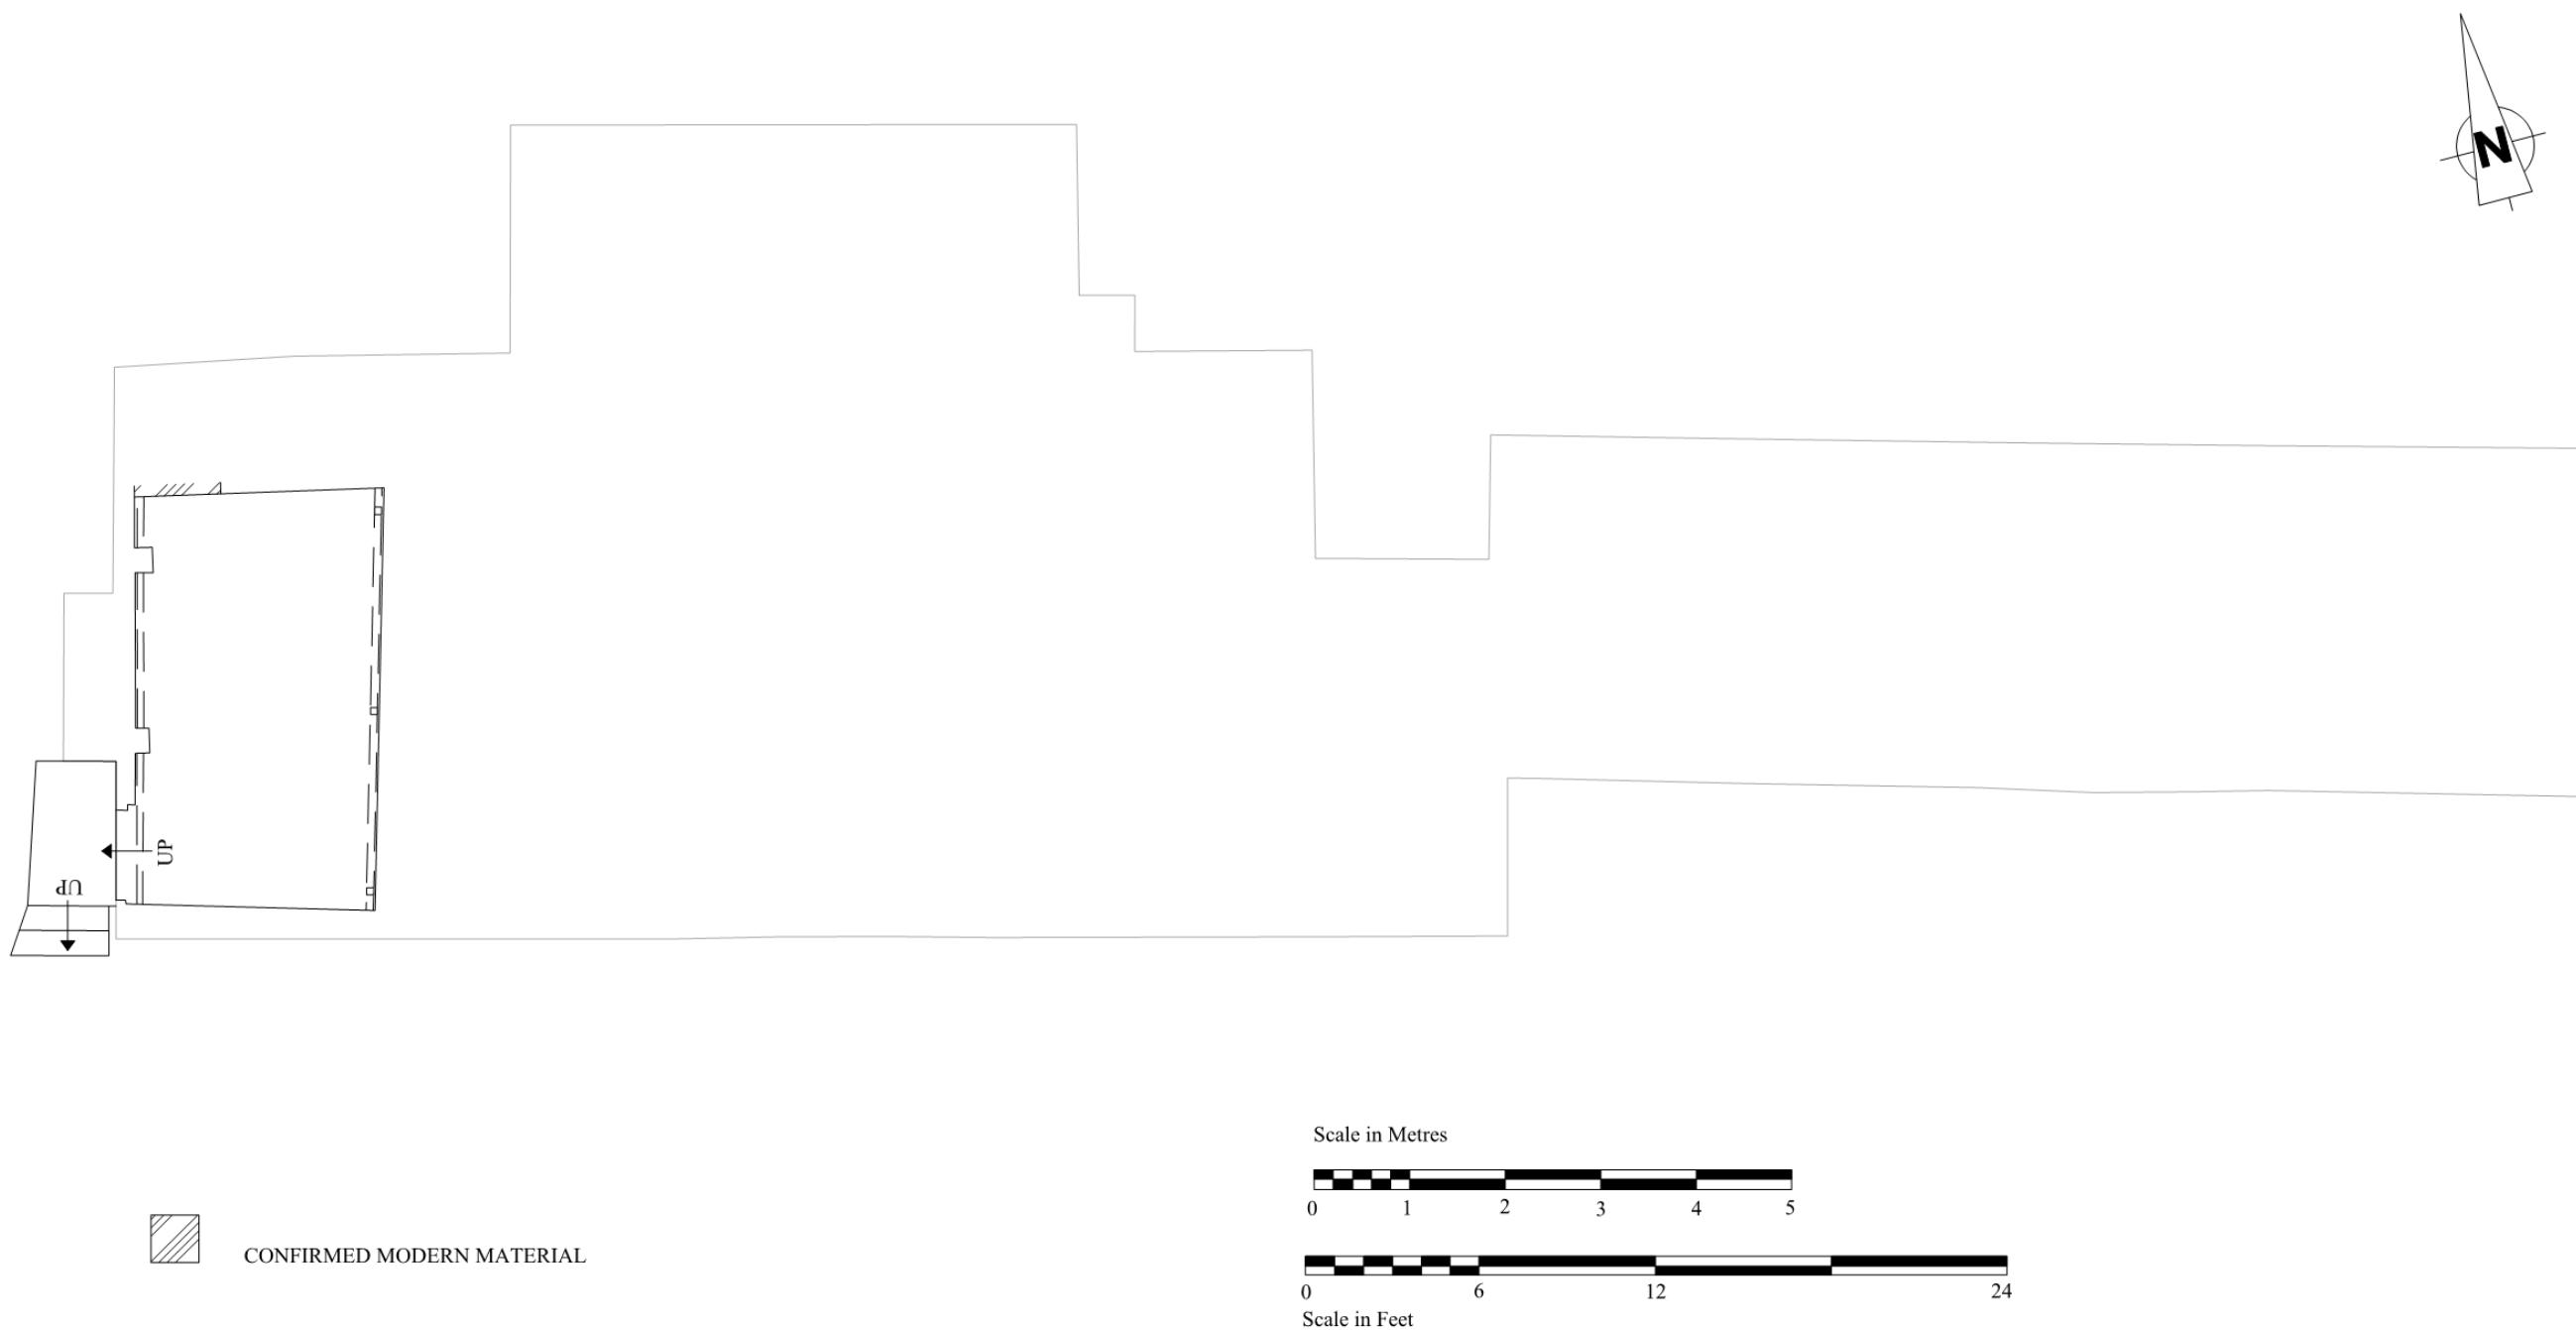
**Figure 24**  
Buildings A & B Ground Floor  
Plan.

Internally, the ground floor consists of three principle bays (*Figure 24*). Below the northernmost bay is a small cellar (*Figure 23*), now accessed via an external stone stair on the north gable, an arrangement indicative of a fruit cellar, a common enough feature in the county. Internally the cellar consists of a single bay with 19th century brick to the south and east, the northern wall is sandstone. In the east wall is a recently blocked doorway indicating that there was originally internal access to the cellar from the house also.

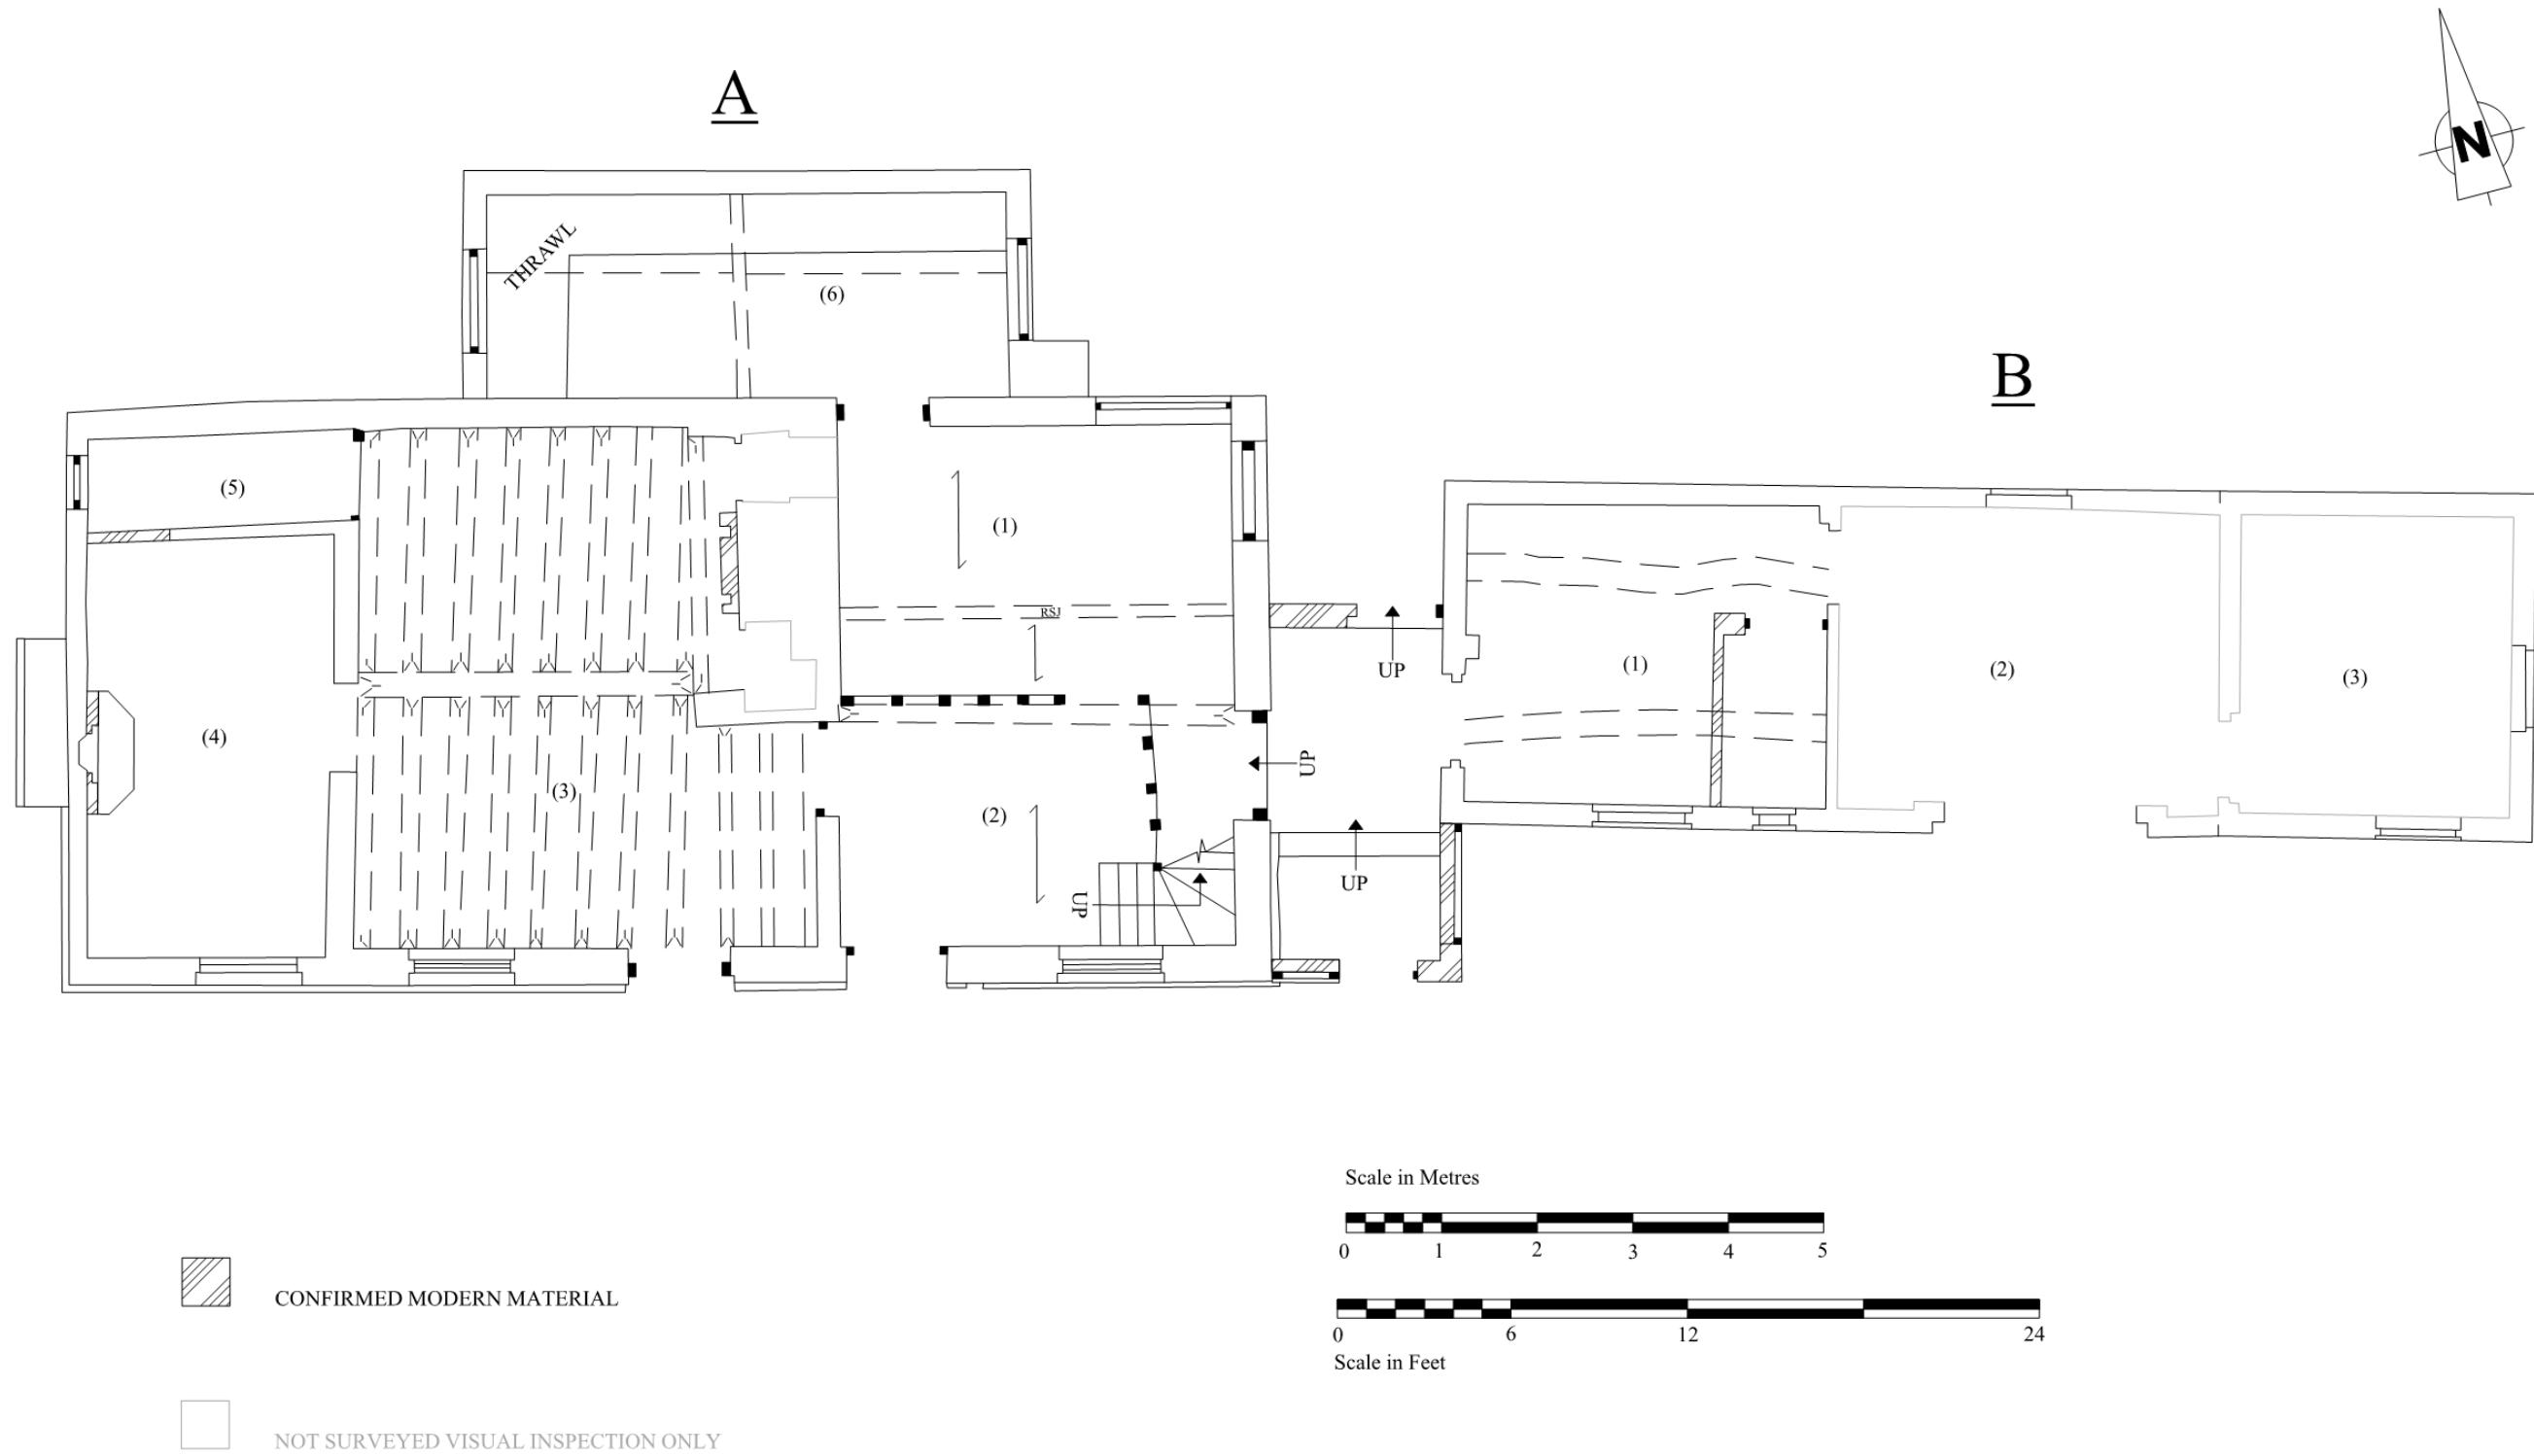
**Figure 25**  
Building A First Floor Plan.

The first floor plan (*Figure 25*) mirrors that of the ground floor with three principal bays, the southernmost bay has again be the subject of modern subdivision creating a bedroom, (8) and a small bathroom, (9) under the eaves in the south east corner. The use of the same 20th century materials to divide (8) from the stairwell is further evidence to support the stairs being non original. Both (8) and (9) retain exposed purlins, both are heavily painted and lack any diagnostic features.
