Field House, Maggotts End, Manuden, CM23 1BJ

Ecological Impact Assessment – Addendum

Planning Application Ref. UTT/23/2743/HHF

December 2023

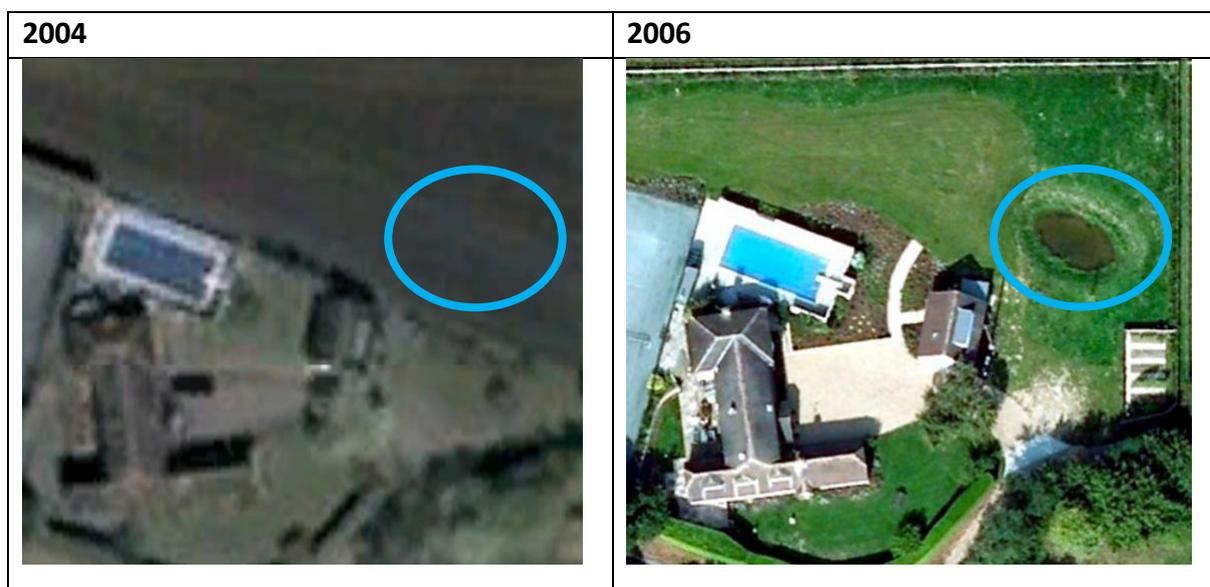
Figure 1. Google aerial images from 2004 and 2006, showing creation of the on-site pond over the intervening period. Pond location is ringed blue

It is not known whether the pond on site supports great crested newts (GCNs). An HSI survey (Oldham et al. 2000) of the pond showed it has 'good' suitability to support GCNs. However, inspections of historical Google aerial images show it was created between 2004 and 2006 (see Figure 1 for relevant images), when the curtilage of the property was extended onto arable farmland to the north. Therefore, the pond is approximately 18 years old, and would rely on dispersal of GCNs from nearby breeding ponds over that time to colonise and form a breeding population. Cresswell and Whitworth (2004) and Müllner (2001) found that GCNs rarely disperse further than 100m from their breeding pond, but occasionally disperse further.

The accepted maximum dispersal distance is 250m, demonstrated for example by Natural England's approach to District Licensing schemes, where only ponds within 250m are incorporated into the DL calculation. As detailed in the PEA report, the only other two ponds within 250m of the site are both heavily shaded and unlikely to be suitable for GCNs, and certainly not for anything greater than a small population. We therefore conclude that despite the on-site pond being suitable for GCNs, it is unlikely that it has been colonised by dispersing GCNs since its creation.

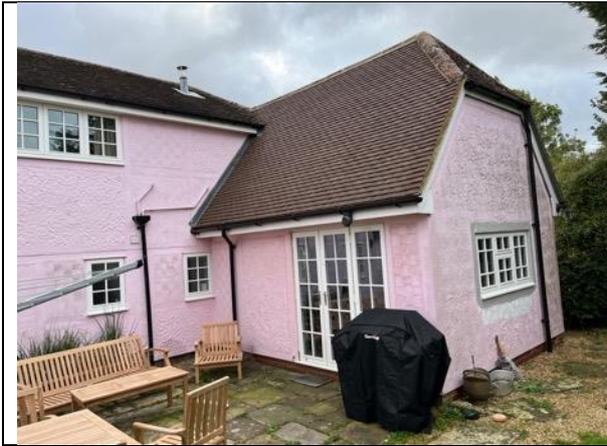
- the roof of the north aspect of the southwest kitchen area – this area has a new roof with tight fitting tiles and no bat roost potential (Photo 1).
- the walls and eaves areas of a section of the northwest elevation of the house where the new 2-storey extension is proposed – this area has tight-fitting fascia boards and roof tiles (although note that the roof will not be directly impacted), and a wooden shed, all of which support negligible bat roosting potential (Photo 2).

Photo 1. Rear of house (southwest section) showing kitchen area to be extended (wall with French doors and roof above). Note relatively new roof tiles in immaculate condition and closely fitting paving slabs.

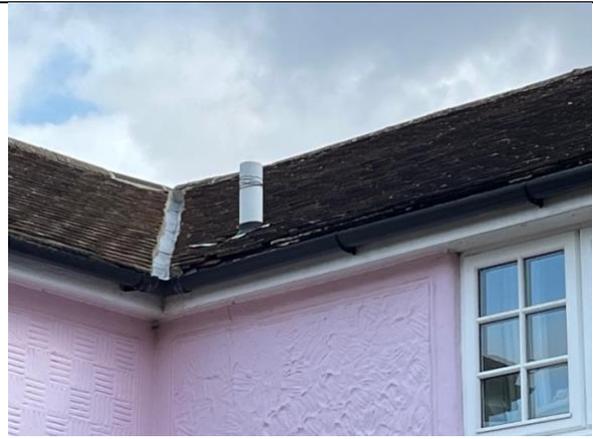
Photo 2. Northwest section of the house showing the walls and soffit boxes in the location of the proposed 2-storey extension. Note tight soffits and walls with no gaps or potential bat roost features.

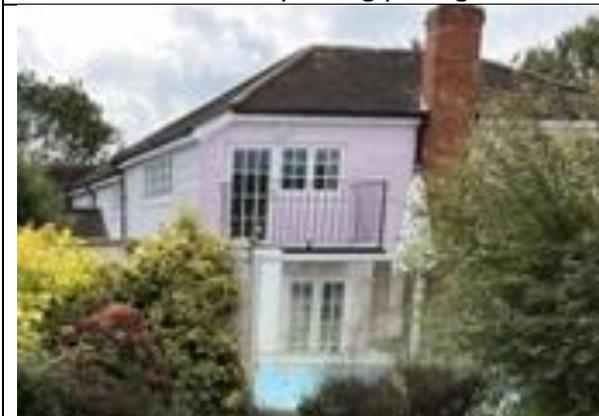
- Existing balcony and surrounding wall of north elevation – this area has no bat roosting potential (Photo 3)
- the north elevation of the garage – this area has tight-fitting fascia boards and roof tiles (although note that the roof will not be directly impacted), and a wooden shed, all of which support negligible bat roosting potential (Photo 4).

Photo 3. Balcony on north elevation to be replaced

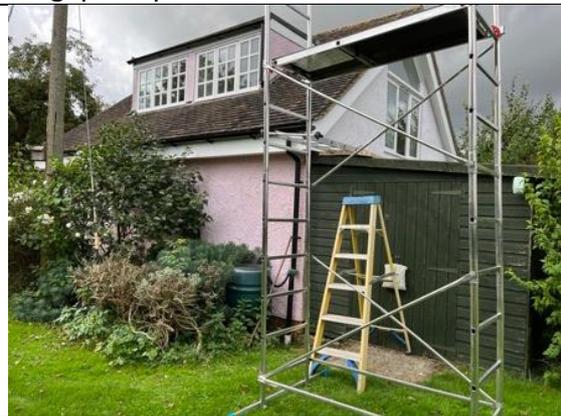
Photo 4. Garage from the northeast, showing north elevation with lean-to shed and tight-fitting soffit and fascia boards and roof tiles

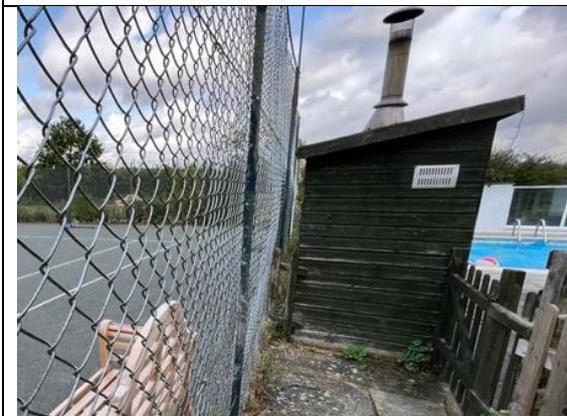
- the existing pool shed which has negligible bat roosting potential (Photo 5).

Photo 5. Existing pool house (shed)

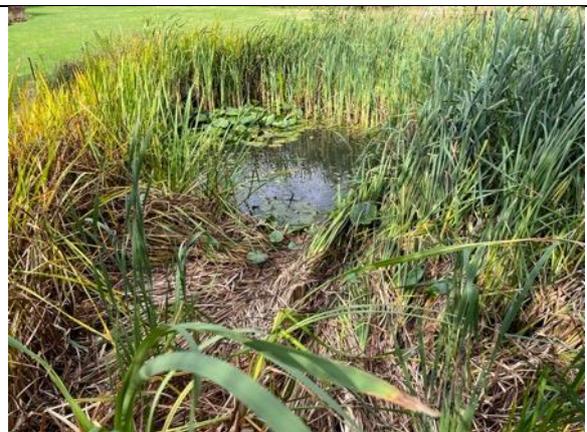
Photo 6. Pond taken from east, showing tall marginal vegetation and tightly mown lawn beyond, in direction of proposed pool house

To provide enhancement for GCNs, should they be present in the pond (and/or for other semi-aquatic species such as other amphibian species), 200m² of existing mown lawn to the west and southwest of the pond will be allowed to develop into rough neutral grassland ideal for GCNs.

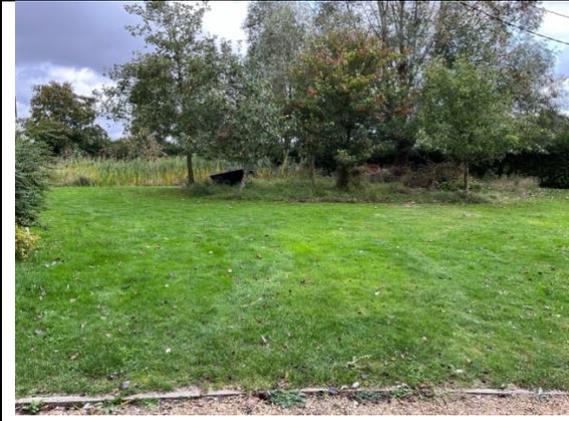
All work within 20m of the pond will be on either tightly mown amenity grassland lawn (cartshed) (Photo 7) or hardstanding and a 2m area of bare ground beneath a shrub (garage extension), all of which are unsuitable for GCNs. As detailed in the PEA report, the cartshed will not impede dispersal of GCNs to or from the pond. Work between 20-50m with potential to impact GCNs (the balcony will not) will be the new pool building and associated new areas of paved patio. The footprint of this element of the proposed development will cover 115m² of which 60m² is existing tightly mown grass lawn and 45m² is existing well-managed ornamental shrubs (Photo 8). Between this area and the pond is 20m of open, closely mown grass lawn (Photo 6), unsuitable for GCNs, which will discourage their dispersal in the direction of the work, particularly when habitats in other directions immediately surrounding the pond are ideal for GCN dispersal.

Photo 7. Area of mown lawn in the location of the proposed cartshed, showing the trees and rough grassland surrounding the pond in the background

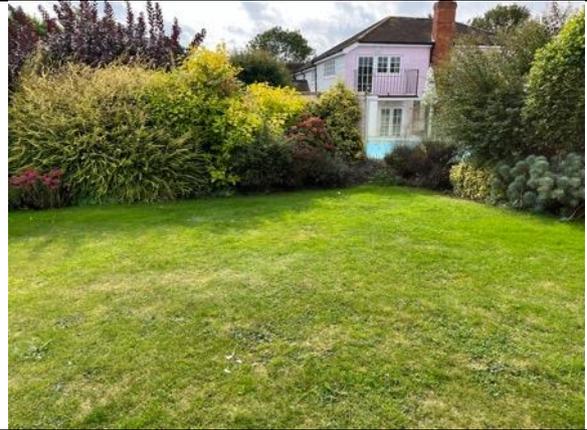
The areas of shrubs to be impacted to the north of the swimming pool and west of the house (east of the tennis court), where they will be removed to facilitate development of paved patio, paths and the new pool house, all have moderate potential to support nesting birds. Therefore, appropriate timing (September-February inclusive) of these shrubs is recommended to avoid the nesting bird season. If the nesting bird season cannot be avoided, a bird-nesting survey should be undertaken prior to shrub clearance, to ensure no active birds' nests will be damaged or destroyed.

Photo 8. Mown lawn area with shrubs to north of swimming pool showing the location of the proposed new pool building
