Project: Rosemay, 12 High Street, Elie, Fife
Client: Mr and Mrs Kelly
Date: March 2024

Existing Window Survey

This document provides a condition appraisal of all external windows to the property at Rosemay, Elie. The entrance door and fanlight over and utility door are to be retained and are not included in this survey.

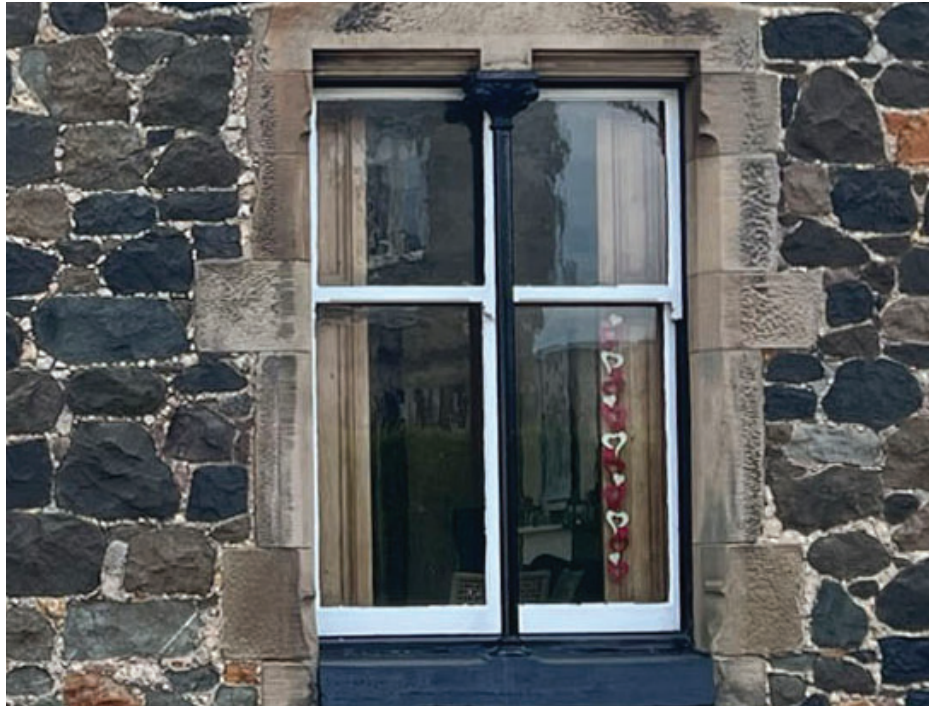
Window 1

Two over two victorian style timber sashes - paint in good condition, putty poorly applied and multiple overpaint coats onto glazing. Single glazed.

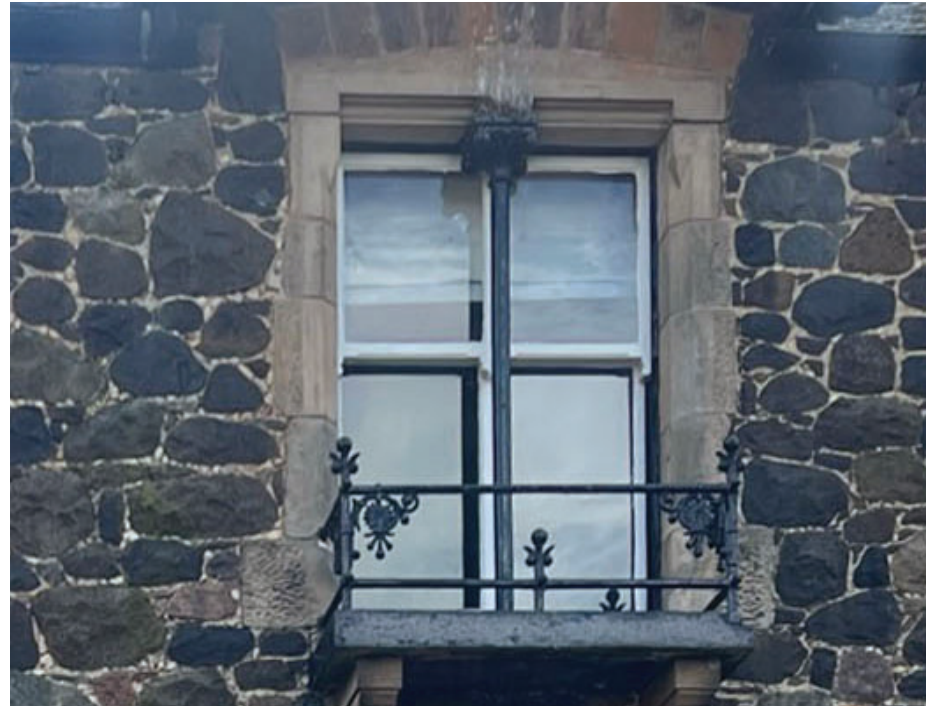
Window 2

Two over two timber sashes - small hole in glass, paint in good condition, putty poorly applied and multiple overpaint coats onto glazing. Single glazed.

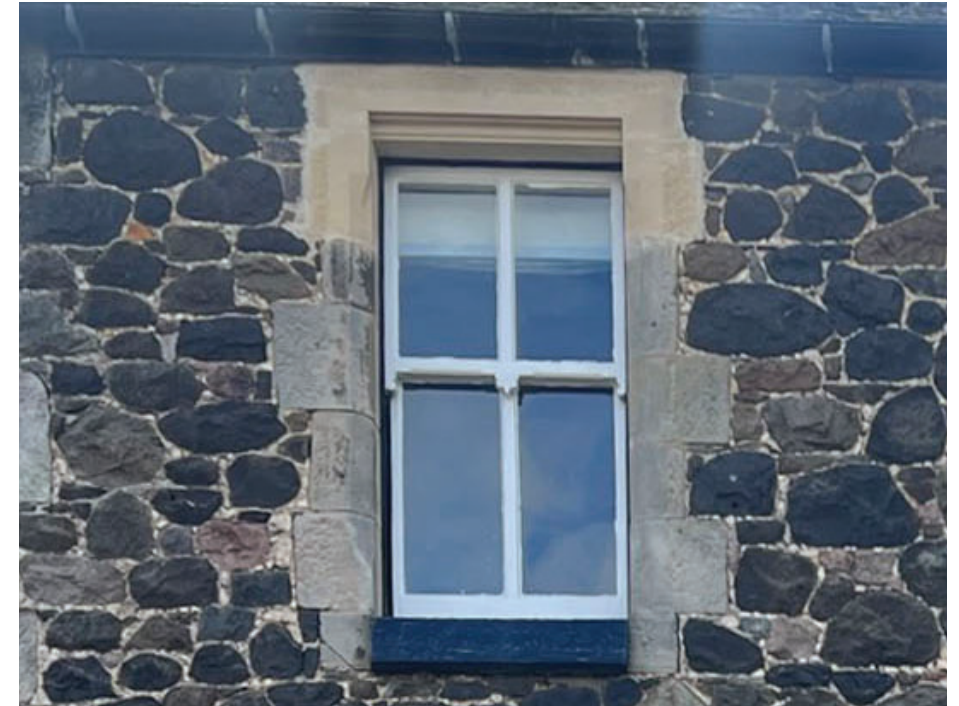
Window 3

Two over two victorian style timber sashes - multiple over paints to timberwork, cill soft, putty poorly applied and multiple overpaint coats onto glazing. Single glazed.

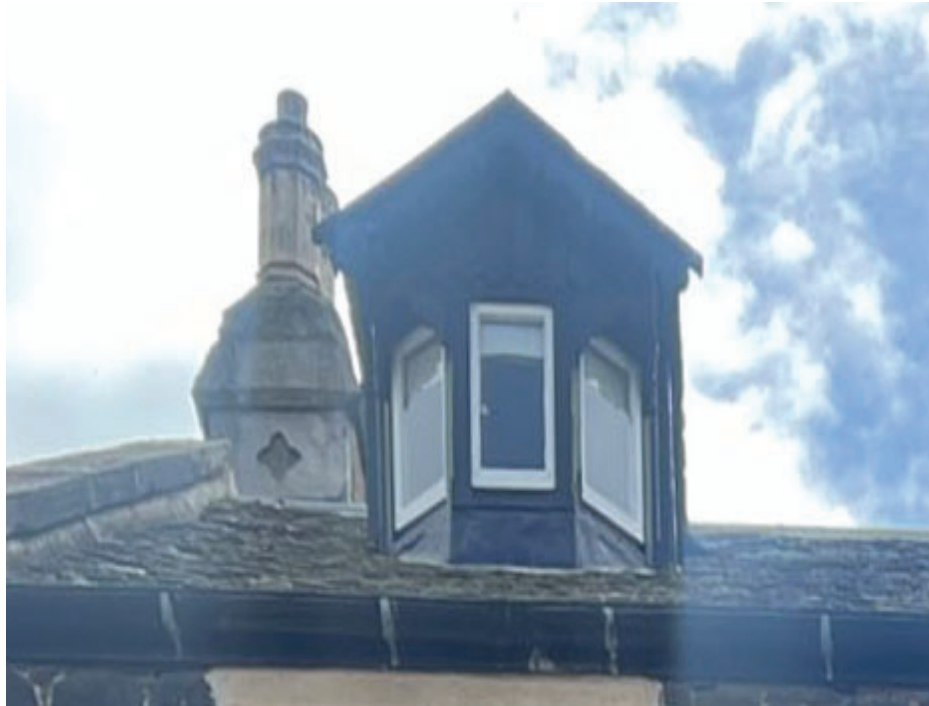
Window 4

Two fixed and one central casement window. - paint in good condition, multiple overpaint coats. Single glazed.

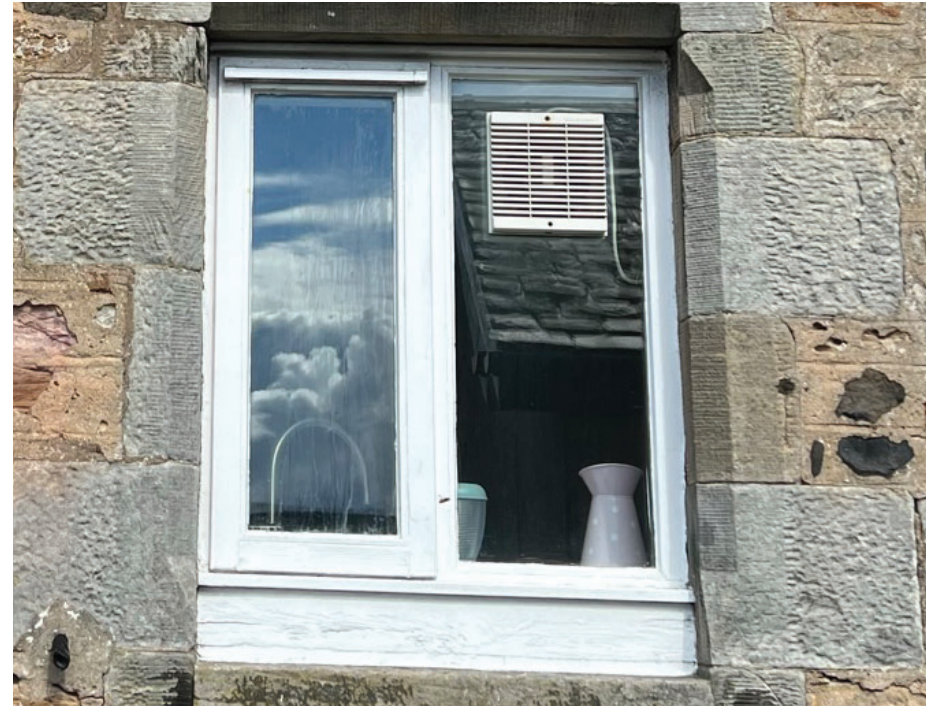
Window 5

Casement window with one pane side fixed with vent located in glazing. Multiple over paints onto timberwork. Painted timber plinth not in good condition, Single glazed.

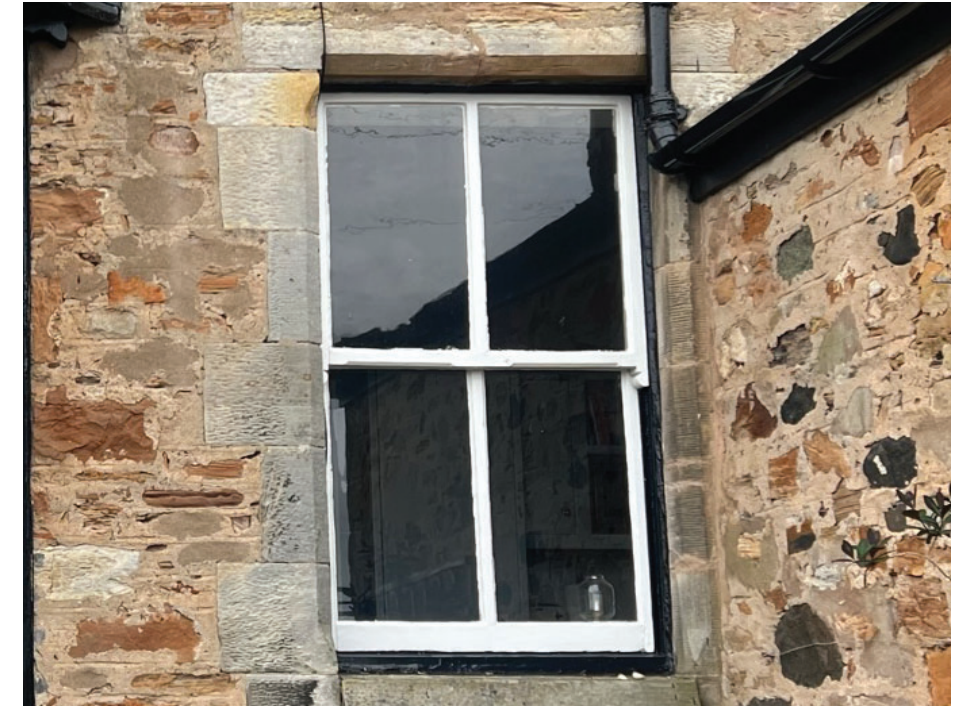
Window 6

Two over two victorian style timber sashes - paintwork in good condition, putty poorly applied and multiple overpaint coats onto glazing. Single glazed.

Window to be retained.

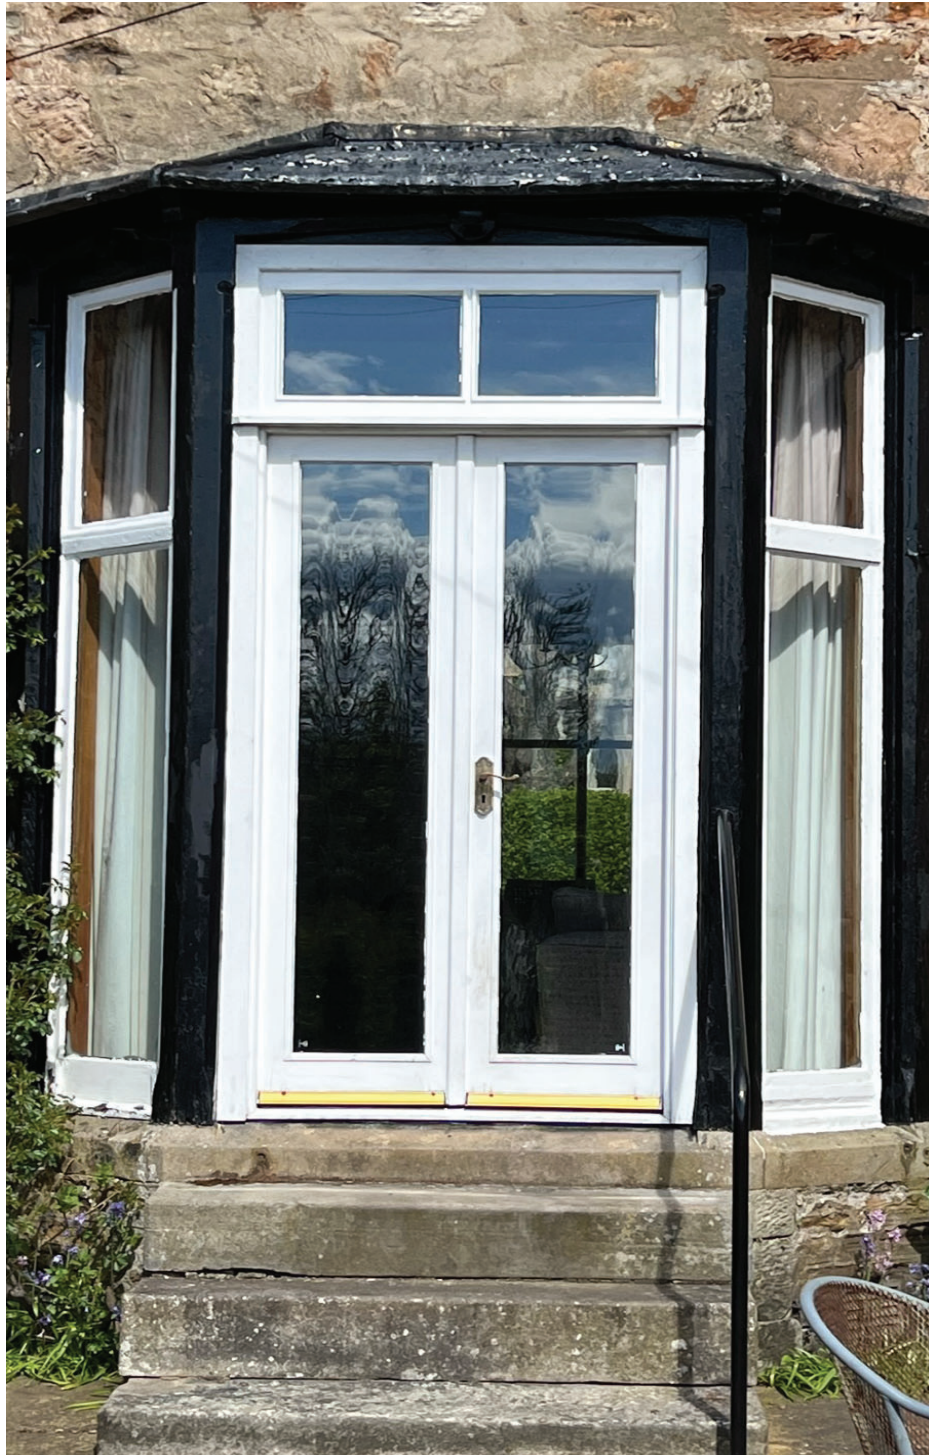
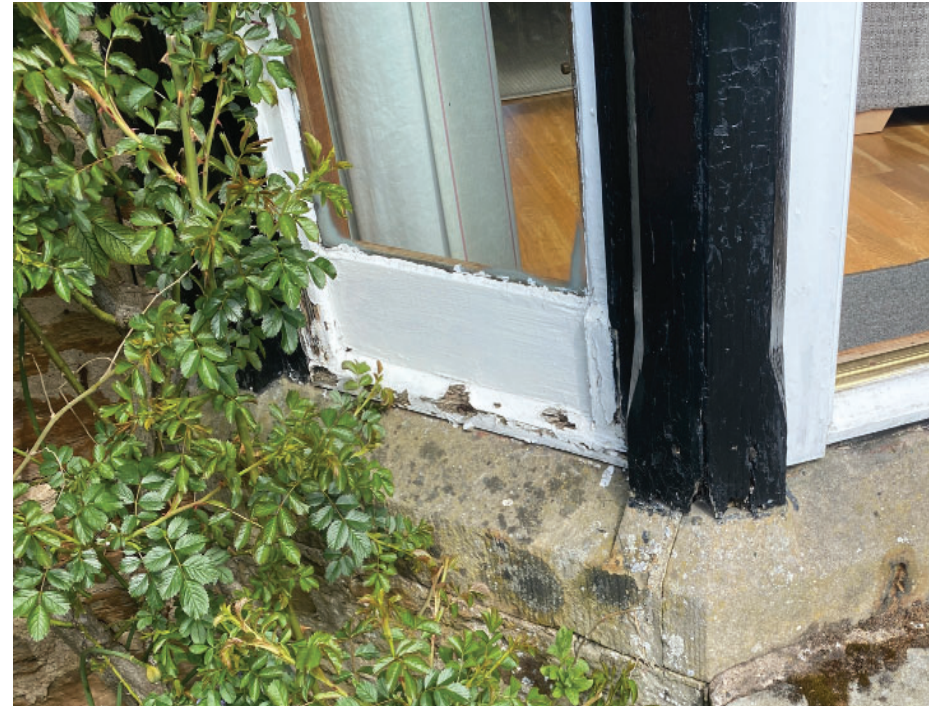
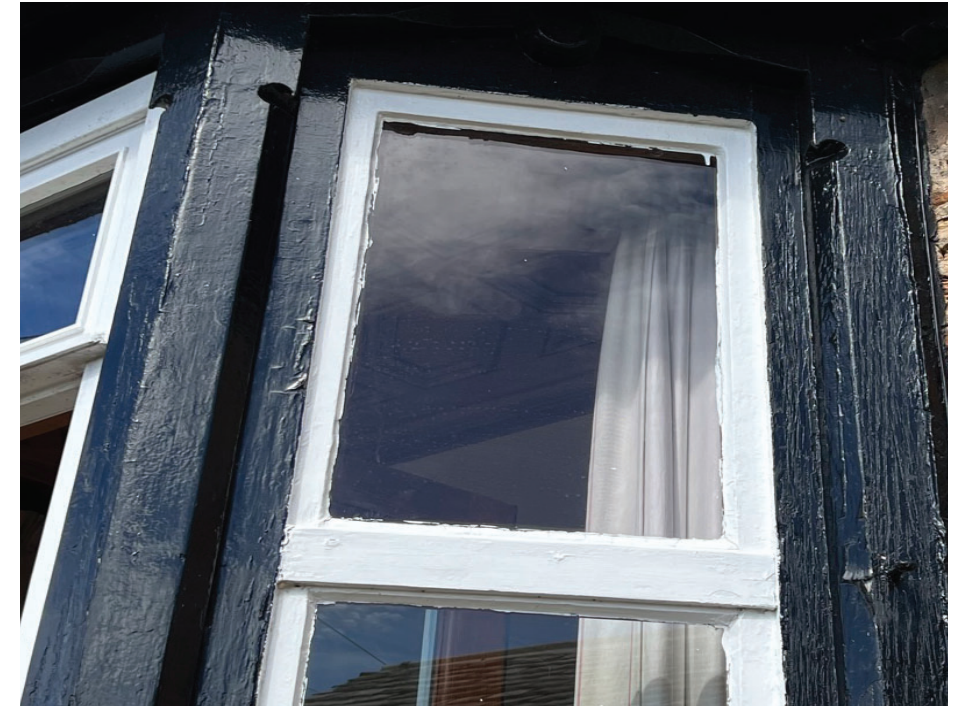
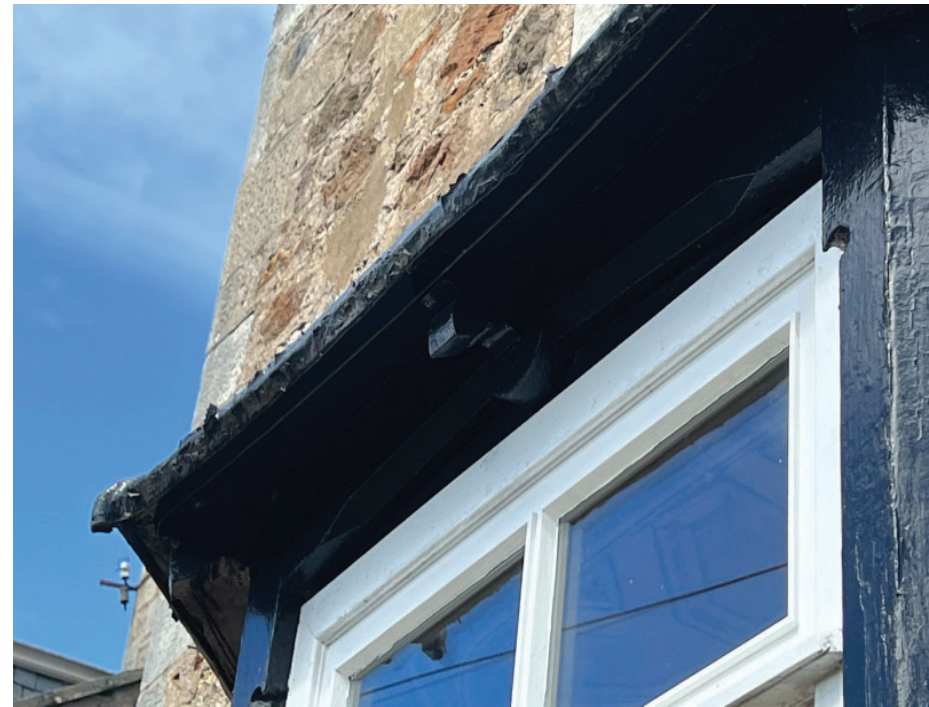
Window 7

Modern double glazed french doors to bay window with fixed single glazed side lights with raised transom. Fanlight with central glazing bar above french doors.

Timber posts and structure with noticeable poor condition at base. Paint flaked off at side light cill. Putty poorly applied to side lights and overpainted onto glass. Timberwork overpainted numerous times.

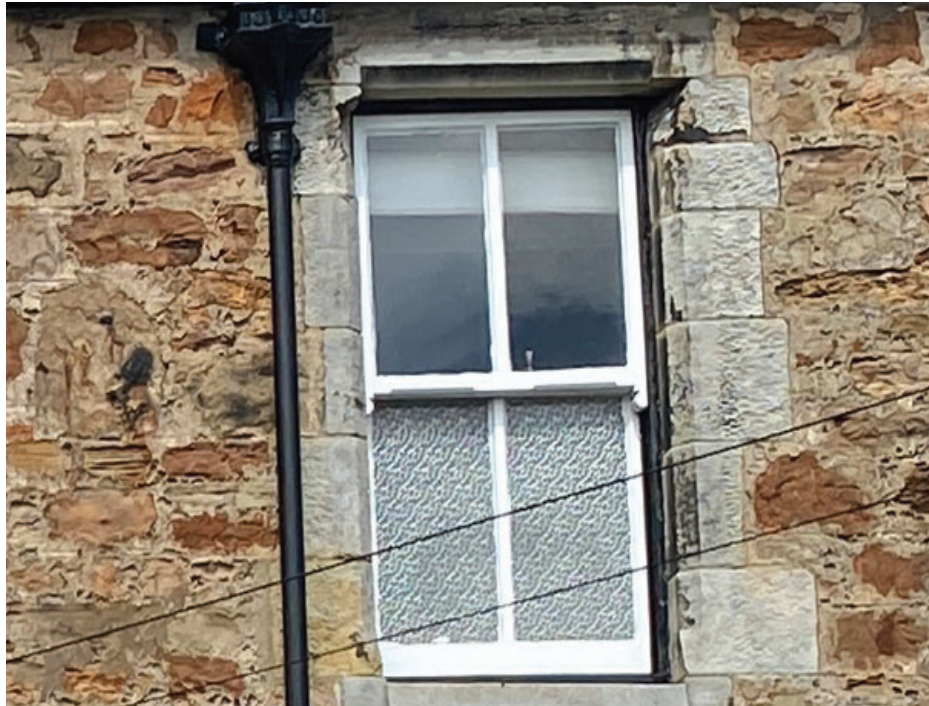
Window 8

Two over two victorian style timber sashes - paintwork in good condition, putty poorly applied and multiple overpaint coats onto glazing. Single glazed.

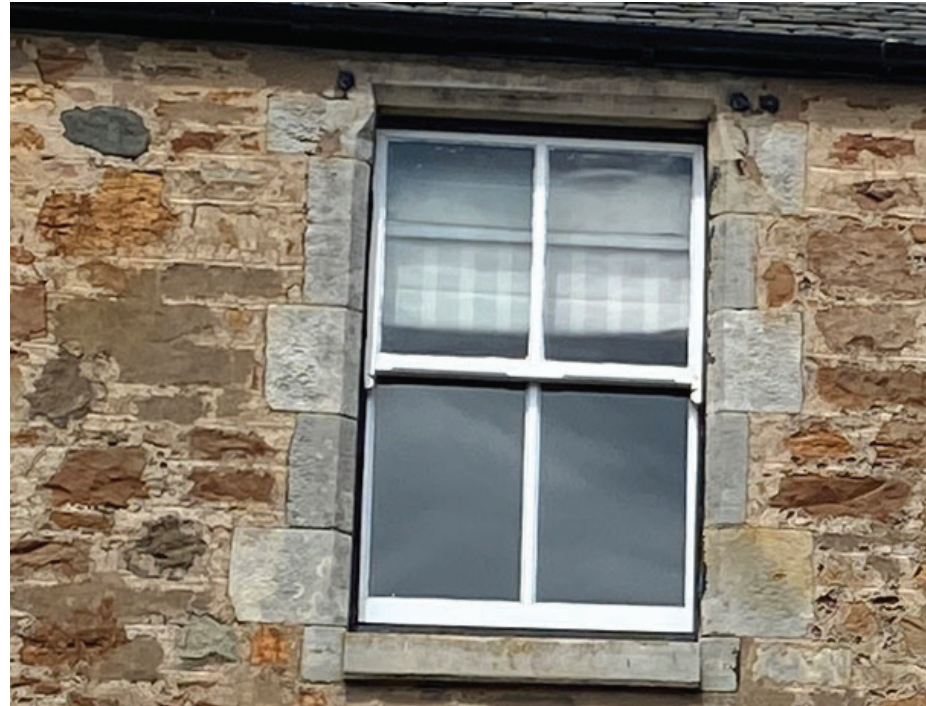
Window 9

Two over two victorian style timber sashes - meeting stile and cill temporarily patched up due to rotten timber frames. Paintwork in good condition, putty poorly applied. Single glazed.

Window to be retained.

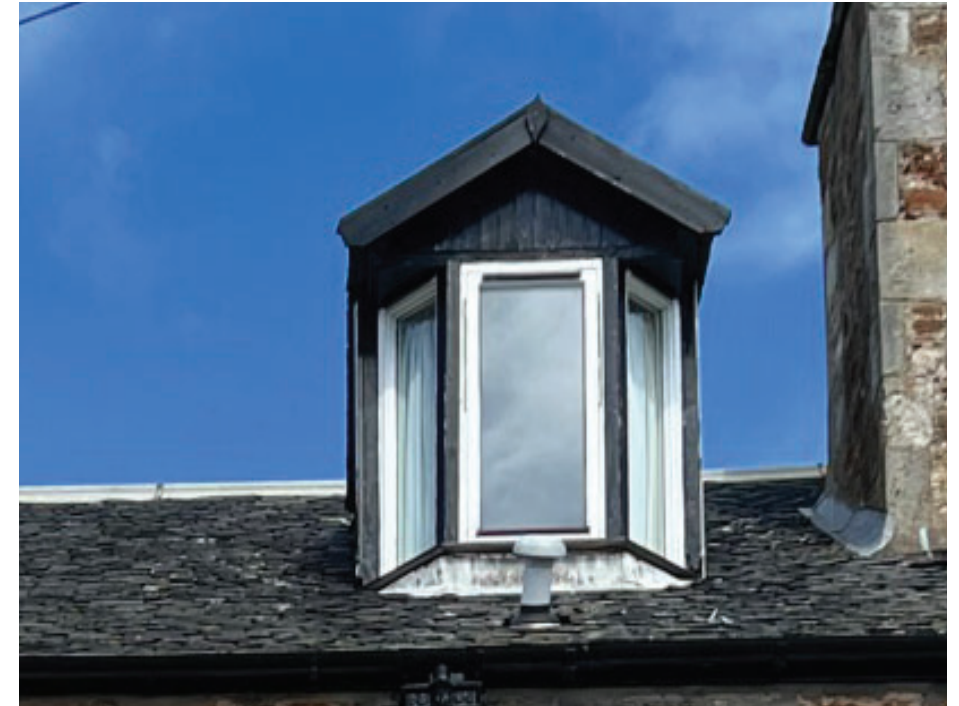
Window 10

Two fixed and one central casement window. - paint in good condition, multiple overpaint coats. Single glazed.

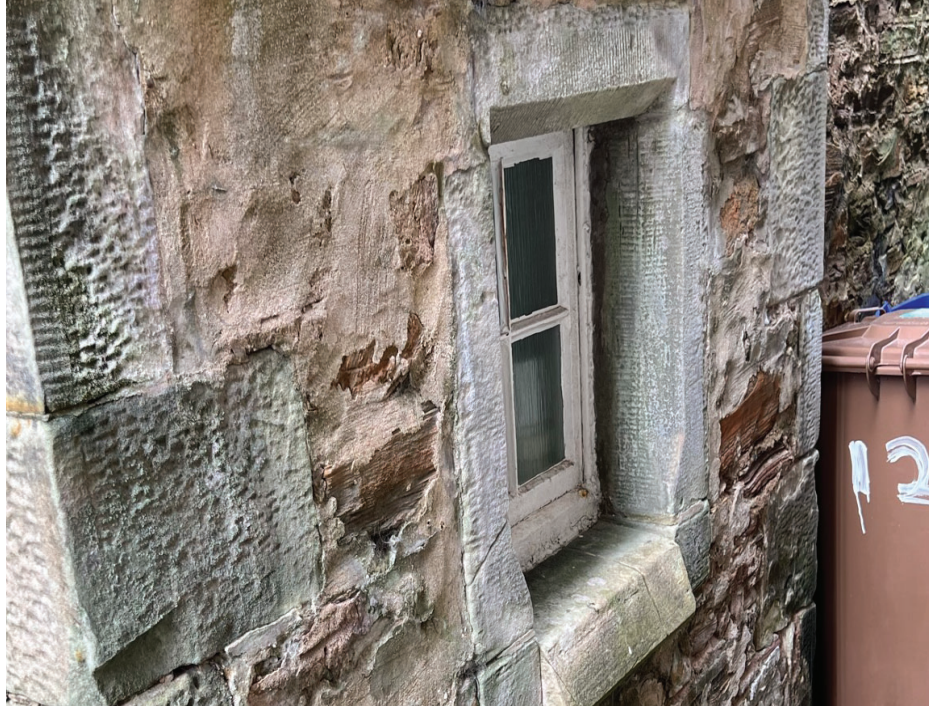
Window 12

Four pane casement window, putty poorly applied- overpainted onto glass. Single glazed.

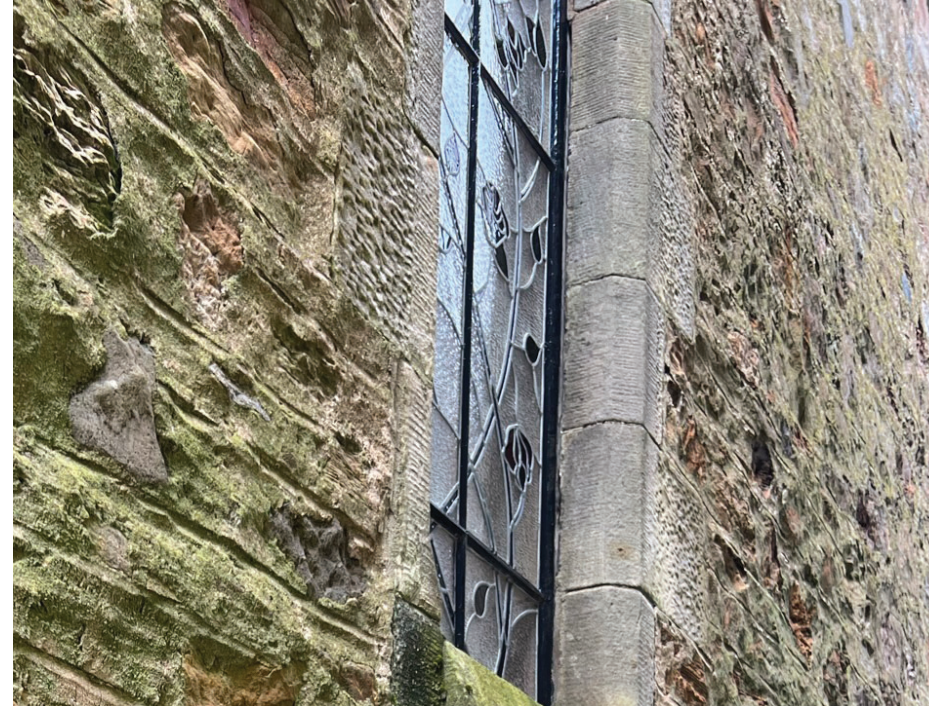
Window 13

Stainglass window to internal stair to be retained.
