Phase I & II Geo-Environmental Assessment

Leeds City Academy
Bedford Field
Woodhouse Cliff
Leeds
LS6 2LG

EPS Reference Number: UK22.6213

Date Issued: 28th March 2024

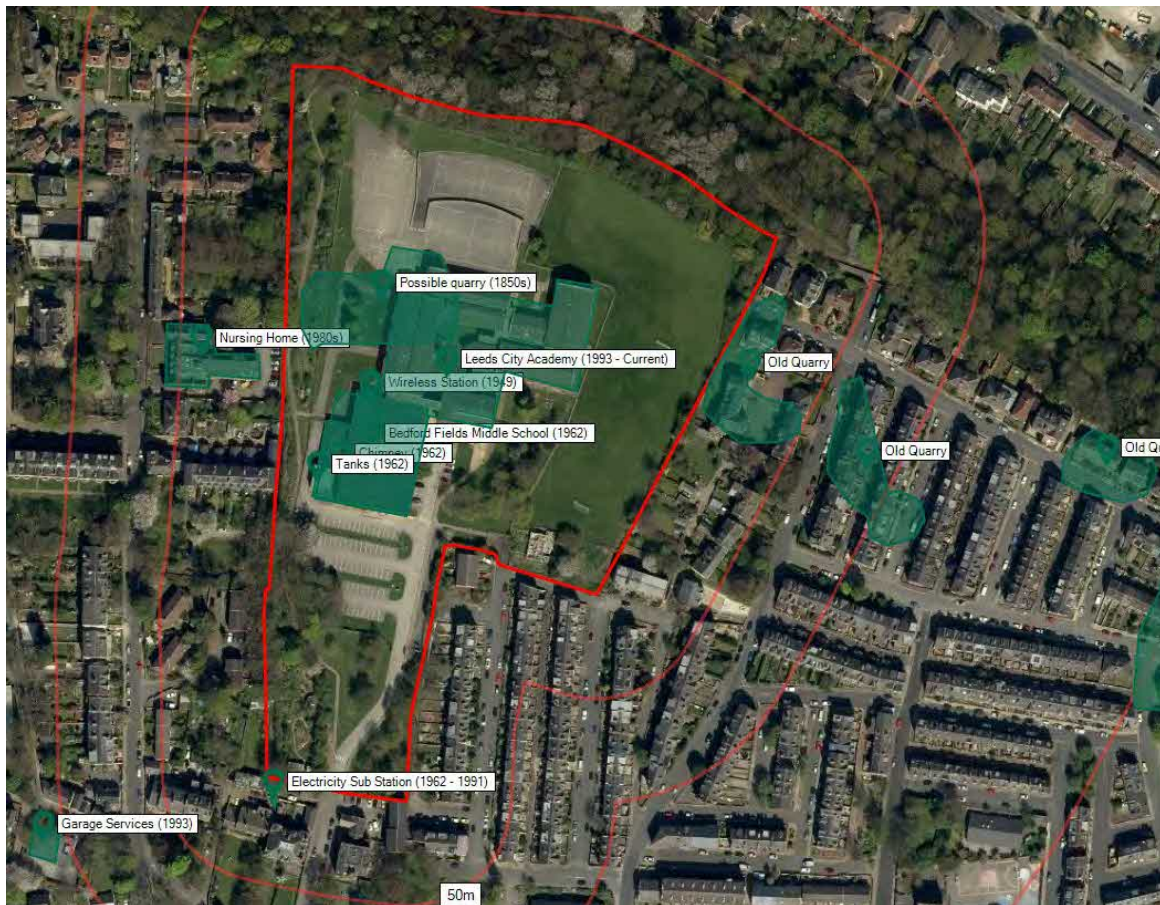
A summary of historical map data from 1851 to 2022 is provided below and copies of relevant historic maps and any others examined during the investigation are included in this report as Appendix F. A map detailing historic features in the area surrounding the site is displayed below.

Earliest maps from 1851-1854 shows the site and surrounding area to have been a region of sandstone quarrying. These quarries have been assumed to have been infilled by the start of 1900s where the site area remained undeveloped and labelled as playing fields until 1949 where a wireless station for the police was constructed onsite.

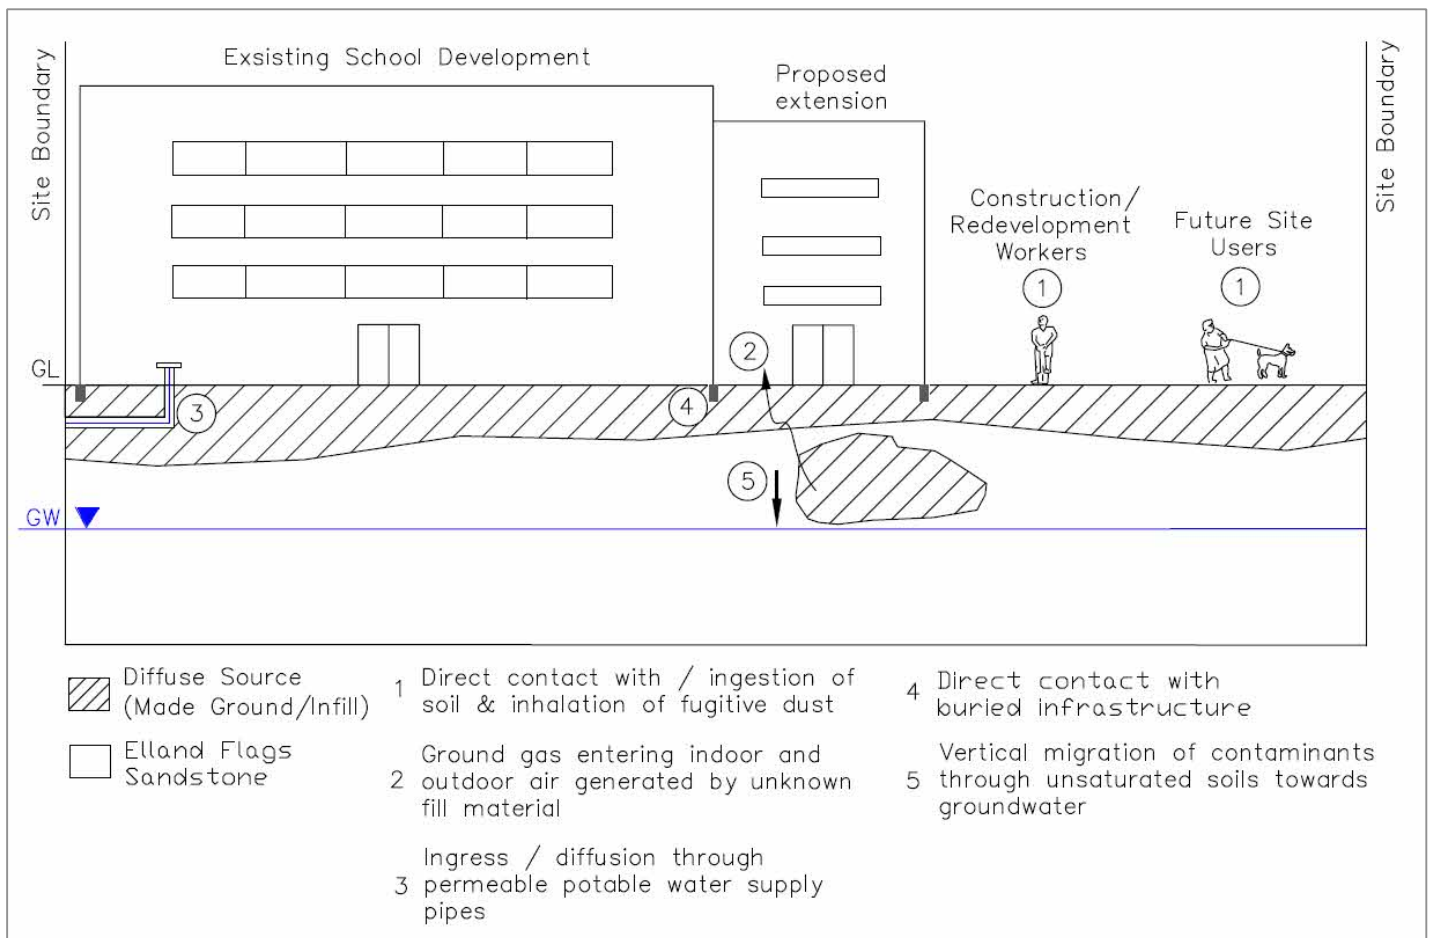
Illustrative Conceptual Site Model –Leeds City Academy

The following diagram provides an illustration of the plausible contaminant linkages that may be active at the site and which may need further investigation or control to ensure safe development:

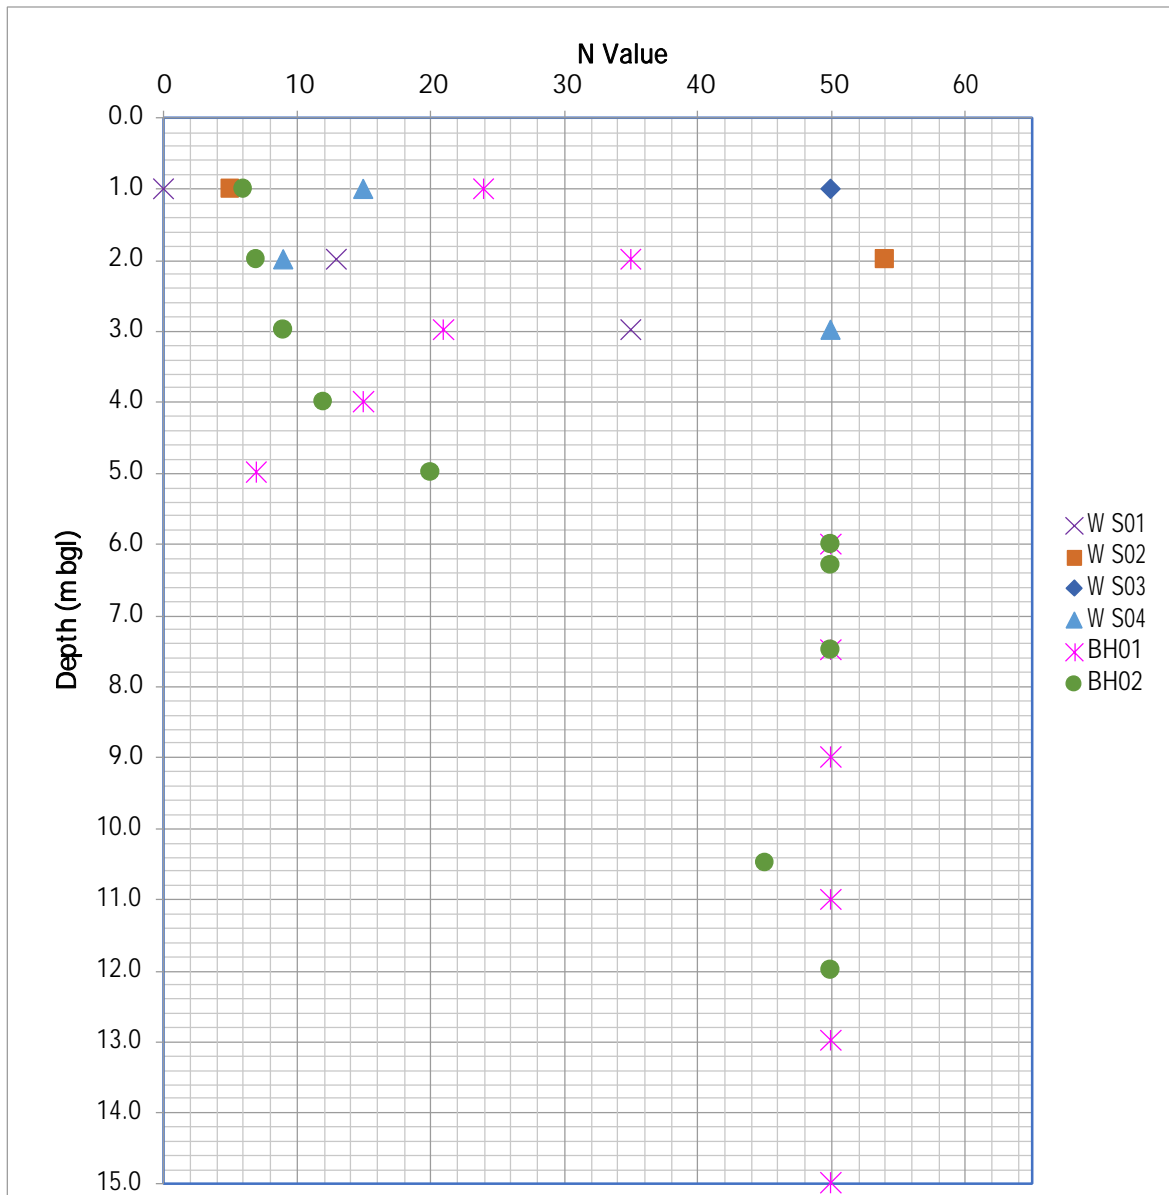
The results of in-situ geotechnical testing are summarised in the graph below.

The data above shows that within the first 5.0m below ground there is a large range of N-values obtained matching the variability of the made ground. After which the majority of results are refusals (N=50) which is reflective of the strength of the sandstone underlying the property. A copy of a dynamic probe log from WS01 is also included within Appendix G to highlight strength from 3.0m to 5.0m following drilling refusal while window sampling at that location.

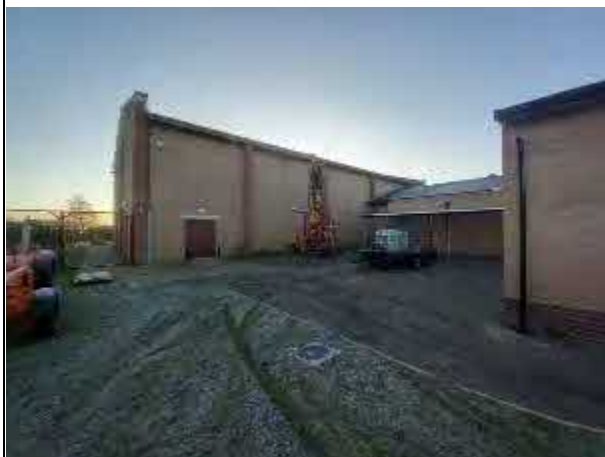
Photo 3: Photograph overlooking rotary drilling rig on BH01, facing south east.

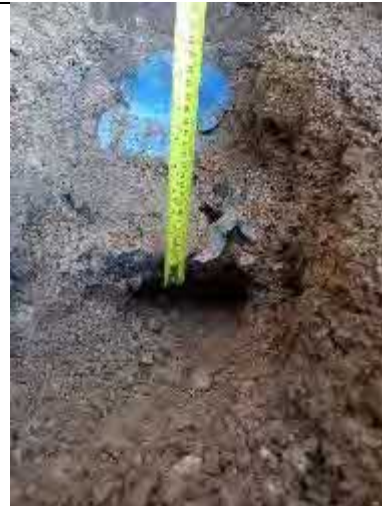
FE02 was undertaken on the northern wall of the main school building and was found to comprise a vertical brick course extending to a depth of 0.30m bgl, sitting on a concrete foundation. This section stepped out 0.27m perpendicular from the building line, before progressing a further 0.05m vertically and resting on made ground. Blue membrane is found on top as with FE01.

Photo 4: Photograph showing foundation exposure at FE02 with blue membrane.

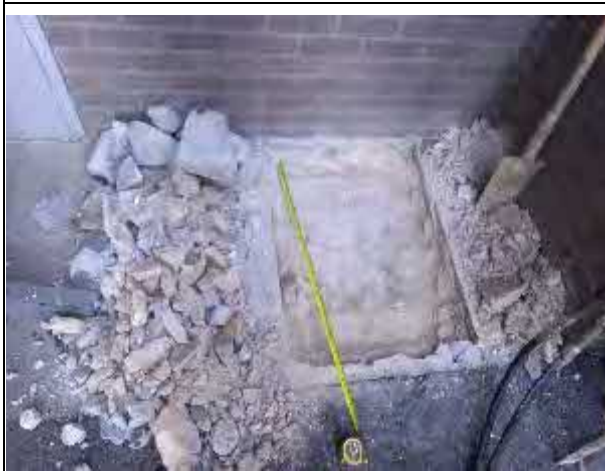
FE03 was undertaken on a wall adjacent to the existing dining area. An hydraulic breaker was used to break through an 11cm thick concrete slab, beneath this was further concrete which could not be broken through with the hydraulic breaker.

Photo 5: Photograph at FE03.

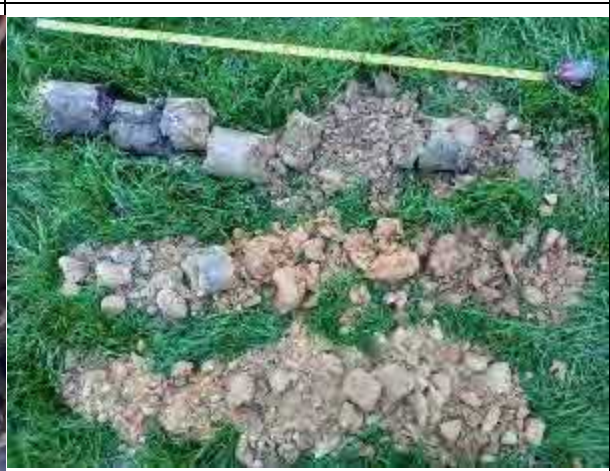
Photo 6: Photograph of material taken from WS04.
