PRELIMINARY ROOST ASSESSMENT

Site: Grange Lodge, Wallington

18.01.2023

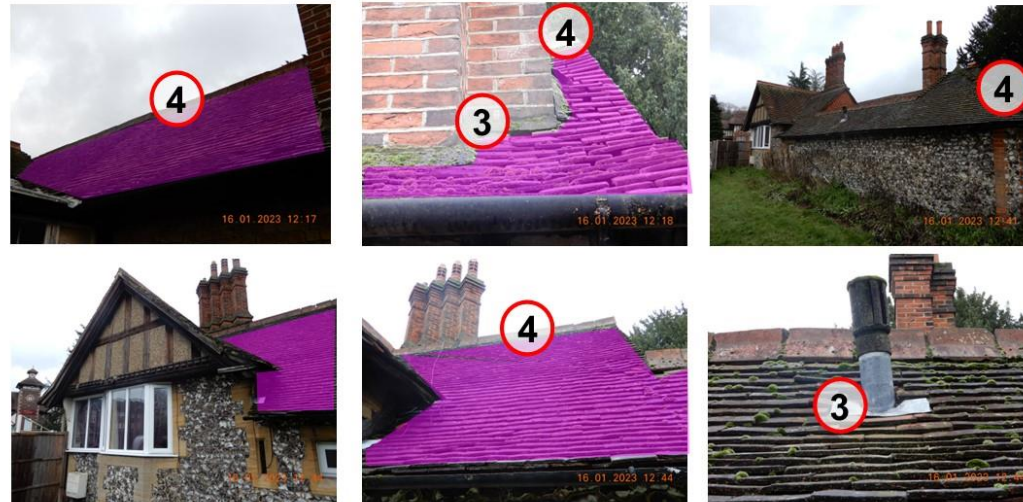
External Inspection (Building B1) — Western Elevation

-   Lifted, Missing and Slipped Tiles
-   Lifted Lead Flashing
-   Lifted Coping and Ridge Tiles

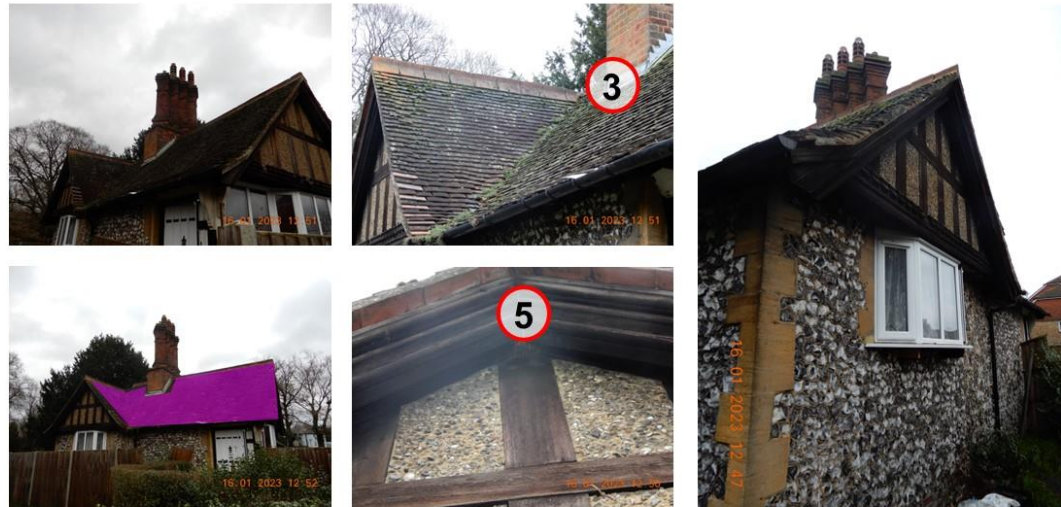
External Inspection (Building B1) — Northern Elevation

Lifted Lead Tiles
-

Lifted, Missing and Slipped Tiles
-

Gap in Roof Apex

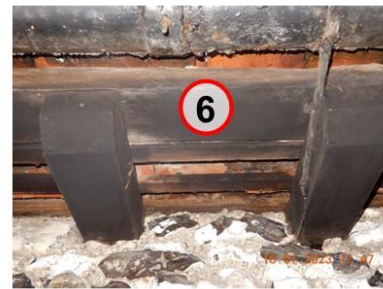
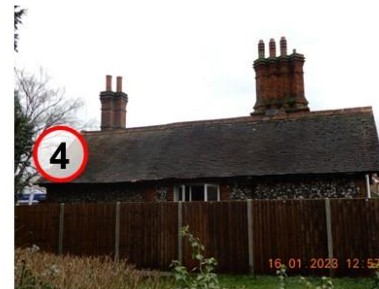
External Inspection (Building B1) — Eastern Elevation

-   Lifted Coping and Ridge Tiles
-   Open Eaves
-   Lifted, Missing and Slipped Tiles

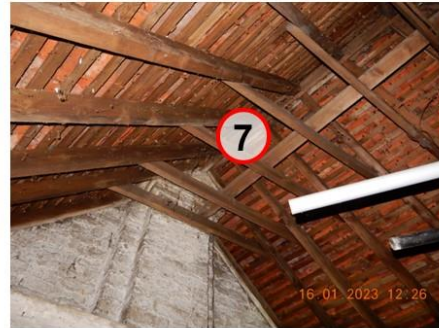
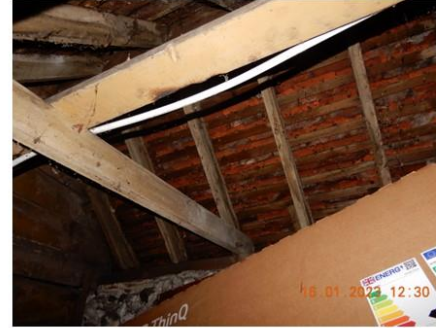
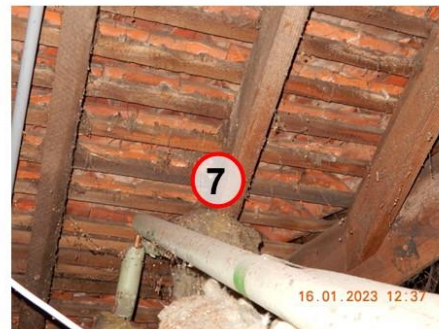
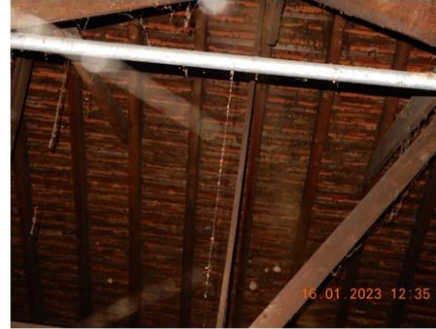
Internal Inspection (Building B1)

Crevices in Timber Framework
