Bat Survey of:

Palace Green Library and the Education and Learning Centre
Palace Green
Durham

HL_PalaceGreen_Bat2.1

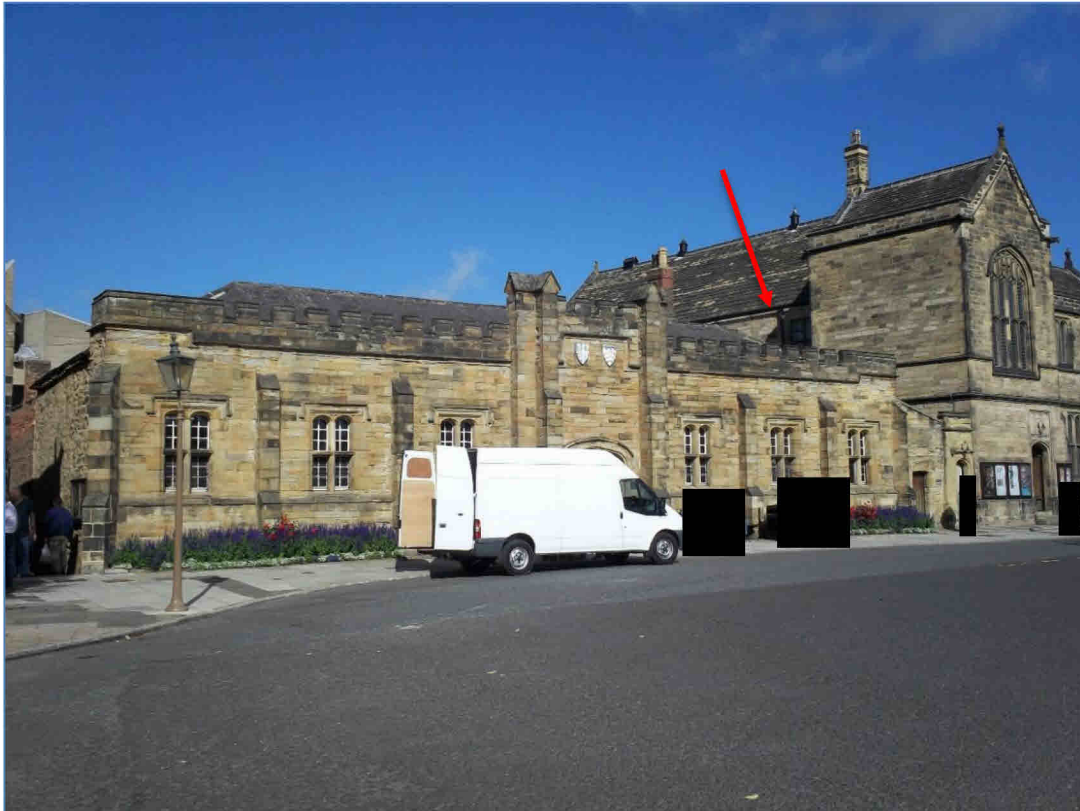
3.4.1 The Education and Learning Centre (Photographs 1 and 2) is a two storey stone built structure attached to other buildings on its north, south and west elevations. The east elevation overlooks Palace Green. The roof is pitched and covered with stone slates. Information from the client suggests that the roof is lined with breathable membrane below the tiles. No internal inspection was undertaken.

Photograph 1 – East and south elevations of The Education and Learning Centre. Red arrow shows roost location found in 2013

A previous roost was found in 2013 by Dendra Consulting Ltd in The Education and Learning Centre. Five common pipistrelles were found emerging from a point shown in Photograph 1. Other surveys of the adjacent Exchequer Building to the north were undertaken in 2013 by Dendra Consulting Ltd and did not record any bats from The Education and Learning Centre, but did record a roost of a single Common Pipistrelle from the west elevation of The Exchequer Building. Generally the buildings on Palace Green are likely to hold small numbers of common pipistrelles and various times of the year. The Cathedral, to the south, is a known autumn swarming site for large numbers of common pipistrelles.

6.5.1 The roof covering will be arranged so that bats will have access at the eaves of The Education and Learning Centre. It is hoped that one such location will be in the area previously identified as a bat roost in 2013. Critically the roof will

not be recovered with a breathable membrane that has not passed a 'snagging propensity test'. The roof will be covered with either a breathable membrane that has passed a snagging propensity test (and has a certificate) or it will be covered with traditional 1F felt. This will help improve the overall opportunities for bats on site.

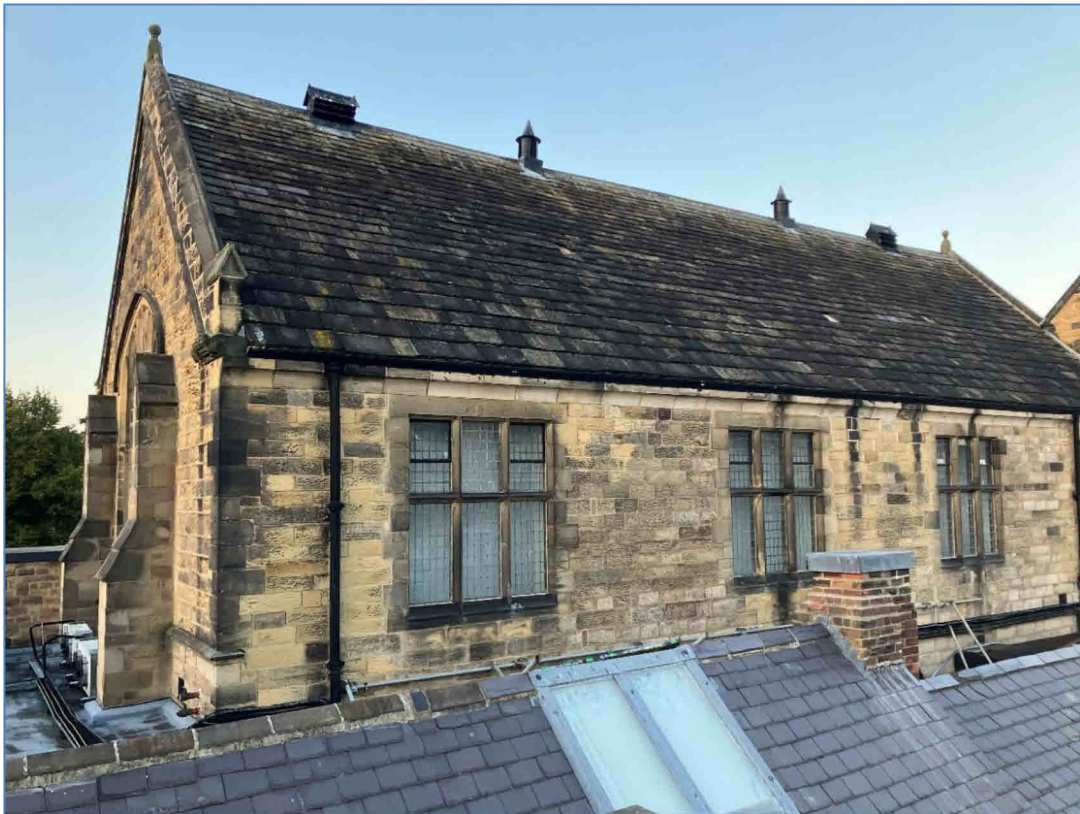
Photograph 2 – South and West elevations of The Education and Learning Centre viewed from roof of neighbouring building.

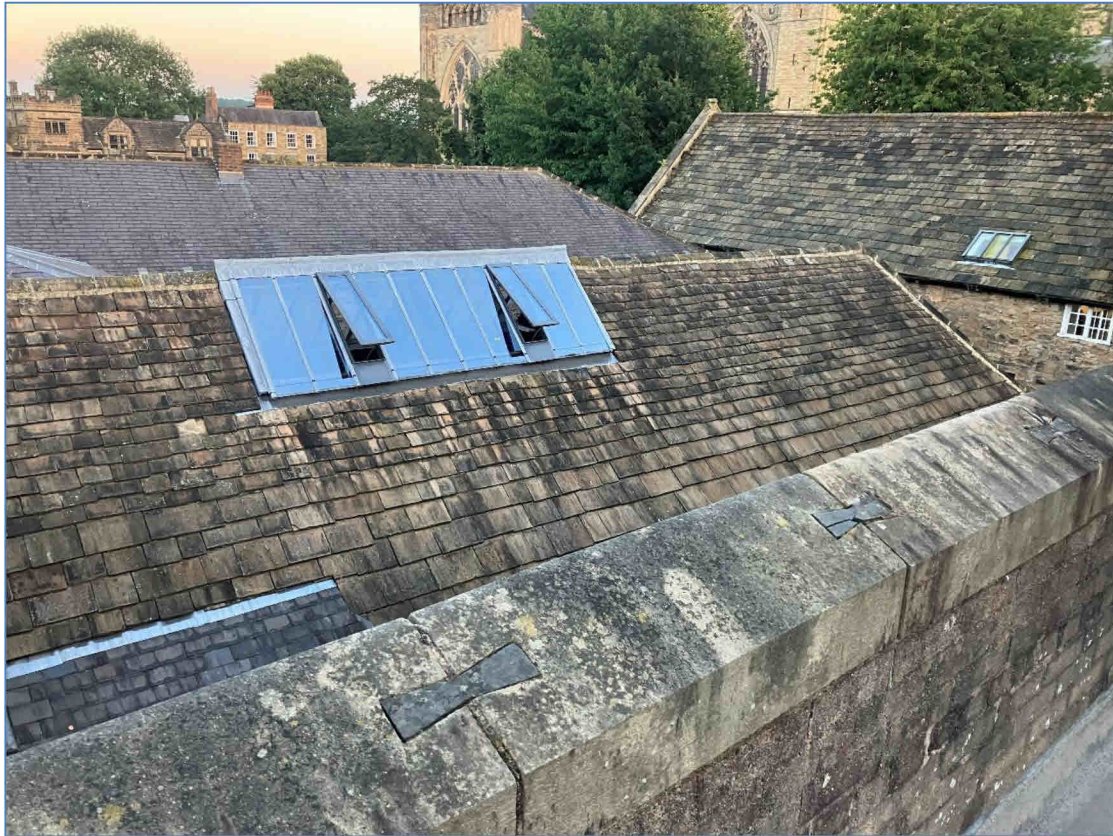
3.4.2 Palace Green Library is a single storey stone built structure attached to other buildings on its north, east and west elevations. The southern elevation overlooks a narrow alley. The roof is virtually impossible to view from ground level and photograph 3 shows it viewed from the roof of a neighbouring building. The roof is covered with stone tiles. Information from the client suggests that the roof is lined with breathable membrane below the tiles. No internal inspection was undertaken.

Photograph 3 – West elevation of Palace Green library roof viewed from roof of adjacent building

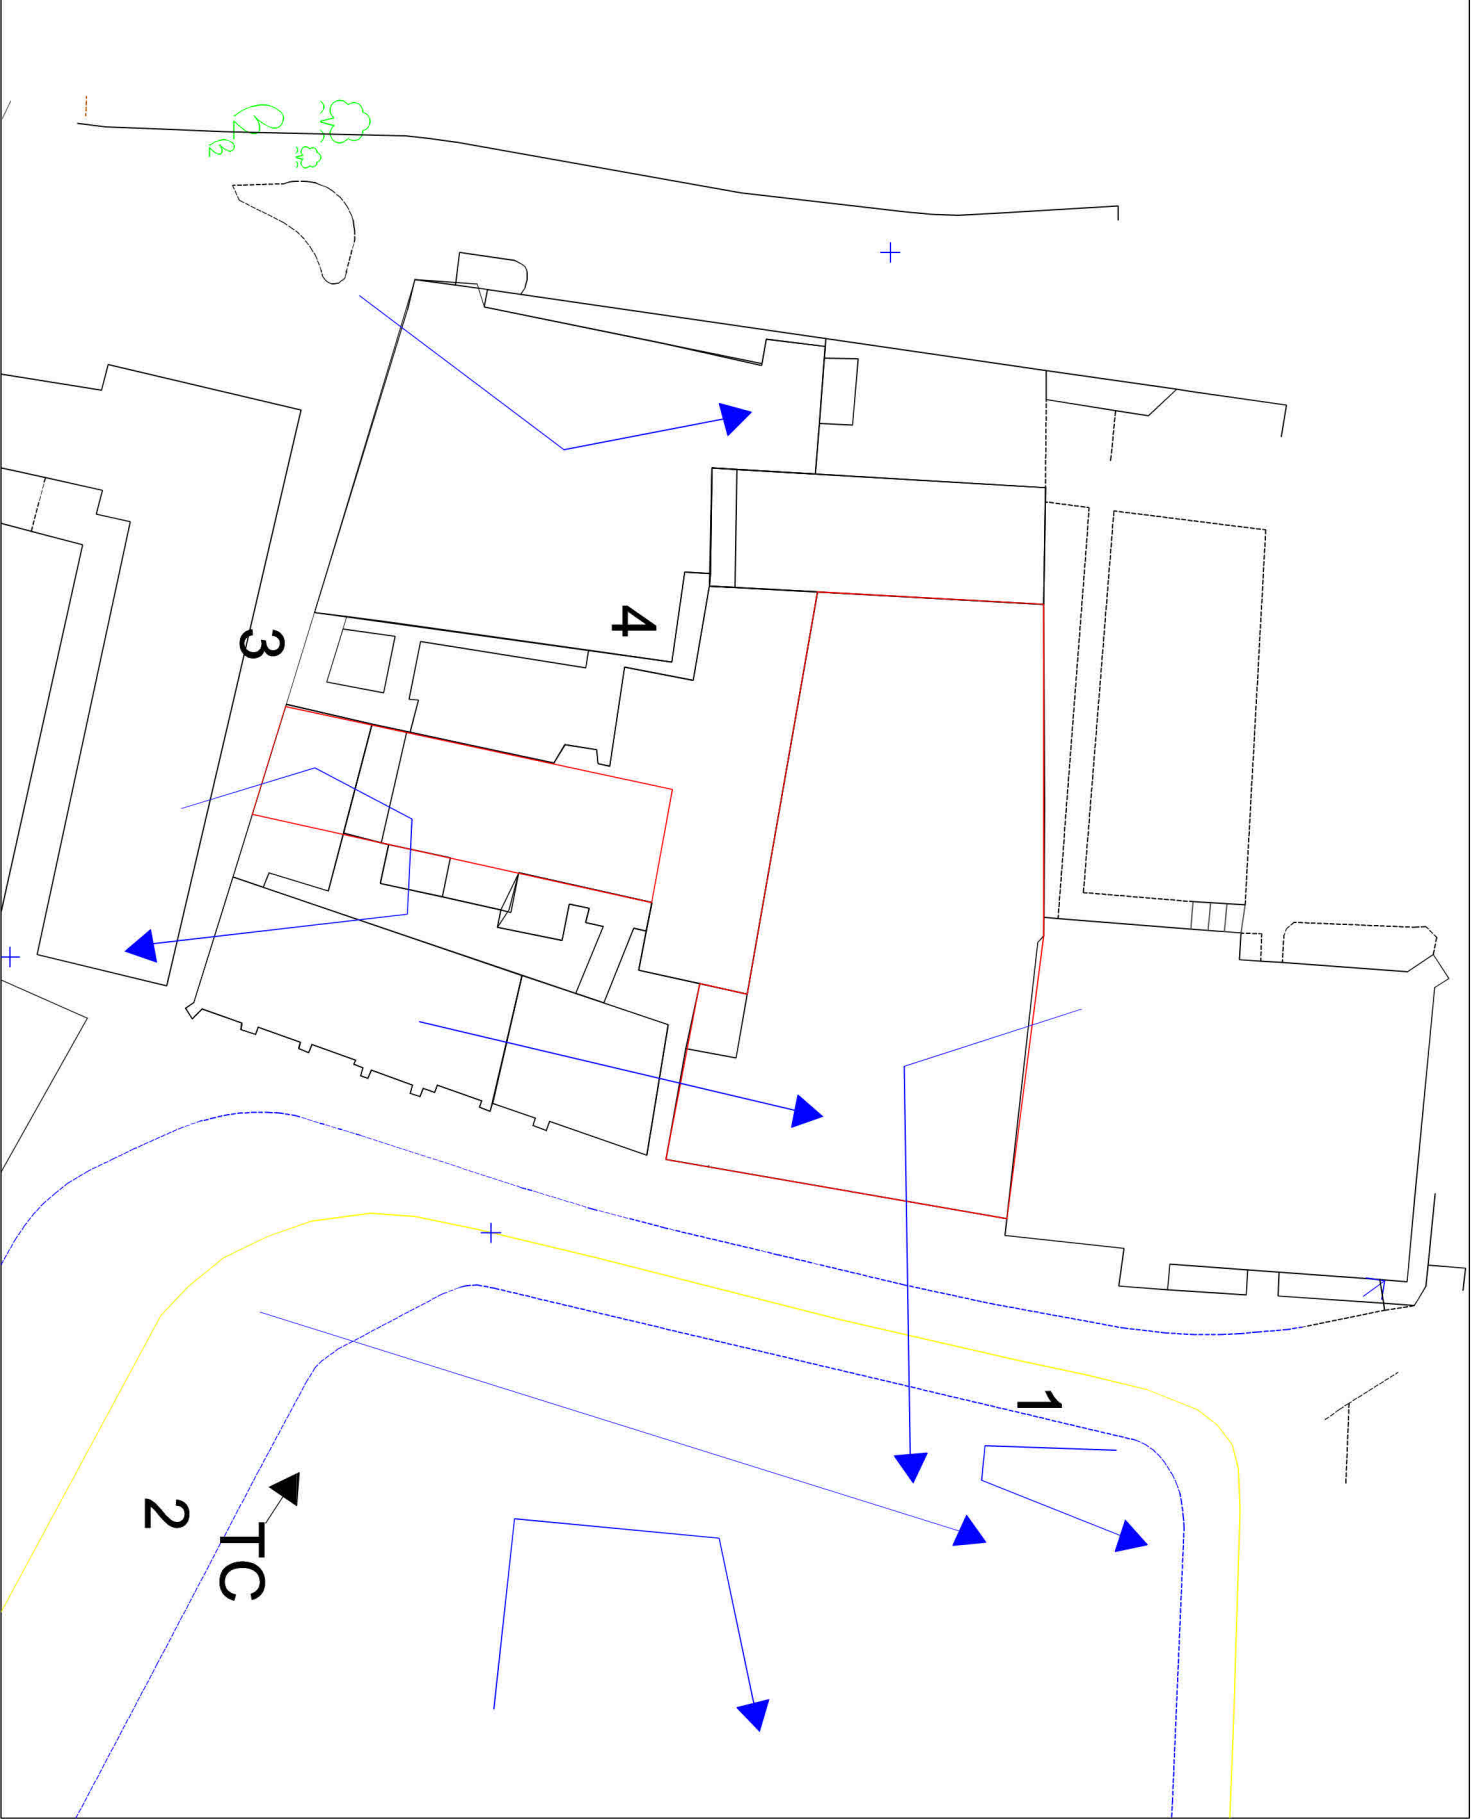
Appendix 1 – Bat Activity Flight Plan for 05/09/2023

During the dusk survey bat activity was constant but surprisingly low given the location, time of year and weather conditions. Common pipistrelles were regularly observed commuting past and foraging near the buildings. Noctules were observed high overhead. Brown long-eared bats were recorded by one of the surveyors. No bats were recorded leaving the buildings by any of the surveyors.

3.6.3 A thermal imaging camera was deployed, and set to record, for the duration of the survey. The footage was viewed the following day and no bats were recorded emerging from the buildings.

3.6.3 The results of the nocturnal bat activity survey are summarised in Figure 4 below. A bat activity plan (appendix 1) shows surveyor locations, the location of the thermal camera, main flight paths and foraging areas.
