Archaeological Standing Building Recording

Horncliffe Mansion

April 2024

BA2420HOM/ASBR

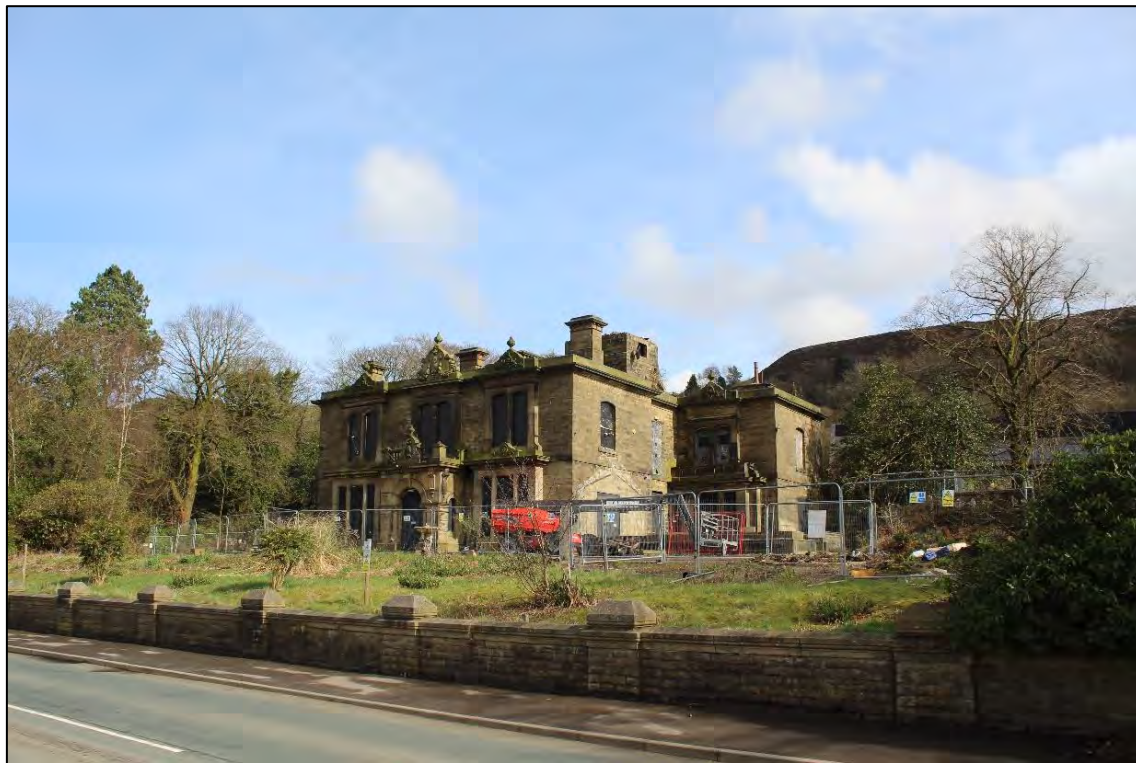
Plate 1: General view from Bury Road looking NE towards Horncliffe Mansion

Horncliffe Mansion was built in 1869 as a private residence for Henry Hoyle Hardman, a local businessman, and is situated on an elevated position east of Bury Road and the A56 (*Plate 1*), affording westerly views over the River Irwell and valley above, and lies within extensive grounds. The house currently lies derelict after suffering substantial fire and water damage in 2019, both of which greatly affected the interior of the property (*Plate 2*). The formal gardens and outbuildings to the rear and east of the property, along with a late 20th/early 21st century function room which do not form part of the subject of this report or the planning application, are equally neglected. Access to the site is by either north or south driveway up from Bury Road, although these have been blocked in an effort to maintain site security (*Plates 3 & 4*).

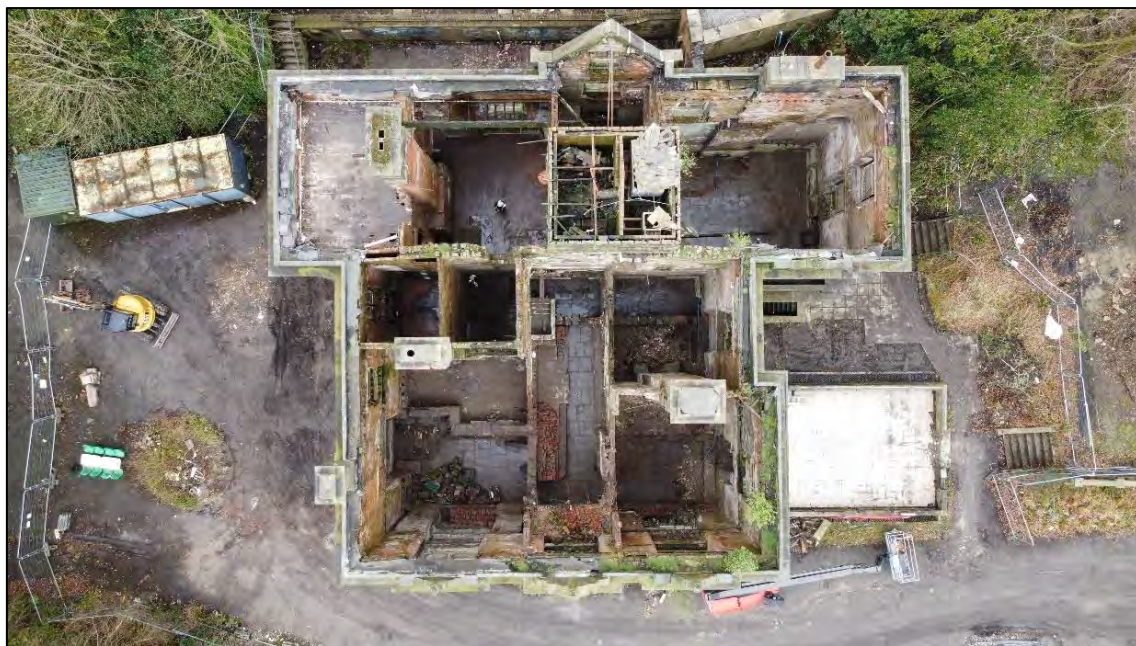
Plate 2: Aerial view of Horncliffe Mansion showing the extent of the internal fire damage

Whilst the internal floors, ceilings, stair cases, windows, and roof were lost during the fire (*Plate 2*), the internal brick built dividing walls still largely survive (*figs. 5 & 6*), allowing the original internal arrangement of the house to be read within the surviving structure which was built around a double pile plan with a central staircase. Also, whilst the majority of the internal adornments and fixtures have been lost, there remains fractured remains of decorative mouldings and fixtures within several locations.

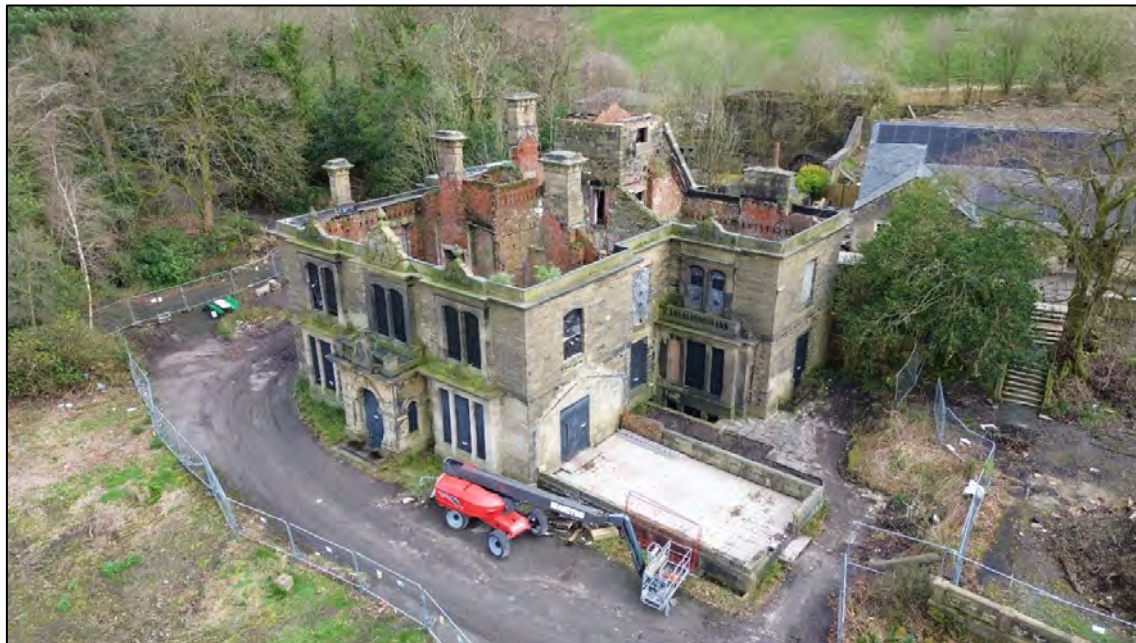
Plate 5: View looking NE towards the principal W facing elevation

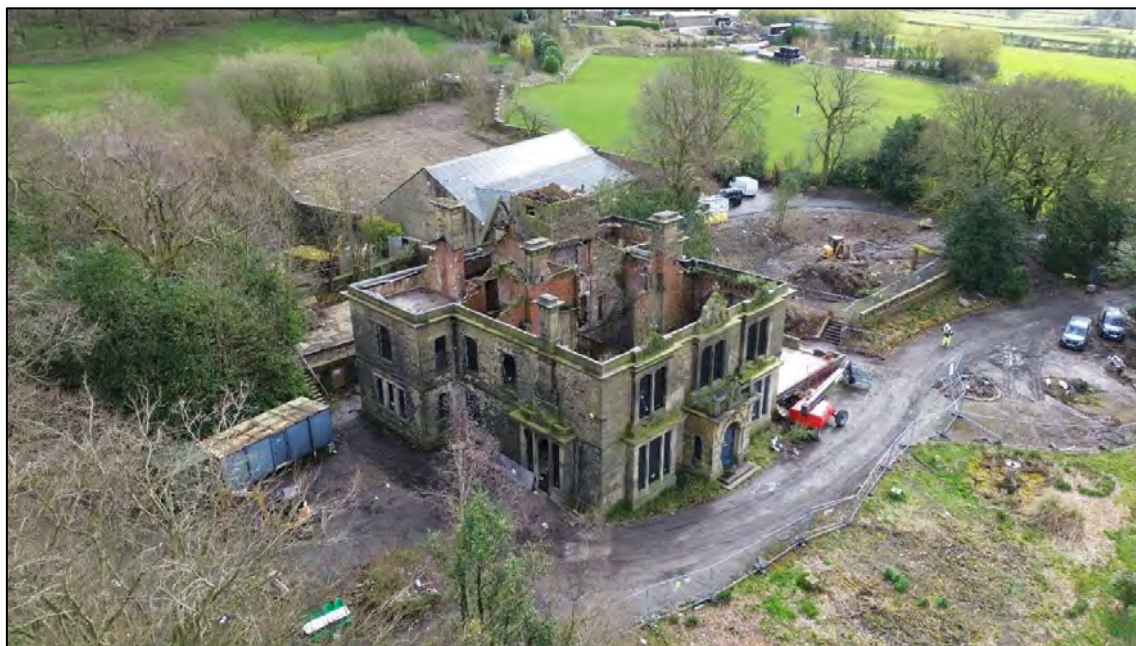
Plate 6: View looking SE towards the principal W facing elevation

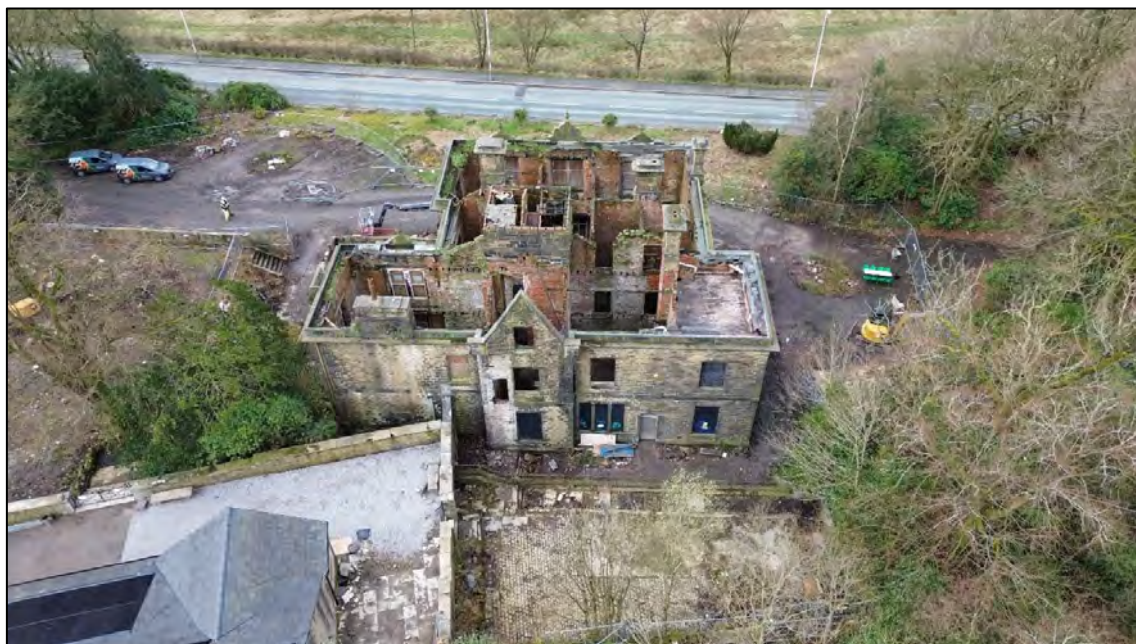
Plate 7: View looking W towards the rear elevation

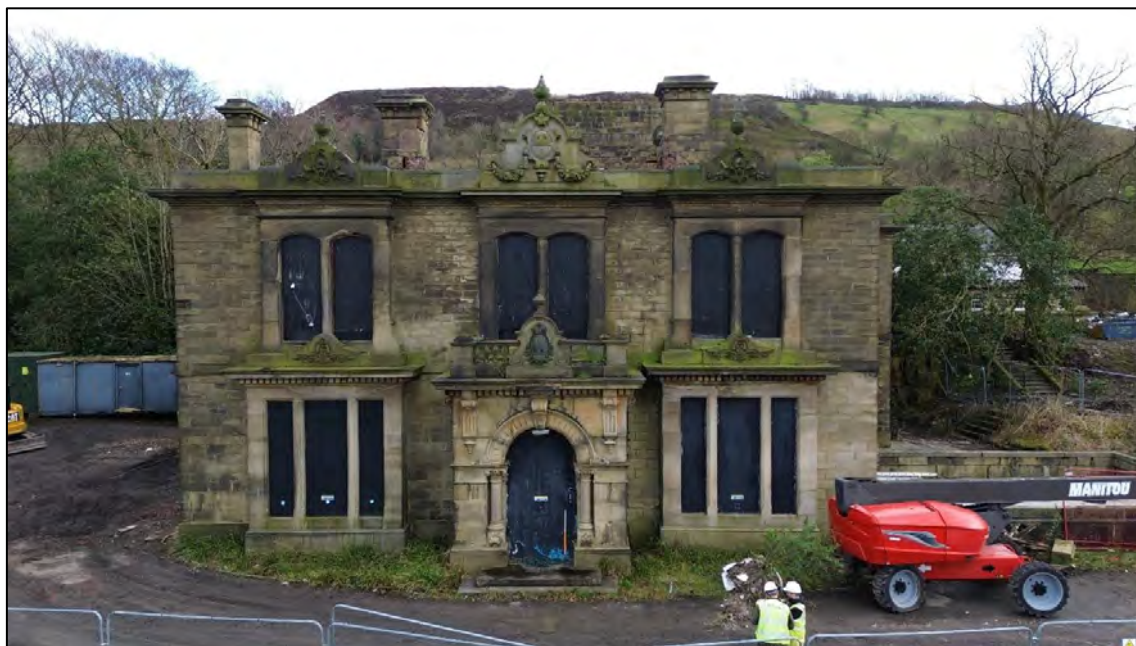
The principal west facing elevation (*Plate 8*) has a symmetrical three bay façade with a central flat roofed entrance porch with a round-headed entrance approached by two stone steps (*Plate 9*). The doorway is flanked by doric columns with moulded capitals of scrolled acanthus leaves, and are set upon low pedestals with floral mouldings. The astragal below the capitals wraps around the entrance porch to form a plain fascia with a moulded cornice. The columns support a round topped incised stone arch with a moulded hood. The dentilled cornice above is supported by three fluted and scrolled corbels, the central most forming the keystone to the arch which is engraved with Hardman family crest comprising a hand issuant holding a sickle. The porch is topped by a rounded stone balustrade with central ornamental pediment with escutcheon, and topped by a fluted urn finial. Earlier photos show matching finials at the corners of the balustrade but these are now missing. Within the sides of the porch are arched windows, with coal shoots below.

Plate 8: View looking E towards the principal W facing elevation

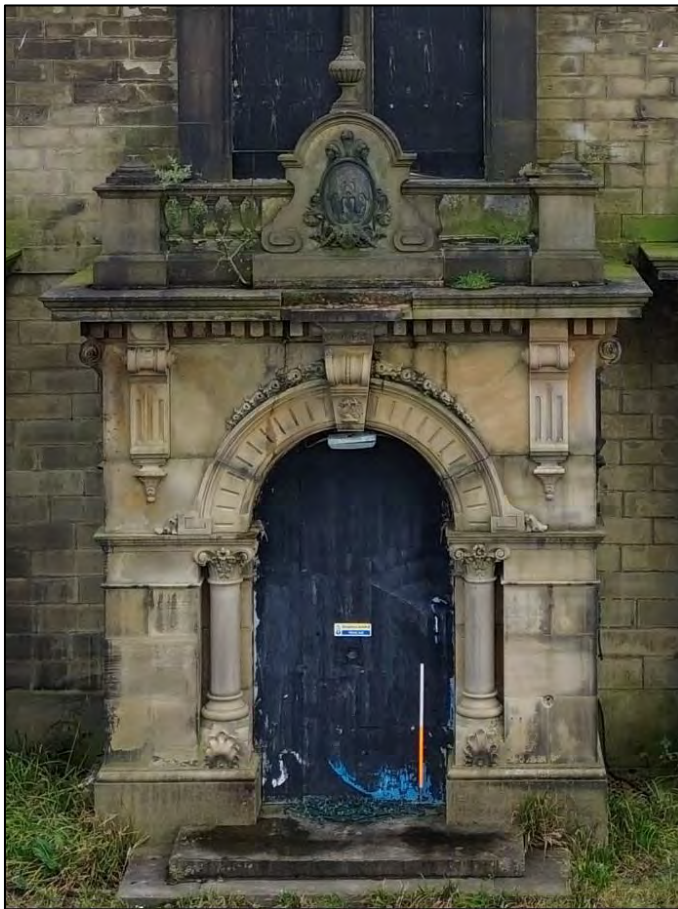
Plate 9: View looking E towards the principal entrance porch

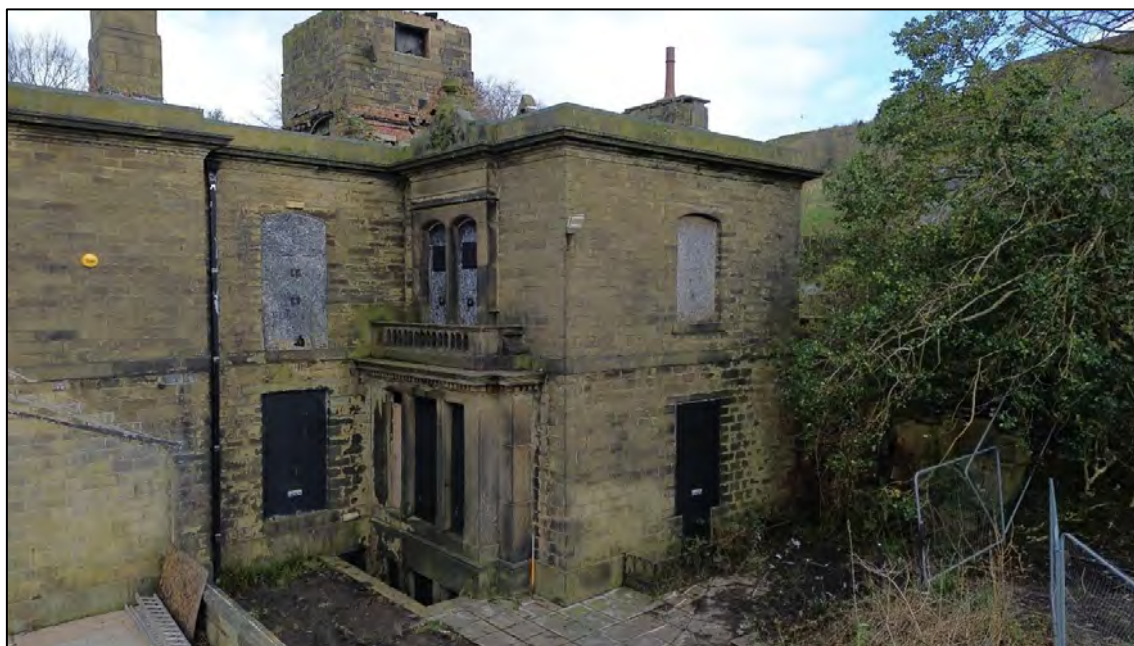
Plate 10: View looking NE towards the southern elevation

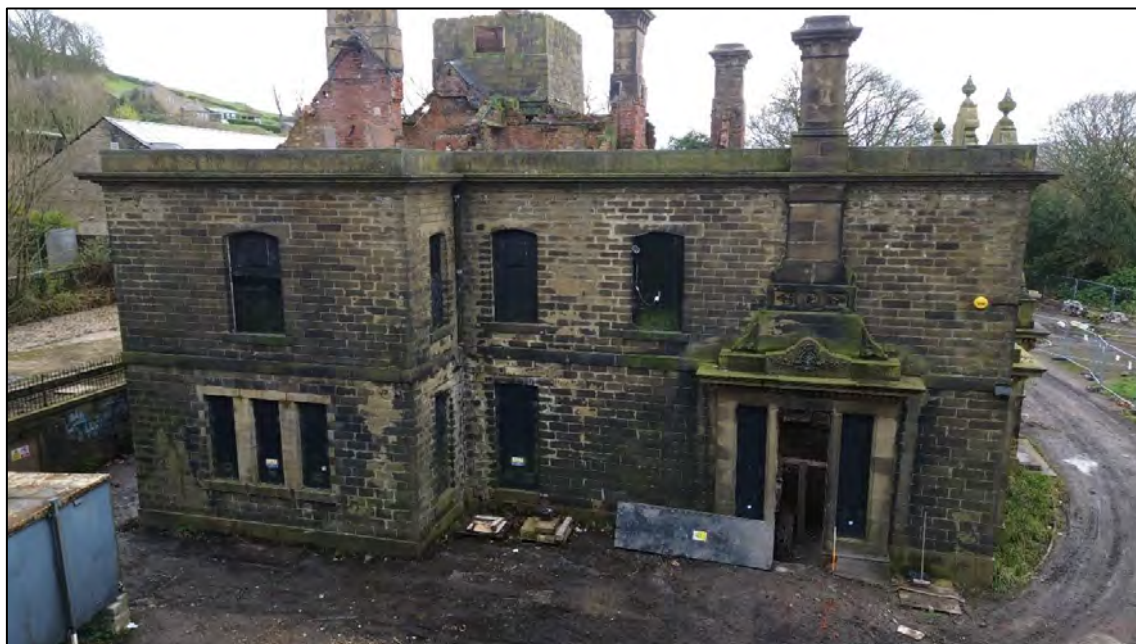
To the north facing side elevation (*Plate 11*) there is a further entrance porch with a central entrance way flanked by two windows and surmounted by a dentilled cornice and decorative pediment with a floral motif. Rising up from the porch is a moulded chimney stack at first floor level. There is a second entrance within the main range to the E of the porch, and a three-light window with stone mullions. At first level there are three segmental arched windows.

Plate 11: View looking S towards the N facing elevation

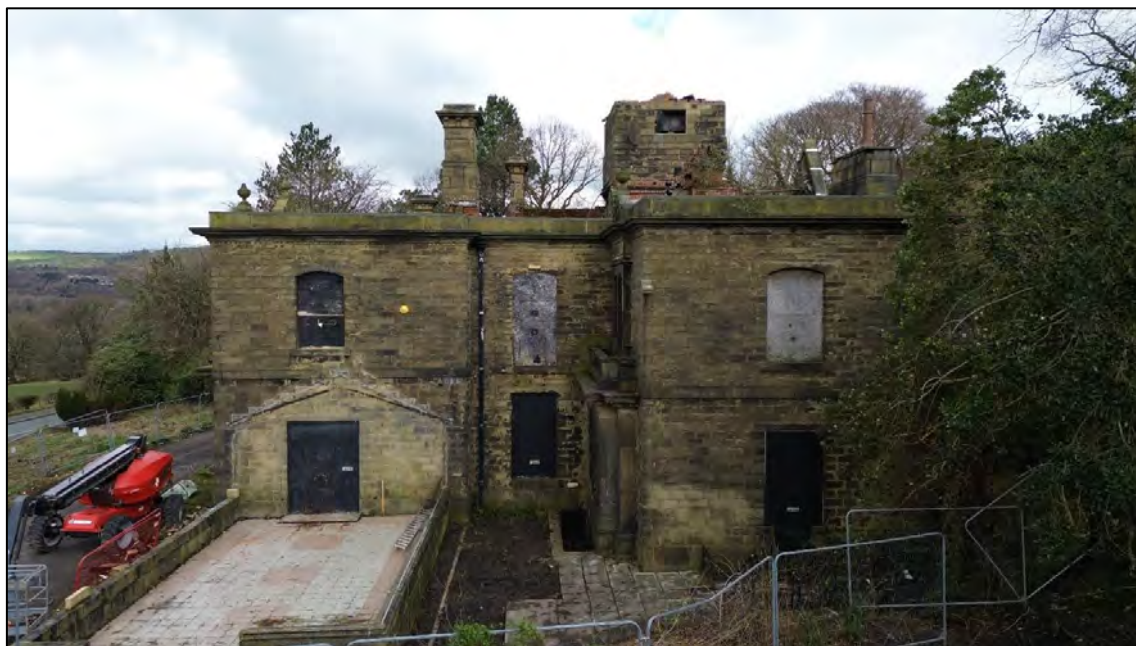
Plate 12: View looking N towards the S facing elevation

The S facing elevation (*Plate 12*) previously incorporated a large conservatory, but only the stone foundation plinth and heating ducts at ground level survive. At ground floor level within the principal range there is a large opening for the former conservatory entrance, and to the E of this there is a second opening for a doorway with low iron balustrade at ground level opening onto two windows below at basement level. At first floor level there is a segmental arched window and a central doorway with a matching segmental arch which formally opened onto a fire escape. To the wider range to the rear there is a doorway at ground level, and a window with a segmental arch above.

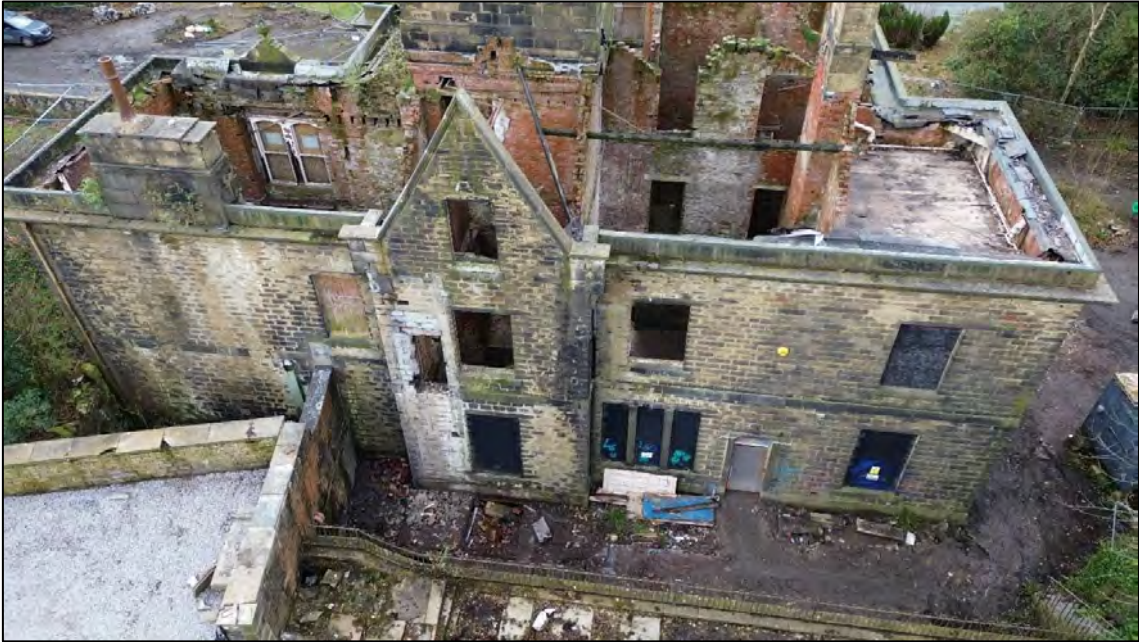
The east facing rear elevation (*Plate 13*) is of five bays, and overlooks a series of out buildings built in the slope of the bank. The central bay projects slight forward has a stepped gable with stone copping and moulded kneelers. Behind the gable are the remains of a low garret with a small south facing window. At ground floor level there is a central entrance way with a basement entrance below approached by covered stone steps, to the north of which there a tripartite window with plain stone mullions, a second entrance way, and a single square window. At first floor level there are four window apertures, and at second floor level there is window within the central gable.

Plate 13: View looking W towards the rear E facing elevation

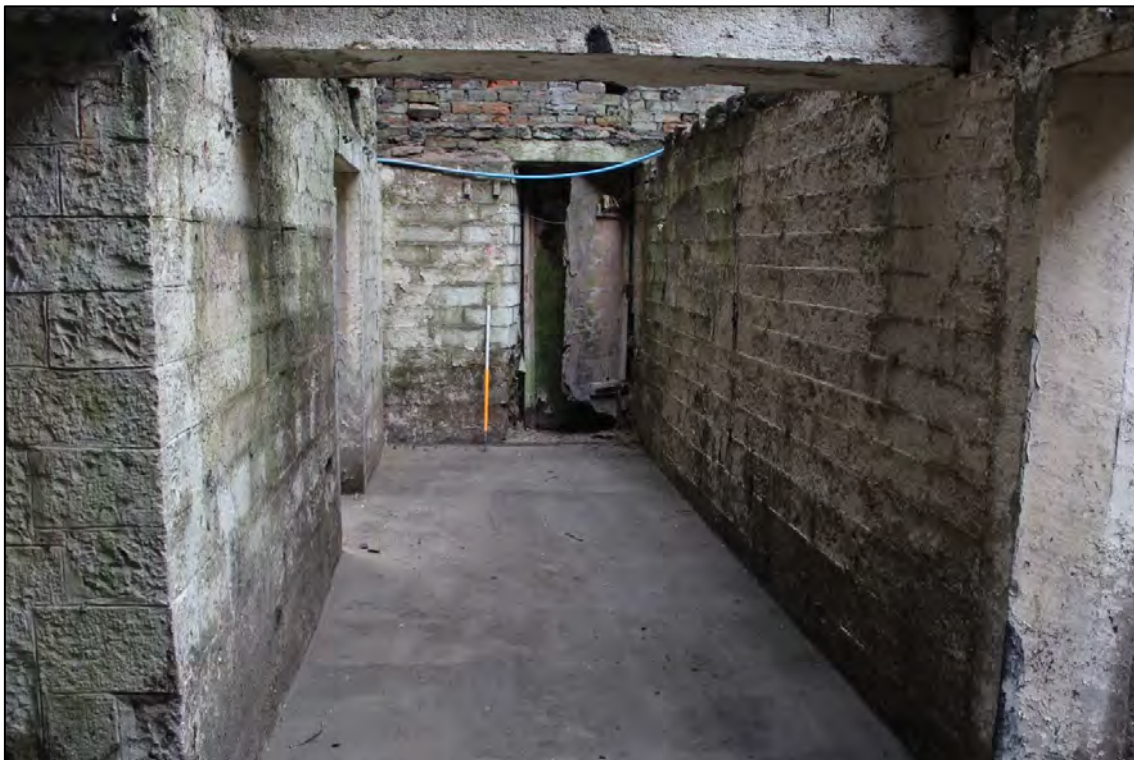
Plate 16: Internal view looking S within the basement corridor towards the external entrance to the S

The N-S aligned corridor (*Plates 16 & 26*) towards the rear of the basement opens externally to the S, and to the E into four interconnected compartments. The internal basement staircase opens to the W. The northernmost two compartments have vaulted brick ceilings braced which incorporate steel beams (*Plate 27*). The northernmost was largely inaccessible, but was observed to contain a large iron water storage tank (*Plate 28*). The adjoining compartment to the S has two blocked windows with the external W wall (*Plate 29*), and two ash chutes within the northern wall (*Plate 30*), presumably from a former cooking range on the floor above. The central compartments to the south have been heavily modified to house the central elevator shaft which was installed during the latter half of the 20th century. The southernmost compartment has two windows within external wall to the S (*Plate 31*), a blocked fireplace to the E (*Plate 32*), and a three-light window with stone mullions to the E which retains elements of its wooden casements (*Plate 33*).

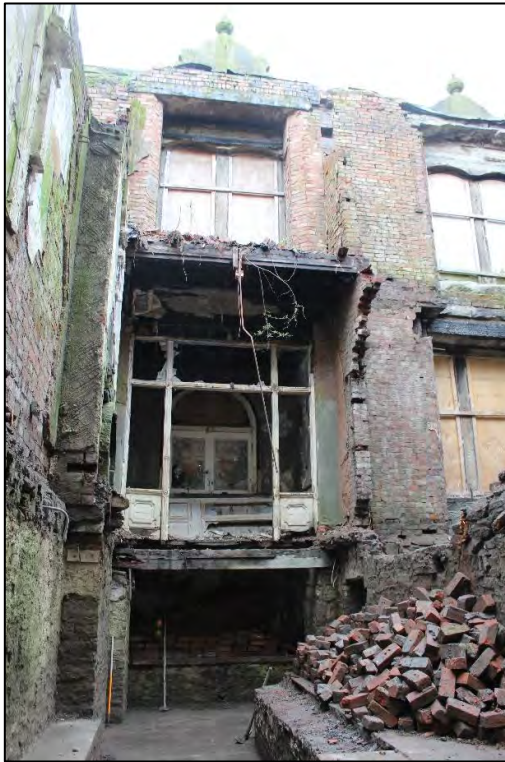
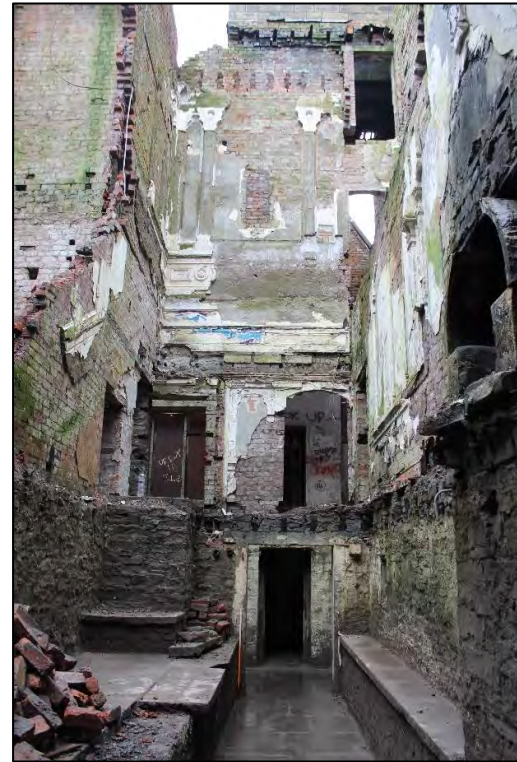
The basement is arranged around an internal cross axial corridor from which the principal compartments can be accessed. The central corridor, aligned E-W (*Plates 17 & 18*), has low stone topped storage shelves alongside its N and S sides, and its W end below the entrance porch, there is a similar storage shelf with possible coal chutes either side opening to the E and W of the porch (*Plate 19*). At the E end of the corridor a doorway opens into a N-S aligned corridor, and iron hinge brackets and a latch remain intact within the door jamb (*Plate 20*).

Plate 17 (left): Internal view looking W along the central corridor within the basement
Plate 18 (right): Internal view looking E along the central corridor within the basement

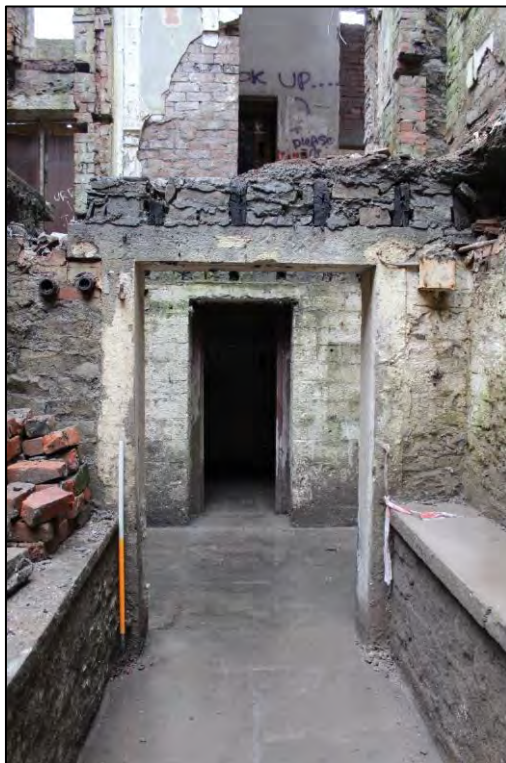
Plate 20: Internal view looking E towards the doorway within the eastern end of the central corridor with the basement

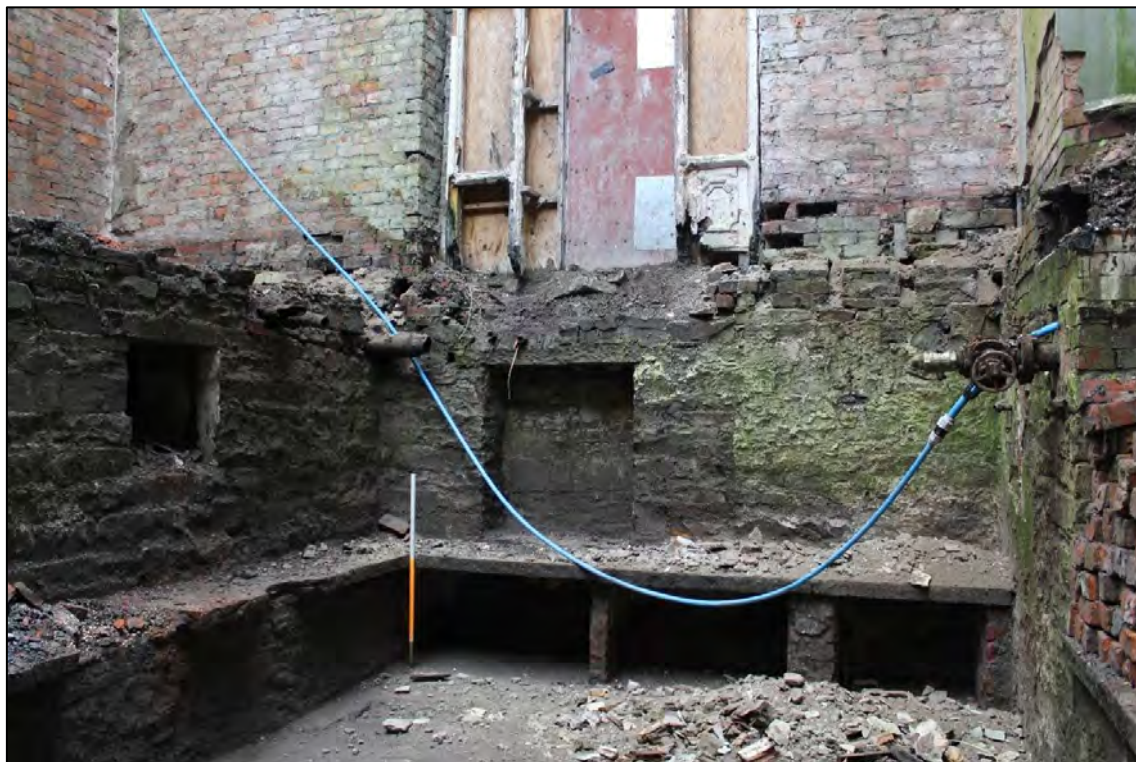
Opening E and W from the western end of the central corridor are two storage compartments. The S compartment has low stone topped storage shelf to the E and S (*Plates 21*), above which are a series further recessed storage nooks, and to the W there is a similar recessed shelf. The compartment to the N is similarly arranged but less well preserved (*Plates 23-25*). There is also a blocked coal chute at the N end of the room.

Plate 21: Internal view looking S within the basement

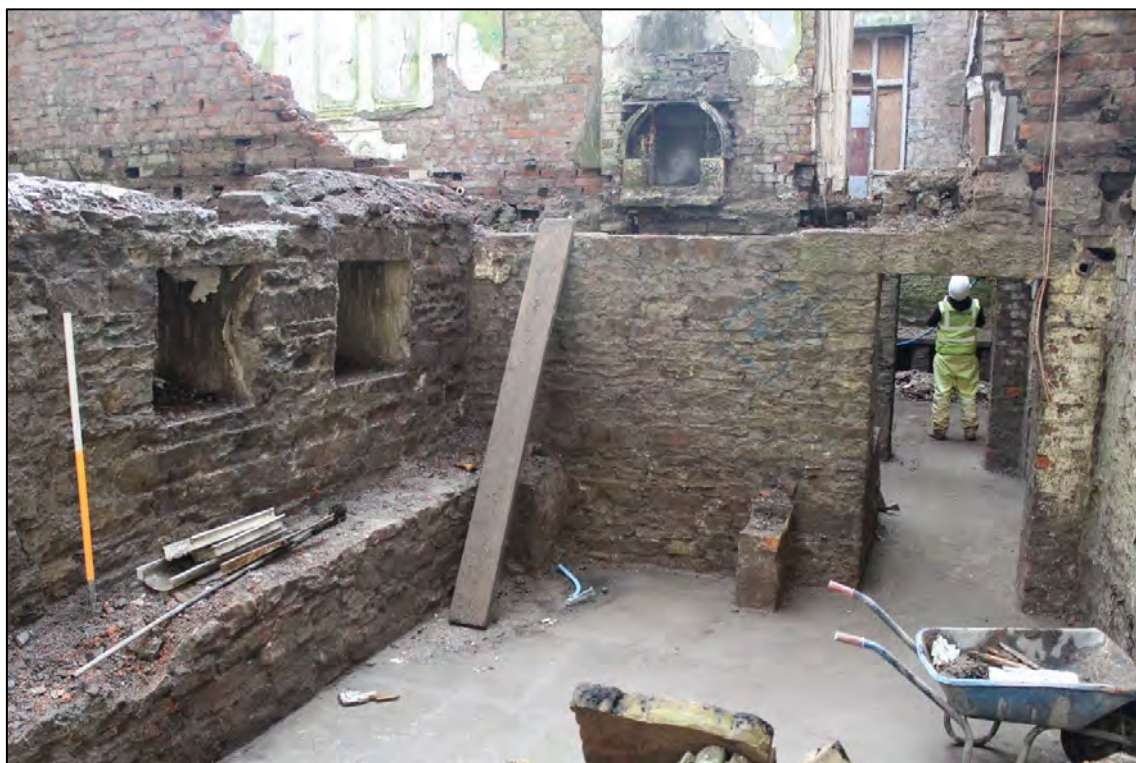
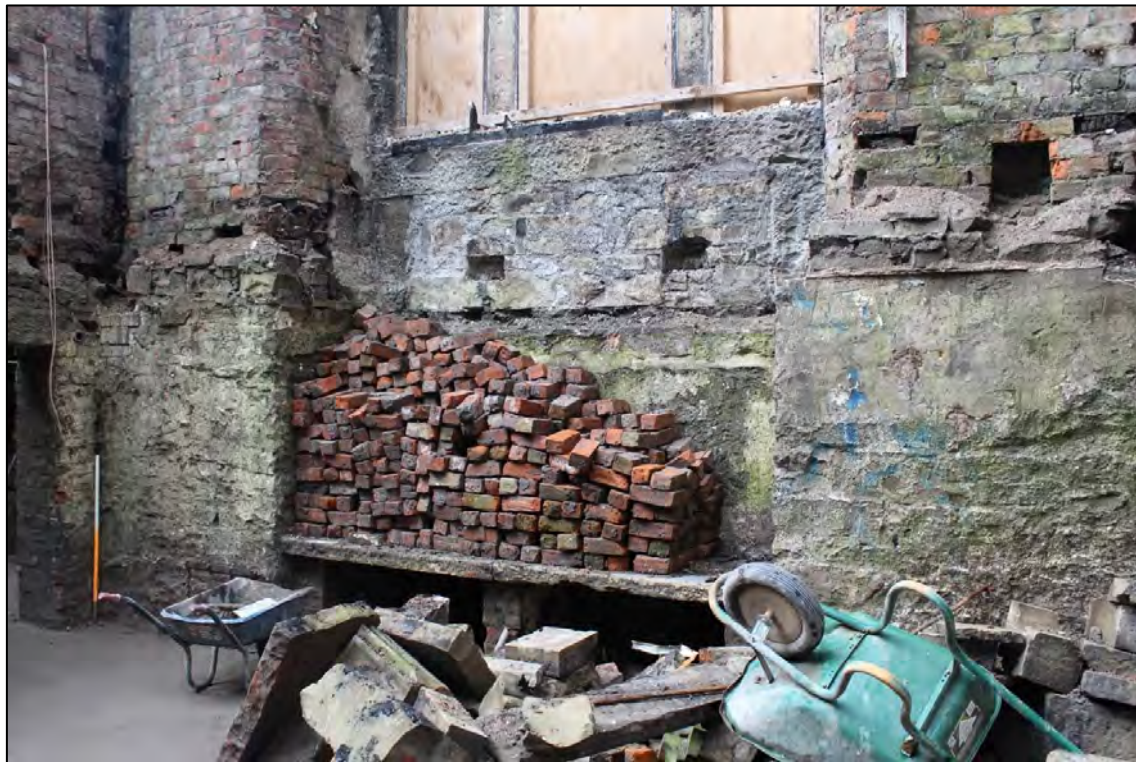
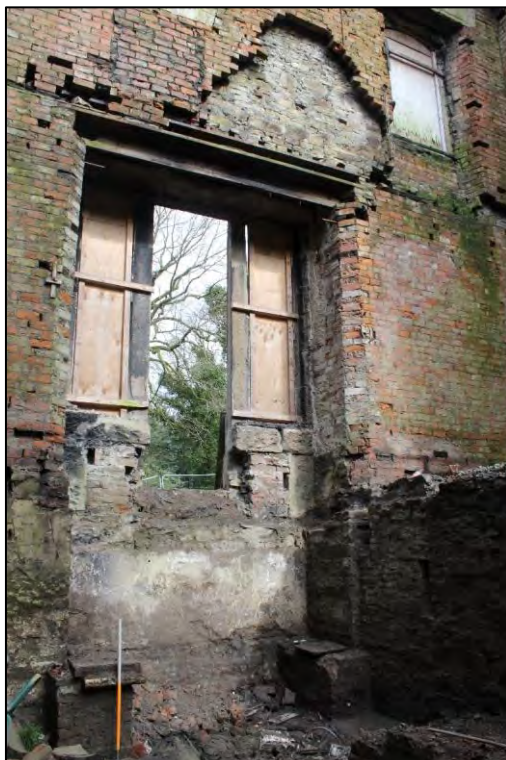
Plate 23: Internal view looking SSE within the basement

Plate 24: Internal view looking SW within the basement

Plate 25: Internal view looking NE within the basement

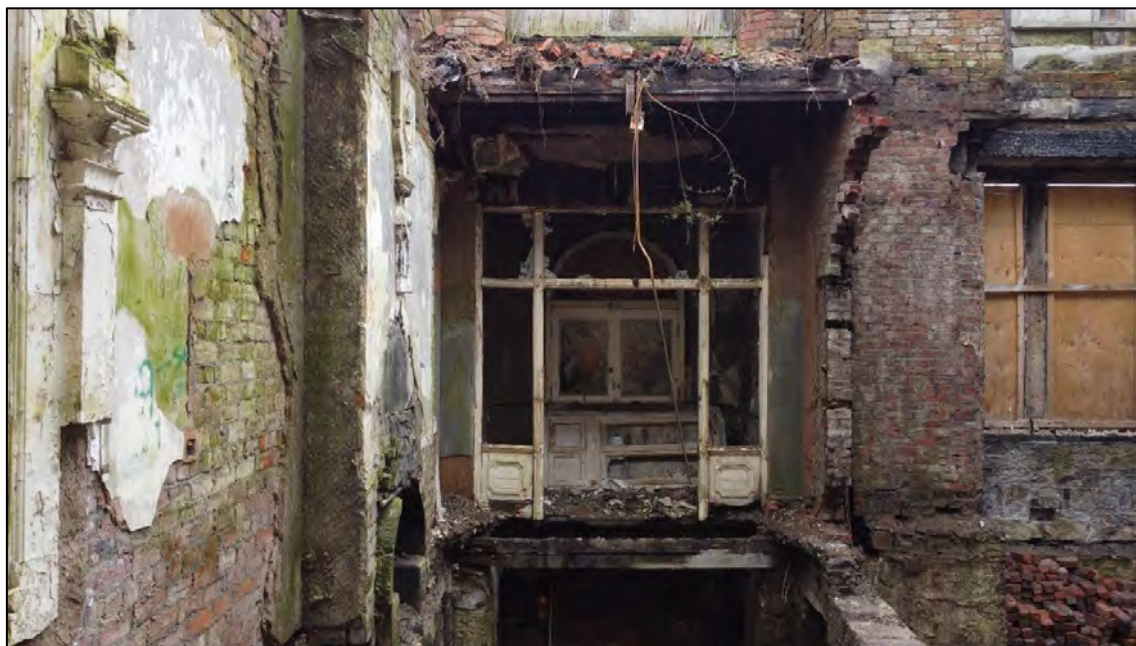
The main entrance porch to the west opens through a pair of partly glazed double swing doors set within a part glazed surround (*Plate 34*), into what will have formally been the main entrance hall (*Plate 35*). This opened to the N and S into the three principal living compartments (*Plates 36-43*), and led E into to the rear of the building where the open dog leg stair case was formally situated. Below the former location of the stair case, is the basement stair (*Plate 44*). At the eastern end of the corridor a doorway opens into short internal through passage towards the rear of the house containing the central elevator (*Plates 45 & 46*), and five further interconnected service compartments (*Plates 47-58*) in which a number of blocked fireplaces are visible. To the S the corridor opens into a larger living compartment which can be accessed externally through the entrance porch to the S (*Plates 31-32 & 59-60*).

Plate 34: Internal view looking W towards the main entrance with the entrance hall at ground floor level

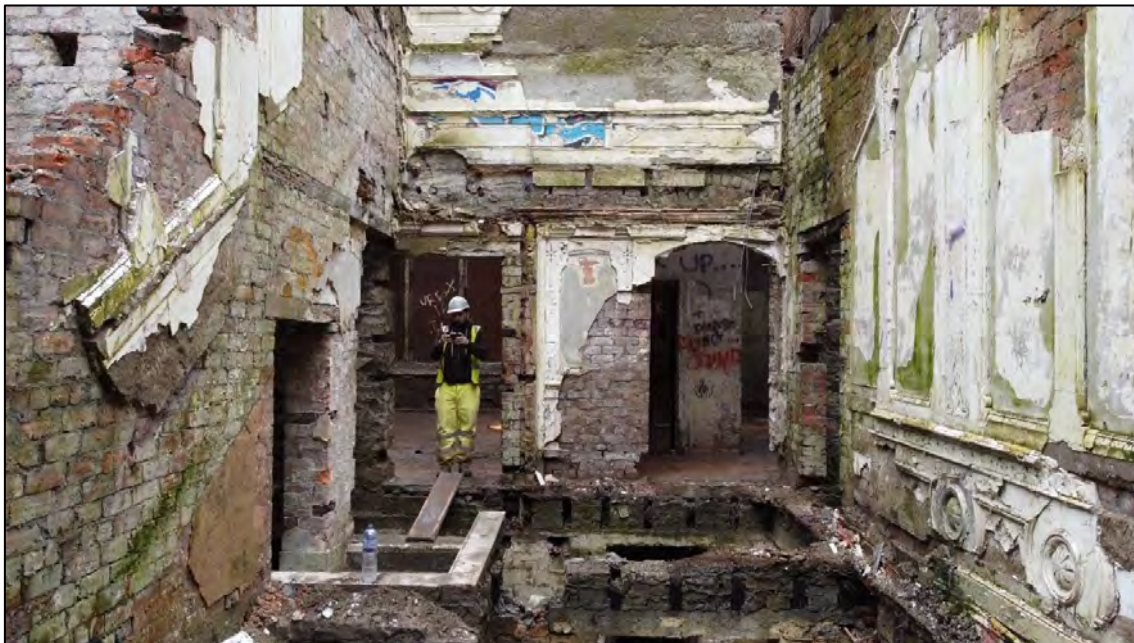
Plate 35: Internal view looking E along the entrance hall at ground floor level

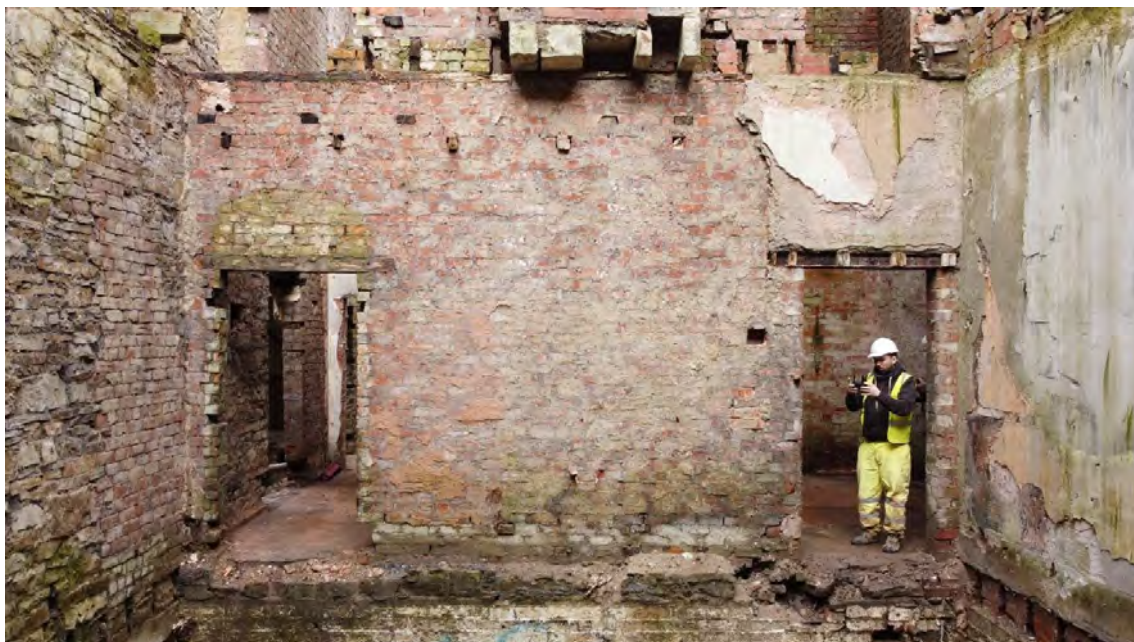
Plate 59: Internal view looking N within a ground floor living compartment

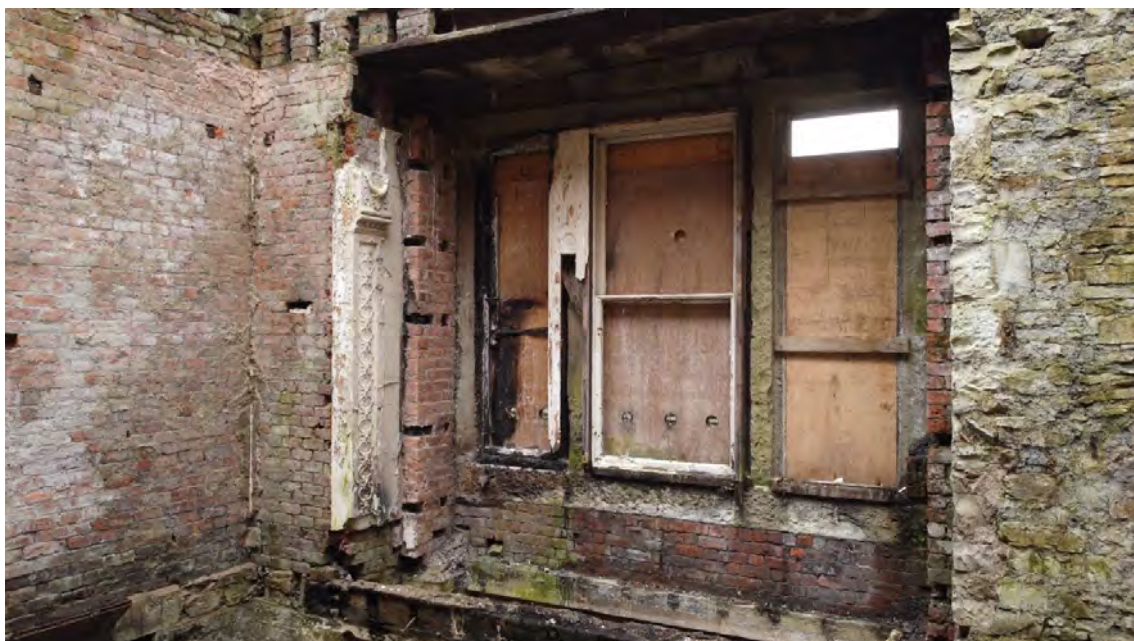
Within the largest compartment to the rear of the house are the remains of pilaster infilled with guilloche mouldings, and part of a moulded capital above (*Plate 60*), which formed part of the decorative frame to the second entrance porch to the south of the house

Plate 60: Internal view looking WSW within a ground floor living compartment

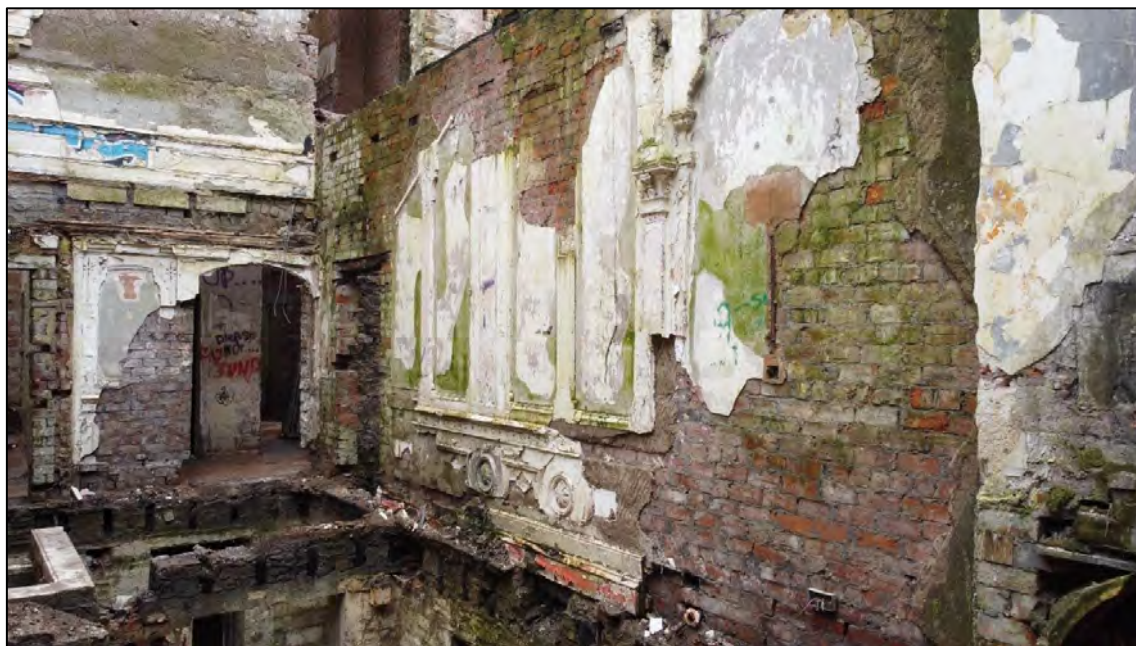
Plate 62: internal view looking ESE showing the wall mouldings at ground floor level within the entrance hall

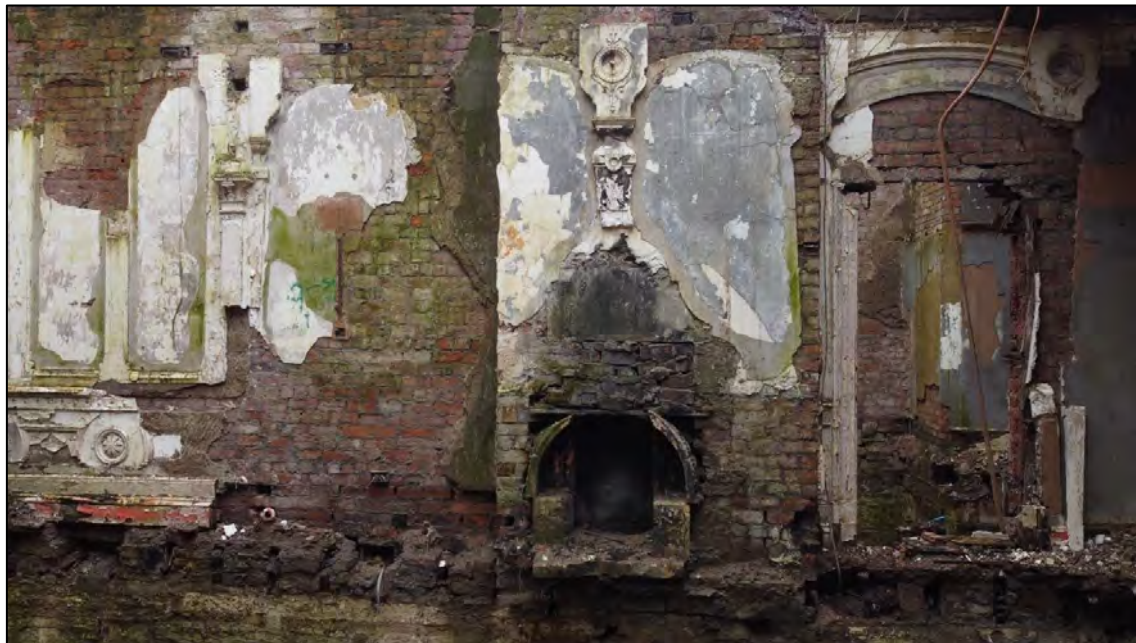
Plate 63: internal view looking S showing the wall mouldings at ground floor level within the entrance hall

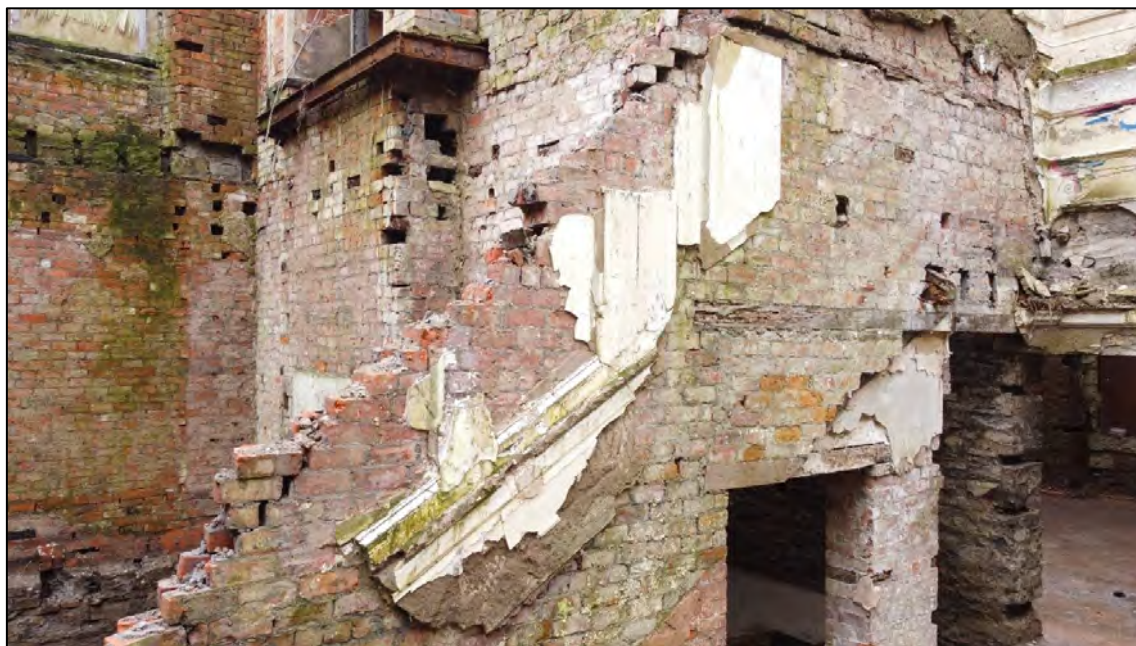
Plate 64: internal view looking NE showing the wall mouldings at ground floor level within the entrance hall

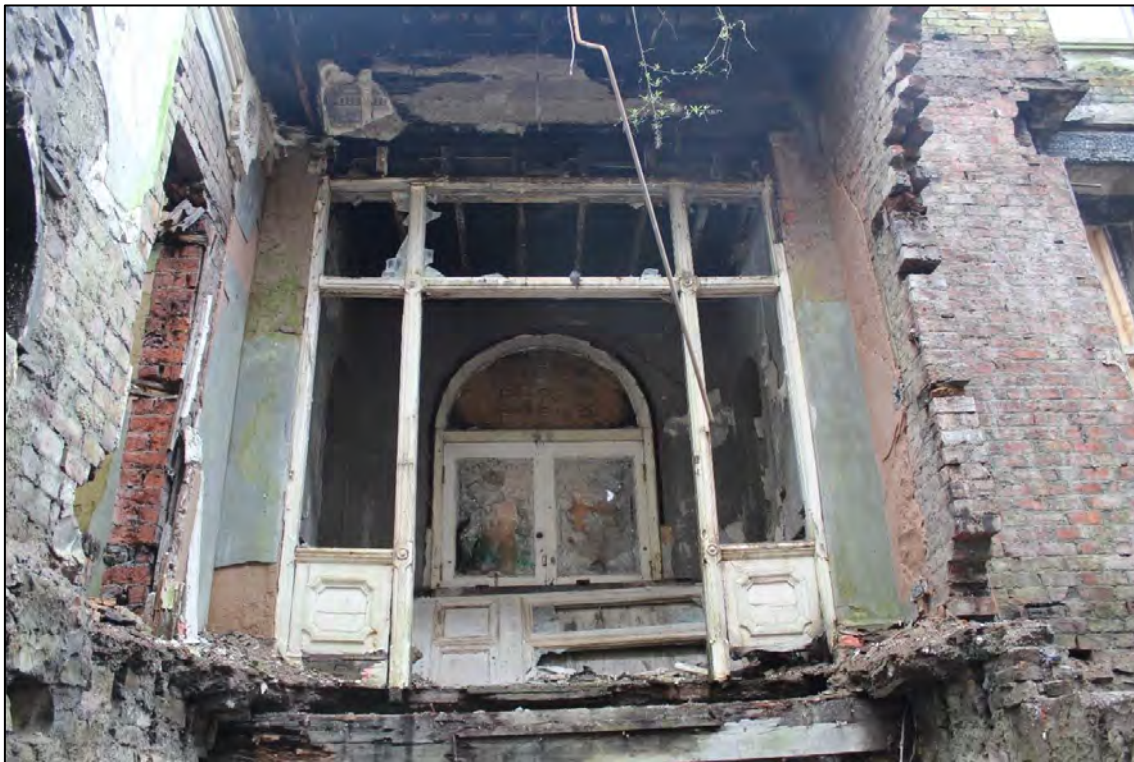
Plate 65: internal view looking W showing the wall mouldings at ground floor level within the entrance hall

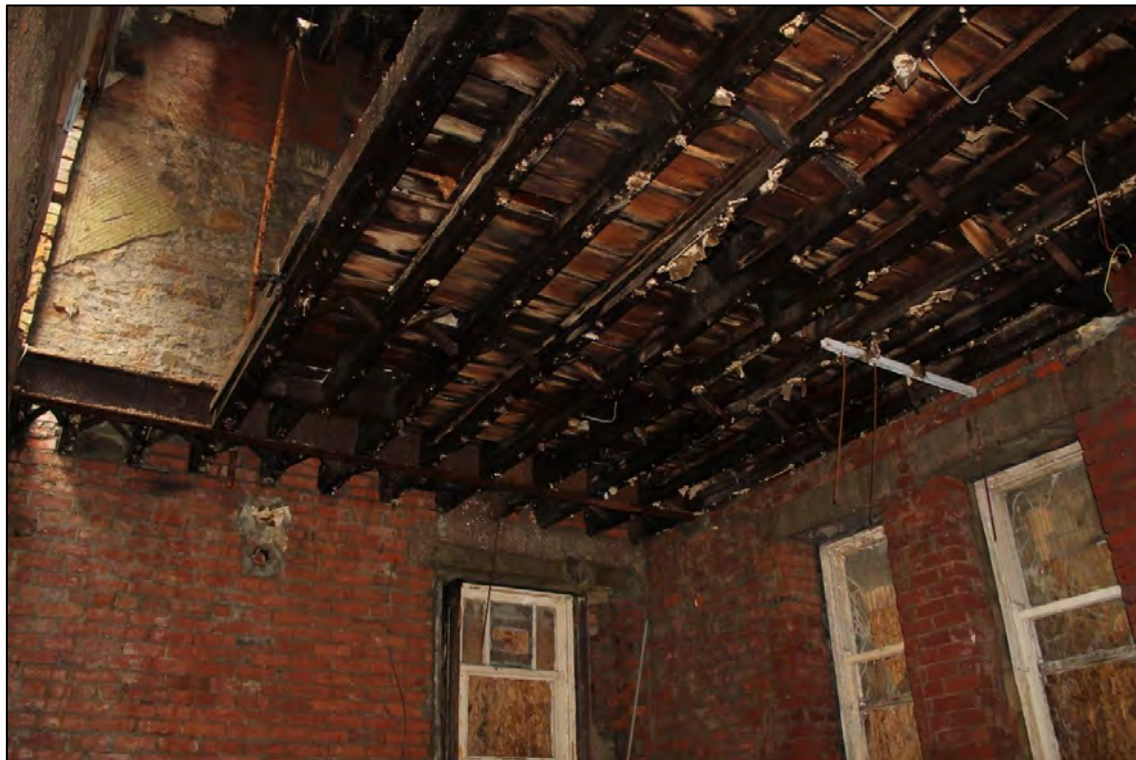
Plate 67: internal view looking NW at the only surviving ceiling at ground floor level

The floors of the service rooms to the NE have largely survived, and correlate with the vaulted brick ceiling observed within the basement. Where visible they are laid with quarry tiles, and an intact ceiling within the northern most compartment has exposed wooden joists with cross bridges/braces (*Plate 67*), which are tied into steel beams.
