Archaeological Standing Building Recording

Horncliffe Mansion

April 2024

BA2420HOM/ASBR

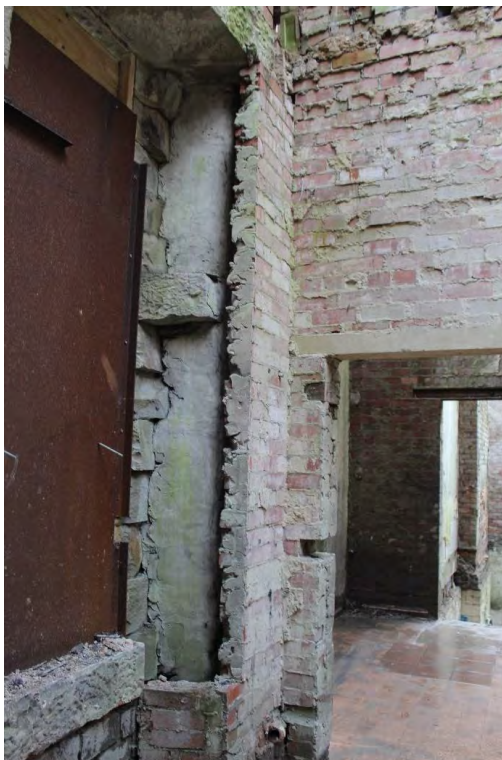
To the rear of the house there are a series of construction breaks observed within the brick work, where the original moulded bricks have been observed to have been replaced with 20th century engineered bricks. Where this has been undertaken, the cavity between the bricks and stone work infilled with concrete. Whilst there does not appear to any external alterations, it is likely these modifications were a result of damp ingress, and may have been made at the same time of the installation of the elevator shaft during the latter half the 20th century.

Plate 68: internal view looking SW showing internal refacing with engineered bricks

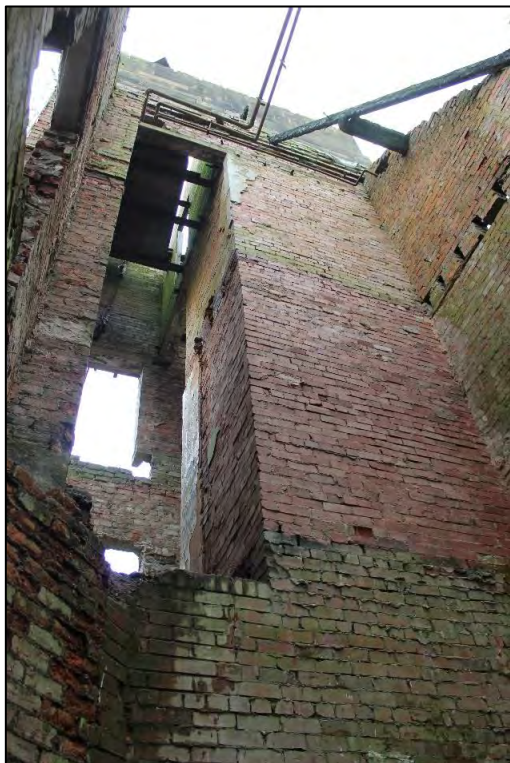
Plate 77 (left): View looking W towards the elevator shaft at first floor level
Plate 78 (right): View looking N at first floor level

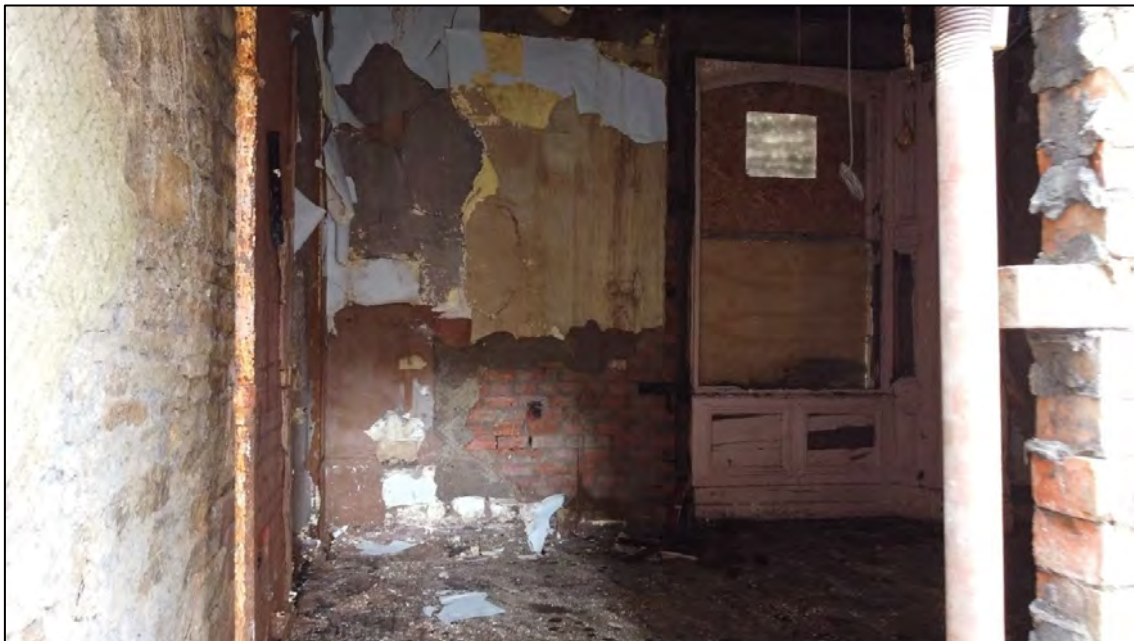
At first floor level, several of the windows retain elements of timber sashes and there is a single example of a timber panel surround to the windows (*Plate 85*). There are also a number of infilled doorways which were likely infilled during the buildings use as a residential home and later a hotel (*fig. 6*).

Plate 85: View looking N at first floor level

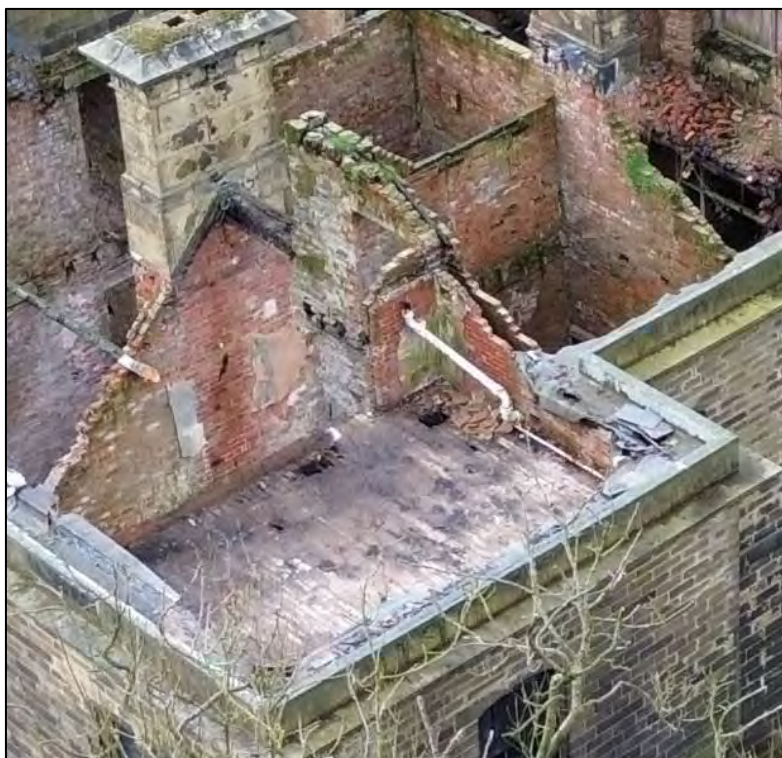
Plate 90: View looking SE towards two inaccessible first floor and attic level compartments

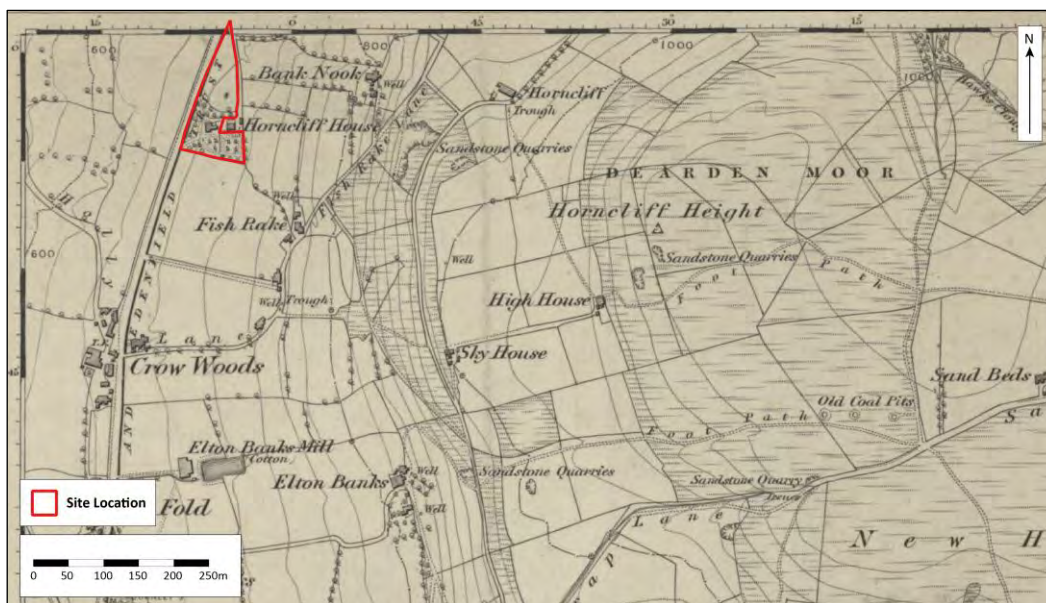
The quarries are shown on the 1851 Ordnance Survey 1st edition 6-inch map (*fig. 8*) to the E of Horncliffe House, which appears roughly of the same plan seen on the tithe map. The reduced detail of this map means the house is depicted as a T-shaped building with the other buildings to the E and S still shown. It is clear from this map that Horncliffe House was set in formal gardens, which are particularly evident to the S.

Fig. 8: Extract from the 1851 OS 1st Edition 6-inch map.
(Reproduced by courtesy of the National Archives)

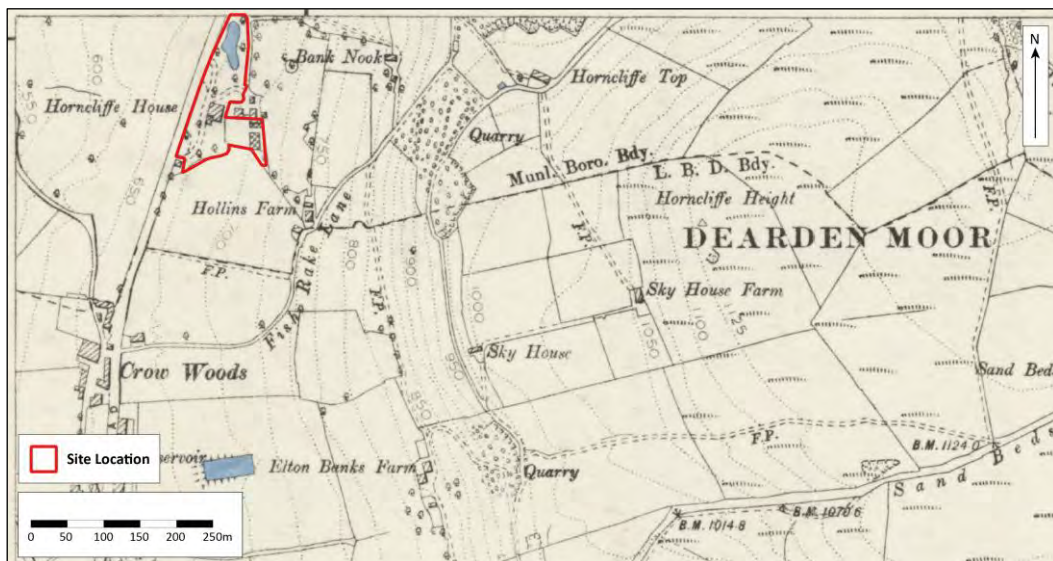
The Ordnance Survey 1895 2nd edition 6-inch map (*fig. 9*) is the first to show the building, which occupies a roughly rectangular footprint with a rectangular conservatory projecting from the SW corner of the building. The outbuildings also appear to have been redeveloped, with two L-shaped buildings to the E, of which one has a glazed section on its southern part. Smaller square outbuildings are shown to the N and E of these outbuildings and a large, rectangular glasshouse is shown to their S. A lake first appears to the N of the house at this time and a gatehouse is indicated on the driveway leading from the Bury Road to the property. The map predates the rear off-shot, which is subject to demolition in the proposals, and is not depicted.

Fig. 9: Extract from the OS 2nd Edition 6-inch map of 1895
 (Reproduced by courtesy of the National Archives)

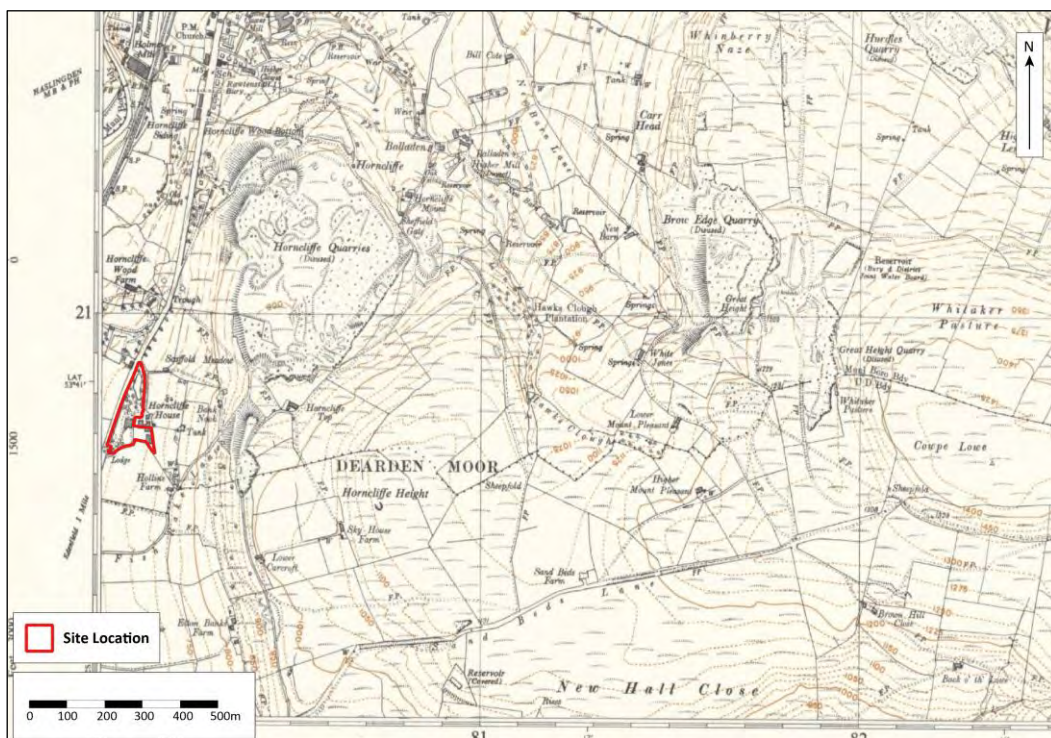
The Ordnance Survey 1929 4th edition 25-inch map (*fig. 11*) shows little change affecting the principal residence but the glasshouse is now shown as three distinct narrow structures. There are no further changes shown on the Ordnance Survey 1947 5th edition 6-inch map (*fig. 12*) or Ordnance Survey provisional edition 6-inch map of 1956 (*fig. 13*). The Ordnance Survey 1:10000 map of 1960 (*fig. 14*) shows no change to the building itself but the pond to the N of the house has gone. The period between Rawlinson taking ownership of the house in 1903 and its purchase by Lancashire County Council (LCC) in 1969 is poorly documented. LCC bought Horncliffe for conversion to a care home for the elderly which closed in 1993. During this period, in 1984, Horncliffe was designated a Grade II Listed Building.

Fig. 13: Extract from the OS provisional edition 1:10,560 map of 1956
(Reproduced by courtesy of the National Archives)
