# Validation Report

Mount Close, Pontesbury, Shropshire

Housing Plus

CM/SR/19425/VR/01

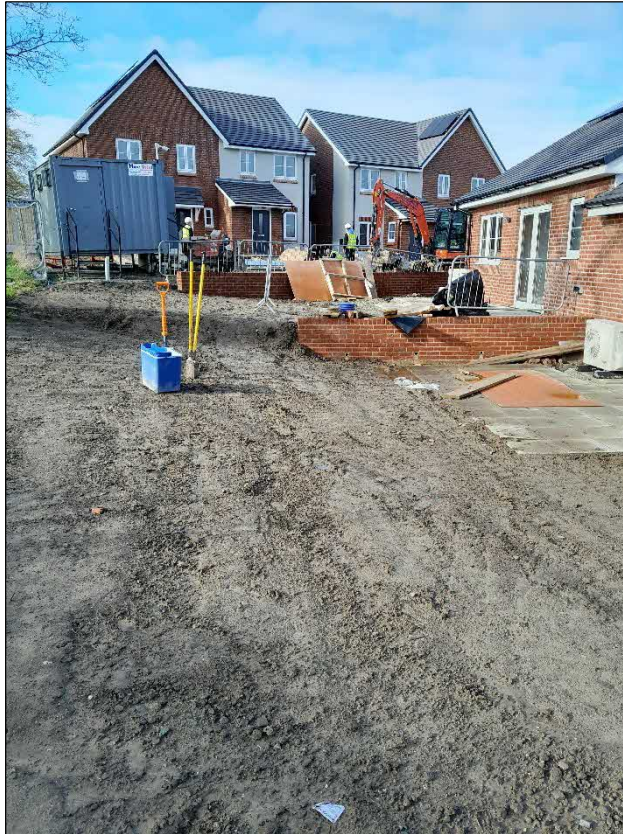
### Plate 1

Plot 1, viewed from the north, showing the location of VT01.

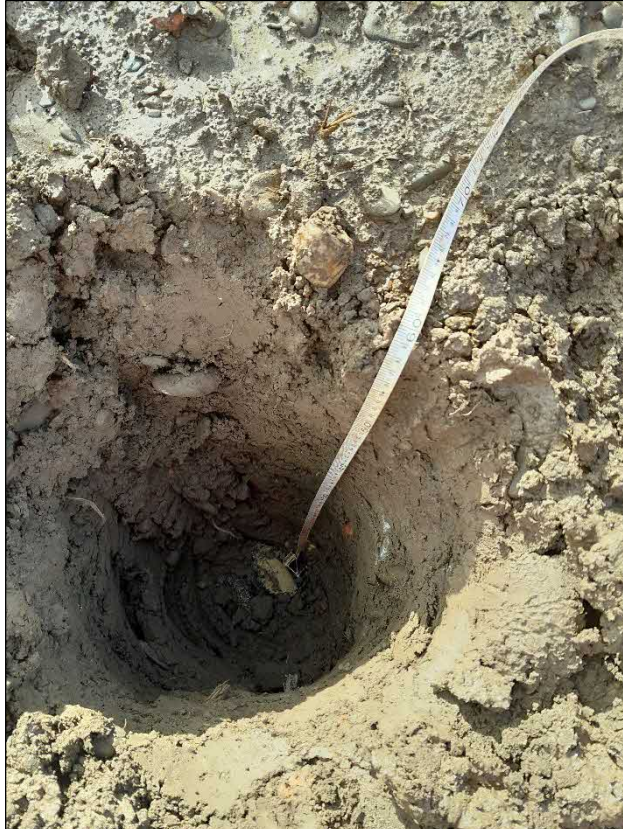
### Plate 2

Ground conditions encountered in VT01:  
TOPSOIL: dark brown slightly gravelly clay, to a depth of 0.65m, underlain by a geotextile membrane.

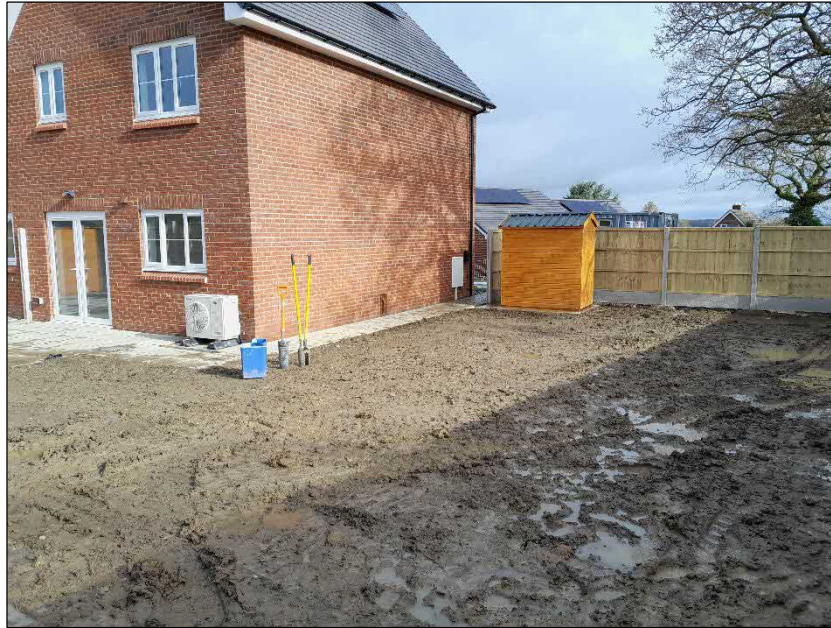
### Plate 3

Plot 3, viewed from the southeast, showing the location of VT02.

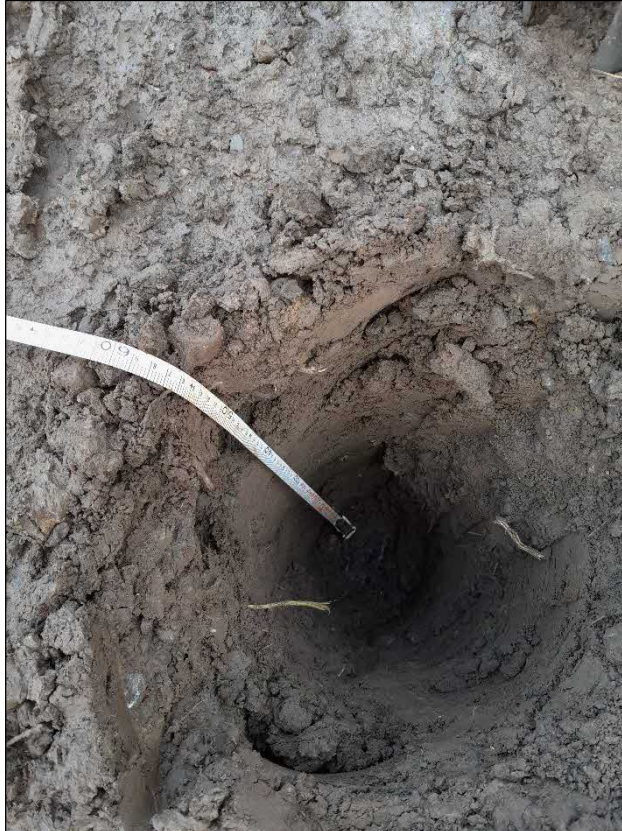
### Plate 4

Ground conditions encountered in VT02:  
TOPSOIL: dark brown slightly sandy slightly gravelly clay with occasional rootlets, to a depth of 0.60m, underlain by a geotextile membrane.

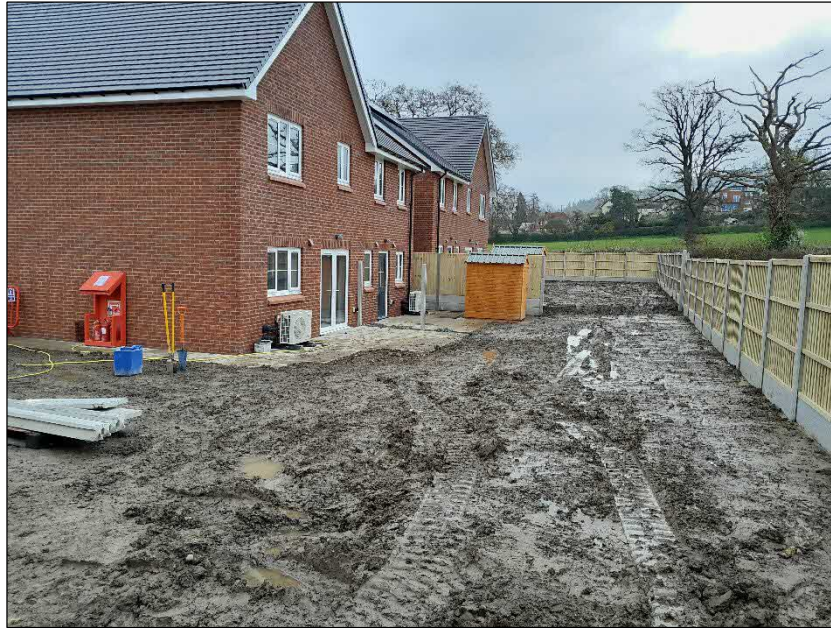
### Plate 5

Plot 6, viewed from the west, showing the location of VT03.

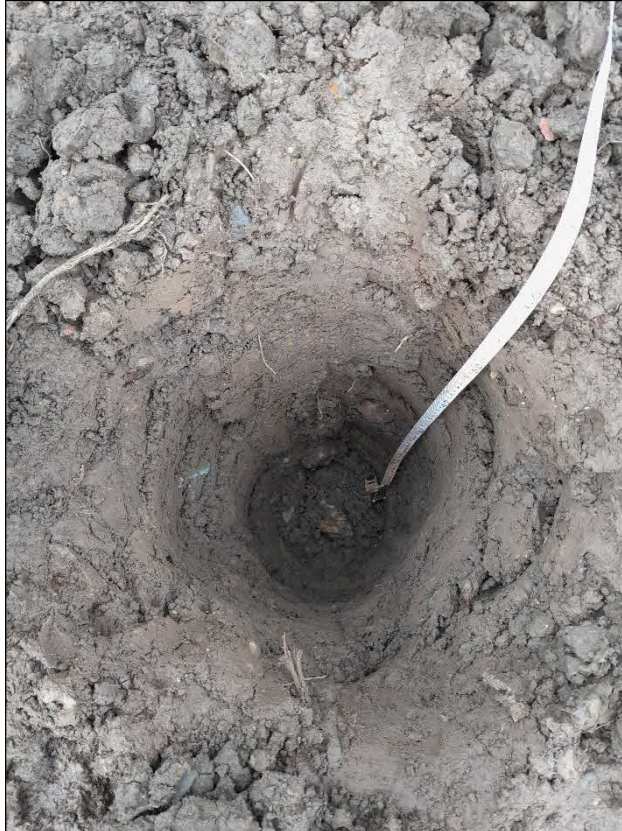
### Plate 6

Ground conditions encountered in VT03:  
TOPSOIL: dark brown slightly sandy slightly gravelly clay with occasional rootlets, to a depth of 0.60m, underlain by a geotextile membrane.

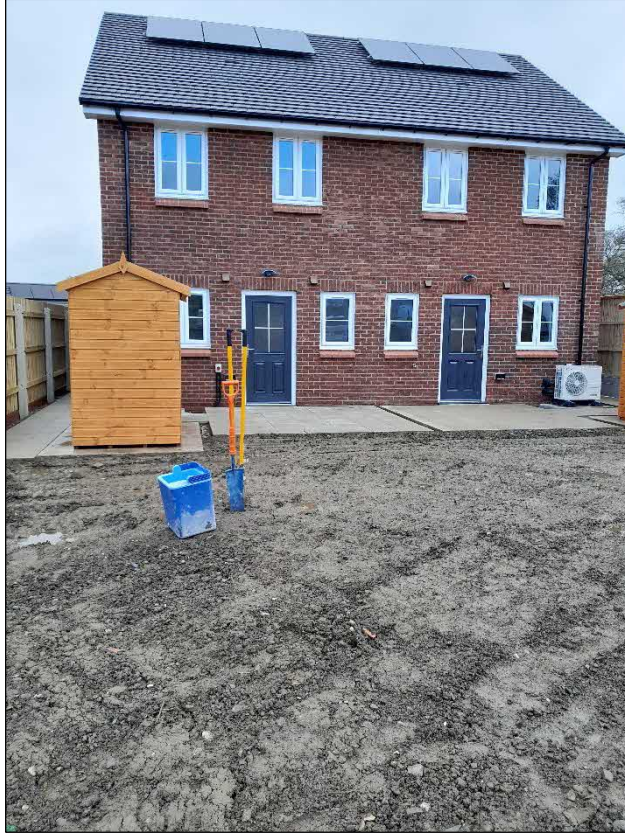
Plate 7

Plot 8, viewed from the southwest, showing the location of VT04.

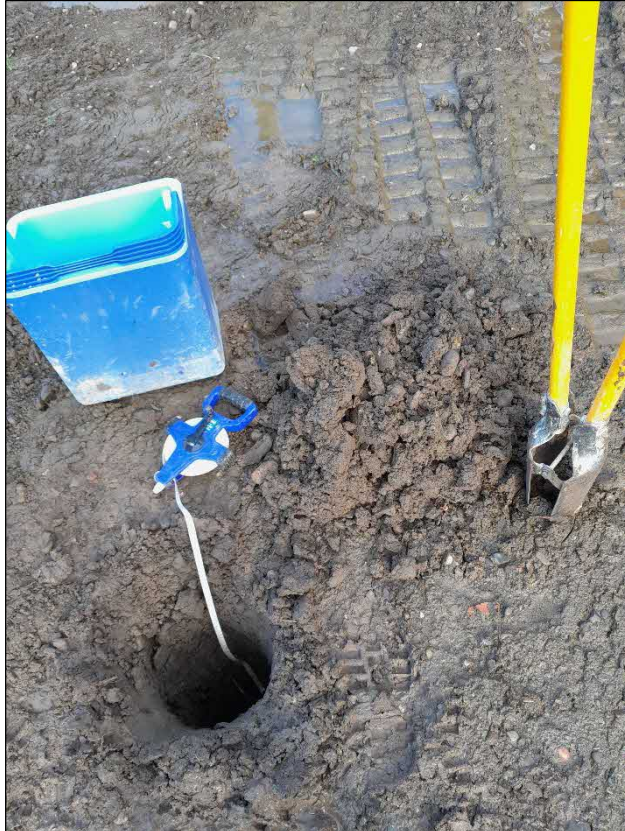
Plate 8

Ground conditions encountered in VT04:  
TOPSOIL: dark brown slightly gravelly clay, to a depth of 0.75m, underlain by a geotextile membrane.

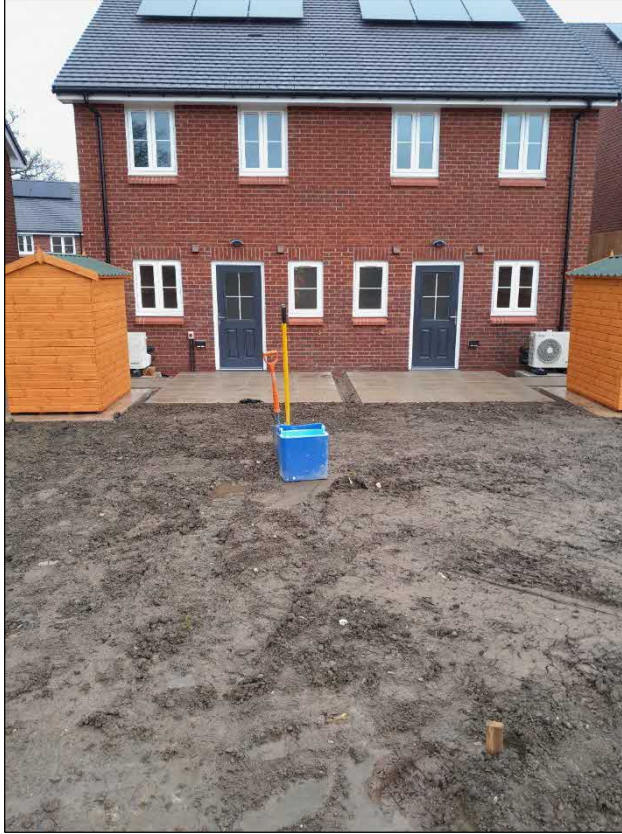
### Plate 9

Plot 10, viewed from the southwest, showing the location of VT05.

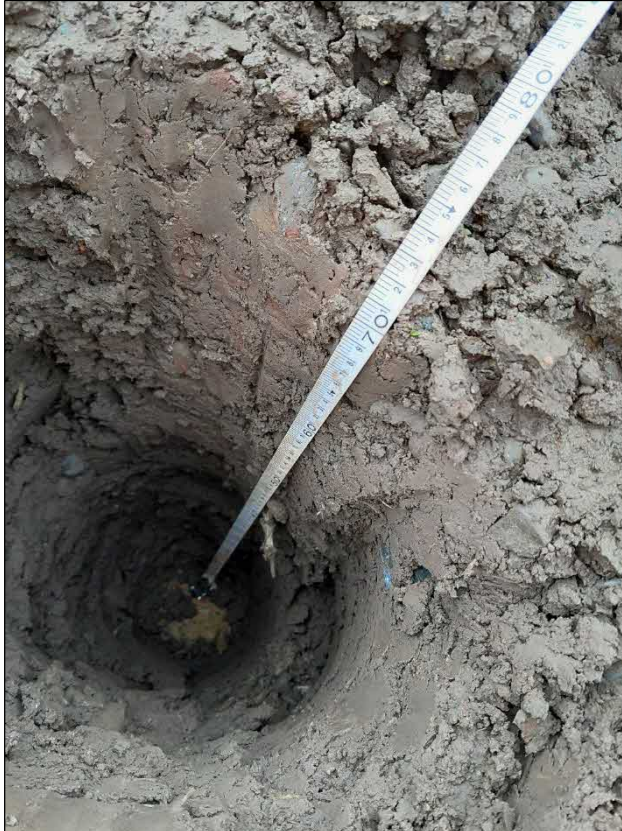
### Plate 10

In VT05, the membrane was underlain by yellow mottled greyish blue clay.

Ground conditions encountered in VT05:  
TOPSOIL: dark brown slightly gravelly clay, to a depth of 0.70m, underlain by a geotextile membrane.

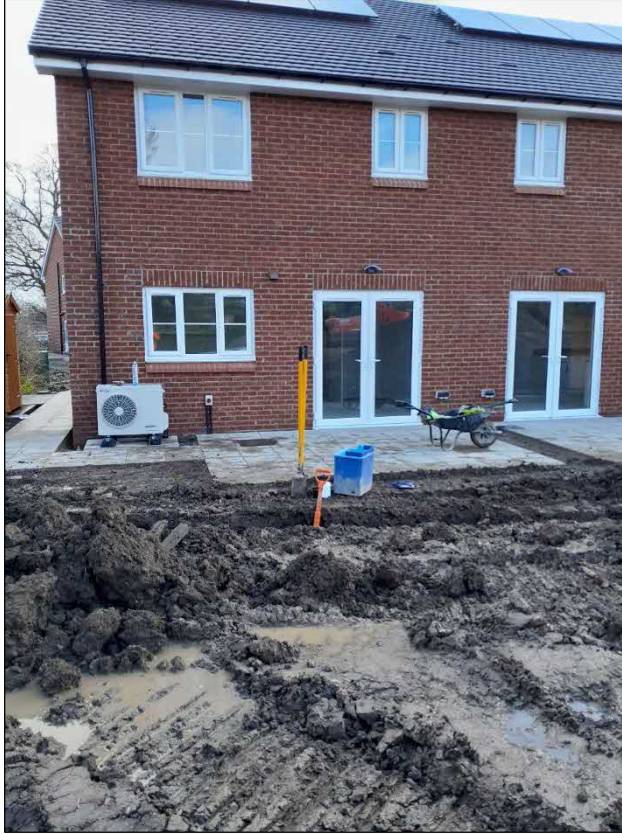
### Plate 11

Plot 12, viewed from the southwest, showing the location of VT06.

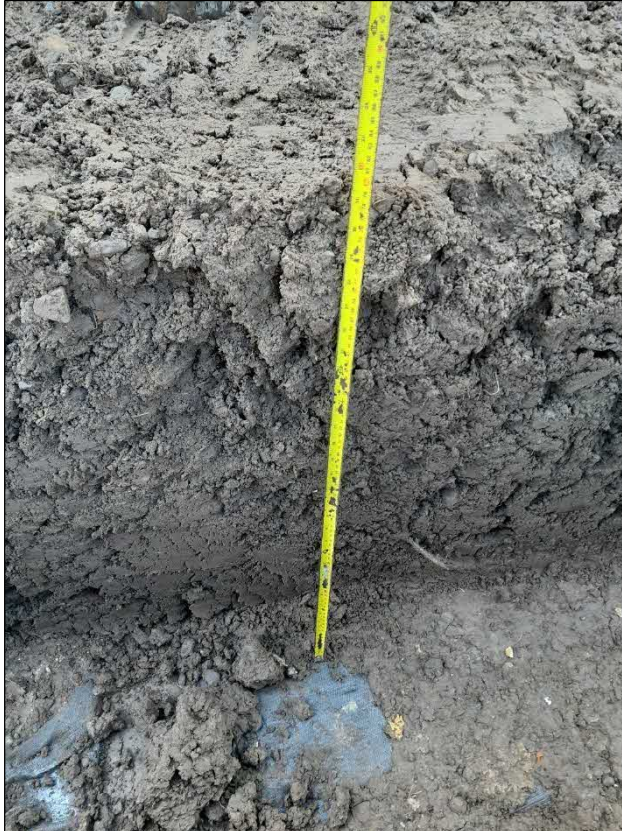
### Plate 12

Ground conditions encountered in VT01:  
TOPSOIL: dark brown slightly gravelly clay, to a depth of 0.80m, underlain by a geotextile membrane.

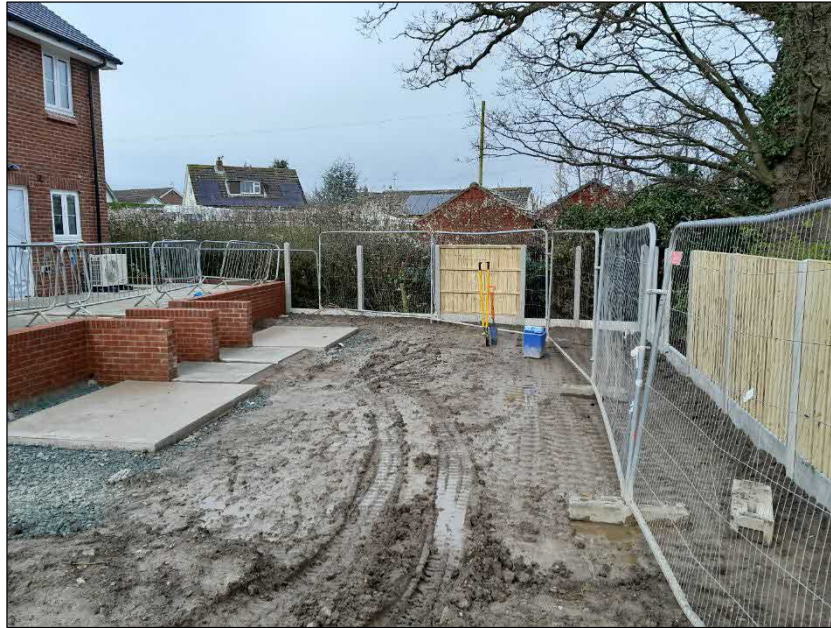
Plate 13

Plot 13, viewed from the east, showing the location of VT07.

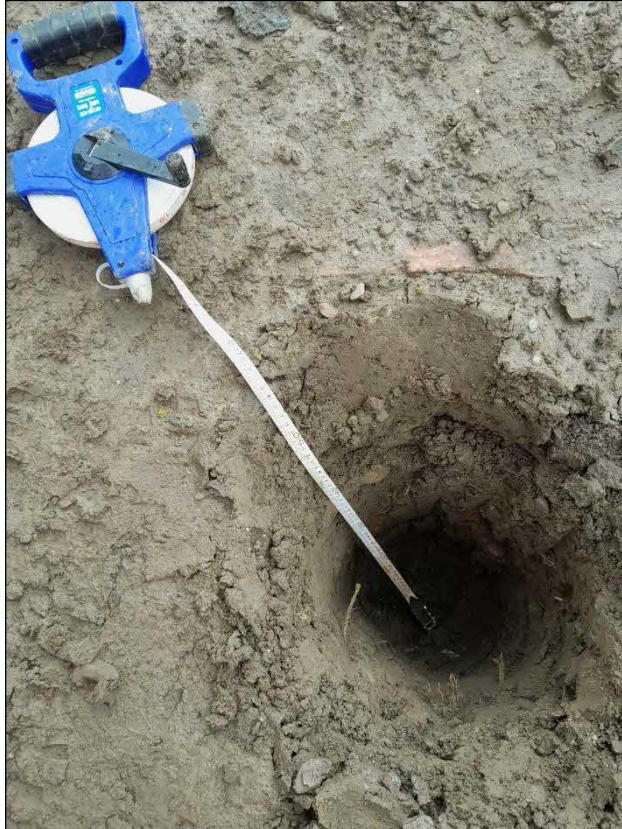
Plate 14

Ground conditions encountered in VT07:  
TOPSOIL: greyish brown slightly gravelly clay, to a depth of 0.60 m, underlain by a geotextile membrane, a tree root was observed under the membrane.

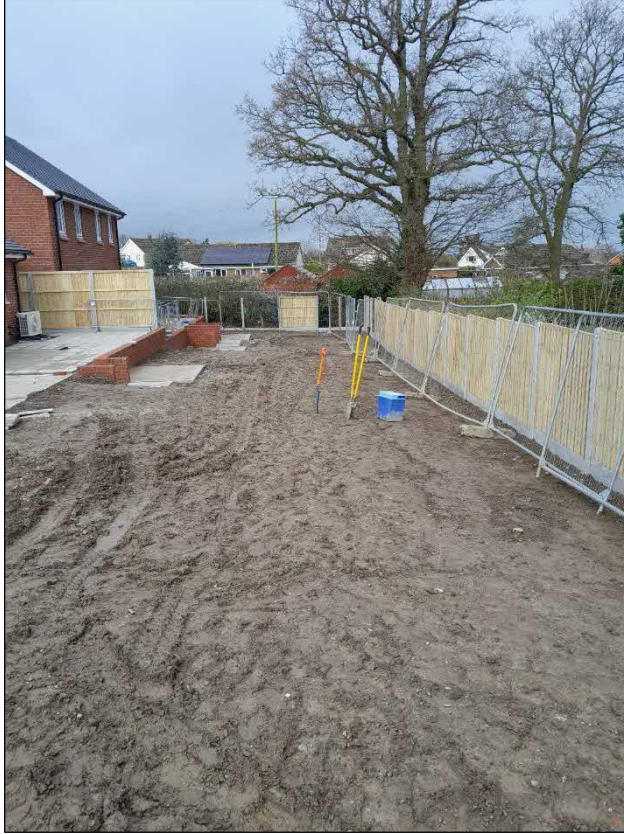
### Plate 15

Plot 16, viewed from the east, showing the location of VT08.

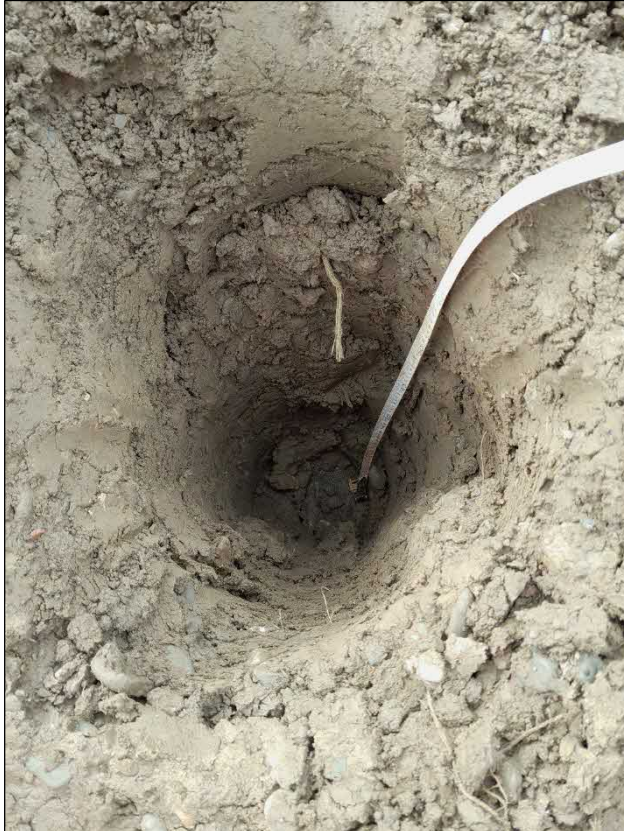
### Plate 16

Ground conditions encountered in VT08:  
TOPSOIL: greyish brown slightly gravelly clay, to a depth of 0.75m, underlain by a geotextile membrane.

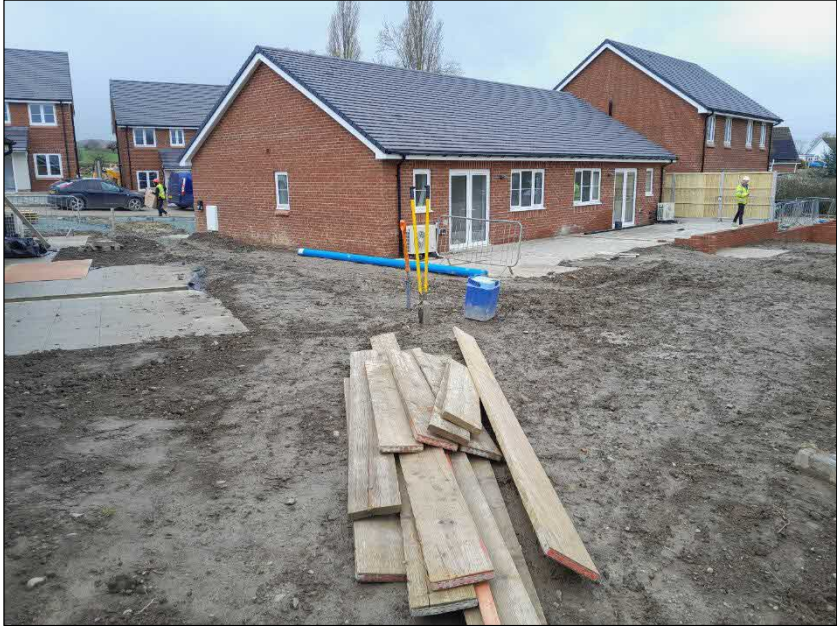
<p>Plate 17</p> <p>Plot 18, viewed from the east, showing the location of VT09.</p> <p>Photograph taken on 03/04/2024</p>

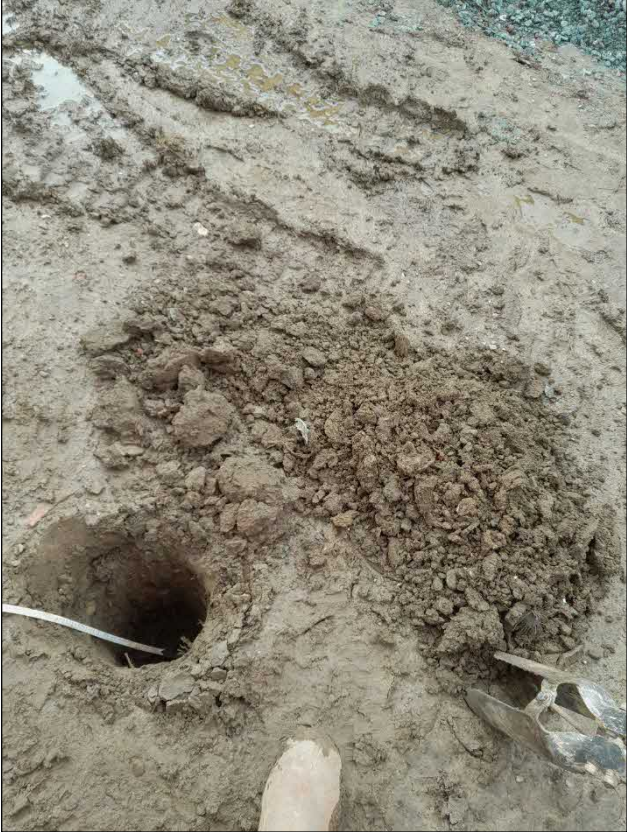
<p>Plate 18</p> <p>Ground conditions encountered in VT09: TOPSOIL: brown slightly gravelly clay, to a depth of 0.65m, underlain by a geotextile membrane.</p> <p>Photograph taken on 03/04/2024</p>

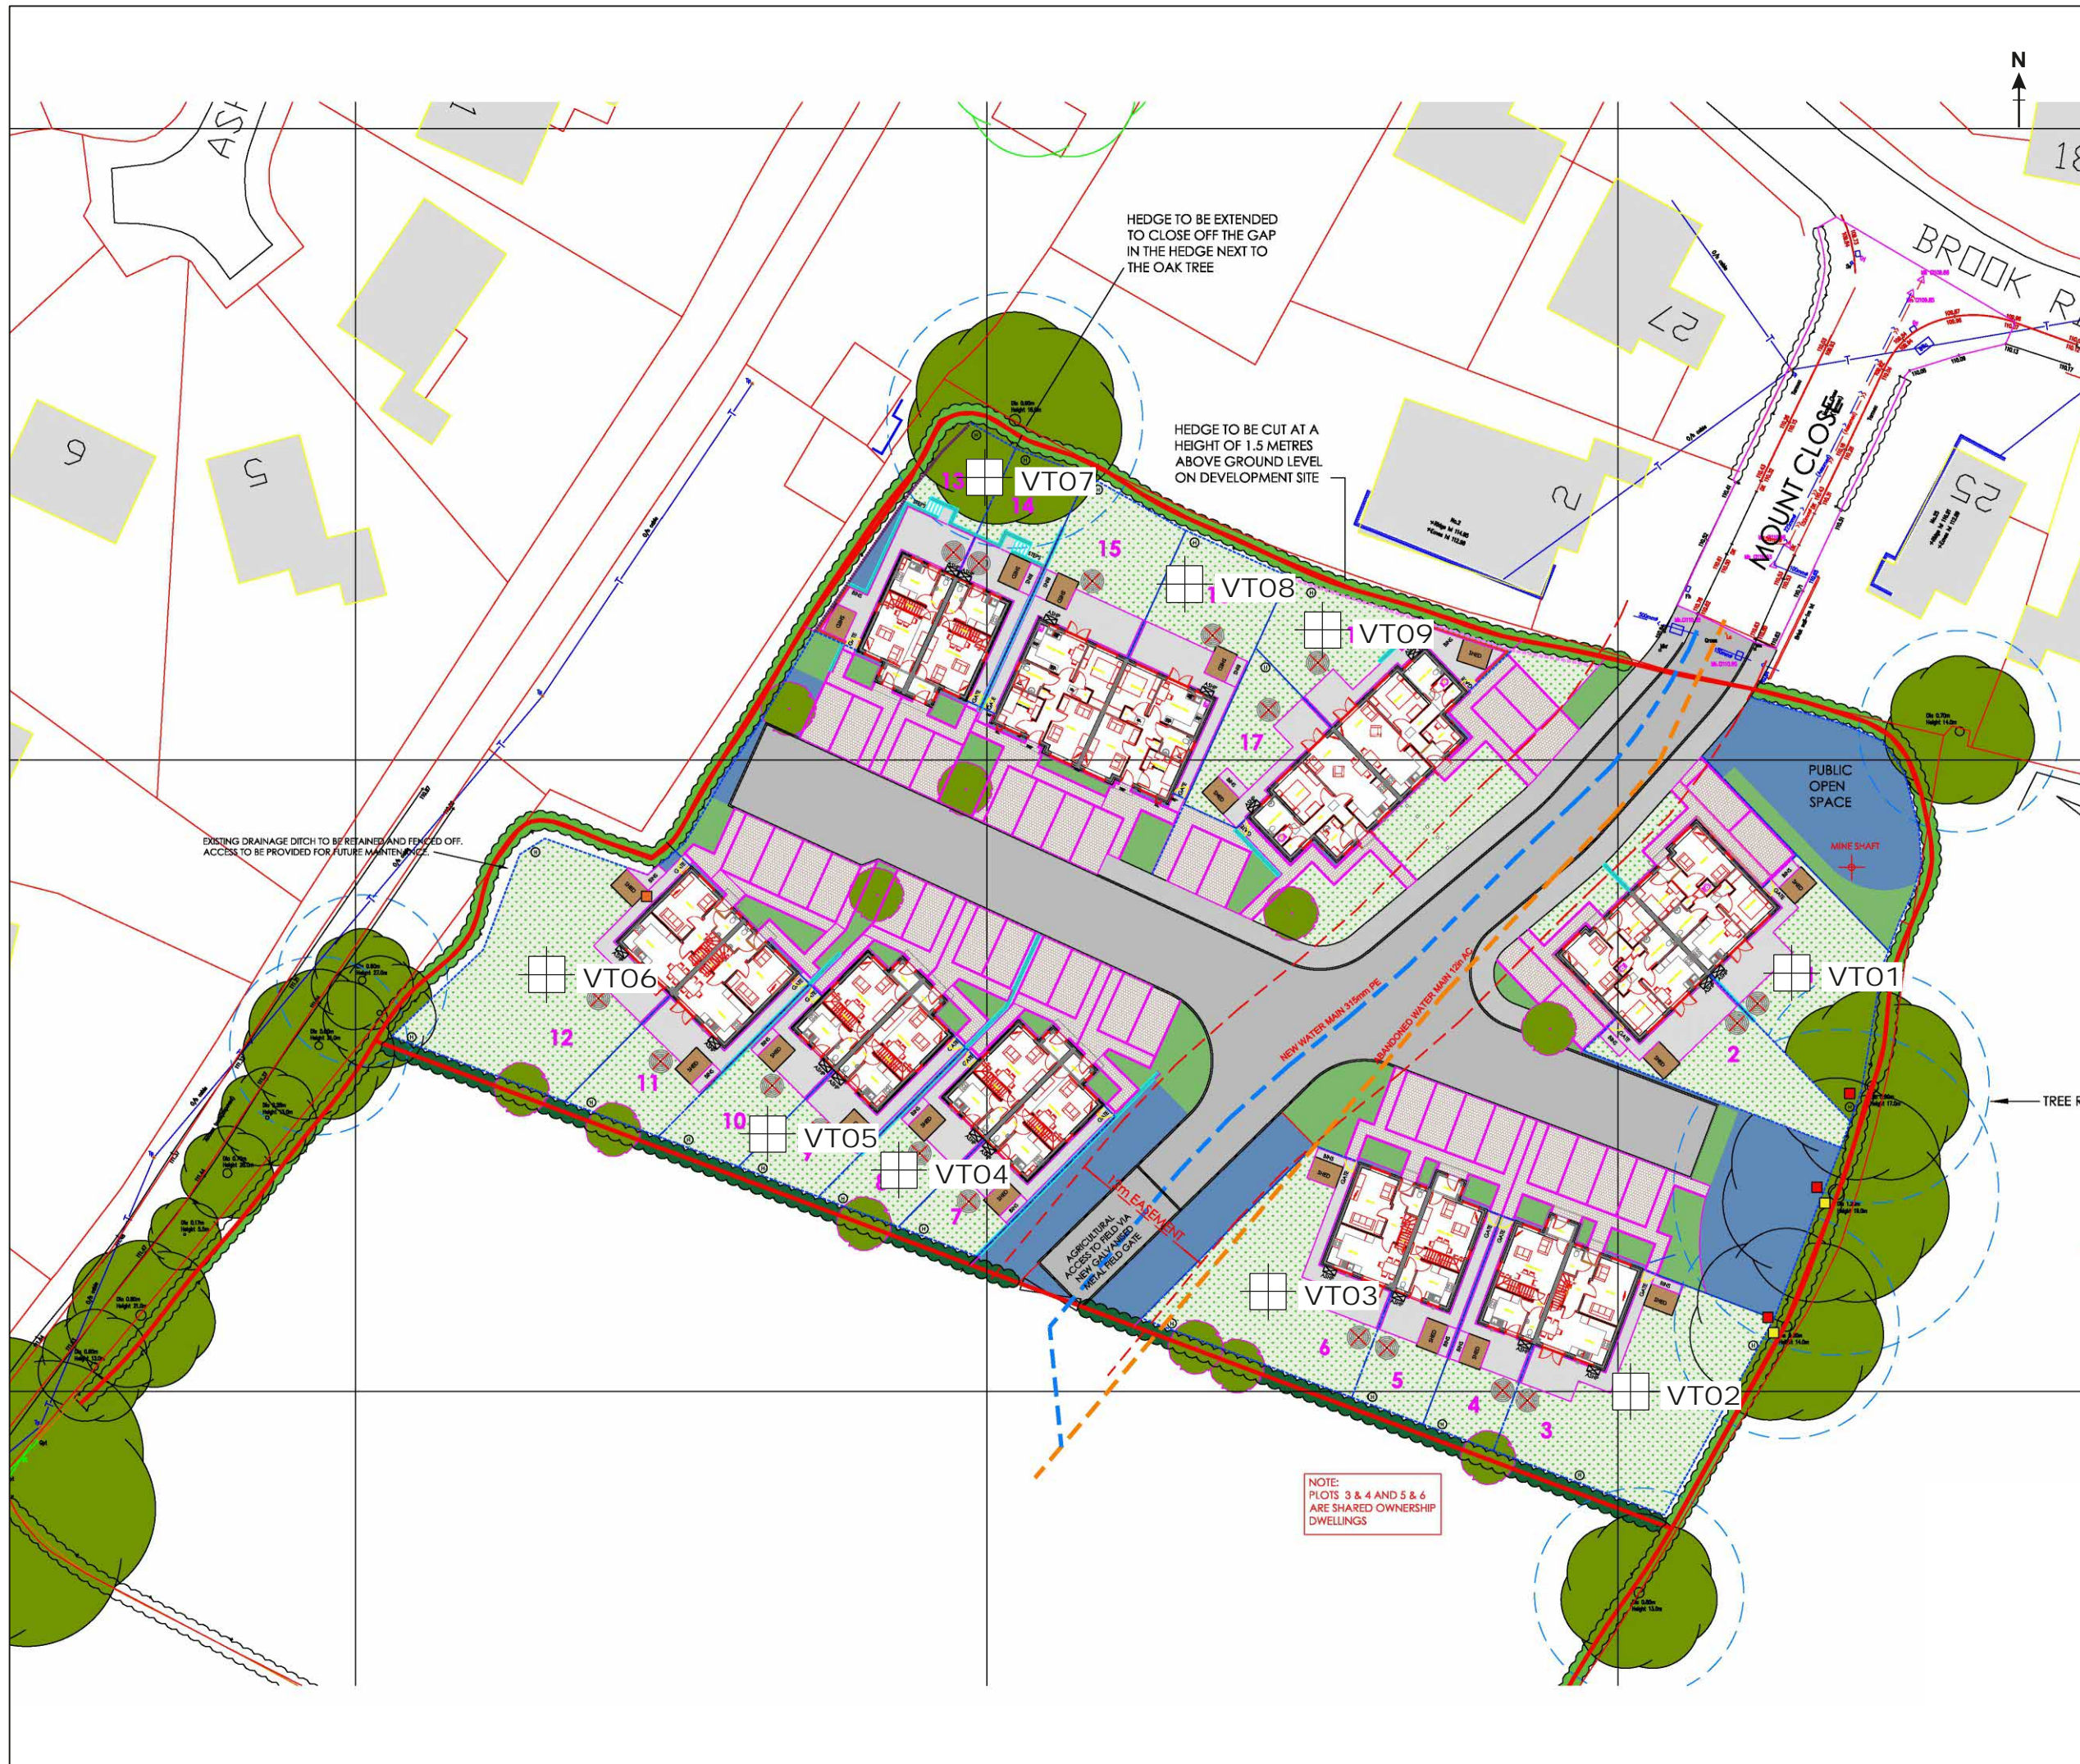
### VALIDATION TEST LOCATION PLAN

The site layout is shown on the validation test location plan (Dwg. No. 19425/10, presented in Appendix C of this report).

The locations of the validation tests are shown on the photographs (Appendix A) and the validation test location plan (Dwg. No. 19425/10, Appendix C).
