PROJECT: 1A RIVIERE TOWANS, HAYLE, CORNWALL

REPORT TITLE: PHASE 1 DESK STUDY

REPORT REF: YES 2147a

REPORT DATE: 20th FEBRUARY 2024

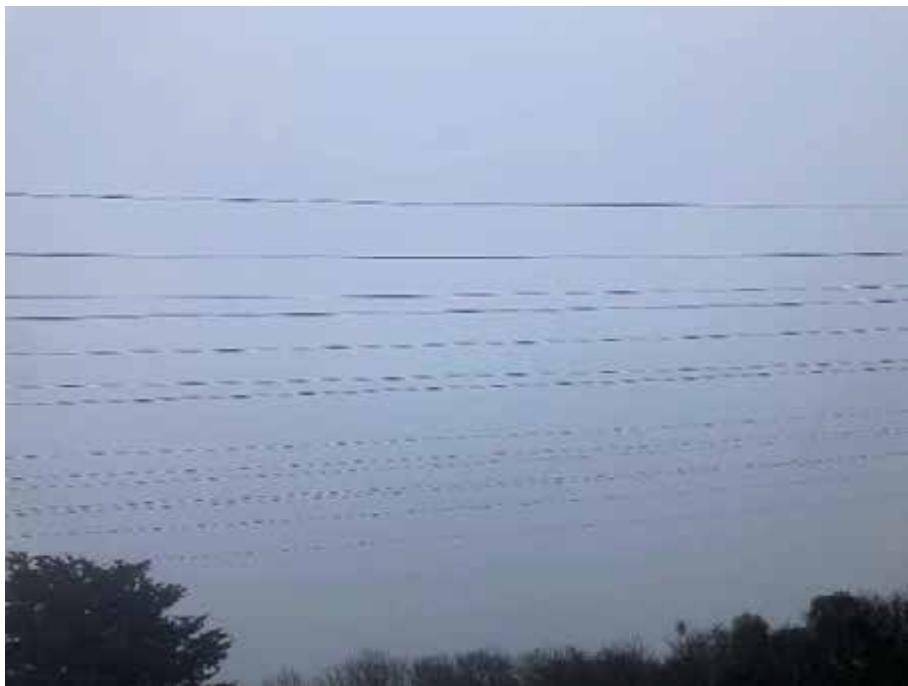
PHOTOGRAPH 10: POWERLINES ABOVE SITE

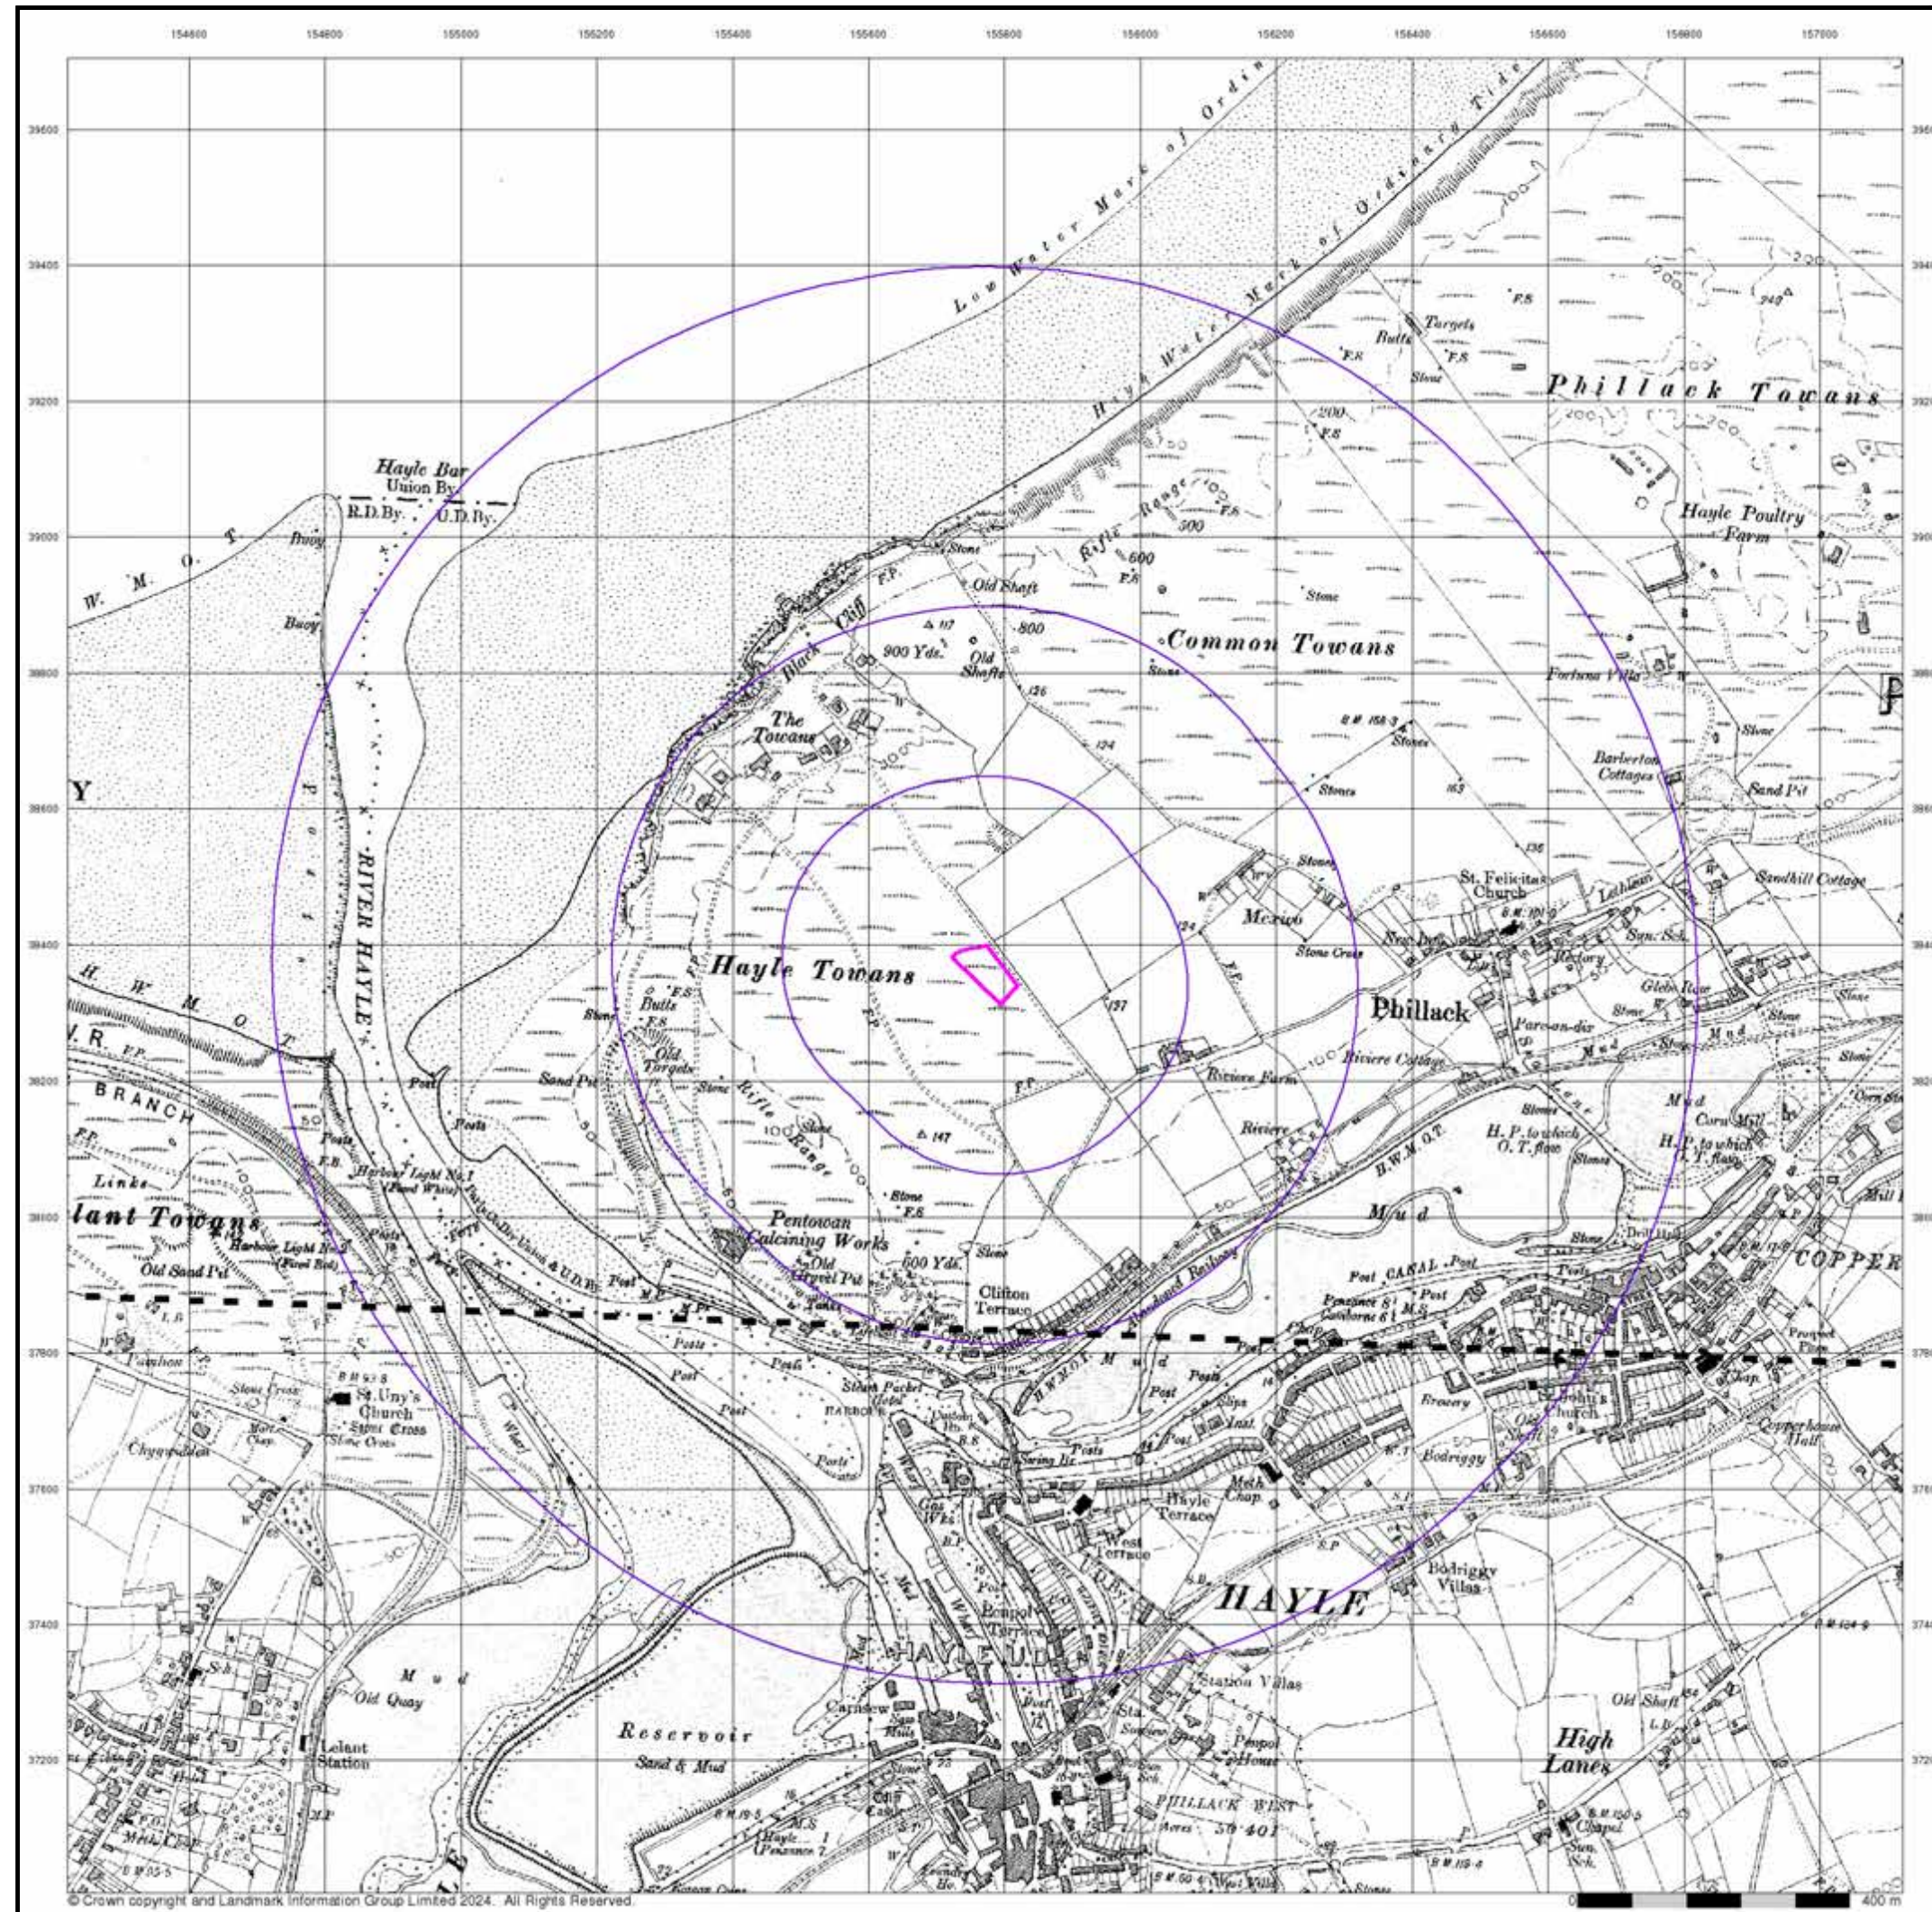
Published 1908

The historical maps shown were reproduced from maps predominantly held at the scale adopted for England, Wales and Scotland in the 1840's. In 1854 the 1:2,500 scale was adopted for mapping urban areas; these maps were used to update the 1:10,560 maps. The published date given therefore is often some years later than the surveyed date. Before 1938, all OS maps were based on the Cassini Projection, with independent surveys of a single county or group of counties, giving rise to significant inaccuracies in outlying areas. In the late 1940's, a Provisional Edition was produced, which updated the 1:10,560 mapping from a number of sources. The maps appear unfinished - with all military camps and other strategic sites removed. These maps were initially overprinted with the National Grid. In 1970, the first 1:10,000 maps were produced using the Transverse Mercator Projection. The revision process continued until recently, with new editions appearing every 10 years or so for urban areas.

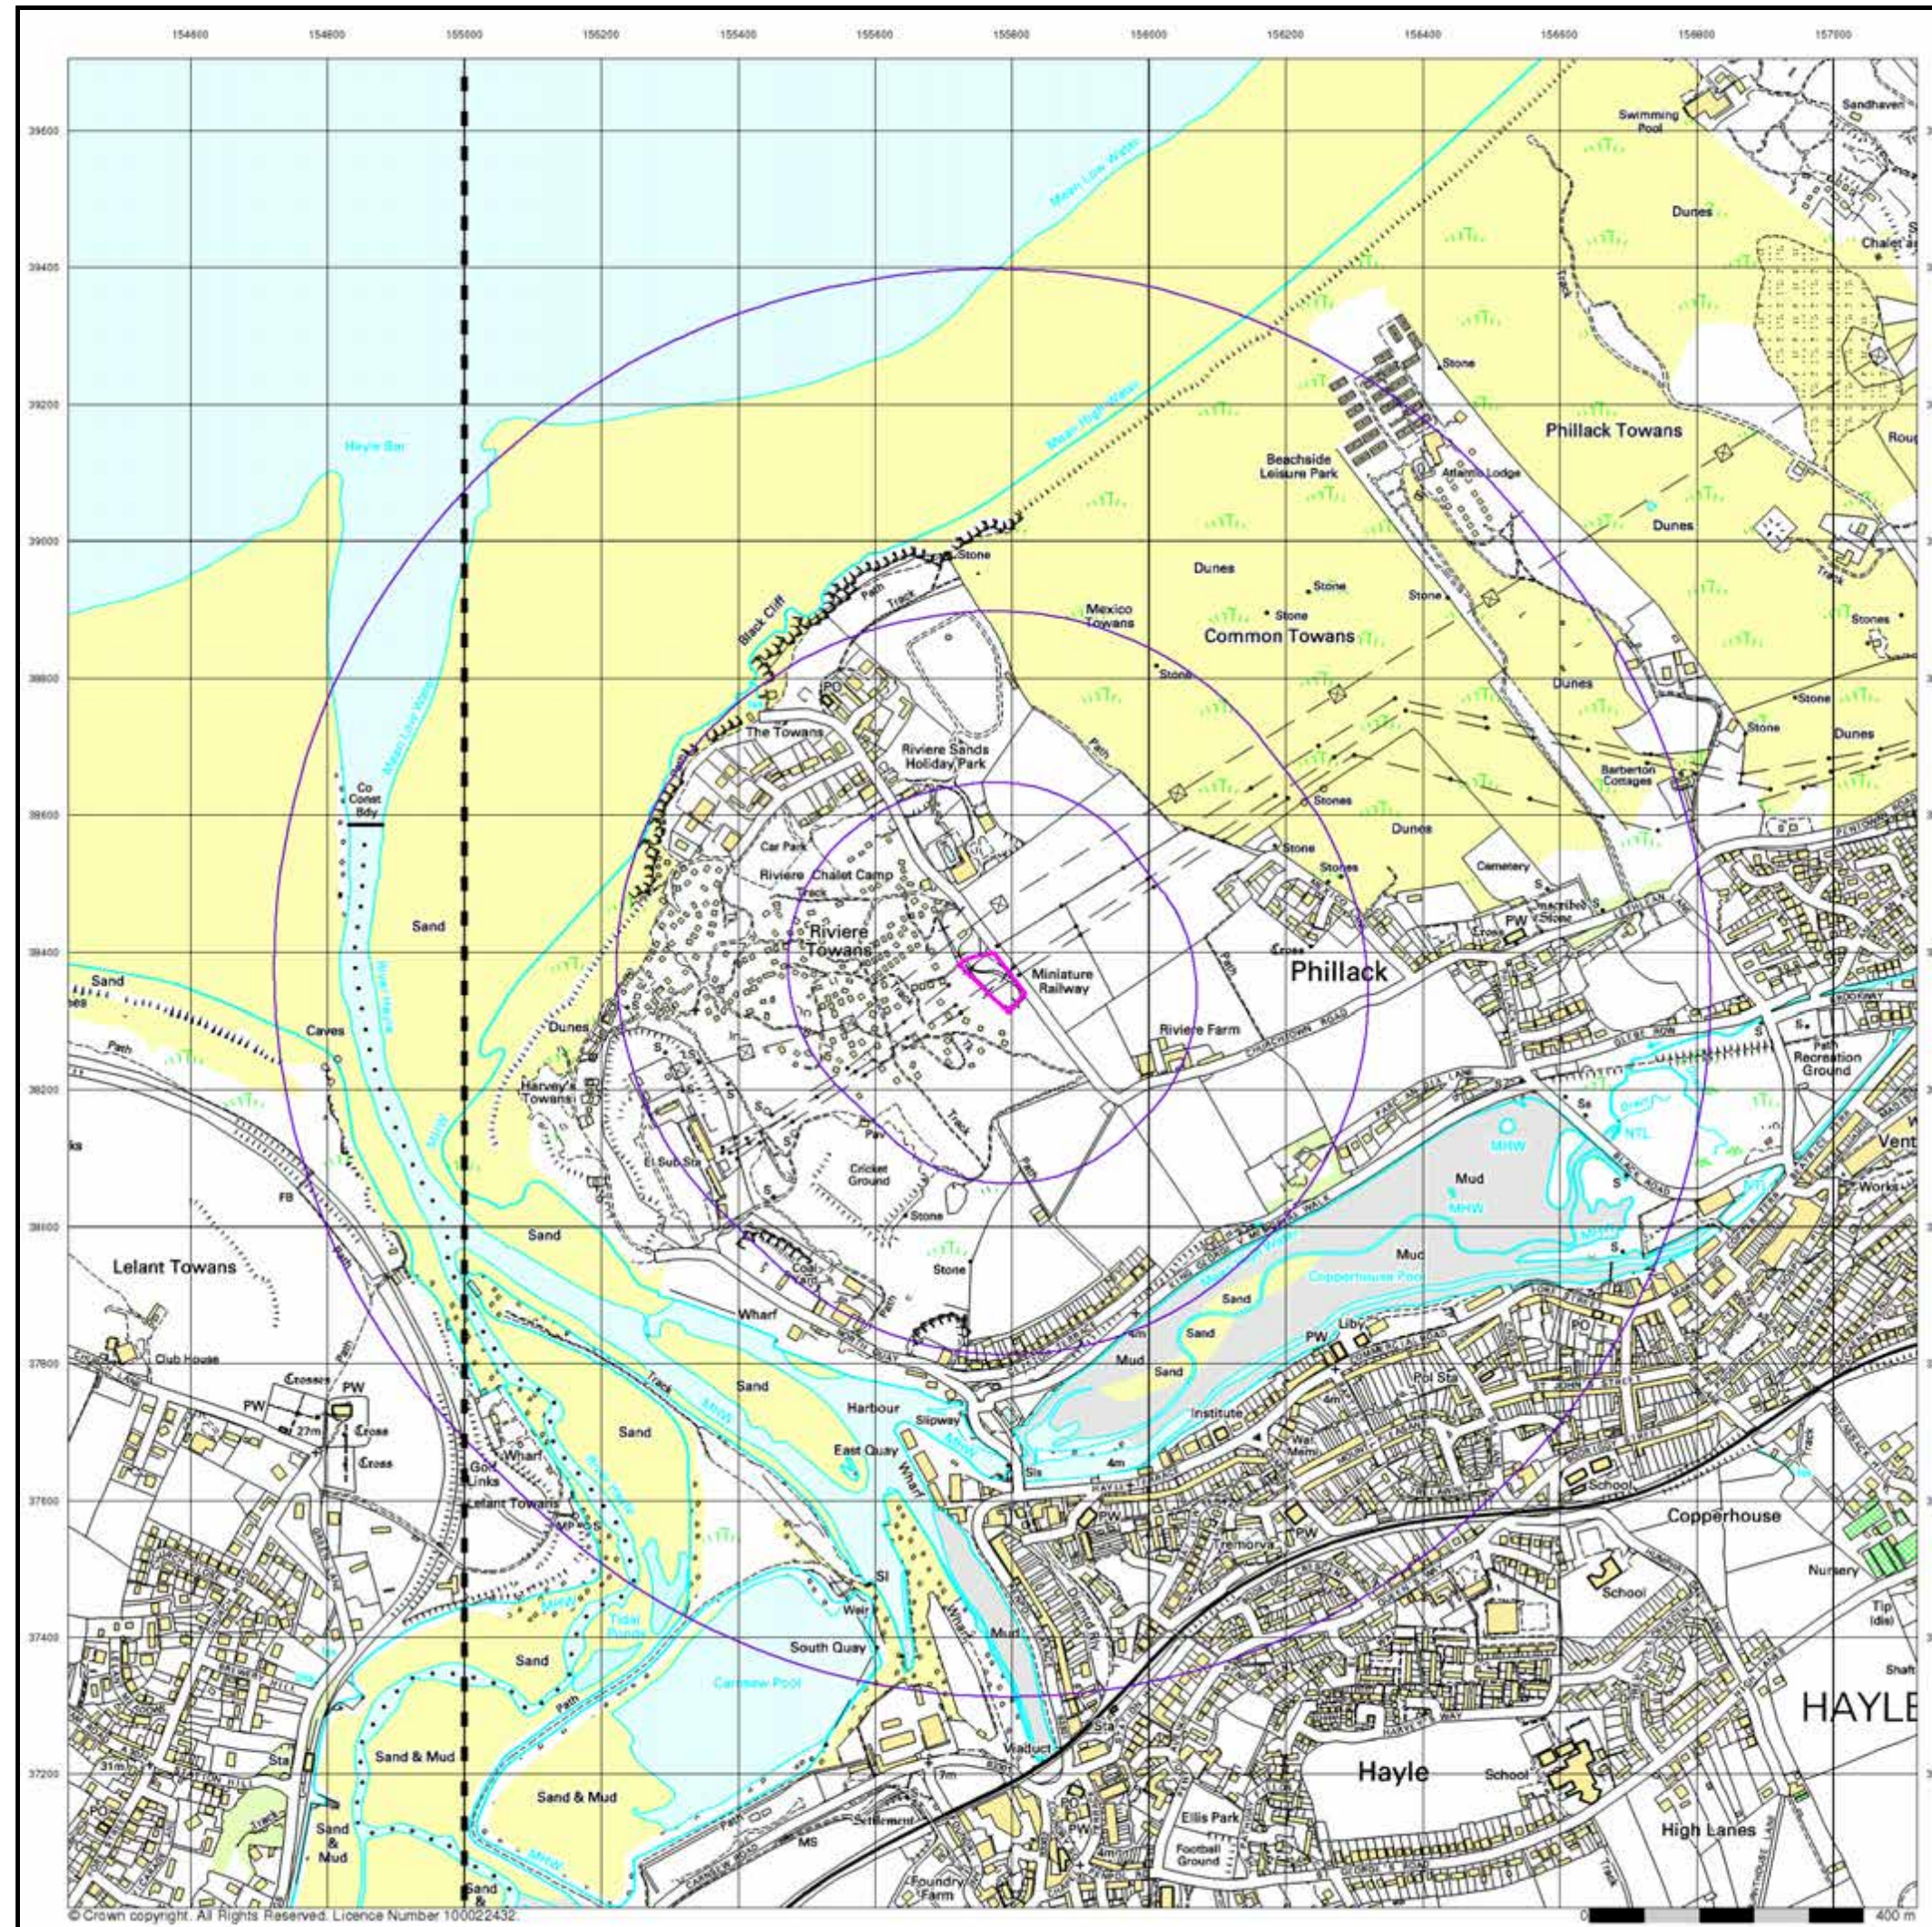
10k Raster Mapping

The historical maps shown were produced from the Ordnance Survey's 1:10,000 colour raster mapping. These maps are derived from Landplan which replaced the old 1:10,000 maps originally published in 1970. The data is highly detailed showing buildings, fences and field boundaries as well as all roads, tracks and paths. Road names are also included together with the relevant road number and classification. Boundary information depiction includes county, unitary authority, district, civil parish and constituency.

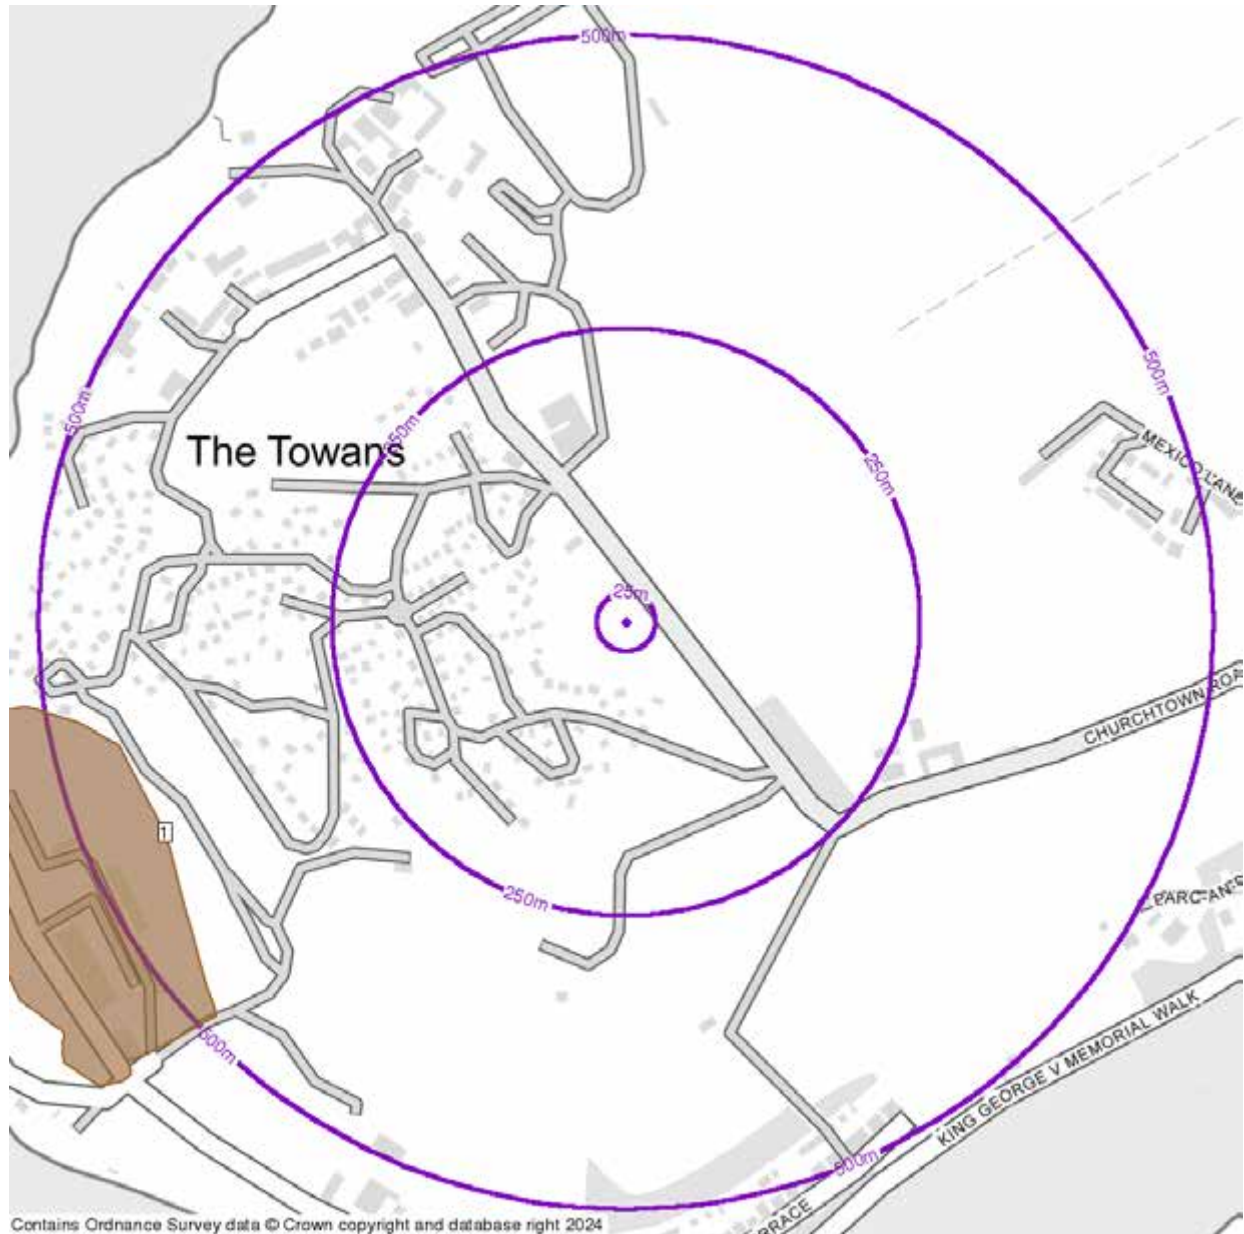
The map detailed below shows the location of the Designated Contaminated Land and Landfill and Waste features highlighted within sections 1a and 1b of this report.

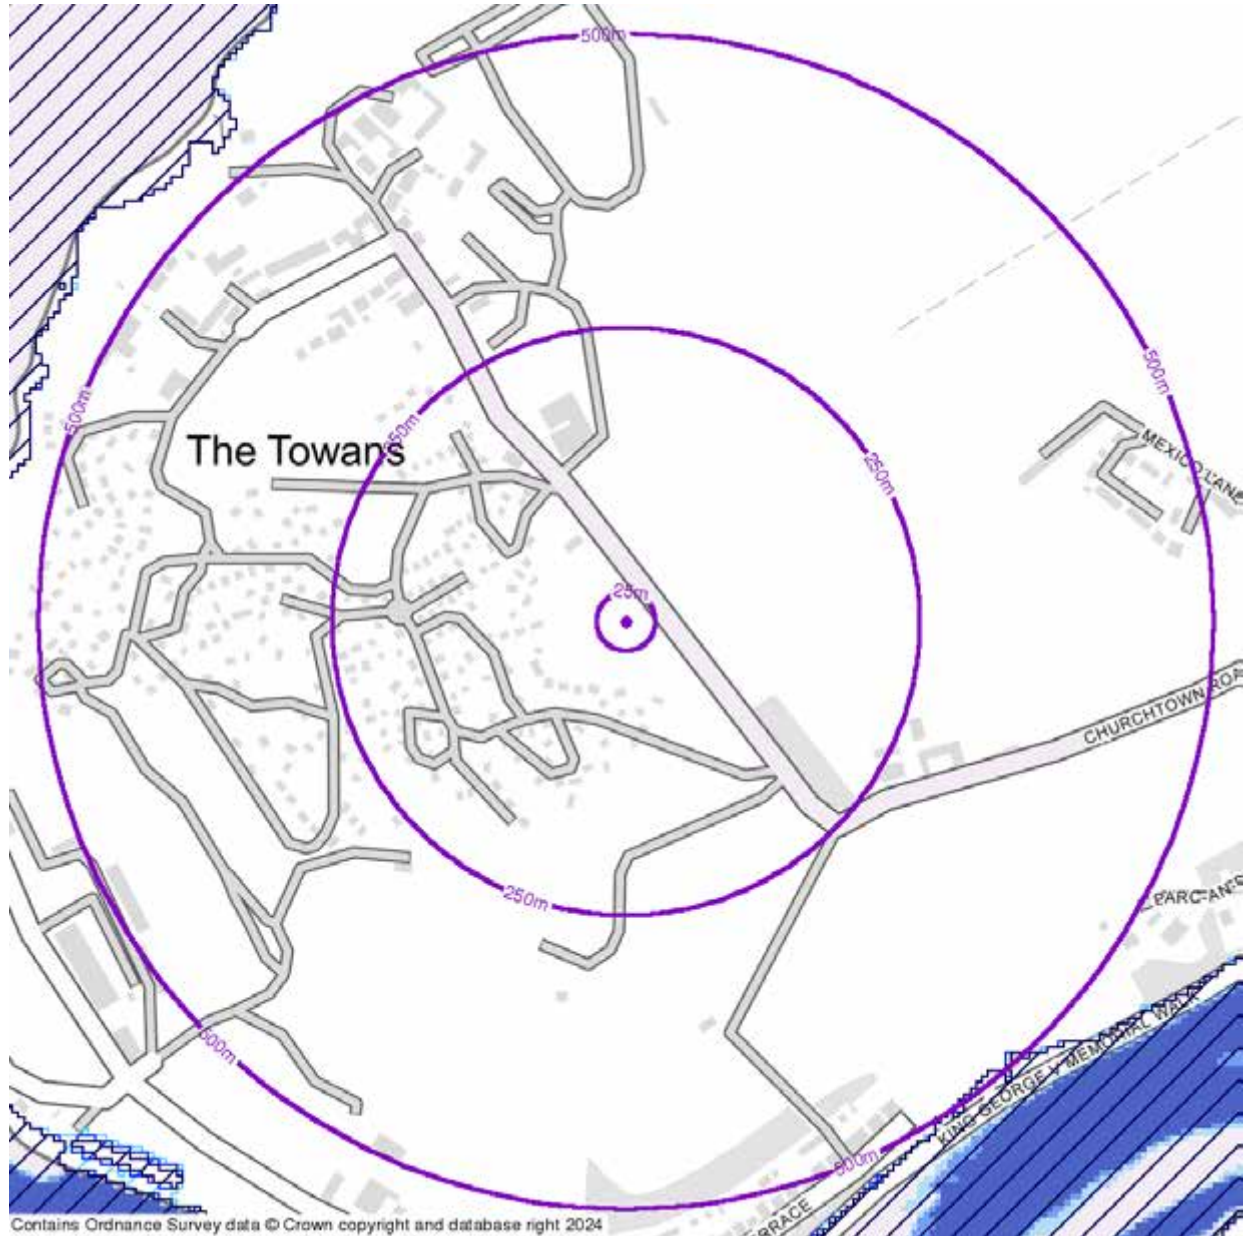
The map detailed below shows the location of potential river and coastal flood risk. The potential risk has been modelled on the basis of an event occurring on average every 75, 200 or 1000 years.

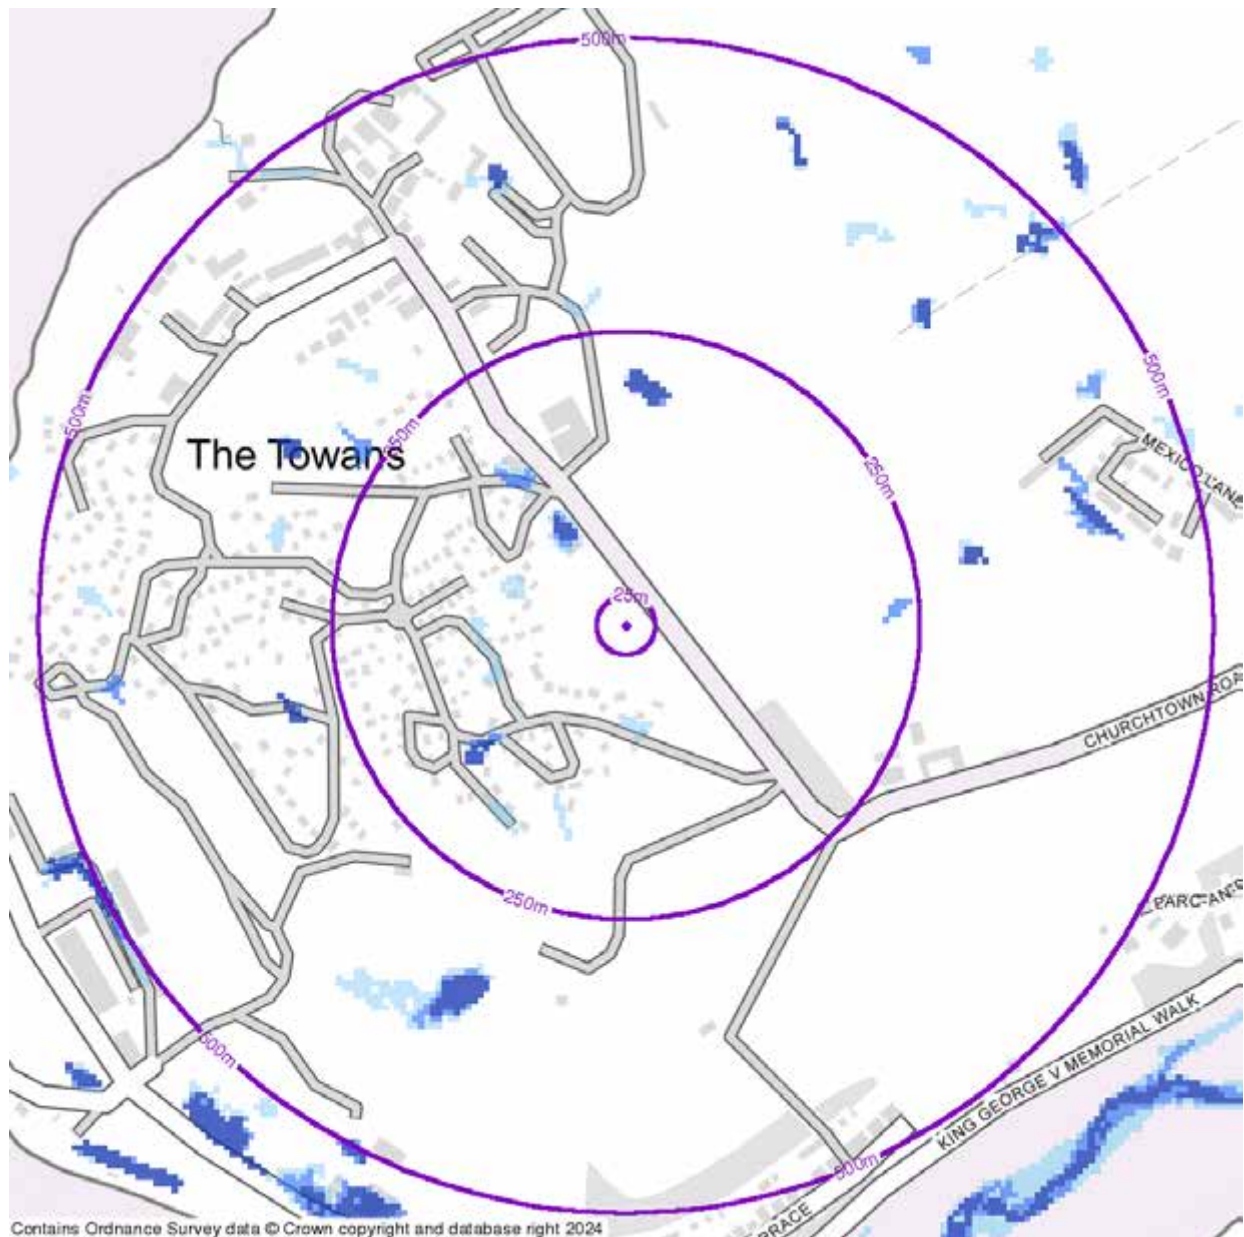
The map detailed below shows the location of potential surface water flood risk. The potential risk has been modelled on the basis of an event occurring on average every 75, 200 or 1000 years.
