**Proposed Class Q Conversion of Existing Barn
Bell House, Humble Green,
Little Waldingfield, Suffolk, CO10 0TB**

Preliminary Ecological Appraisal Report

April 2024

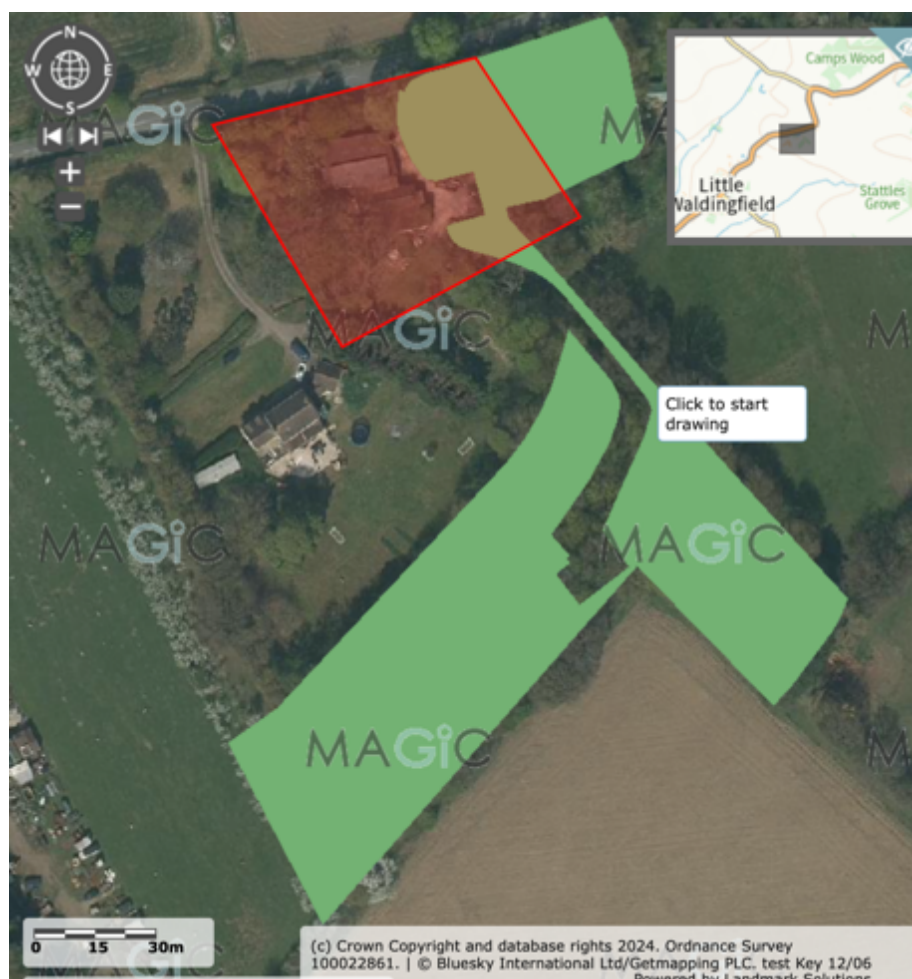
Figure 2. Priority deciduous woodland shown on Defra's Magic mapping website (shaded green, with approximate Site boundary shown as red line)

There are two Priority Habitat parcel within 1km of the Site: the ancient woodland of Camps Wood, mentioned above, and interconnected small patches of woodland on and immediately to the east and south of the Site. The later woodland is shown in Figure 2. Below.

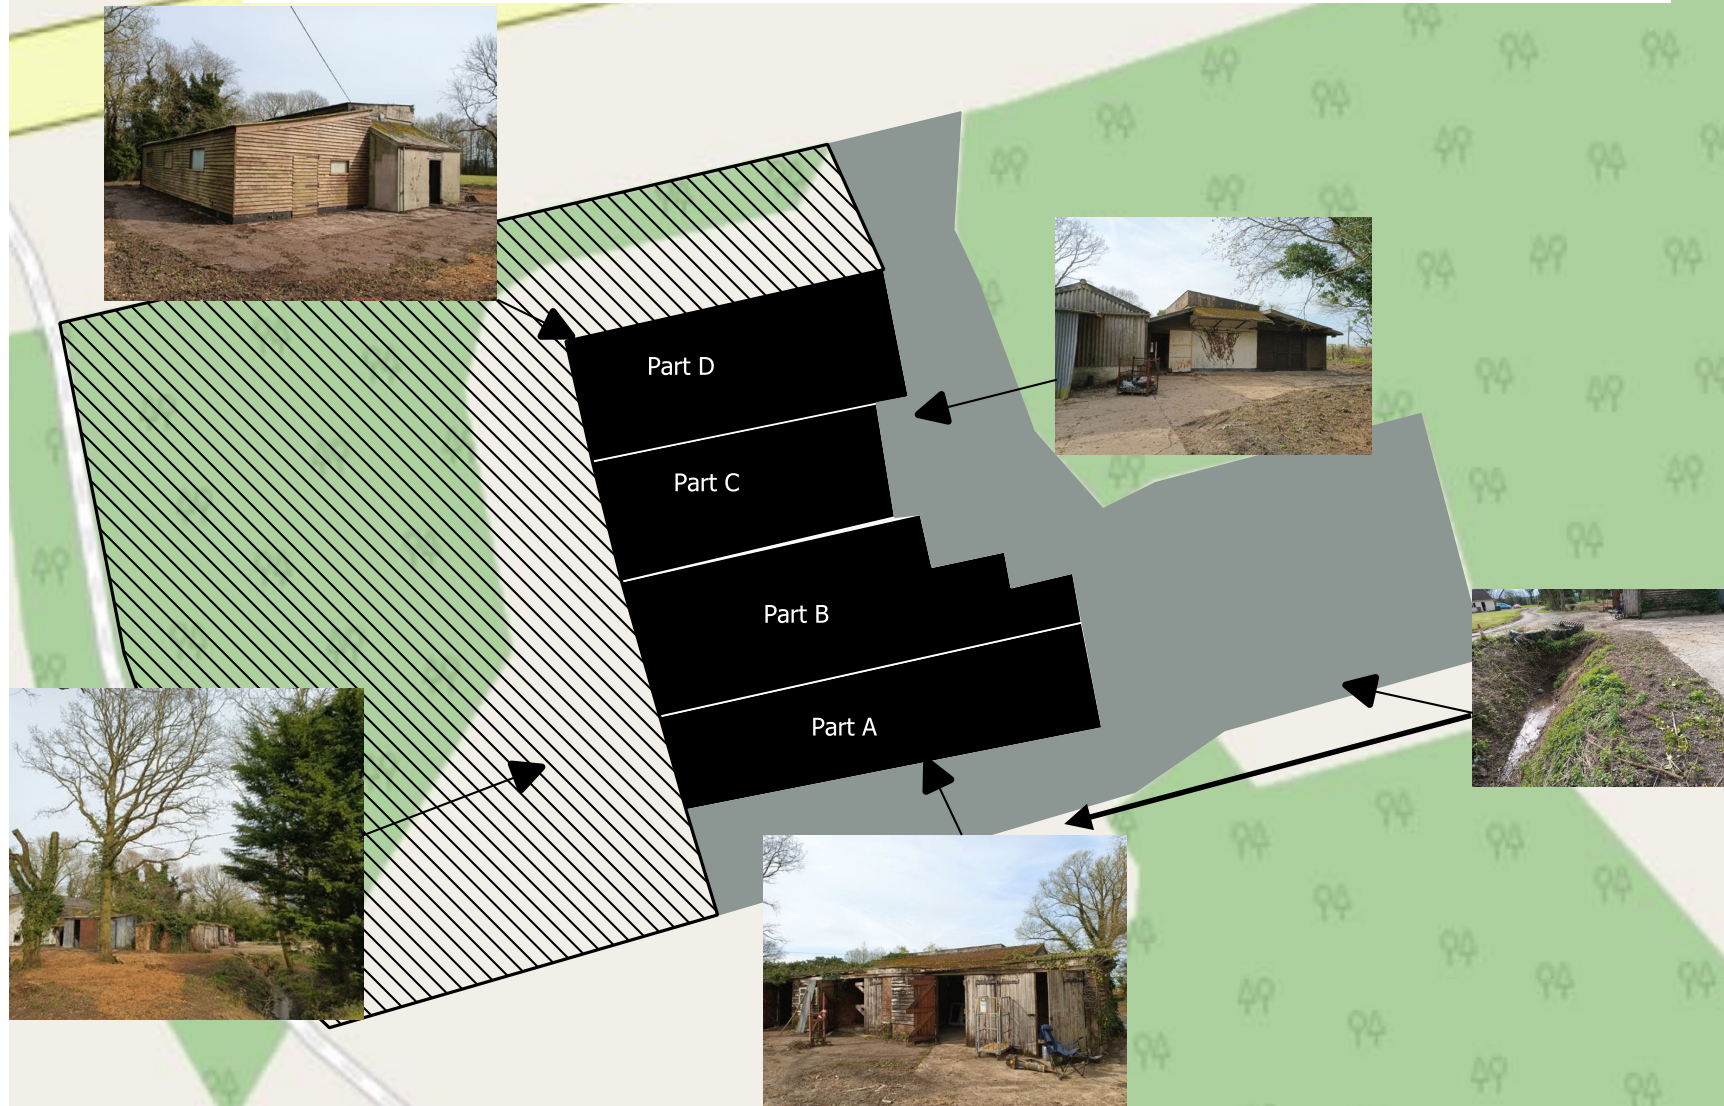
Figure 3. Plan and photos of buildings and habitats within the Site. The barn has been split into four parts and labelled for the purpose of the survey results reporting

Most of the site is the interlinked barn complex, surrounded by concrete hardstanding. Beyond the concrete are areas of bare ground, of which only small portions along the east side of the existing entrance driveway, and to the north-west of the barn complex, will be within the development footprint.

The hatched area to the north and west of the barn complex indicates where some trees have been recently felled, outside the development footprint. The arisings from the felling operation covered much of this area at the time of survey, making it difficult to assess the habitats beneath. However, generally the white areas in Figure 1 were concrete hardstanding, as were the grey shaded areas to the south and east, with bare ground and scattered trees in the green areas to the north and west, plus some modified grassland closer to the Bell House driveway to the west of the Site. Note that some (approximately six) of the scattered trees to the north and west outside the development footprint have now been felled.

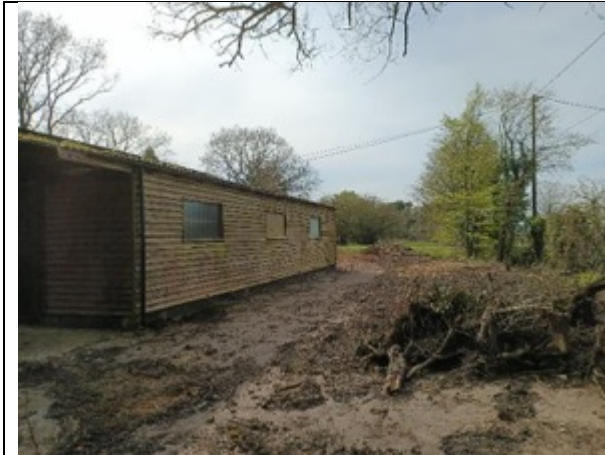
<p>The southern edge of the Site showing concrete south of the barn and woodchip arisings from recent tree felling covering bare ground in the foreground</p>	<p>Tree felling arisings on concrete pad southeast of the barn</p>
<p>Concrete pad and bare ground surrounding the barn to the northeast</p>	<p>Barn complex as seen from the west, with woodchip arisings from recent tree felling covering bare ground in the foreground</p>
<p>Area immediately west of the barn complex looking north-west. The concrete pad surrounding the barn is visible to the right, with bare ground covered in woodchip to the left and modified grassland beyond.</p>	<p>Defunct hawthorn hedgerow with a line of young hornbeam trees forms the north-west boundary of the survey area. These are outside the development footprint and will not be impacted</p>

<p>North-west corner of the Site looking west, showing the concrete pad surrounding the barn, bare ground to the north, and the hedgerow and hornbeam treeline forming the northern boundary (right)</p>

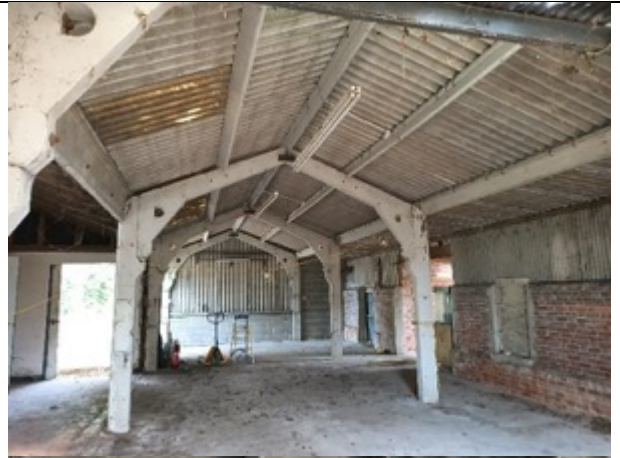
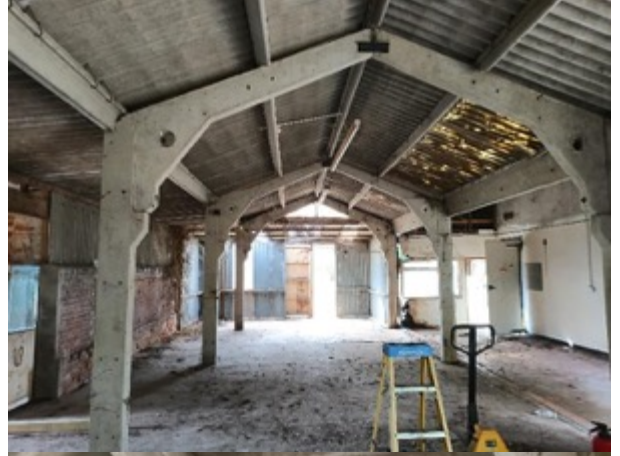
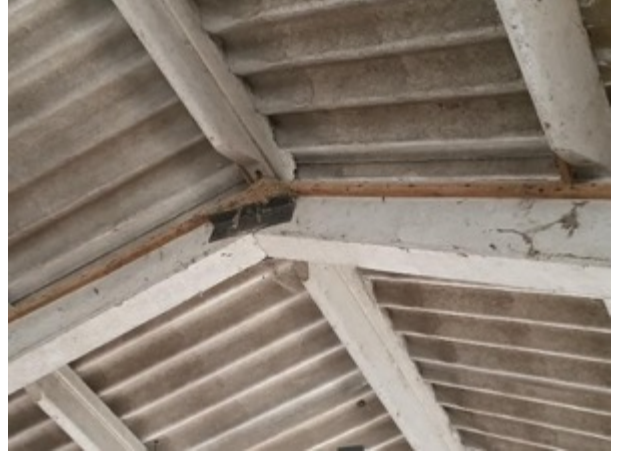
Part B

Cement framed. Walls of various materials, including breeze block, brick and tin. Has an asbestos roof.

The brick and breeze block walls are in relatively good condition, with no deep gaps formed from missing mortar.

No potential bat roost features were identified, and no evidence of bat presence was found. We consider this building has negligible bat roosting potential.

1 x swallow nest inside.

The loss of two swallow nests and other bird nesting habitat in the existing barn complex, will have a minor local impact on the nesting bird resource.

As birds and their active nests are protected from damage or destruction, building conversion work should commence in the period October-February, outside the bird nesting season. Once the site

is under active construction, birds are very unlikely to commence a nesting attempt within the barn complex. If work must commence during the period March-September, a nesting bird check needs to be undertaken by a qualified ecologist before work can commence. Should birds be nesting, work within that area of the Site will need to wait until the nesting attempt has ceased.

To compensate for the loss of habitats of established and potential bird nest sites in the barn complex, new nesting opportunities should be created. Ideally this would be in the form of installing artificial swallow nest-cups within a carport or open-fronted barn or shed. The proposed development does not include such structures, but the client may have suitable locations in the adjacent Bell House landholding. If this is not possible, nesting boxes for other species should be provided on the new buildings or surrounding trees. At least five nest boxes should be provided, including a tawny owl nest box within the woodland to the east.

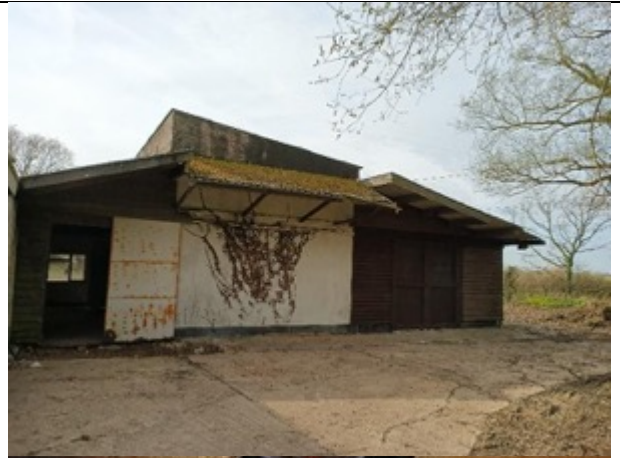
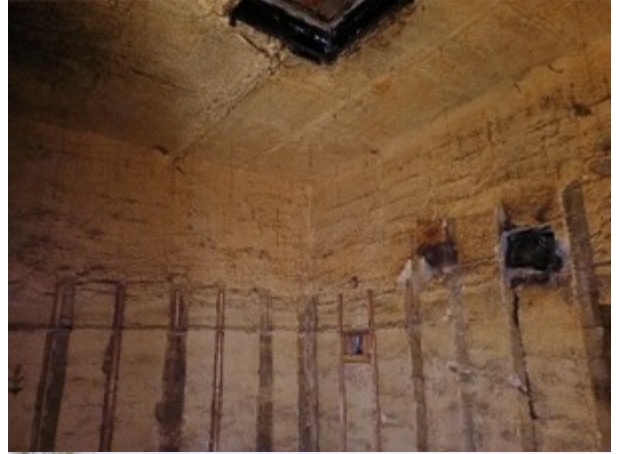
Part C

Asbestos roof, with rendered breeze block walls. The interior of two sections is completely sealed with expanding foam.

This section has no external or internal bat roosting potential, and no evidence of bat presence was found. We consider this building has no bat roosting potential.

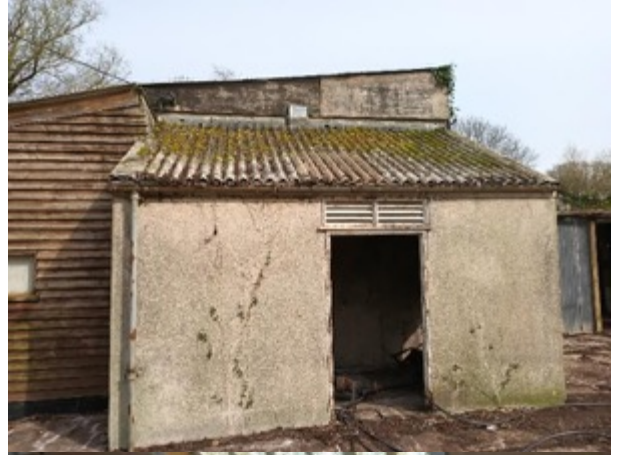
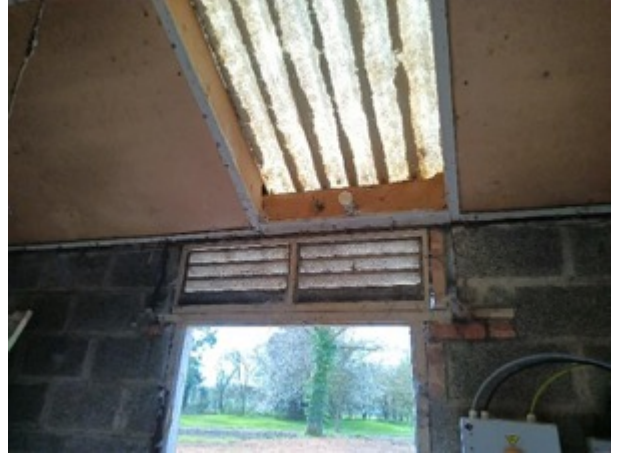
To the rear (west) is a rendered breeze block room attached to the end of part C with an asbestos roof. No door.

This section is light and drafty with no potential bat roost features identified. We consider it to have negligible bat roosting potential.

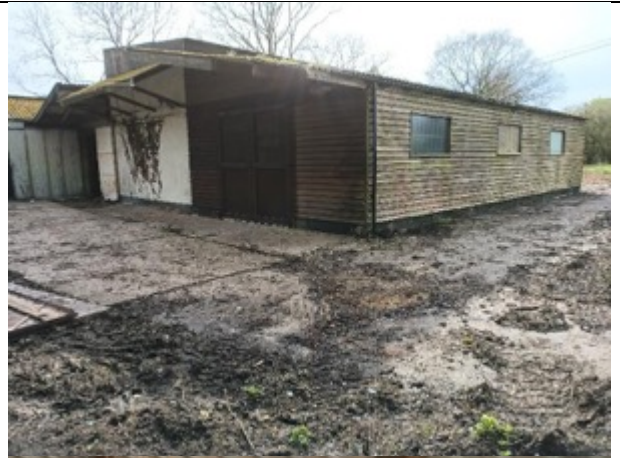
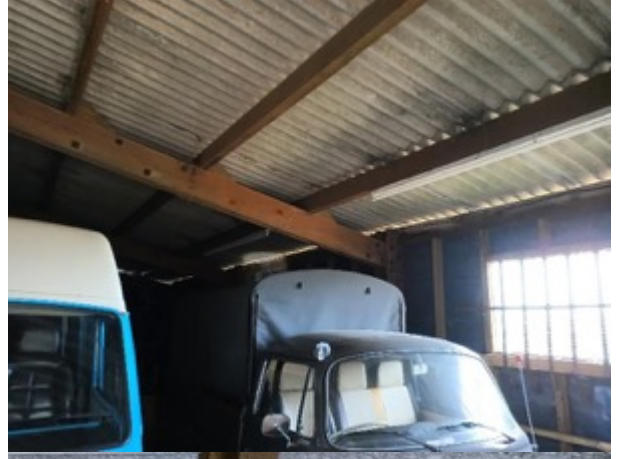
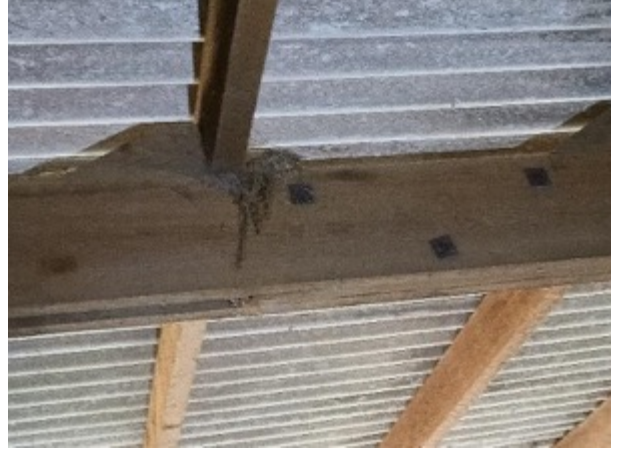
Part D

Timber frame with an asbestos roof. The external timber-clad walls are tight fitting with no apparent gaps and are lined internally with plastic sheeting.

No potential bat roost features were identified, and no evidence of bat presence was found. We consider this building has negligible bat roosting potential.

1X disused bird nest, possibly a blackbird nest.

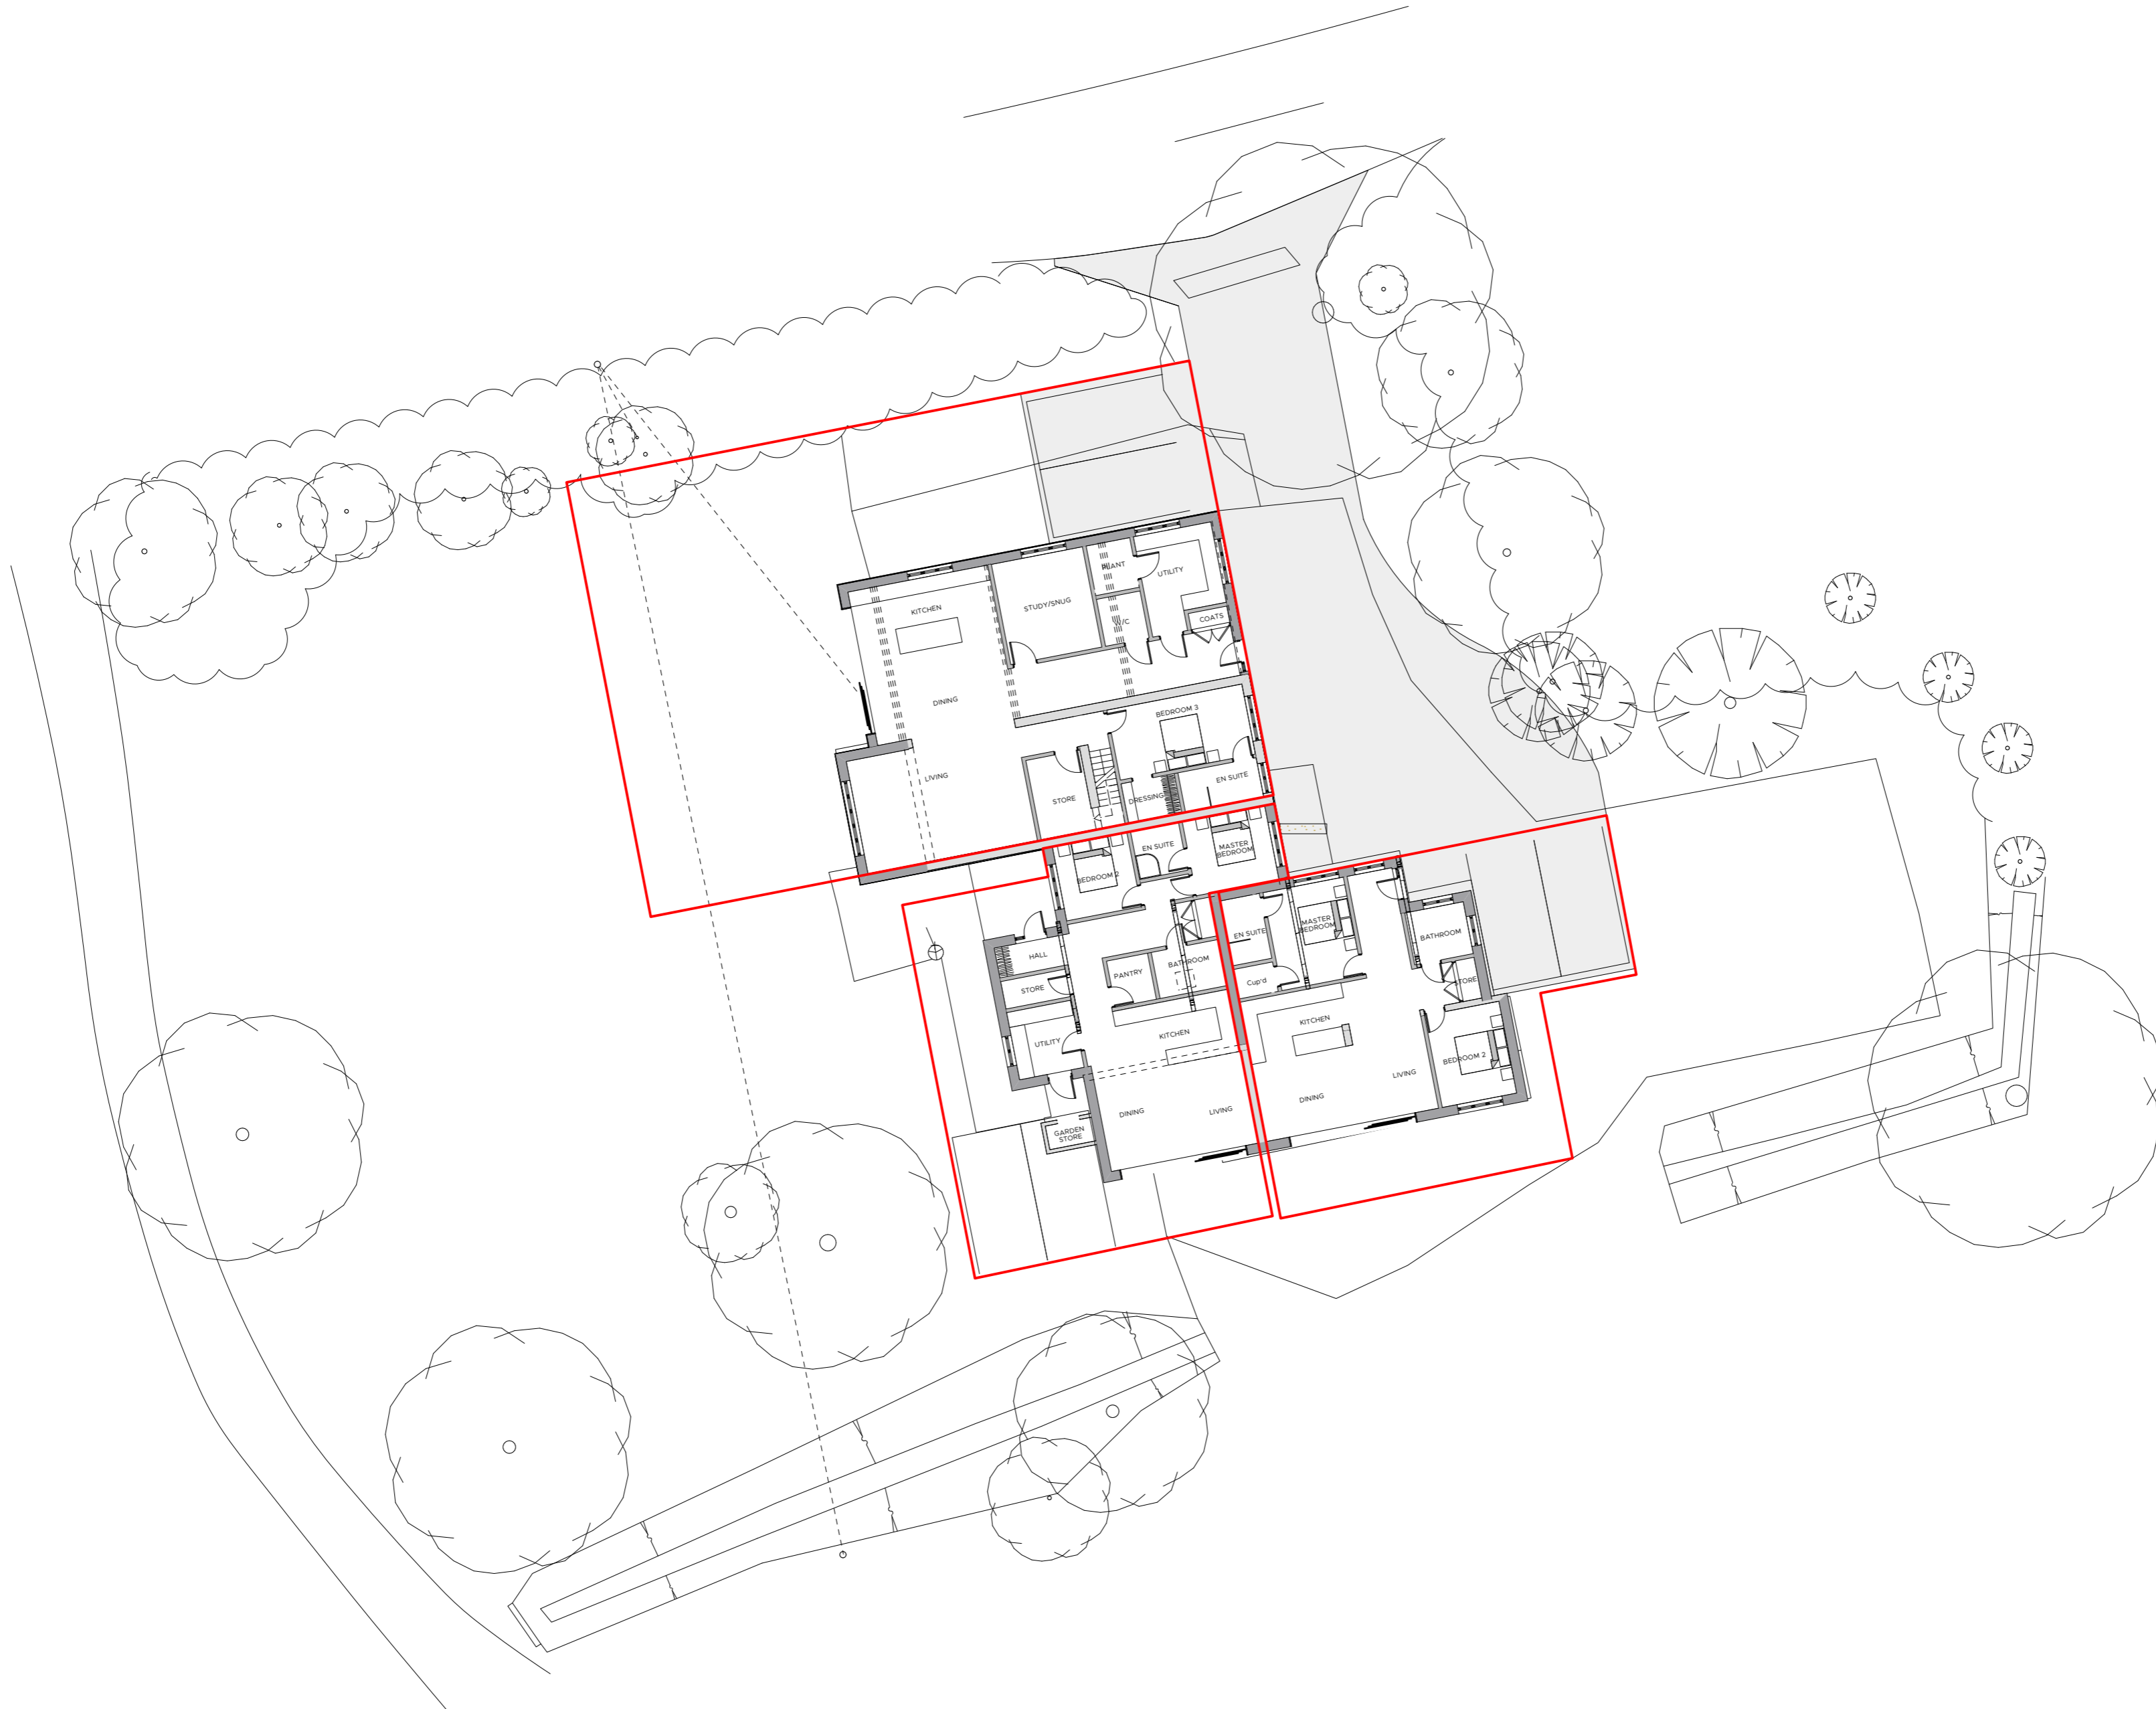
► TITLE Proposed Site Plan

Proposed Site Plan
Scale: 1:200

The current proposal is to convert the existing barns into three residential dwellings, with associated parking, access and landscaping of small garden areas. The development will be a self-build dwelling as defined in section 1(A1) of the Self-build and Custom Housebuilding Act 2015. Proposed layout plans are shown in Appendix 1.
