A	First issue	AM	GL	KB	18.03.2022
REV	DESCRIPTION	PREP	CHKD	APPD	DATE
 environmental • geotechnical • building fabric					
PROJECT					
Red Lion Court, London					
TITLE					
Exploratory hole plan (current layout)					
PROJECT NO.	SCALE AT A3	DRAWING NO.			
STT5486	1:500	02

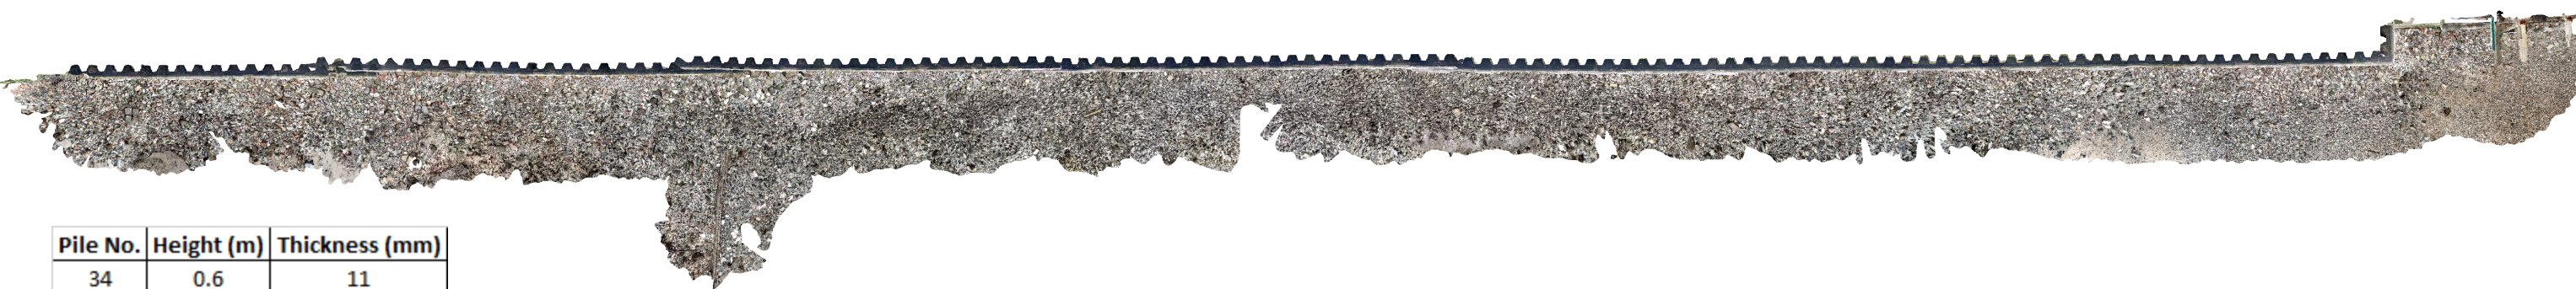
Pile No.	Height (m)	Thickness (mm)
34	0.6	11
39	1.4	14.8
44	1.8	8.8
49	0.6	18.6
54	1.4	16.6
59	1.8	13.7
64	0.6	17.5
69	1.4	15.2
74	1.8	14.8
79	0.6	16.2
84	1.4	12
89	1.8	13.5
94	0.6	14.5
99	1.4	10.8
104	1.8	15.8
109	0.6	15
114	1.4	10.8
119	1.8	8.1
124	0.6	17.5
129	1.4	16
134	1.8	15.4
139	0.6	15.8
144	1.4	15

149	1.8	15.7
154	0.6	16.6
159	1.4	16.3
164	1.8	13.9
169	0.6	17.5
174	1.4	12.5
179	1.8	12.9
184	0.6	14.4
189	1.4	13.8
194	1.8	13.2
199	0.6	12.8
204	1.4	13.8
209	1.8	13.5
214	0.6	16.8
219	1.4	10.7
224	1.8	15.8
229	0.6	14.7
234	1.4	14.1
239	1.8	12.9
244	0.6	12.2
