**Land at Broadmore Cottage, Steam Mills Road,
Cinderford, GL14 3HY**

BRE365 INFILTRATION TESTING

January 2024

P23-306inf

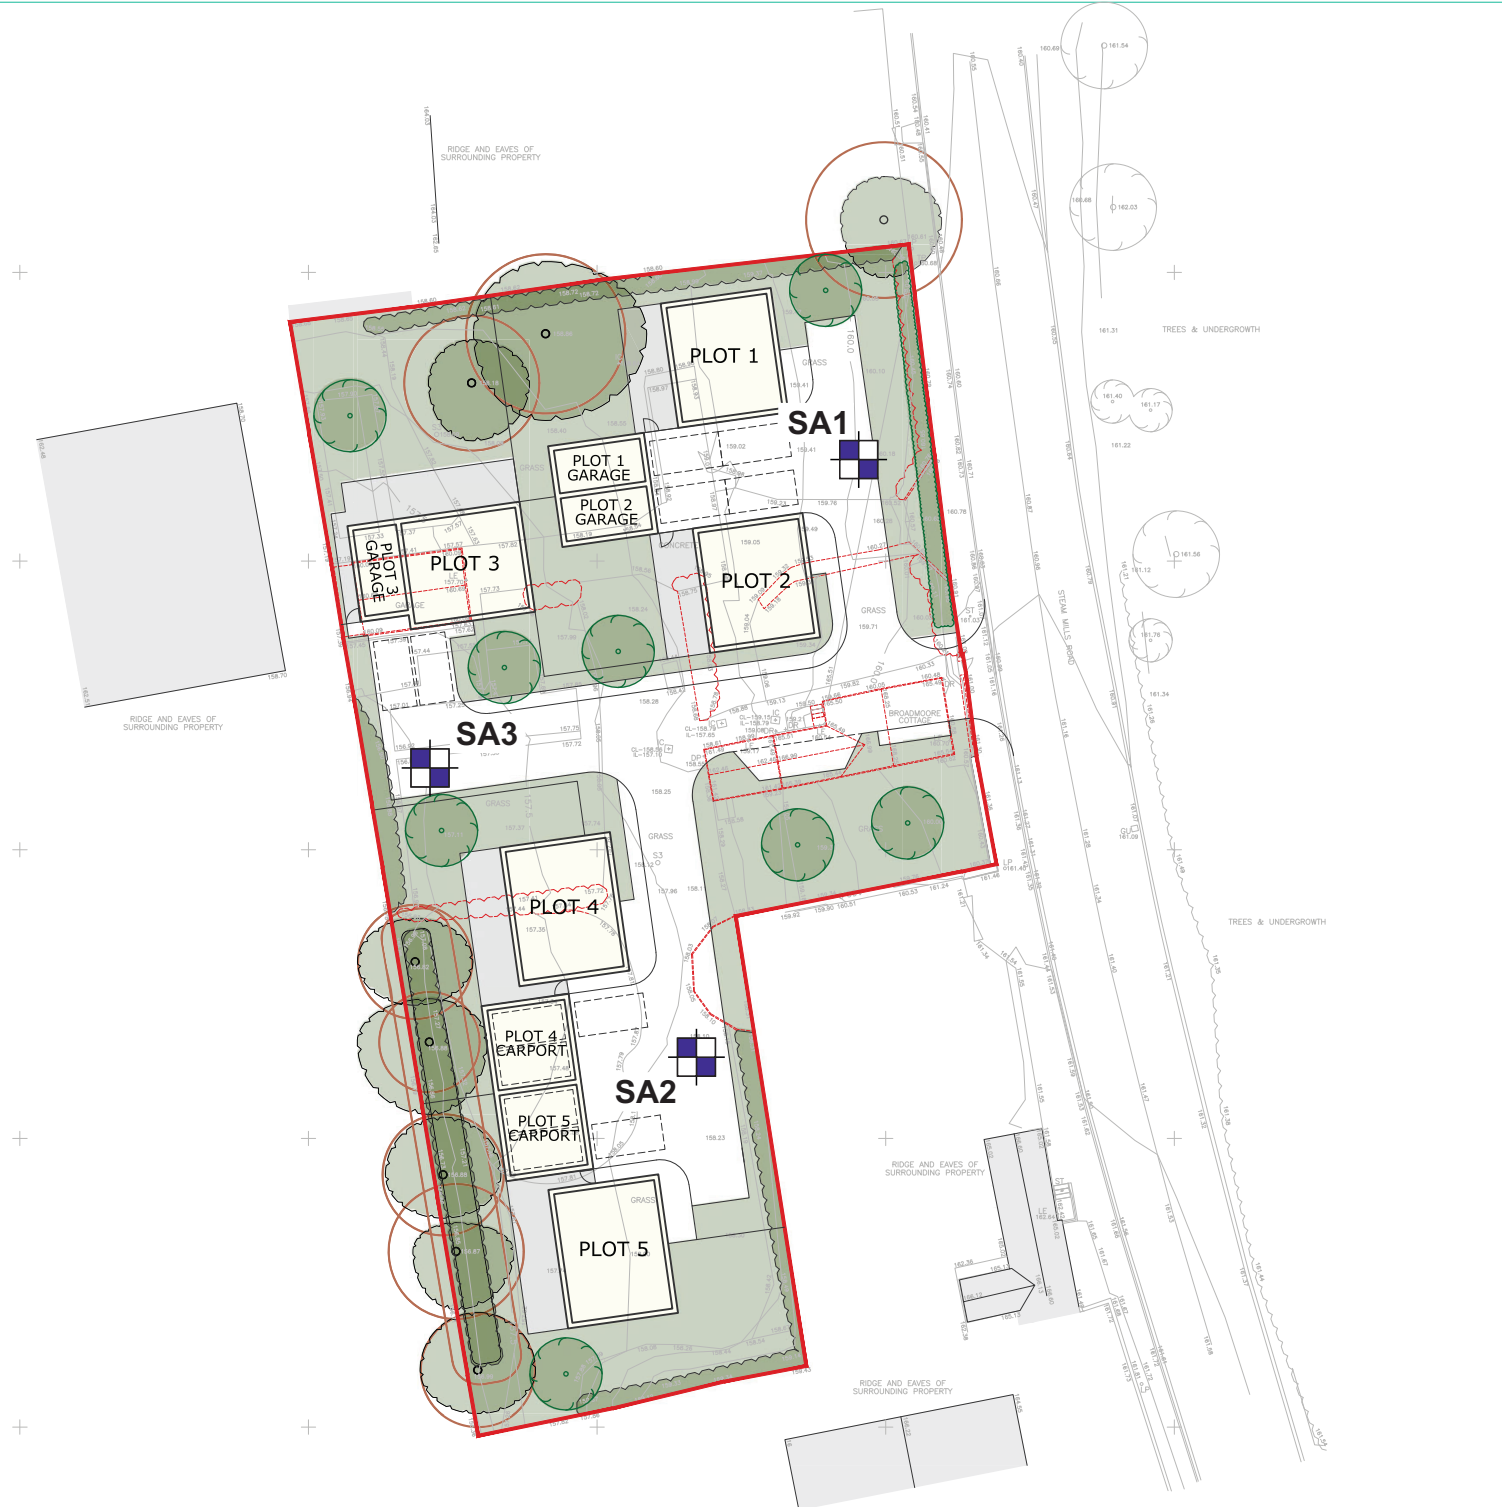
**Exploratory Position
Site Plan**

**Infiltration Testing
Locations**

**Not to scale.
All positions are approximate.**

The trial pits were positioned with consideration of the proposed site layouts and in areas currently clear of any obstruction and any buried services following a Cable Avoidance Tool (CAT) and Signal Generator survey and consultation of buried services plans where available. The testing locations are indicated on the enclosed Exploratory Location Plan presented in Appendix B.

An exploratory Location Plan showing the positions investigated and trial pit logs and are presented in Appendix A and B respectively.

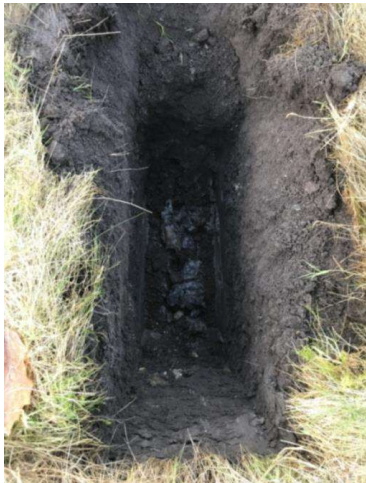
Scale (approx) 1:25	Logged By EA	Figure No. P23-306.SA1
-------------------------------	------------------------	----------------------------------

Depth (m)	Sample / Tests	Water Depth (m)	Field Records	Level (mOD)	Depth (m) (Thickness)	Description	Legend	Water
					(0.30)	Grass onto dark grey brown slightly gravelly slightly sandy loamy CLAY. Gravel is fine to medium subangular to subrounded limestone. (TOPSOIL/MADE GROUND)

0.30 (0.30)	Dark grey slightly gravelly slightly sandy silty CLAY with occasional brick and roof tile fragments. Gravel is fine to coarse limestone. (MADE GROUND)

0.60 (0.20)	Grey blue slightly gravelly silty CLAY with occasional limestone and mudstone fragments fine to medium gravel size. (HEAD)

0.80	Complete at 0.80m

Infiltration test carried out to BRE365 methodology
 Trial pit backfilled with arising
 Trial pit stable upon completion
 No groundwater encountered

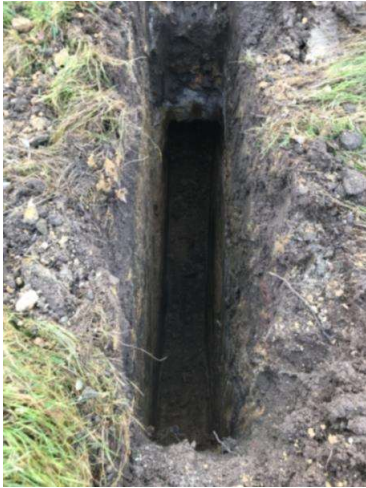
Scale (approx) 1:25	Logged By EA	Figure No. P23-306.SA2
-------------------------------	------------------------	----------------------------------

Depth (m)	Sample / Tests	Water Depth (m)	Field Records	Level (mOD)	Depth (m) (Thickness)	Description	Legend	Water
					0.40	Grass onto dark grey brown slightly sandy loamy CLAY. (TOPSOIL)		
					0.40	Yellow brown mottled light grey sandy to very sandy silty CLAY with frequent pockets and laminae of grey silty fine SAND. (HEAD)		
					(1.60)	...Becoming slightly gravelly from 1.30m depth. Gravel is fine to coarse subrounded and subangular sanstone.		
					2.00	Complete at 2.00m

No groundwater encountered
 Infiltration test carried out to BRE365 methodology
 Trial pit backfilled with arising
 Trial pit stable upon completion

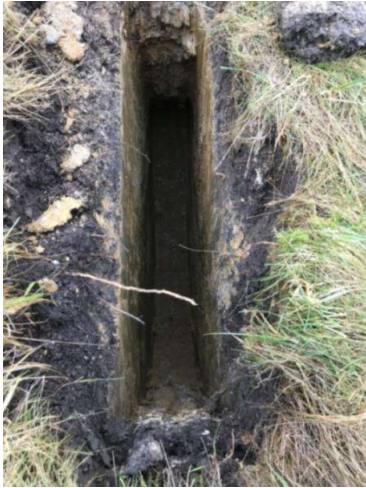
Scale (approx) 1:25	Logged By	Figure No. P23-306.SA3
-------------------------------	------------------	----------------------------------

Depth (m)	Sample / Tests	Water Depth (m)	Field Records	Level (mOD)	Depth (m) (Thickness)	Description	Legend	Water
					0.40	Grass onto dark grey brown slightly sandy loamy CLAY. (TOPSOIL)		
					0.40	Yellow brown mottled light grey sandy to very sandy silty CLAY with frequent pockets and laminae of grey silty fine SAND and occasional subrounded sandstone up to medium gravel size. (HEAD)		
					2.10	...Becoming slightly gravelly from 1.20m depth. Gravel is fine to coarse subrounded and subangular sanstone.		
					2.50	Complete at 2.50m

No groundwater encountered
Infiltration test carried out to BRE365 methodology
Trial pit backfilled with arising
Trial pit stable upon completion

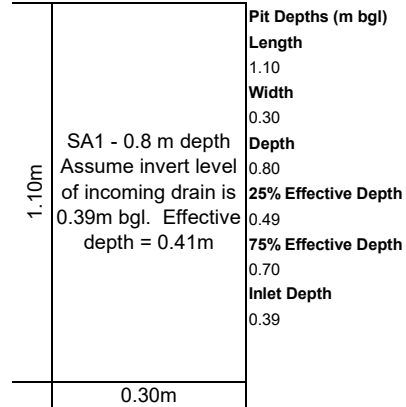
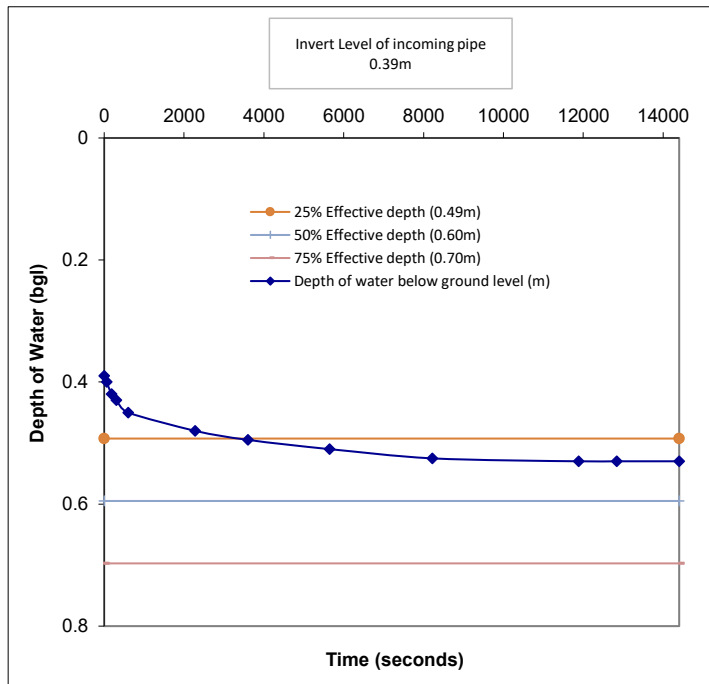
Infiltration Test to BRE365 - SA1 TEST 1

Time	Time Elapsed (min)	Time Elapsed (sec)	Depth of Water below GL (m)
	0.0	0	0.39
	1.0	60	0.40
	3.0	180	0.42
	5.0	300	0.43
	10.0	600	0.45
	38.0	2280	0.48
	60.0	3600	0.50
	94.0	5640	0.51
	137.0	8220	0.53
	198.0	11880	0.53
	214.0	12840	0.53
	240.0	14400	0.53

Strata Tested Head Deposit

Infiltration test terminated after c.4hrs due to failure to reach 50% in the allowed time

Trial Pit	Soil Tested	Test Depth	Infiltration Factor (ms ⁻¹)		
			Cycle 1	Cycle 2	Cycle 3
SA1	HD	0.39 – 0.80m	Test failed <10 ⁻⁷	-	-
SA2	HD	1.44 – 2.00m	Test failed <10 ⁻⁷	-	-
SA3	HD	1.80-2.50m	Test failed <10 ⁻⁷	-	-

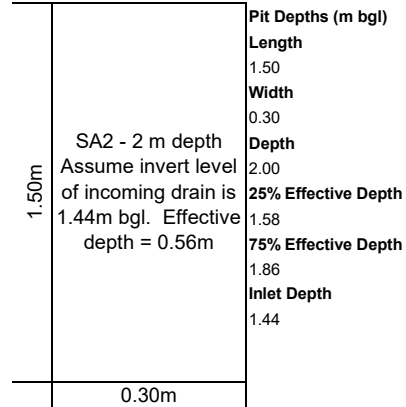
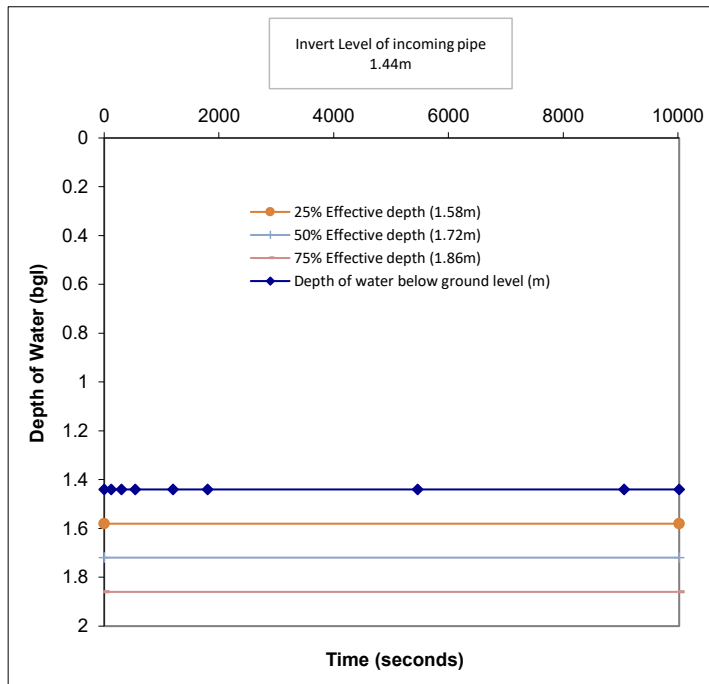
Infiltration Test to BRE365 - SA2 TEST 1

Time	Time Elapsed (min)	Time Elapsed (sec)	Depth of Water below GL (m)
	0.0	0	1.44
	2.0	120	1.44
	5.0	300	1.44
	9.0	540	1.44
	20.0	1200	1.44
	30.0	1800	1.44
	91.0	5460	1.44
	151.0	9060	1.44
	167.0	10020	1.44

Strata Tested Head Deposit

Infiltration test terminated after c.3hrs due to failure to reach 25% in the allowed time

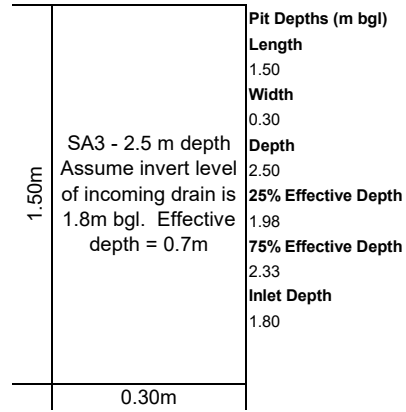
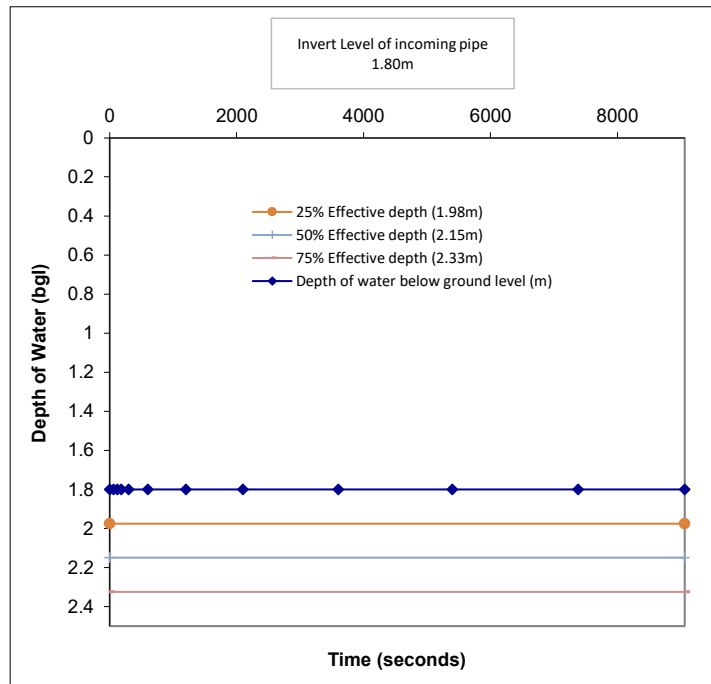
Infiltration Test to BRE365 - SA3 TEST 1

Time	Time Elapsed (min)	Time Elapsed (sec)	Depth of Water below GL (m)
	0.0	0	1.80
	1.0	60	1.80
	2.0	120	1.80
	3.0	180	1.80
	5.0	300	1.80
	10.0	600	1.80
	20.0	1200	1.80
	35.0	2100	1.80
	60.0	3600	1.80
	90.0	5400	1.80
	123.0	7380	1.80
	151.0	9060	1.80

Strata Tested Head Deposit

Infiltration test terminated after c.2.5hrs due to failure to reach 25% in the allowed time

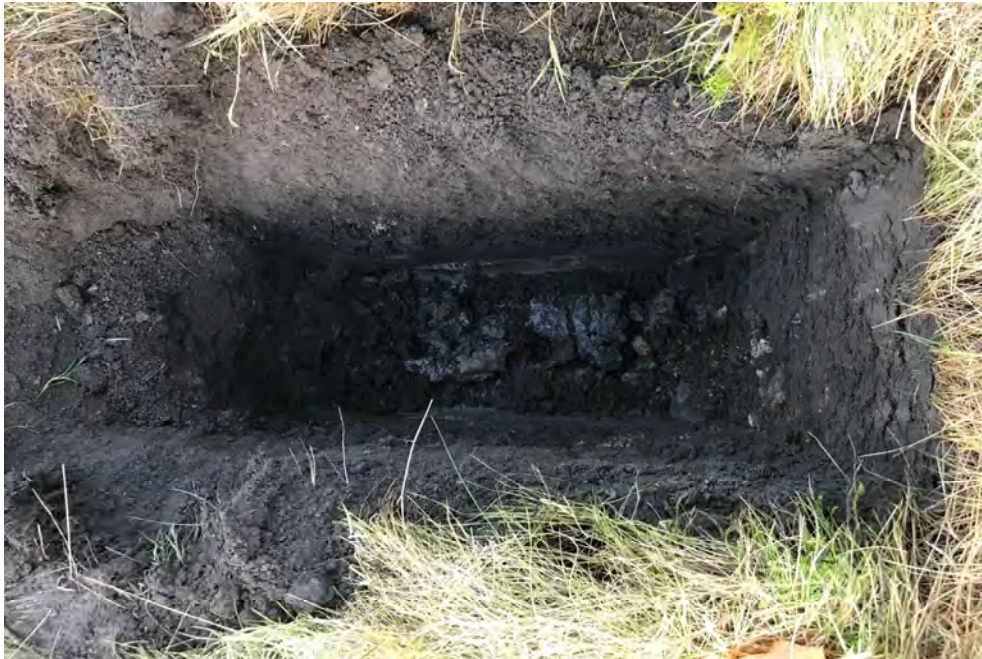
Soil profile of trial pit SA1

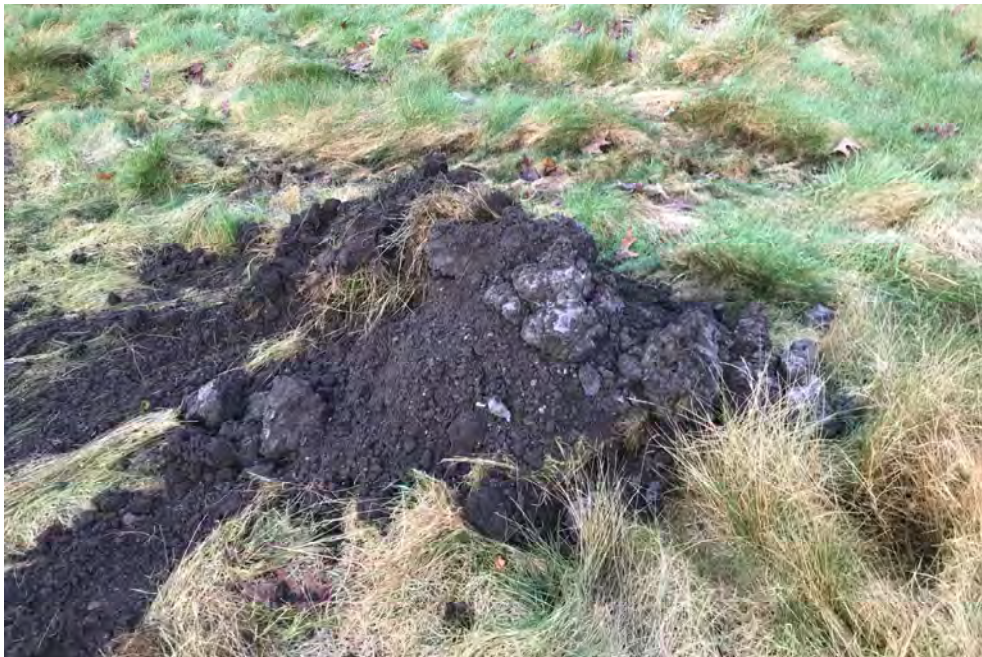
Soil arisings of trial pit SA1

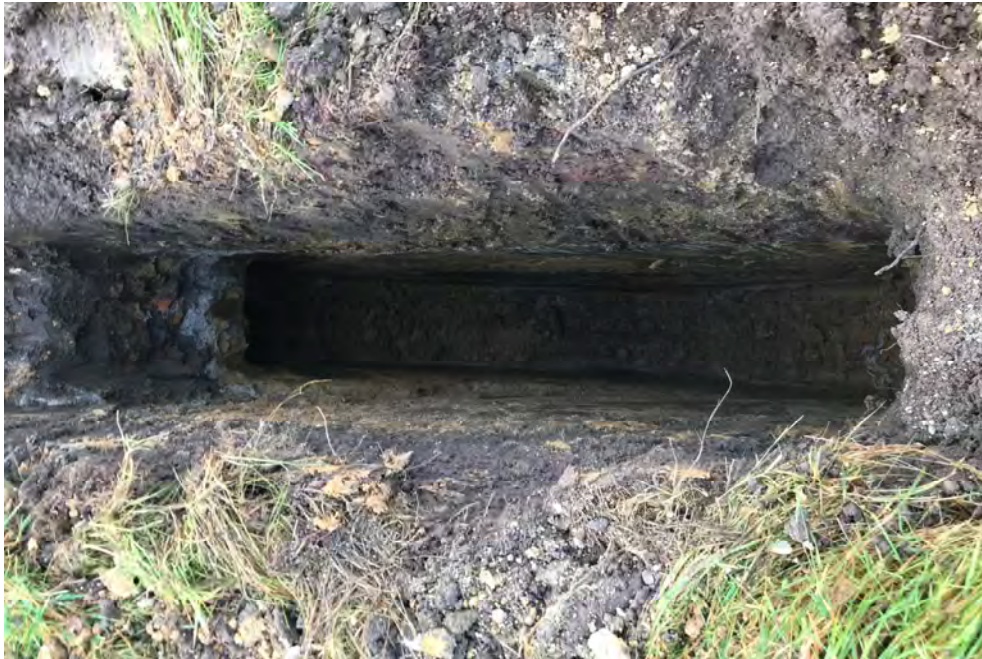
Soil profile of trial pit SA2

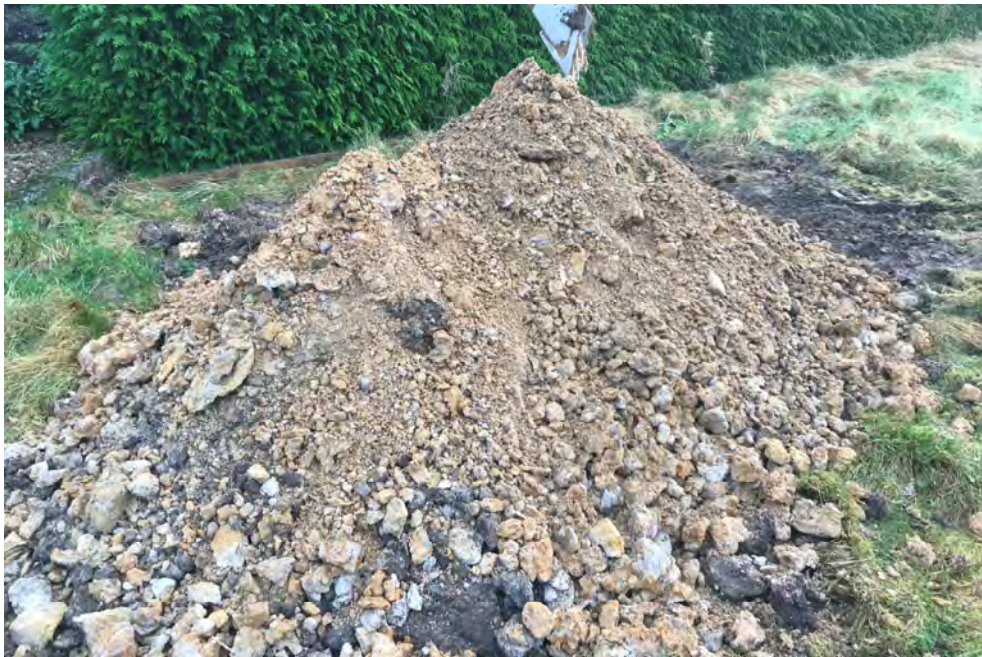
Soil arisings of trial pit SA2

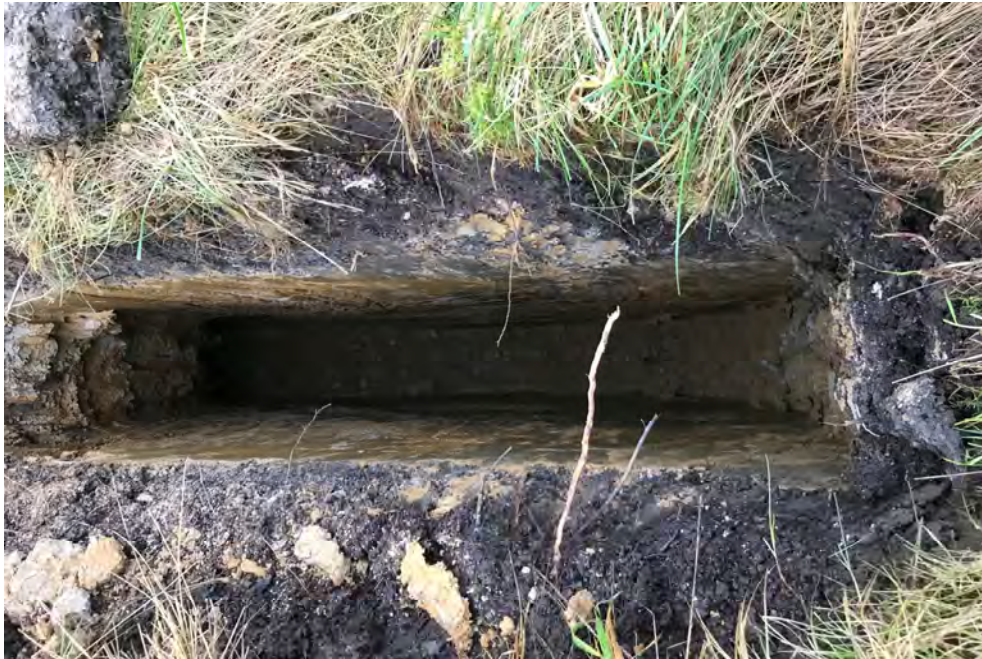
Soil profile of trial pit SA3

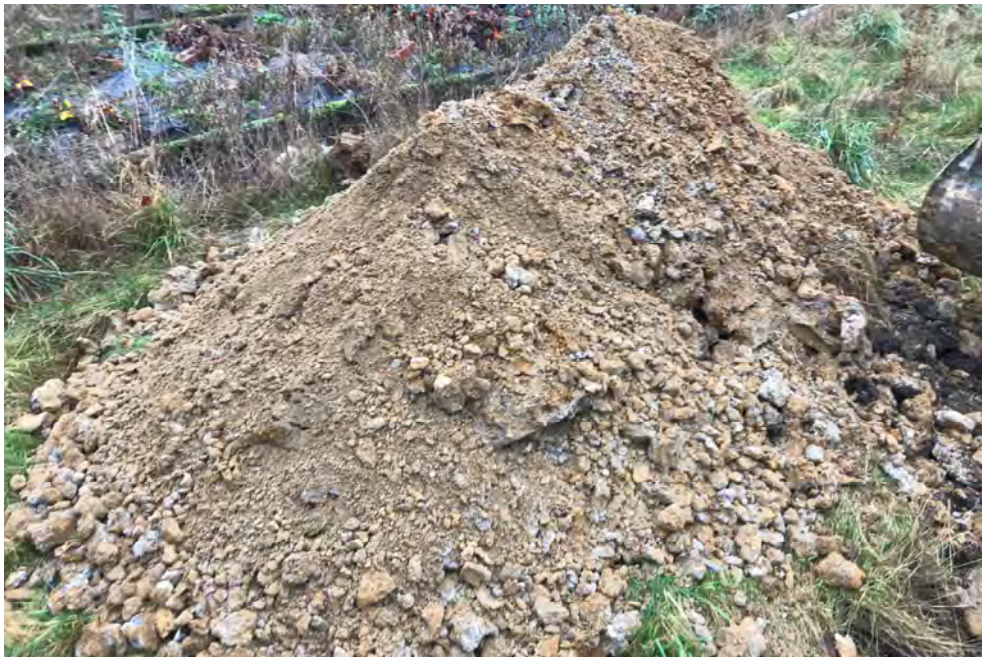
Soil arisings of trial pit SA3
