# GROUND INVESTIGATION REPORT

## FOR BROADMOOR COTTAGE, 6 STEAM MILLS ROAD, CINDERFORD, GLOUCESTERSHIRE GL14 3HY

Report No. 5101/2

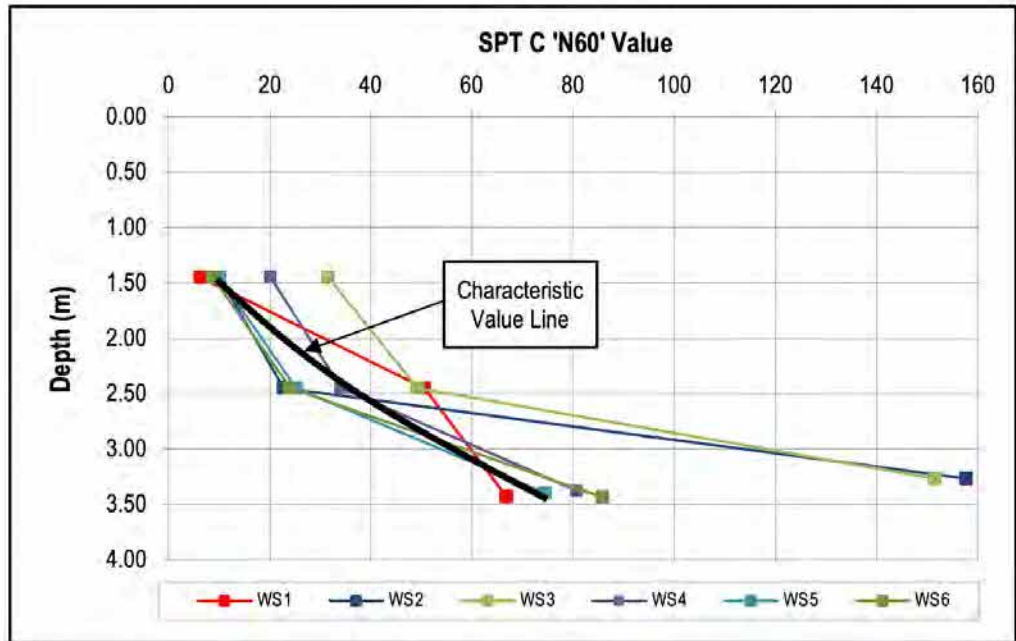
**FIGURE 2: SPT 'N60' VALUES -v- DEPTH**

- 7.8** The results of the insitu SPT's are shown on the respective logs in Appendix 2 and the normalised 'N' values have been presented as  $N_{60}$  versus depth in Figure 2 below. Equivalent undrained shear strength has subsequently been calculated which also takes account of plasticity index values.

**7.9** Using the characteristic value line in Figure 2, characteristic SPT  $N_{60}$  values have been adopted at the minimum founding depth from which to determine the design bearing resistance (bearing capacity).

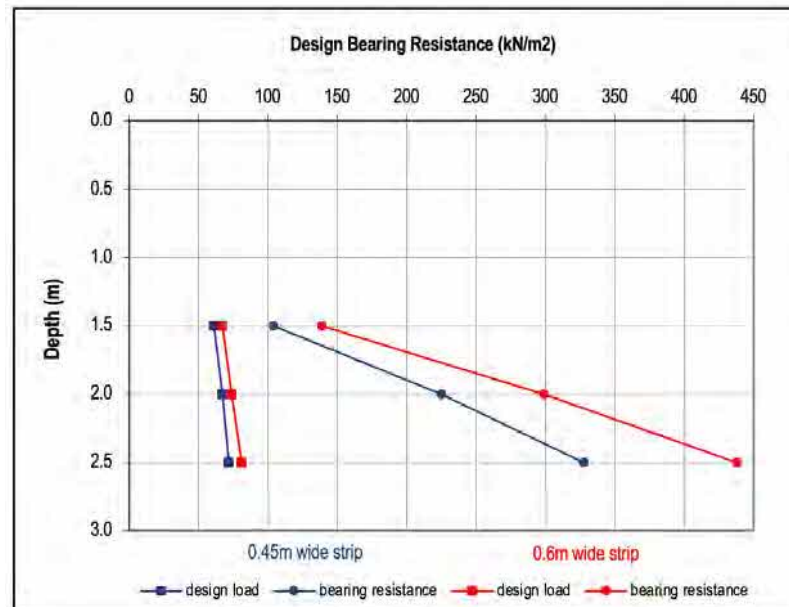
**FIGURE 3: DESIGN BEARING RESISTANCE -v- DEPTH**

**7.10** By adopting a characteristic SPT  $N_{60}$  value of 16 at 1.5m depth, based on a conventional two-storey residential line load of 45kN/m, the design bearing resistance (bearing capacity) for a standard 0.6m wide trenchfill foundation is estimated to be approximately 194kN/m<sup>2</sup>, which exceeds the likely bearing pressure of 67kN/m<sup>2</sup> and confirms suitability. Similar calculations demonstrate suitability for 0.45m wide foundations at this depth (bearing capacity of 146kN/m<sup>2</sup>). Design bearing resistance increases with increasing depth. is plotted against depth in Figure 3 below, so that values can be assigned to any other depths as necessary due to tree influence.

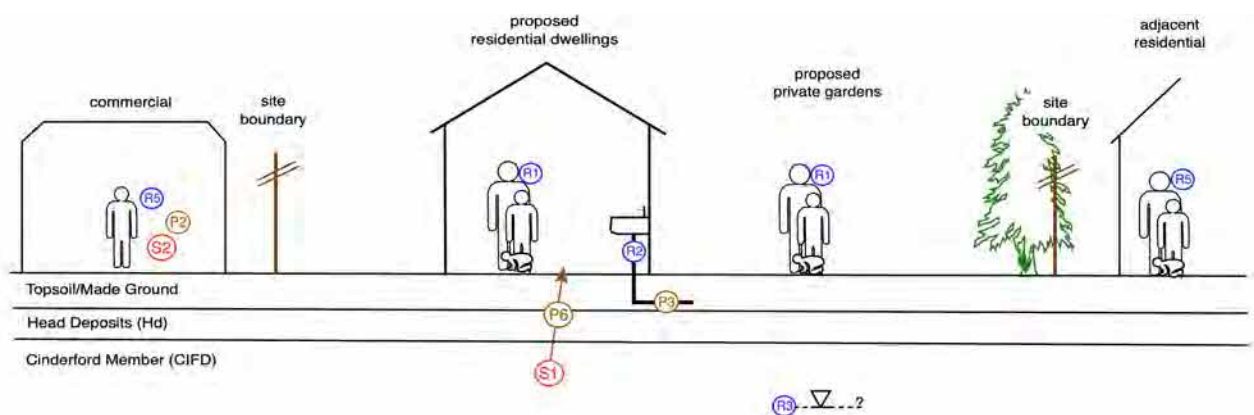
**FIGURE 4: REFINED CONCEPTUAL SITE MODEL (NTS)**

**9.1** In view of the above discussions the preliminary conceptual site model has been refined as shown in Figure 4 and Table 8 below.

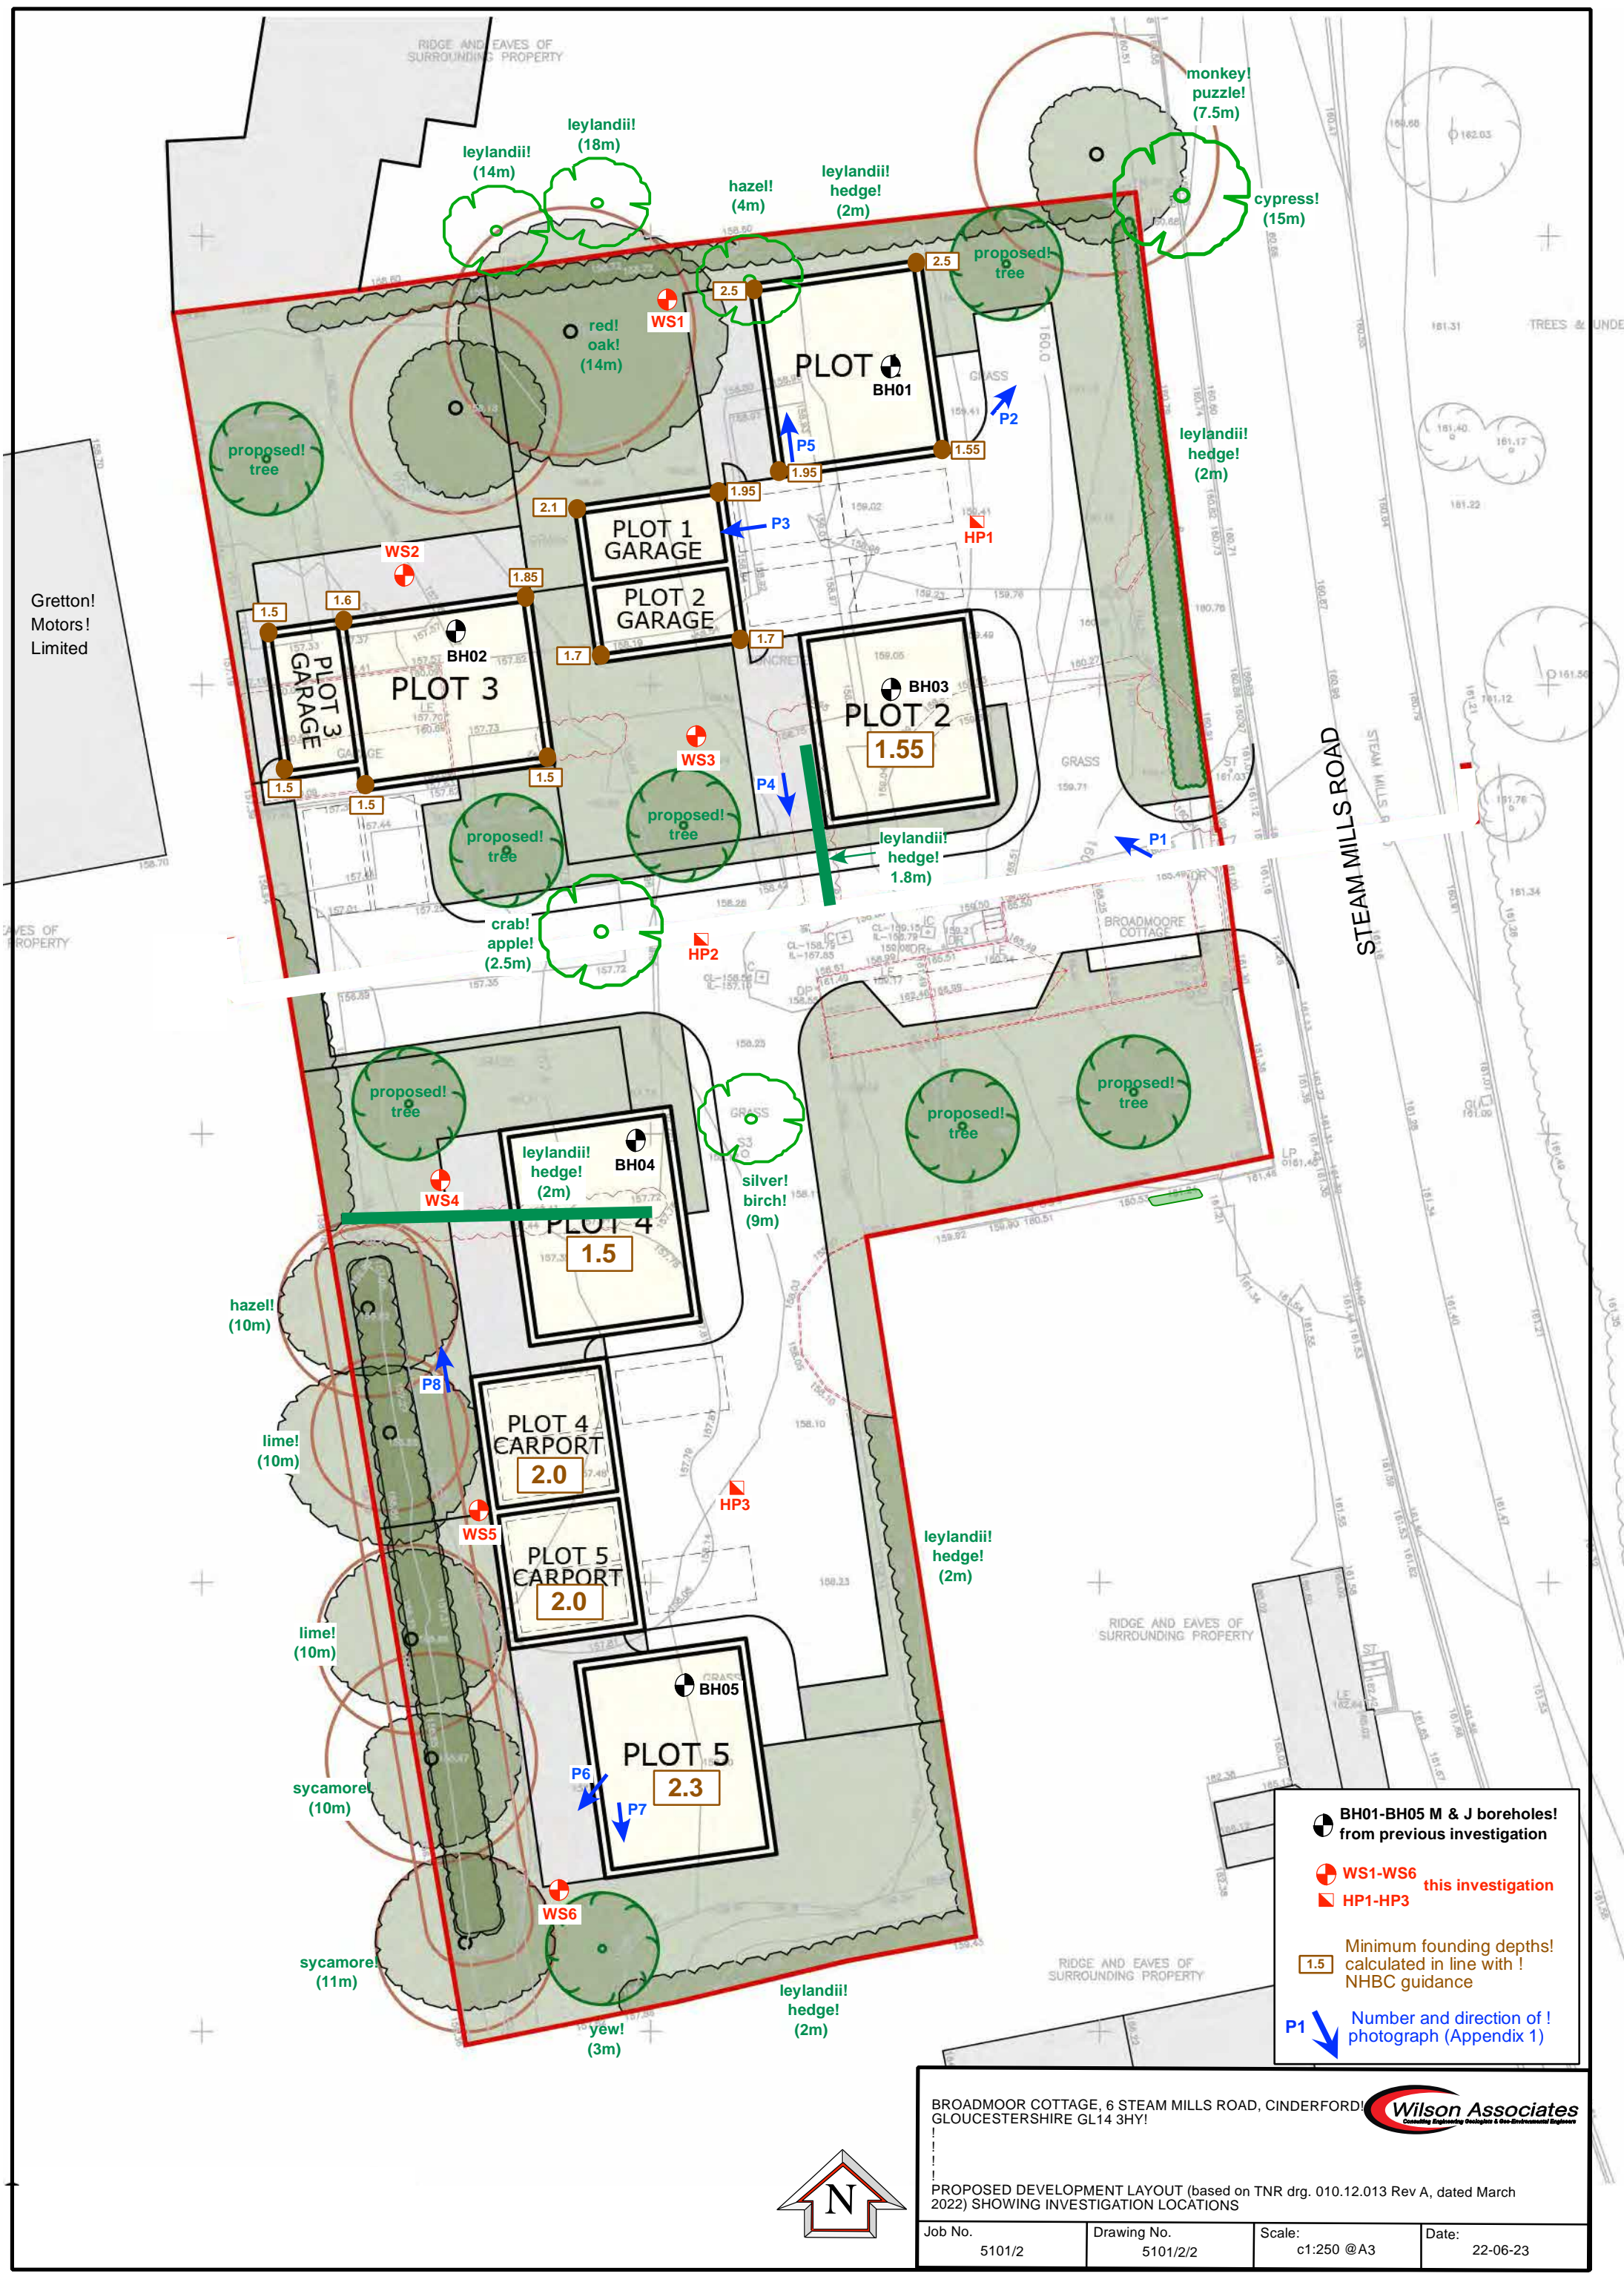
Job No. 5101/2	Drawing No. 5101/2/2	Scale: c1:250 @A3	Date: 22-06-23
-------------------	-------------------------	----------------------	-------------------

- BH01-BH05 M & J boreholes!  
from previous investigation
- WS1-WS6 this investigation
- HP1-HP3
- 1.5 Minimum founding depths!  
calculated in line with!  
NHBC guidance
- P1 Number and direction of!  
photograph (Appendix 1)

**7.3** The natural weathered cohesive soils of the superficial Hd classify as low to medium volume change potential, with underlying bedrock classifying as low to none volume change potential, therefore (following NHBC Standards) a minimum founding depth of 0.9m is considered appropriate, locally deepened within the radius of influence of trees and obviously subject to those foundations also penetrating through any localised softer, infilled or disturbed deposits to found in competent undisturbed and normally hydrated natural material. Visual observations and CI values indicated that cohesive soils (WS1 up to 1.3m, WS4 up to 1.4m and WS5 up to 1.8m) may be desiccated. Plot-specific recommended minimum founding depths are presented on drawing 5101/2.

demand) and hazel, silver birch and yew (of low water demand), although as always it is recommended that all tree species are confirmed by an arboriculturist. Plot-specific recommended minimum founding depths are presented on drawing 5101/2/2.

- 10.4** Foundations will need to penetrate any near surface disturbed, softer and/or desiccated ground to found within normally hydrated soil of the CIFD at a minimum depth of 1.5m (please refer to **Section 7** and drawing 5101/2/2 for specific details). All buildings are within the zone of influence of one or more trees and both suspended ground floor slabs and heave protection will be required.

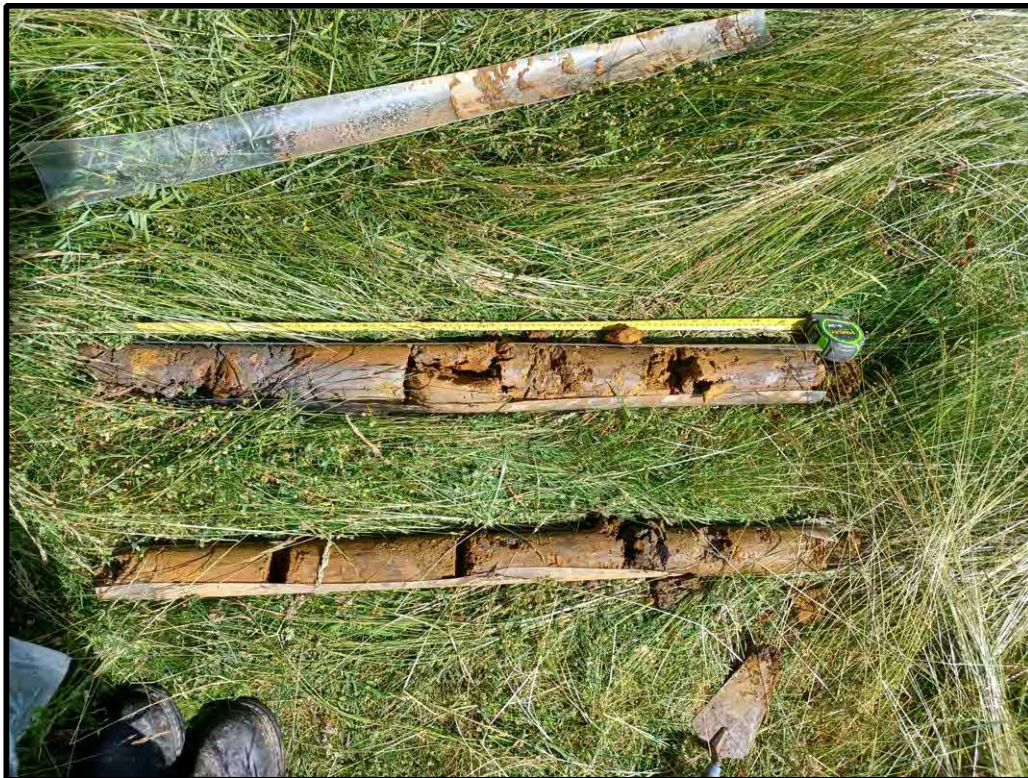
Borehole Core  
1.0-3.0m

1.00-1.45	SPT C			0.60	0.00 - 0.60 - roots (<5mm)				
1.45		N5		(0.70)	GRAVEL: loose grey desiccated silty GRAVEL of sub-angular, medium to coarse laminated mudstone	Hd

1.50	ES			1.30	CLAY: soft light brownish grey, silty desiccated CLAY with structure and frequent sand bands				
2.00-2.45	SPT C			(1.60)	SAND: loose light brown, silty SAND	Hd

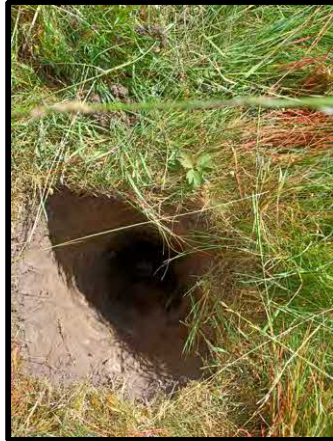
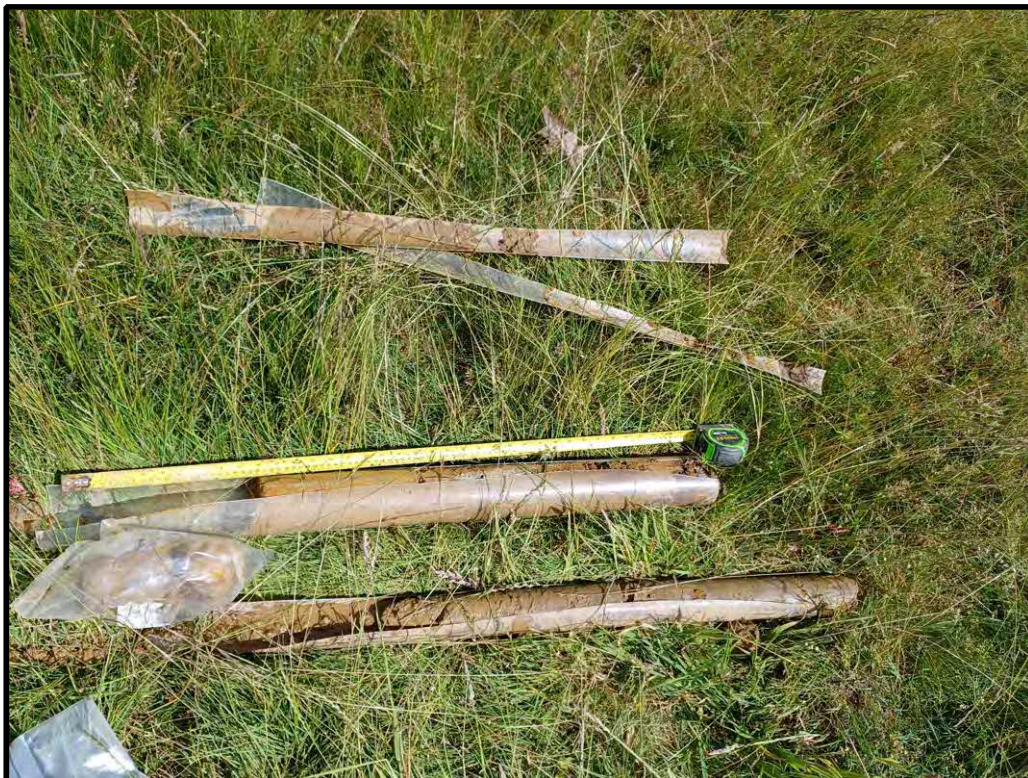
<b>Project</b> BROADMOOR COTTAGE, 6 STEAM MILLS ROAD, CINDERFORD GL14 2HY	<b>Borehole No.</b> <b>WS2</b>
<b>Job No.</b> 5101/2

Hand-dug starter pit: 0.00-1.00m

Borehole Core: 1.00-3.00m

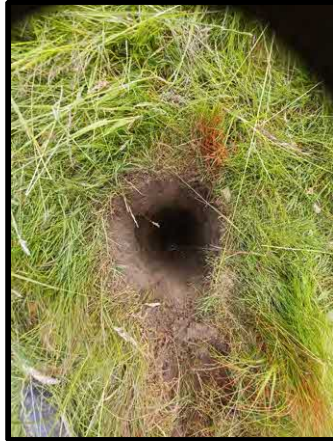
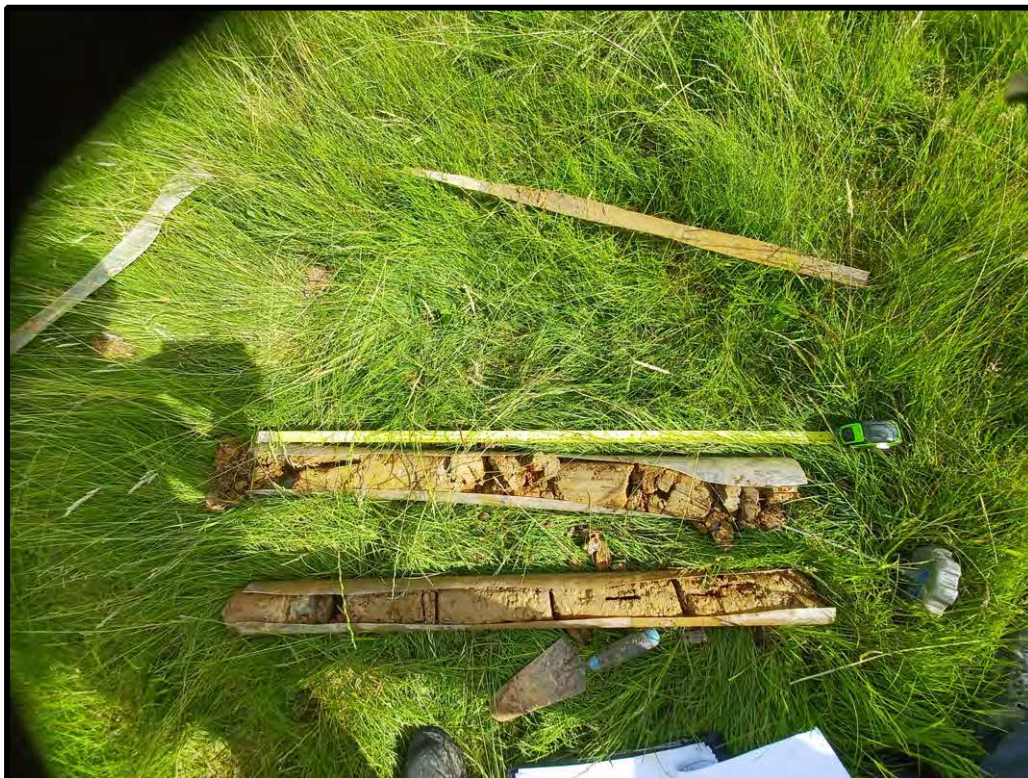
<b>Project</b> BROADMOOR COTTAGE, 6 STEAM MILLS ROAD, CINDERFORD GL14 2HY	<b>Borehole No.</b> <b>WS3</b>
<b>Job No.</b> 5101/2

Hand-dug starter pit : 0.00-1.00m

Borehole Core: 1.00-3.00m

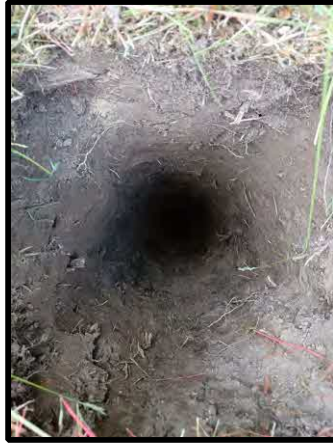
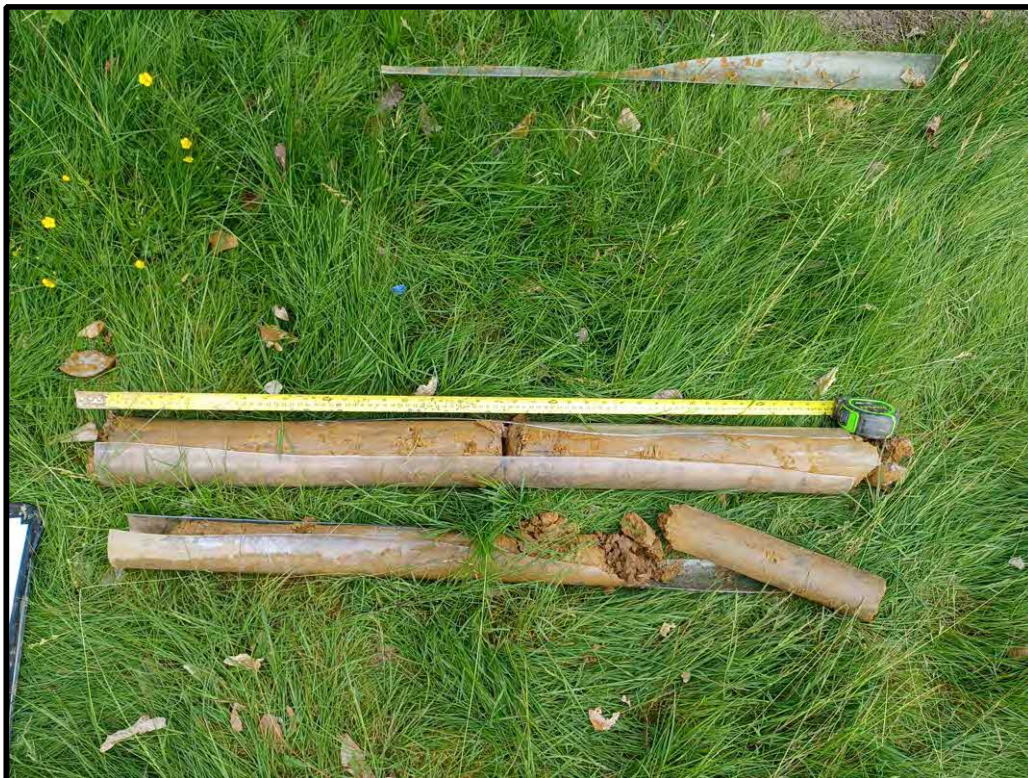
<b>Project</b> BROADMOOR COTTAGE, 6 STEAM MILLS ROAD, CINDERFORD GL14 2HY	<b>Borehole No.</b> <b>WS4</b>
<b>Job No.</b> 5101/2

Hand-dug starter pit: 0.00-1.00m

Borehole Core: 1.00-3.00m

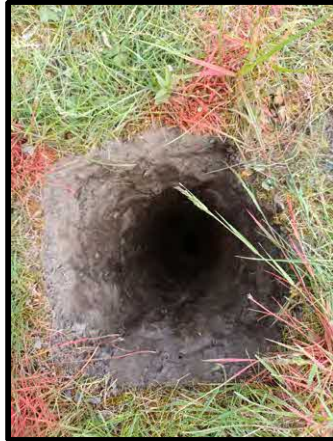
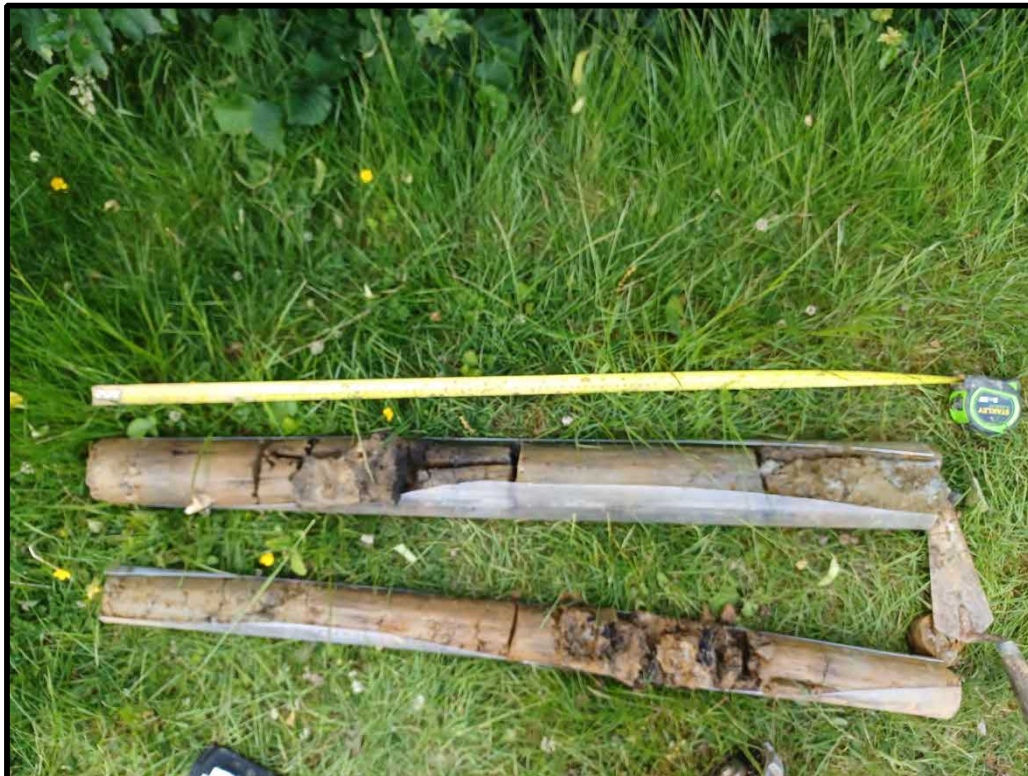
<b>Project</b> BROADMOOR COTTAGE, 6 STEAM MILLS ROAD, CINDERFORD GL14 2HY	<b>Borehole No.</b> <b>WS5</b>
<b>Job No.</b> 5101/2

Hand-dug starter pit: 0.00-1.00m

Borehole Core: 1.00-3.00m

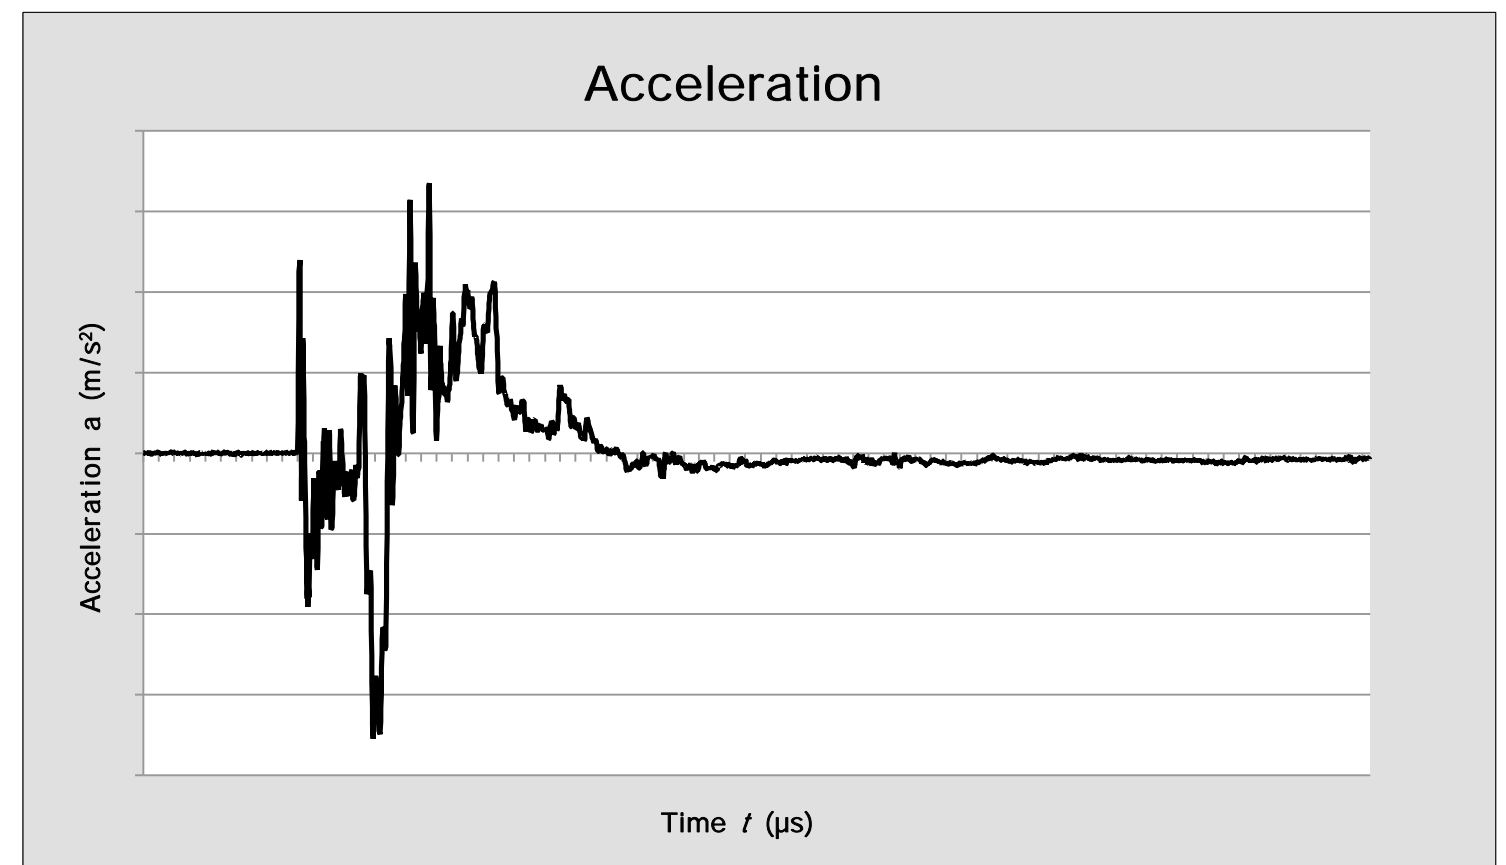
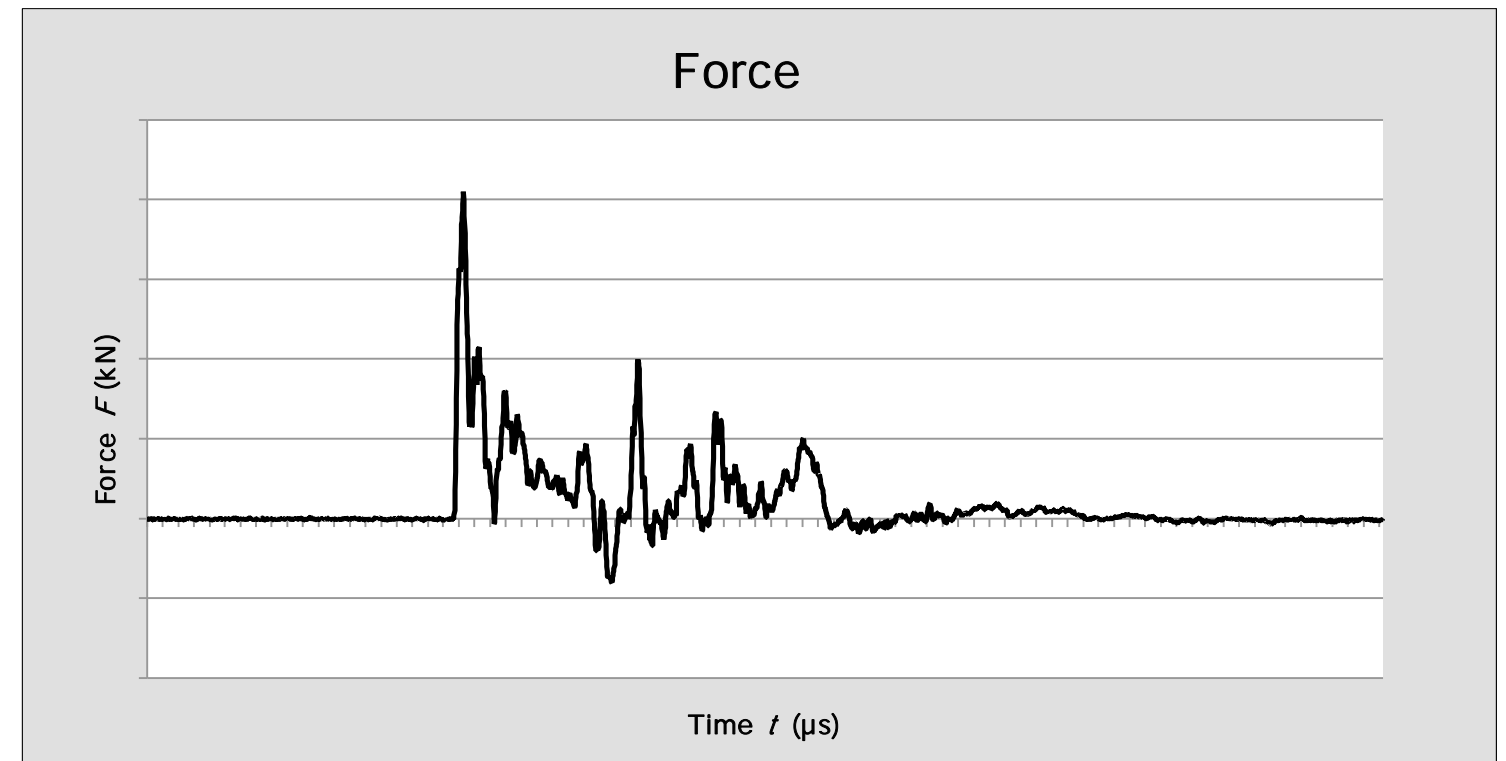
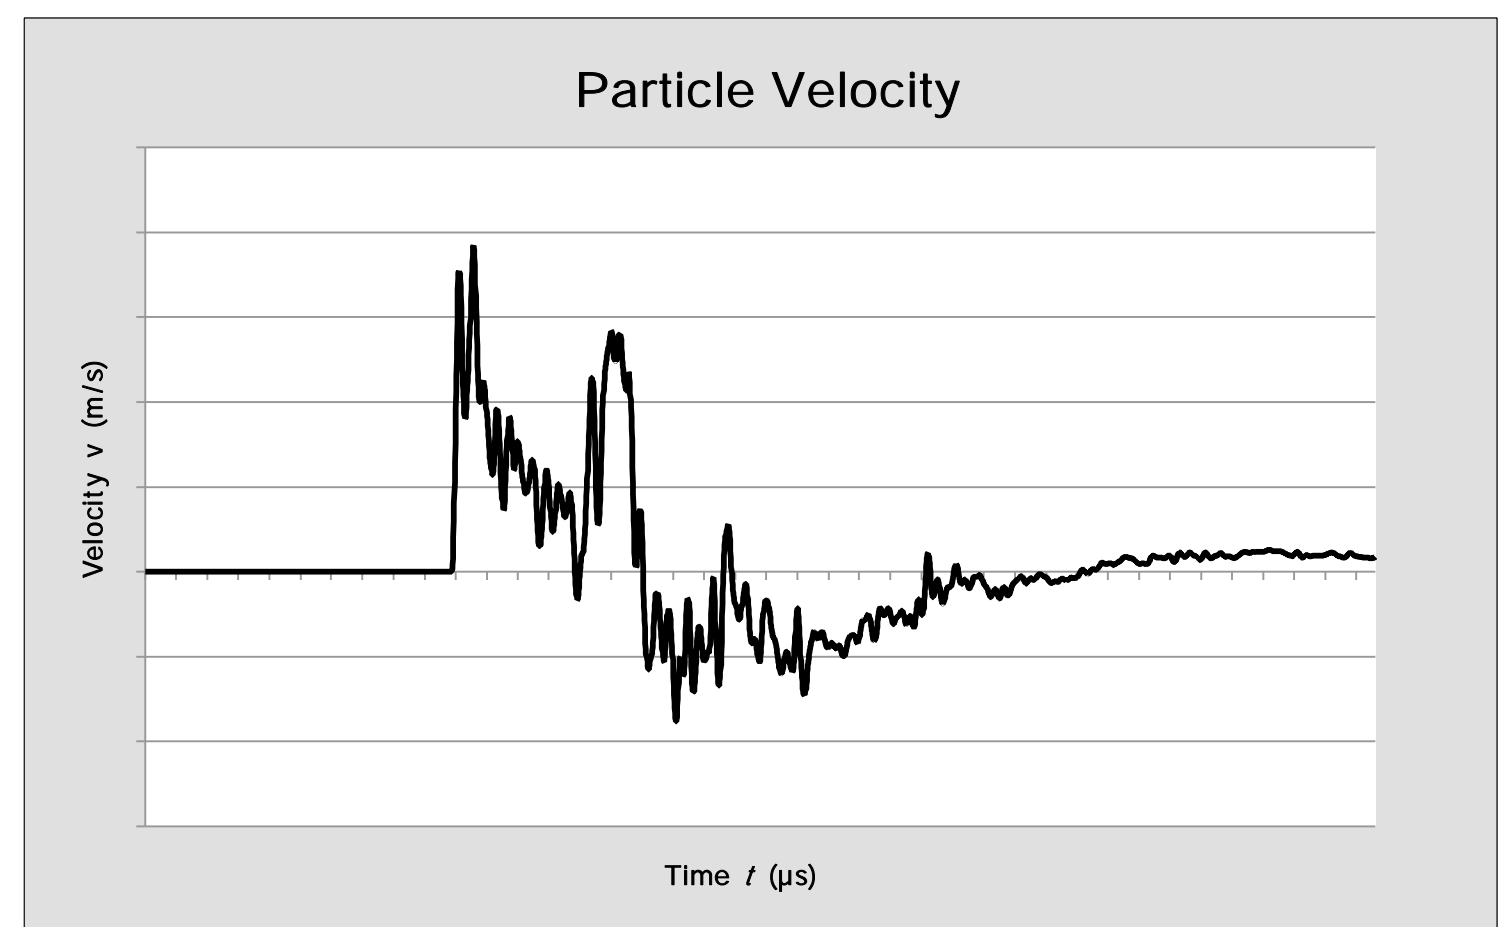
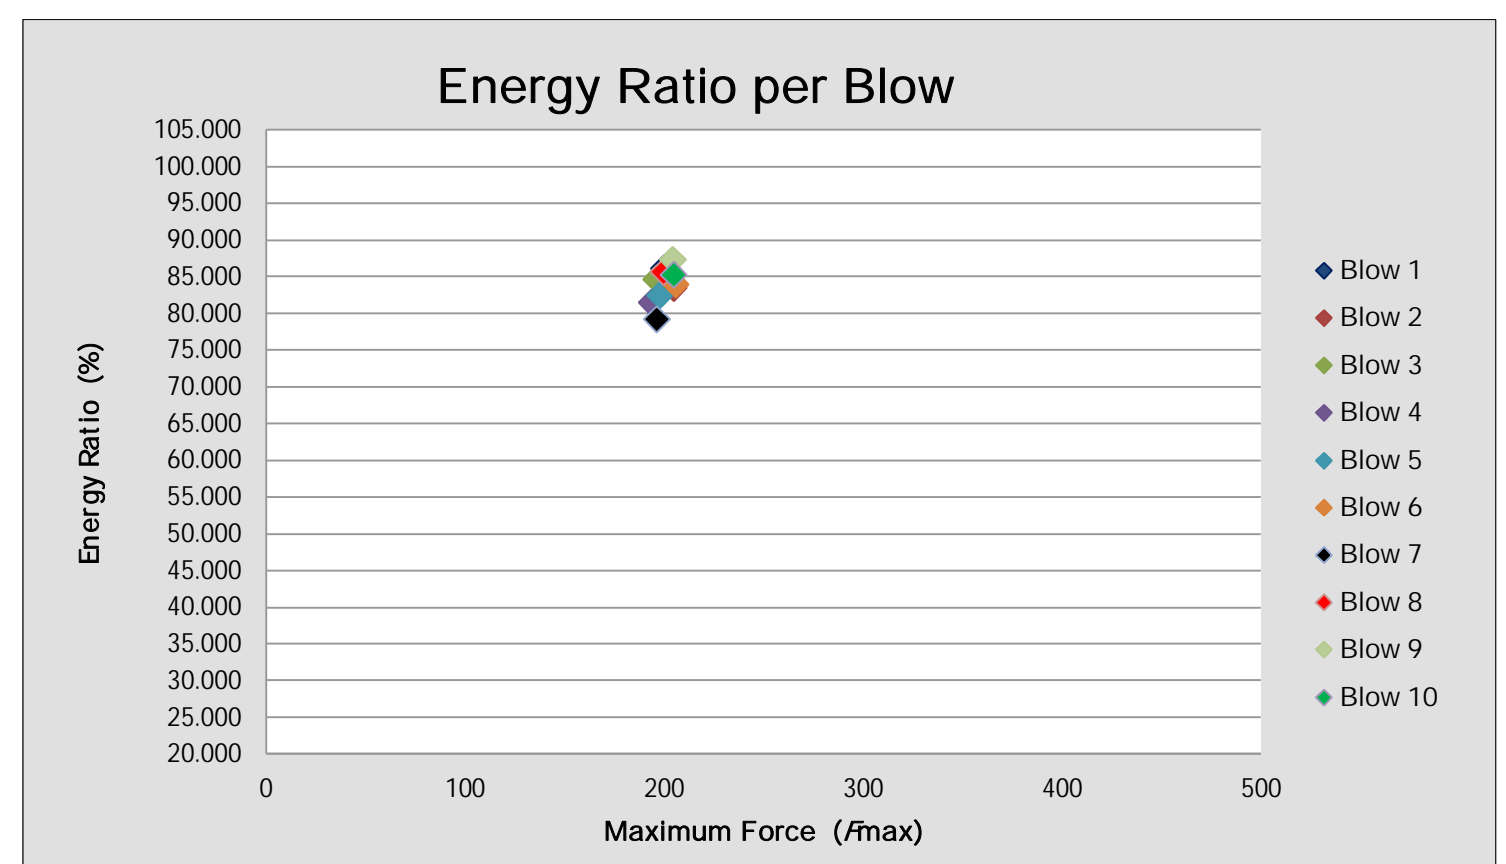
Type of Hammer                      Dart  
 Test No                                    EQU2023\_124  
 Client                                     Cook Ground  
    Investigation  
 Test Depth (m)                        9.70  
 Mass of hamme                         $m = 63.5\text{kg}$   
 Falling height                          $h = 0.76\text{m}$   
 $E_{\text{theor}} =$                                  $m \times g \times h = 473\text{J}$

Energy Ratio ( $E_r$ ) =  $\frac{E_{\text{meas}}}{E_{\text{theor}}}$       **82.88%**  
 © COPYRIGHT 2023
