Bat Surveys 2021

**The garage to the rear of The Bell,
Bury, Odiham**

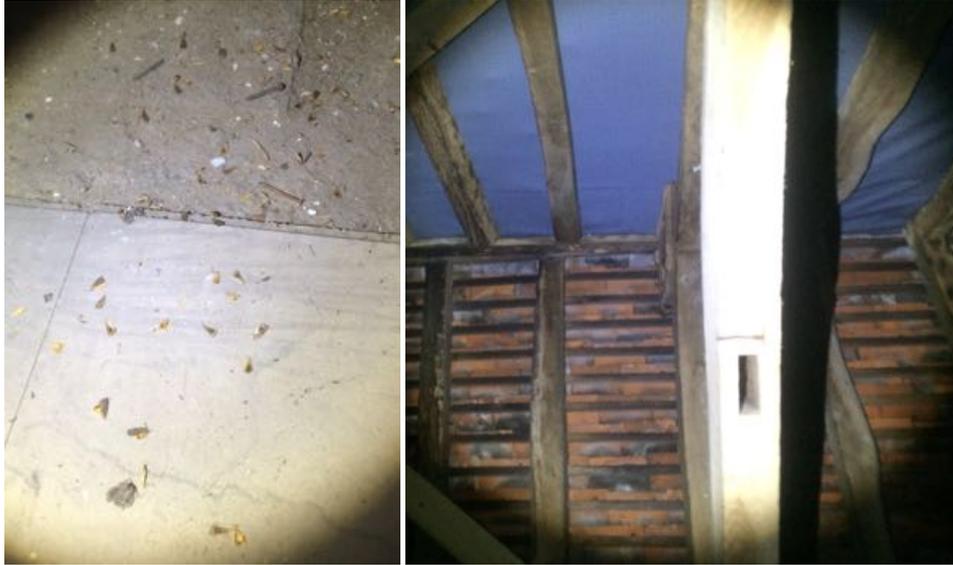
- 4.11 Prior to this survey, an additional ~30 droppings were recorded across the first floor, with numerous yellow underwing moth wings also recorded towards the western end of the building, in a similar location to the butterfly wings found during the initial PRA (Figure 3).

Figure 3- Feeding remains recorded underneath ridge and beam features towards the western elevation, prior to the survey conducted on 27th August 2021.

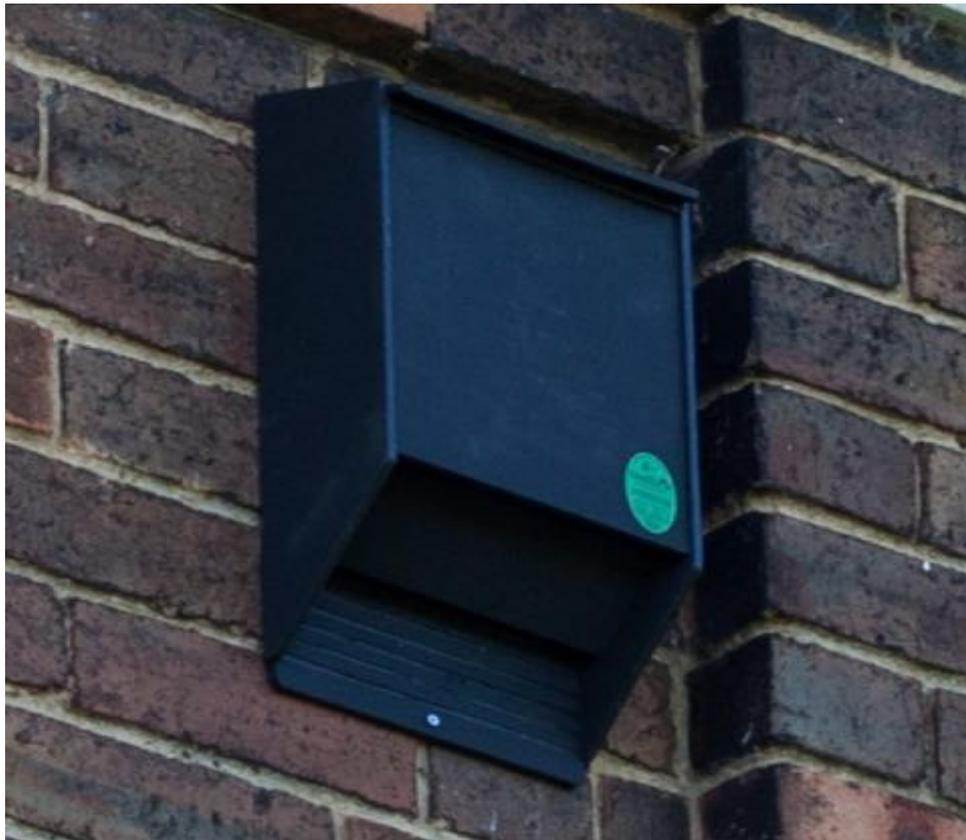
Figure 4: Eco Bat Box – the cavity design model.

- Establish two Eco Bat Boxes or similar box on the eastern elevation of the building (in lieu of any biological features within the red line boundary), prior to any works;
- Conduct a Tool Box Talk (TBT) to all team members on site with regards to the presence of bats using the building, bats legal protection, measures that will be undertaken to ensure that bats are not harmed, good working practises, licensable activities and what to do if a bat is found;
- Once this TBT has been conducted then works to the building can commence under direct supervision of a registered consultant (RC) / accredited agent;
- The tiles of the building will be hand removed. All tiles will be removed by hand individually, with the tiles being turned prior to stacking. If a bat is found, then the RC will gently move the bat to a bat box on site;

- Two bat boxes are to be established on the eastern elevation of the garage building;
- Once the licence is issued (the licence should take 10 working days for issue), all licensable works can commence. All licensable works (removal of tiles etc) should take in the region of 2 or 3 days.
