Preliminary Roost Assessment

The Bell,
The Bury, Odiham

1.1 The Ecology Partnership was commissioned by Iconic Europe to undertake a preliminary roost assessment (PRA) of the old public house at The Bell, The Bury, RG29 1LY.

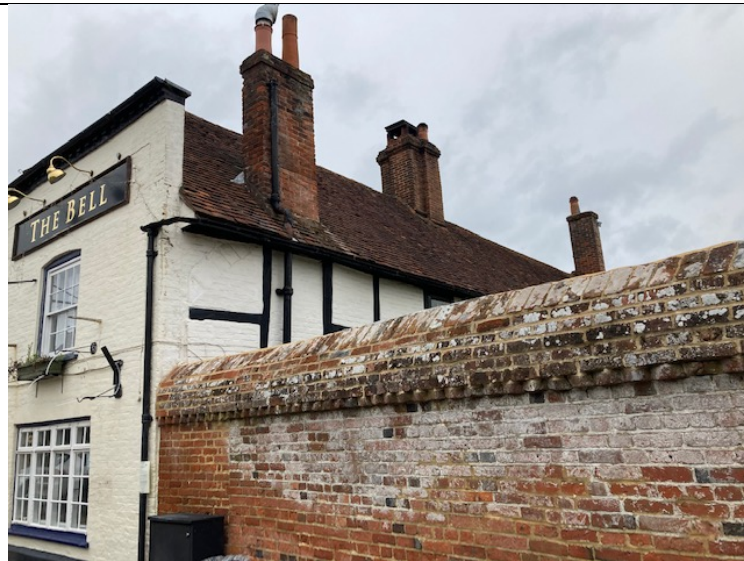
Photo 1: An overview of the southern and eastern elevation of The Bell.

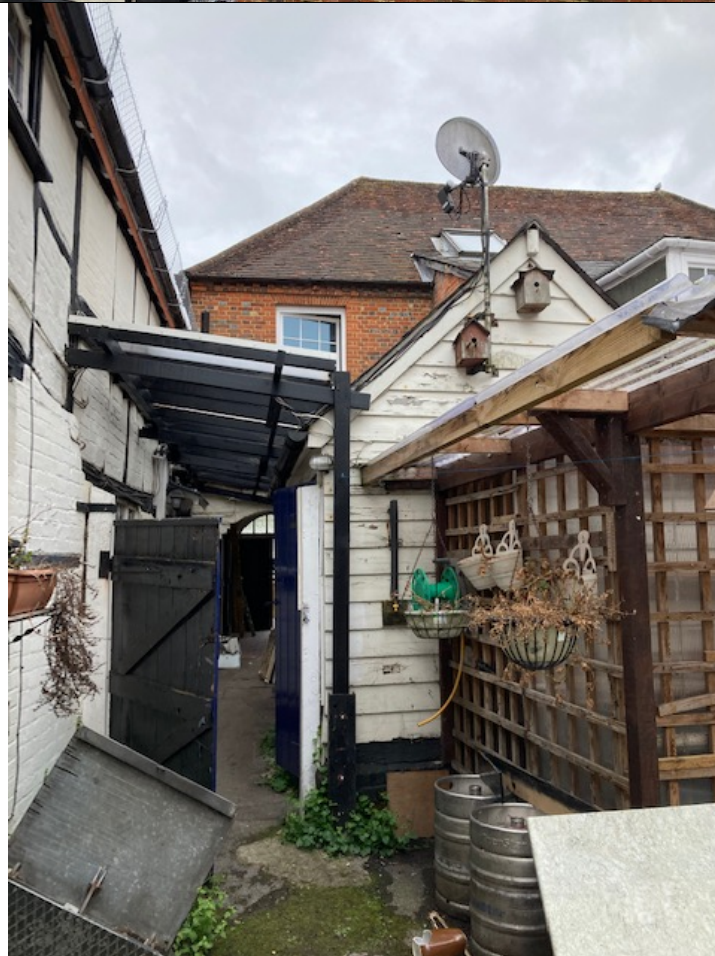
Photo 2: Overview of some of the outbuildings on site, looking south. The Bell lies on the left with lean to and slate covered toilet block on the right.

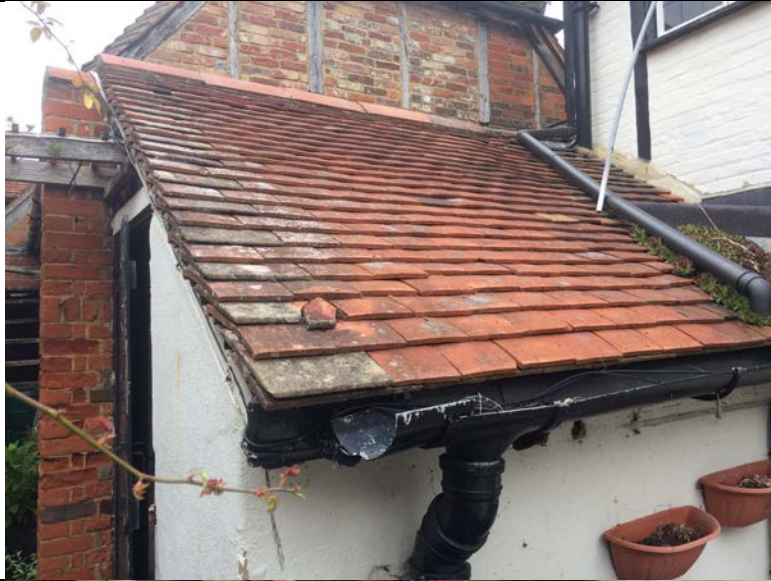
- 3.7 The outbuildings consisted of a toilet block, a lean to and a storage building joined to The Bell on the northwest elevation. The toilet block had a slate tiled, pitched roof but all tiles were flush and eaves were well sealed. Internally the toilet cubicles were all well sealed from the roof void with no features suitable for roosting bats. The lean to, located immediately north of the toilet block was of clear Perspex corrugated sheeting construction and offered no suitability for roosting bats. The storage building joined to The Bell had a south facing clay tile roof with both ridge and roof tiles well sealed with minimal gaps present. Internally, there was no roof lining present with no obvious PRF's

Photo 3:
Another
outbuilding
towards the
centre of
site, joined
onto The
Bell on the
north
western
elevation.

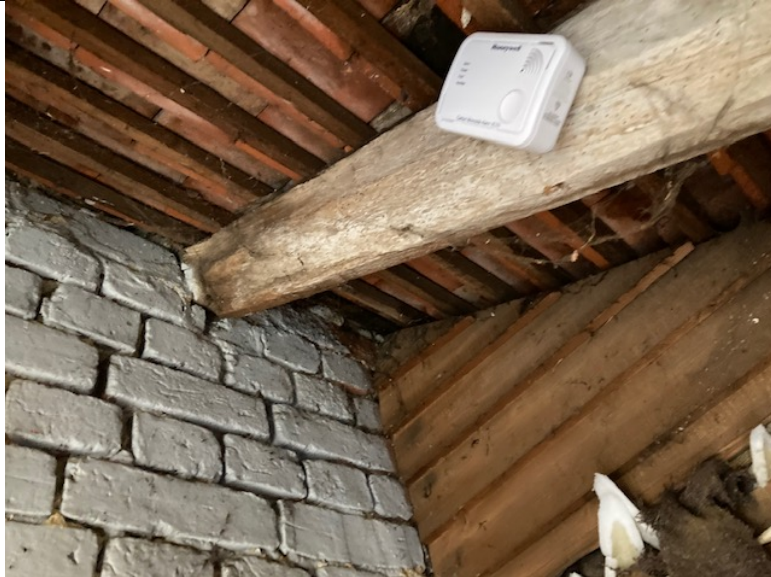
and a few gaps recorded within the brickwork that were shallow and not deep enough for crevice dwelling bats.

Photo 4:
Internal roof
of the
outbuilding
above in
Photo 3.

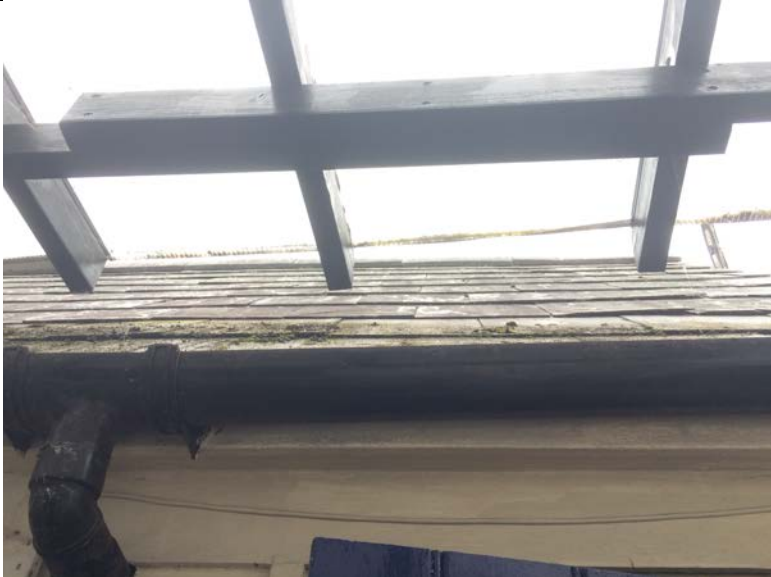
Photo 5:
Showing
well sealed
slate tile
roof on the
toilet block
outbuilding.

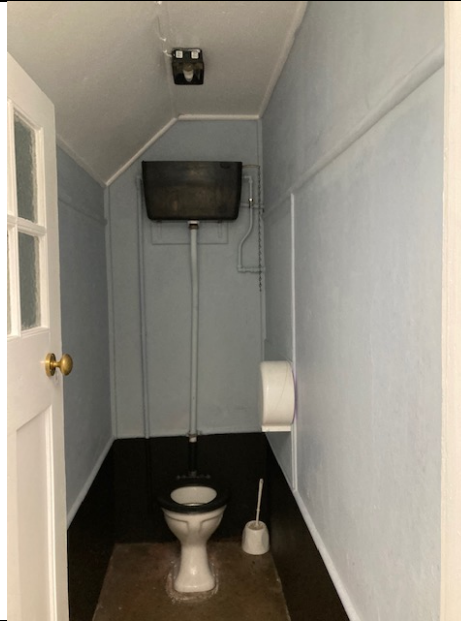
Photo 6:
Well sealed
internal of
toilet block.

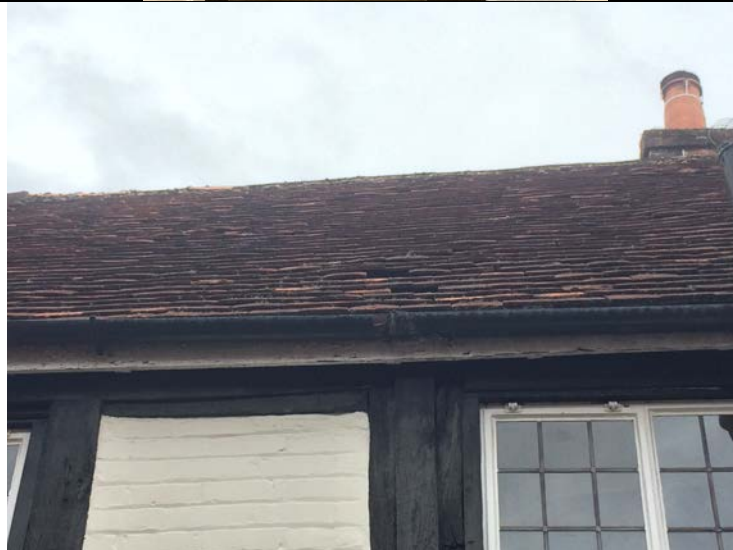
of painted brick and exposed timber with the roof of pitched clay tile construction. Several of the tiles on the roof across all elevations were missing, broken, lifted, slipped or curved, providing potentially suitable crevices for species such as pipistrelle bats. The eaves and exposed wooden beams across the eastern elevation appeared to be well sealed.

- 3.6 The Bell public house had no evidence of bat use internally and bat features with potential suitability for crevice dwelling bat species were limited to missing, slipped or curved clay tiles on the external roof of The Bell.

Photo 7:
Example of
missing tiles
on the
western
elevation of
The Bell
public
house.

- 4.5 If re-roofing works are to be conducted, however, further surveys would be recommended. Internal works within the roof void, such as re wiring and re insulating, can be conducted as this will not impact upon the structure or functionality of the roof space.

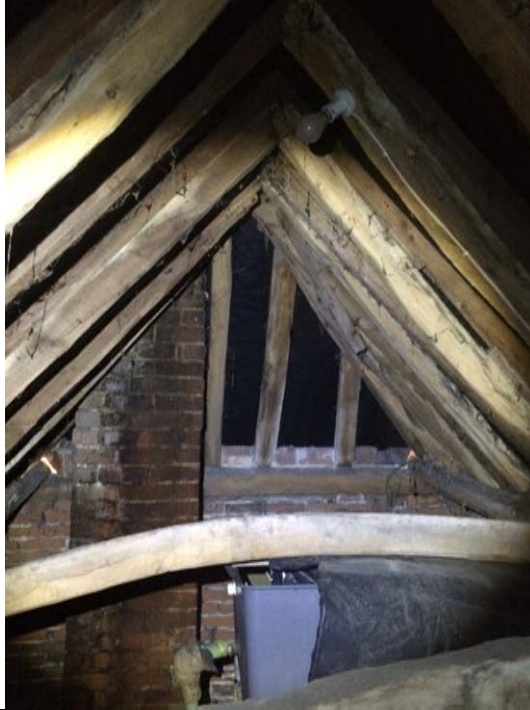
- 3.4 The loft void was one space, split into two different sizes, the northern section approximately 3m wide, 4m long and 4m high. The southern section was smaller, approximately 2.5m wide, 6m long and less than 1m in height. The roof was lined with roofing felt and cobwebs present throughout. Around the chimney breast in the southern most end of the loft void, several gaps in the brickwork were recorded but these areas were very heavily cobwebbed. The exposed timbers showed no suitable potential roosting features for bats. An old birds nest was recorded within the northern end of the loft void. The entire loft void was inspected and no evidence of bats such as droppings, staining or feeding remains were recorded.

Photo 8:
Internal roof space of The Bell, facing north.

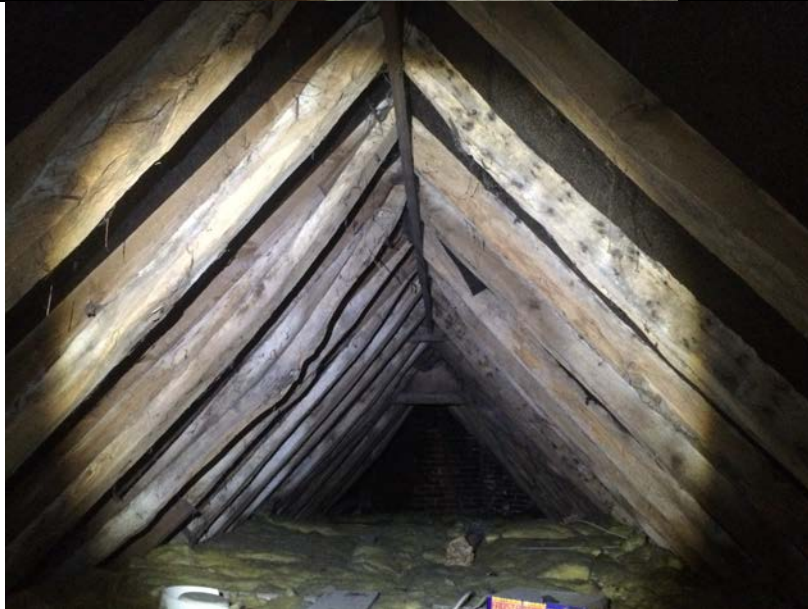
Photo 9:
Internal roof space of The Bell, facing south.

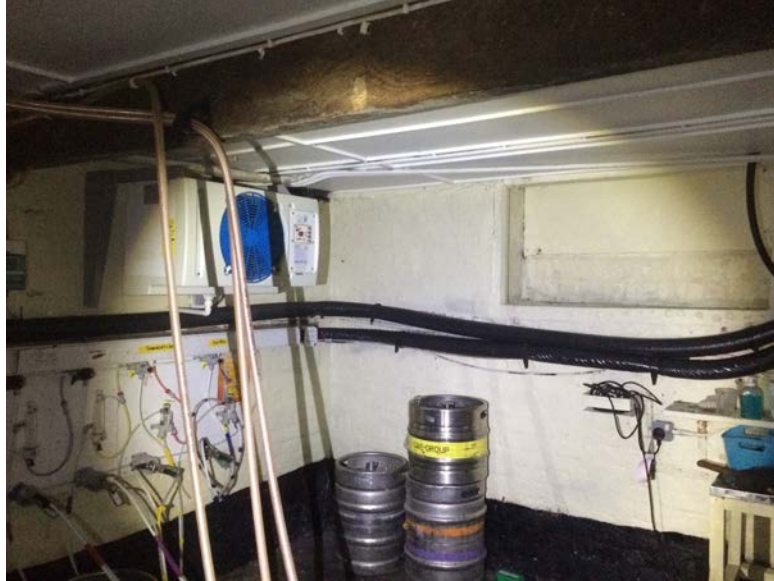
- 3.5 The basement was split into two parts, the larger of the two the consisting of the existing beer cellar with access internally via the bar and externally into the small courtyard. The smaller section was used as storage and both sections had well sealed ceilings. These areas would have been used frequently and this, paired with the lack of roosting features, indicates that use of the basement as a hibernation roost is negligible.

Photo 10:
Showing the
beer cellar
of The Bell.

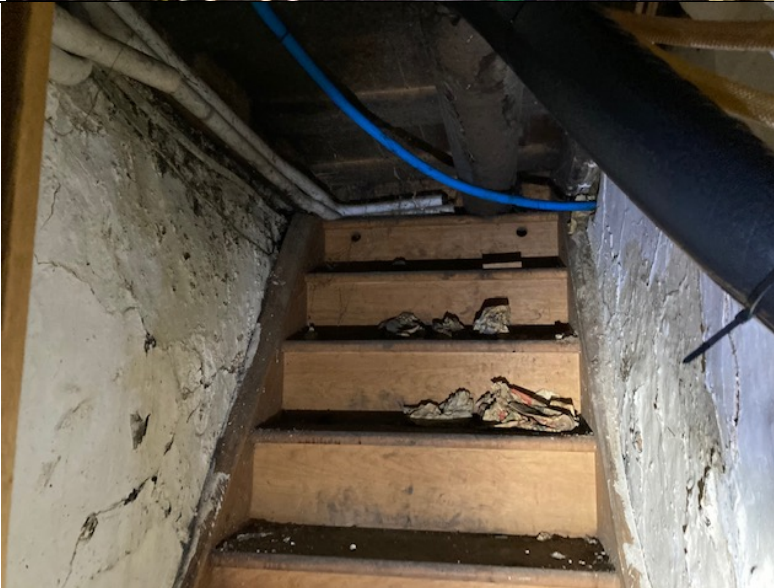
Photo 11:
Steps
leading
from the
public house
bar to the
beer cellar.
