**West Moor Farm Ecological  
Impact Assessment  
Bat and Barn Owl Report**

***IAMP LLP***

***April 2021***

### West Moor Farm, Washington, SR5 3HY

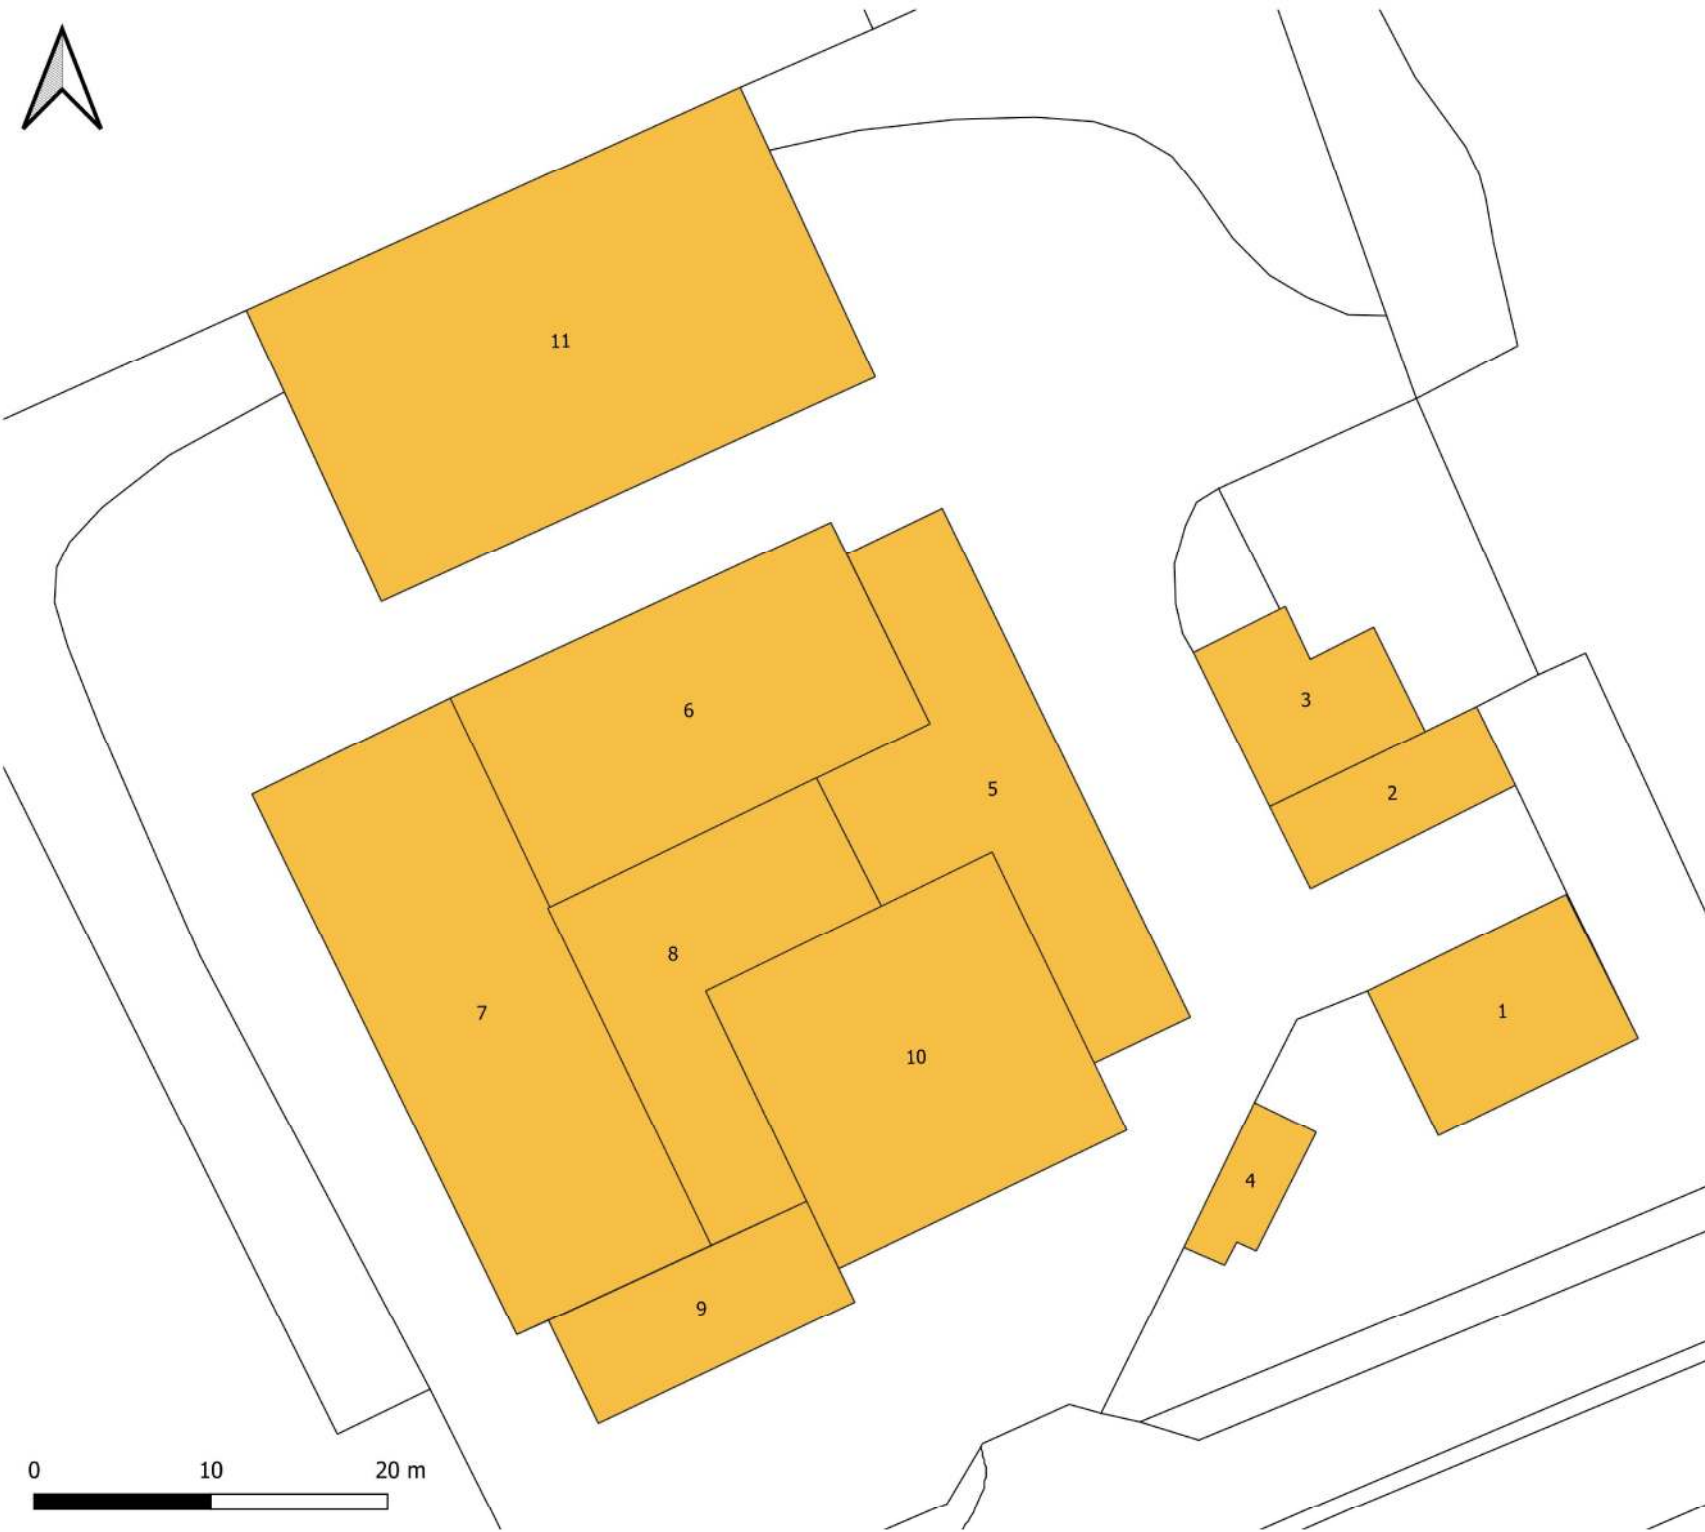
<b>Project</b>	West Moor Farm
<b>Title</b>	Building Reference Plan
<b>Client</b>	IAMP LLP
<b>Date</b>	23/04/2021
<b>Ref</b>	Figure 3

- 4.3.1 Full details of the findings of the building assessment can be found in Table 6 overleaf with photographs in Appendix B and building plan shown in Figure 3, Appendix A.

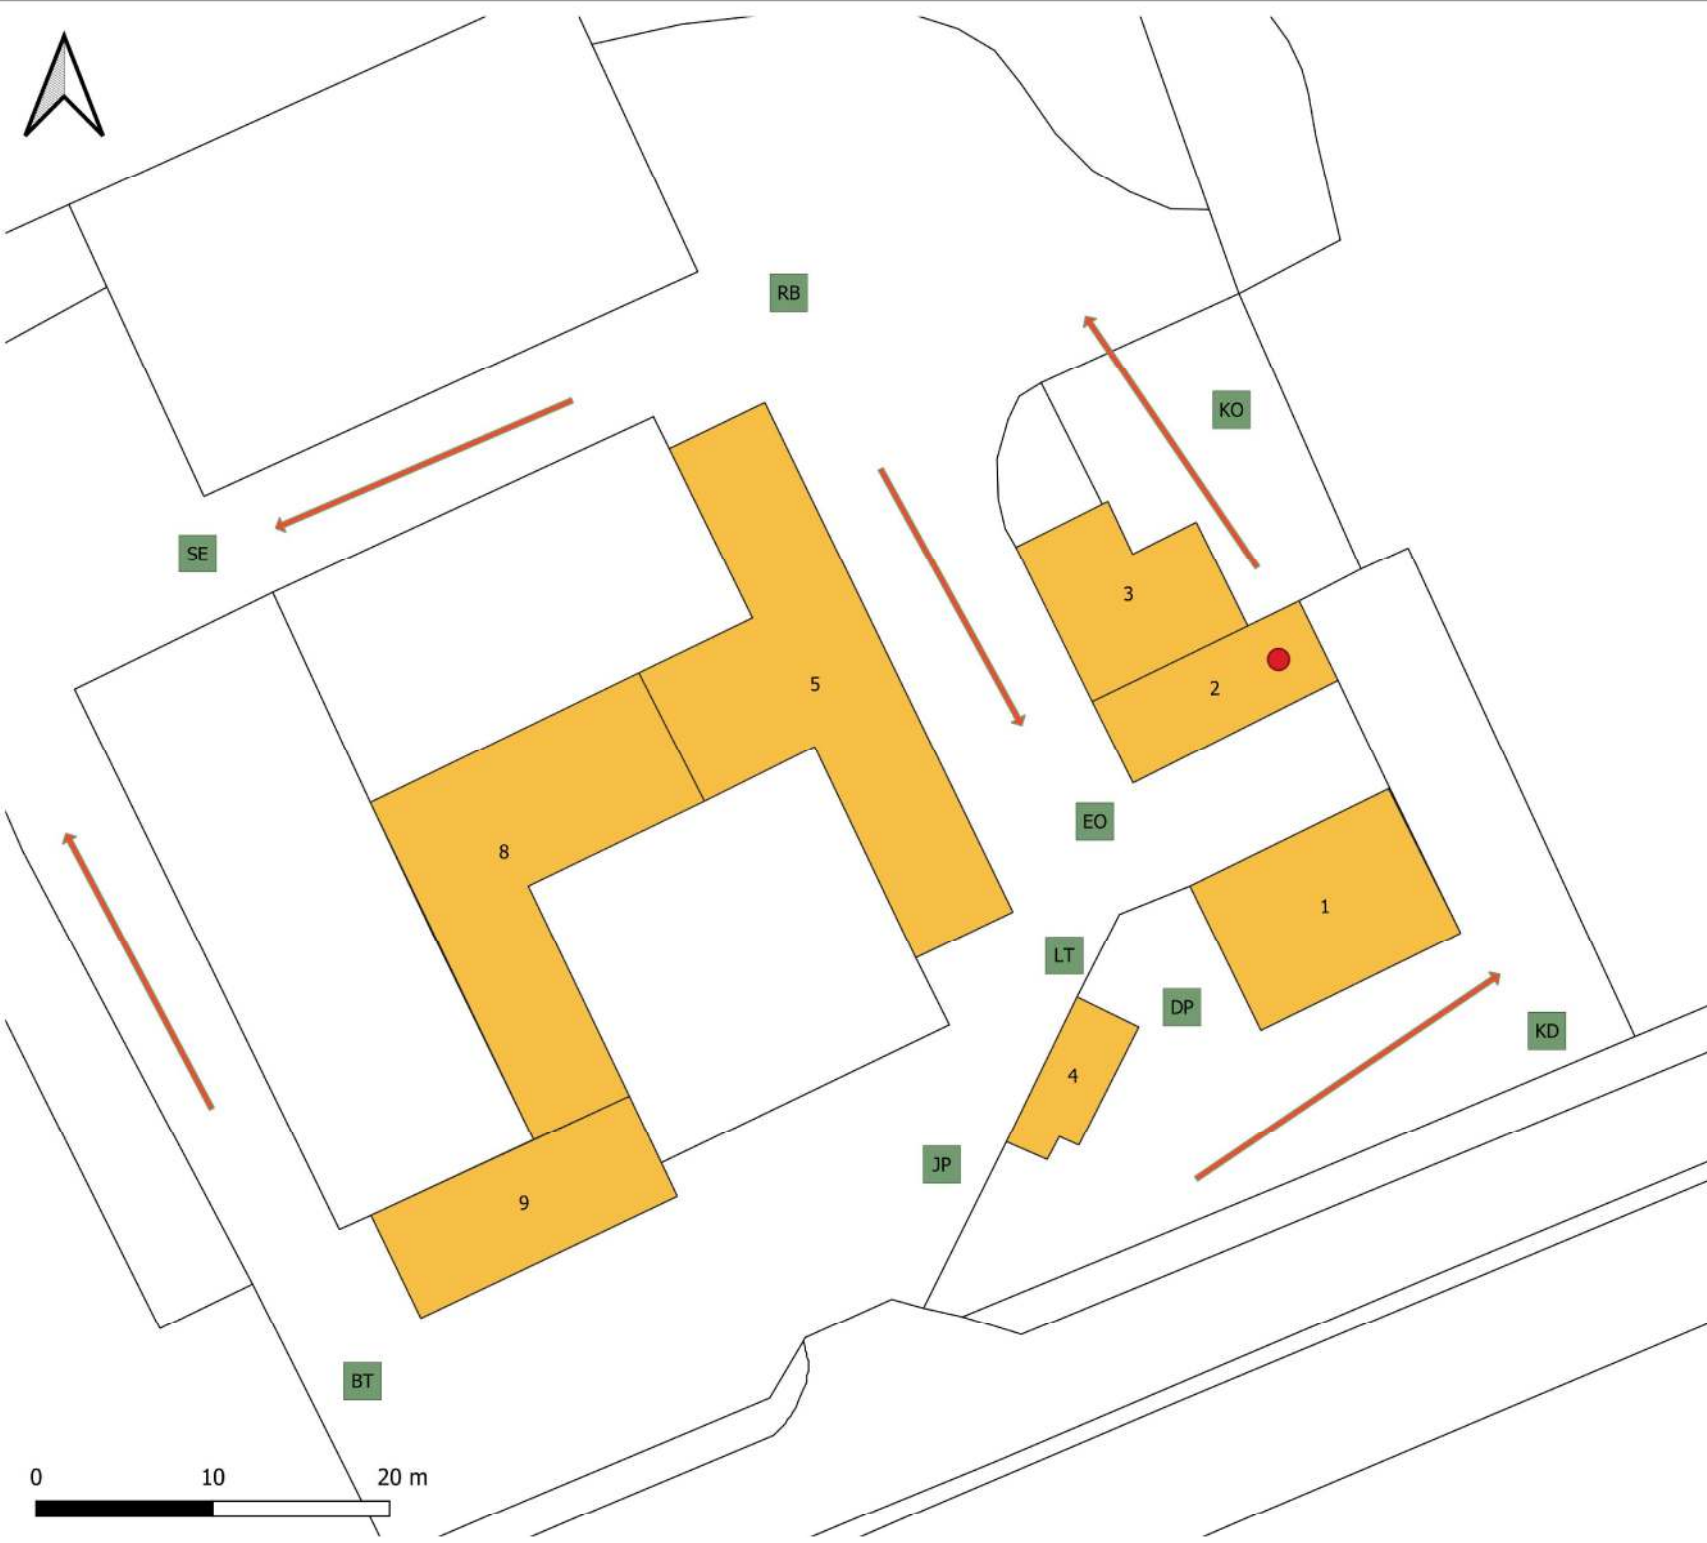
<b>Project</b>	West Moor Farm
<b>Title</b>	Dusk Survey 02/07/2018
<b>Client</b>	IAMP LLP
<b>Date</b>	23/04/2021
<b>Ref</b>	Figure 4b

- Roost Location 1
- Commuting Route
- Surveyor Locations
- Buildings Surveyed

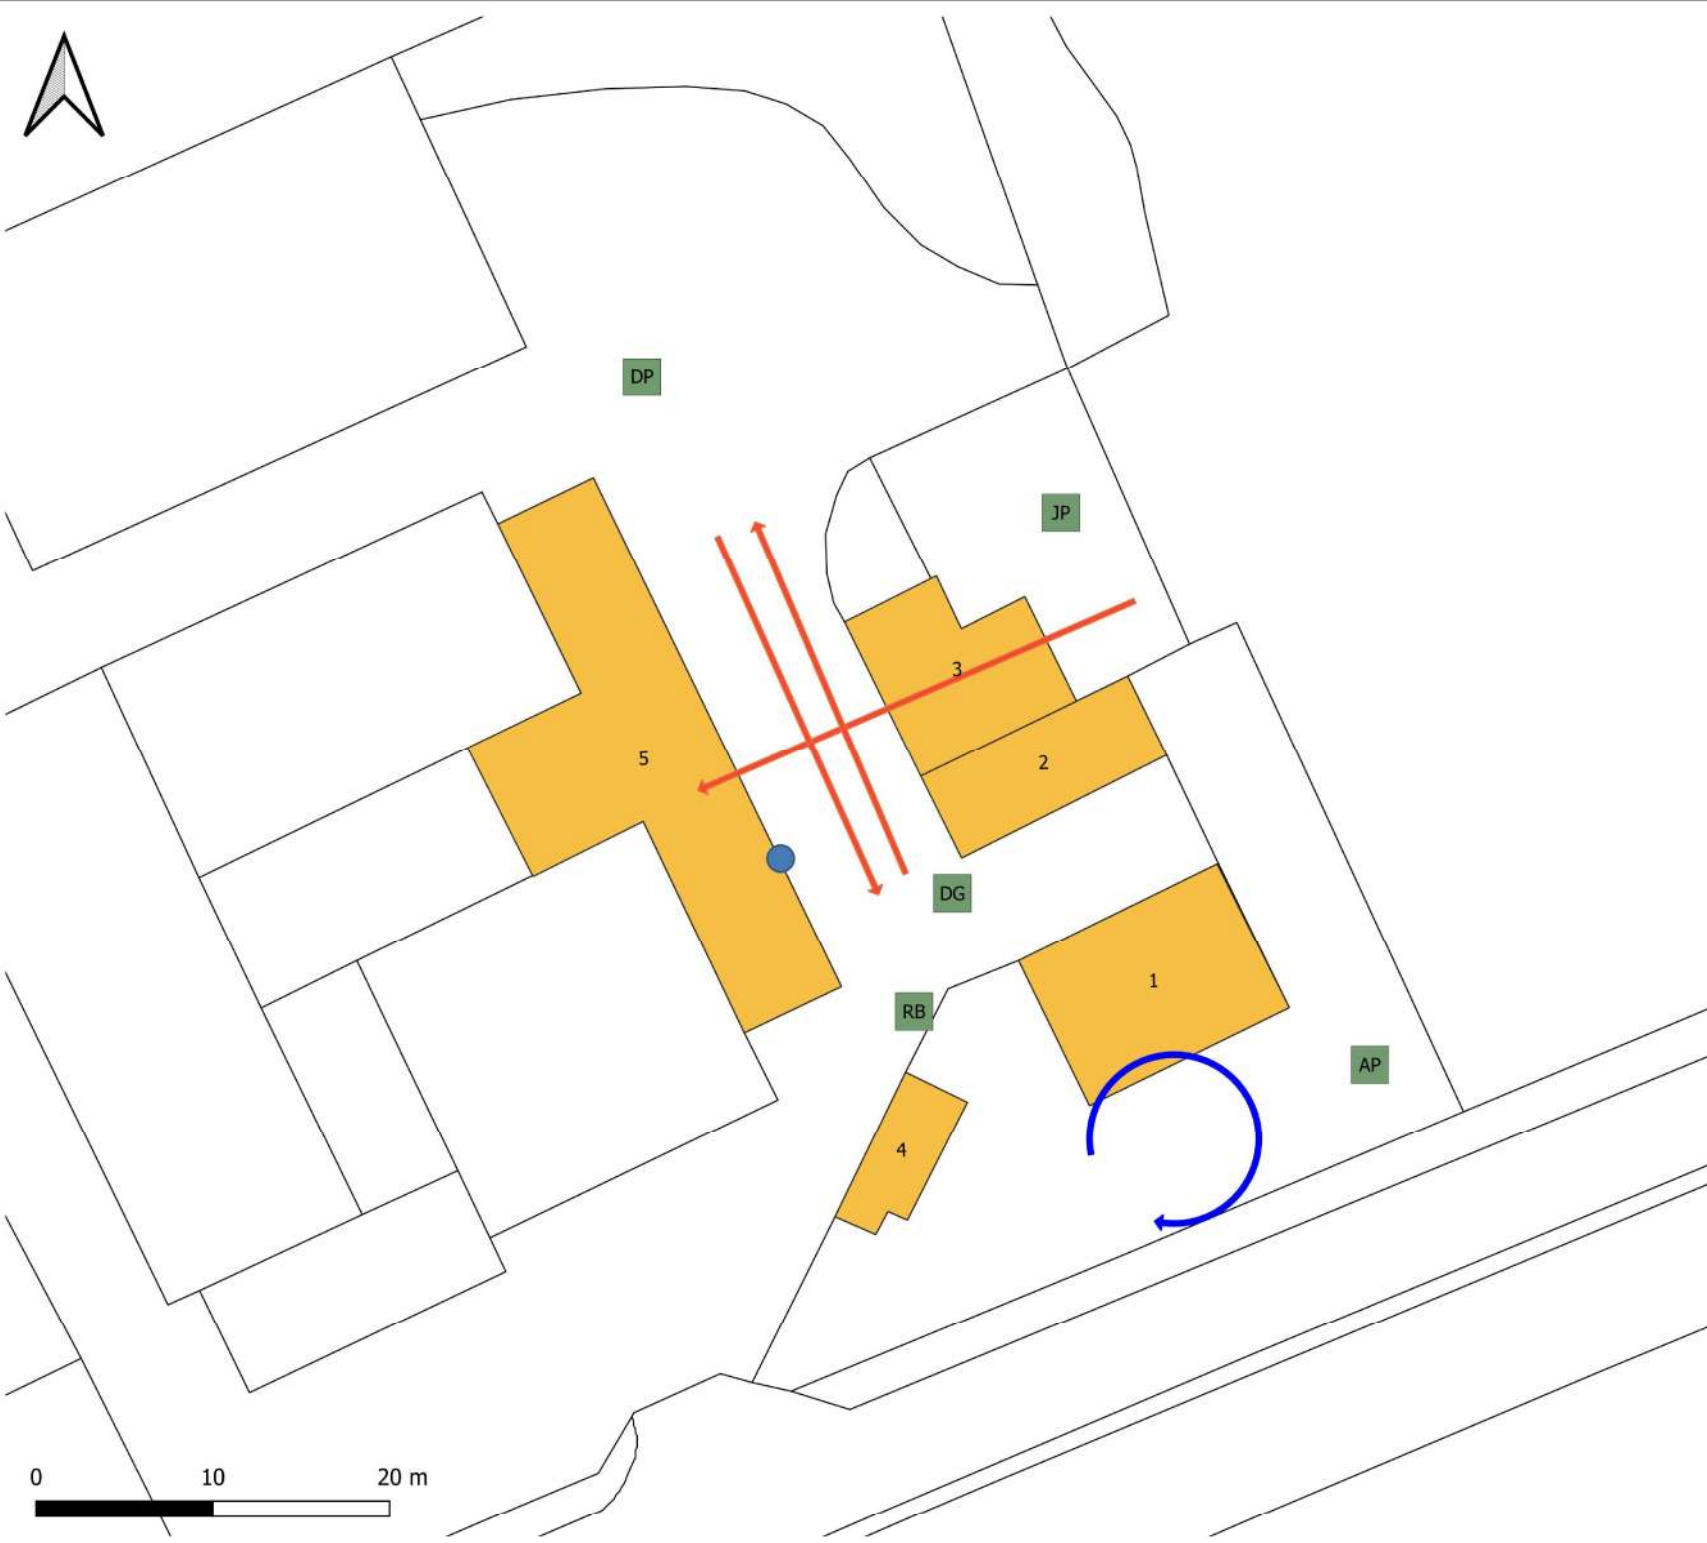
<b>Project</b>	West Moor Farm
<b>Title</b>	Dawn Survey 02/08/2018
<b>Client</b>	IAMP LLP
<b>Date</b>	23/04/2021
<b>Ref</b>	Figure 4c

- Foraging Route
- Commuting Route
- Roost Location 2
- Surveyor Location
- Buildings Surveyed

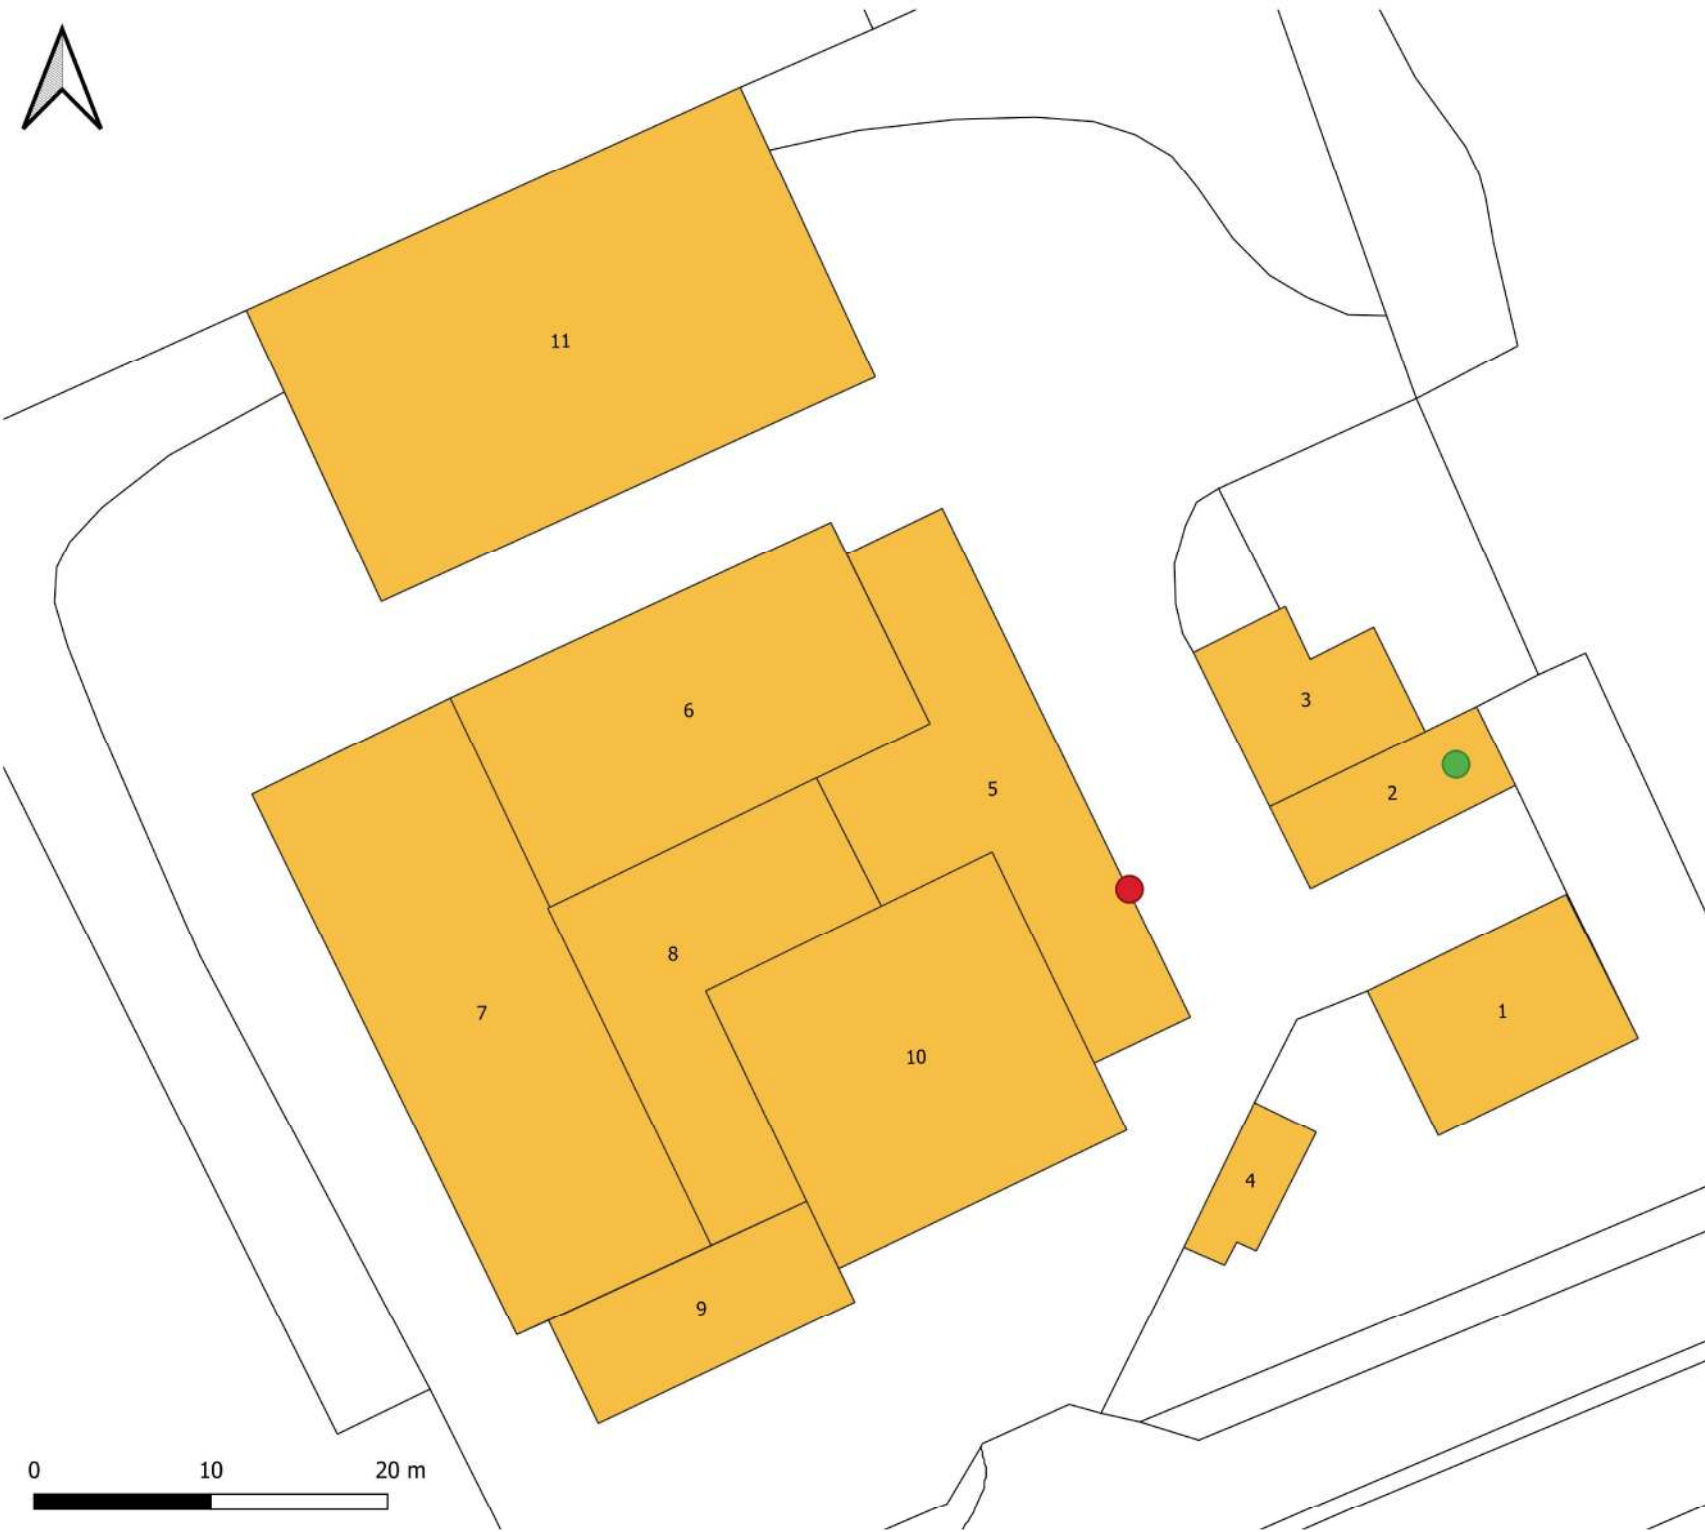
<b>Project</b>	West Moor Farm
<b>Title</b>	Roost Location Plan
<b>Client</b>	IAMP LLP
<b>Date</b>	23/04/2021
<b>Ref</b>	Figure 5

4.4.2 Details of all roosts can be found in Table 7 below, along with Figure 5 in Appendix A and photographs 23 & 24 in Appendix B. In summary, no roosts were recorded across the 2015 and 2019 surveys. During the 2018 surveys, a single pipistrelle (possibly 2) was seen emerging from a gap under the ridge tile on building reference 2. On a separate survey a single common pipistrelle was seen emerging from under the guttering on the eastern elevation of building reference 5.

- 1.0.3 The 2021 risk assessment survey was an update, with surveys also carried out in 2015 (WYG 2015), 2018 (DWS, 2018) and E3 Ecology (2019) these reports should be read in conjunction with this one, but are summarised within this report. Only DWS surveys recorded any bat roosts in 2018, with small common pipistrelle roosts present in buildings 5 and 2 (Figure 5).

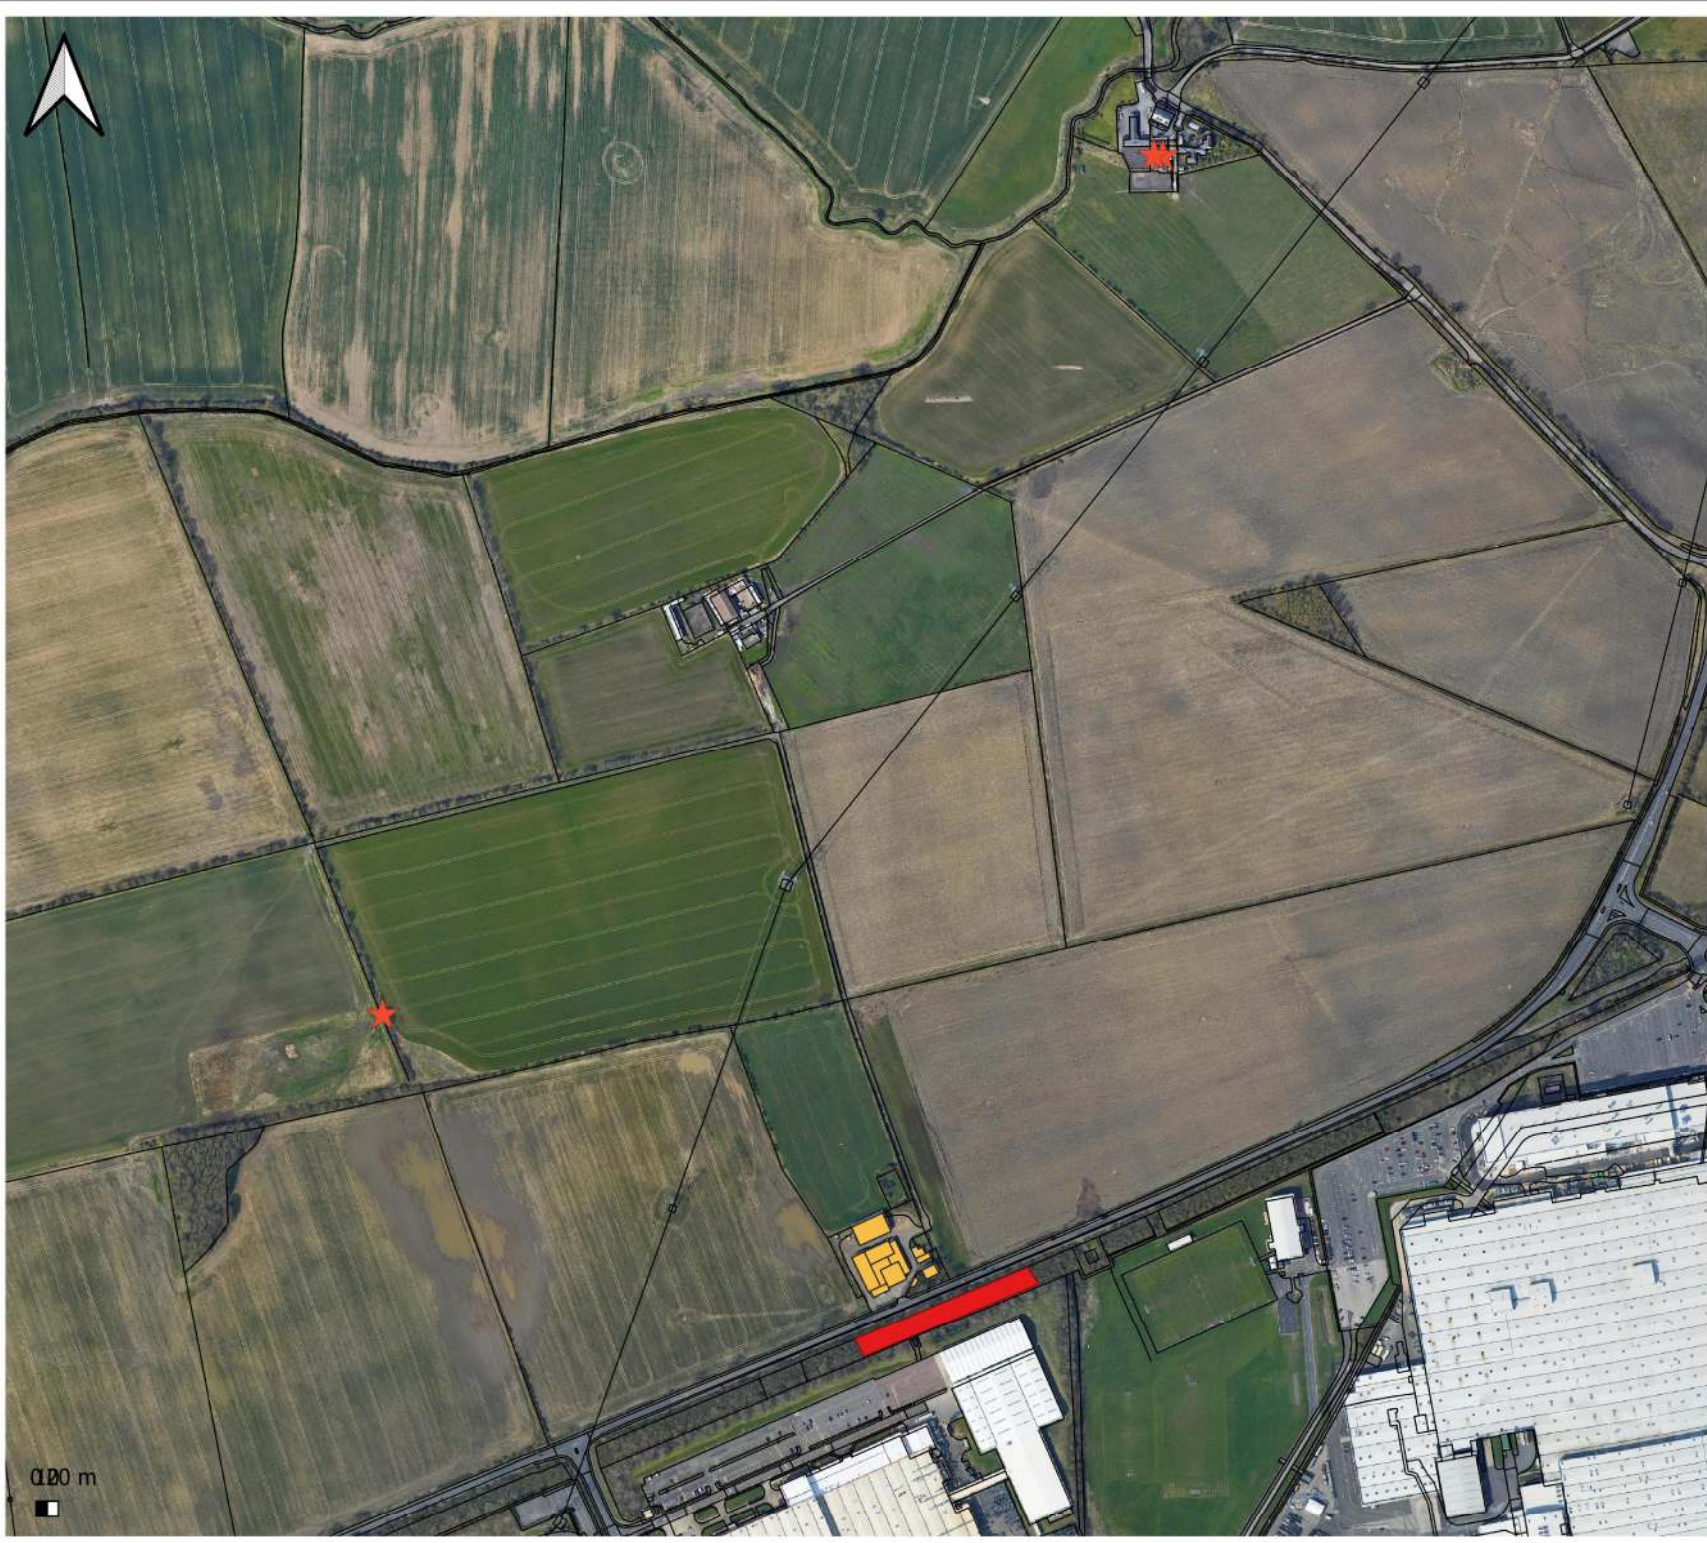
<b>Project</b>	West Moor Farm
<b>Title</b>	Mitigation Plan
<b>Client</b>	IAMP LLP
<b>Date</b>	23/04/2021
<b>Ref</b>	Figure 6

7.3.3 As all buildings are due to be demolished, it is recommended that three tree mounted bat boxes (made of woodcrete or woodstone – similar to Schwegler 2F) are erected in the woodland to the south of the farmyard (Figure 6). For maximum bat potential, these boxes should be at least 3-5m off the ground, sheltered from strong winds and exposed to the sun for part of the day (south/south-west elevations). The position of the boxes should be free from clutter (branches blocking flight path in). A hibernation box will be erected in the same area to provide alternative provision in winter. The hibernation box should be placed on the northern elevation.

- 1.0.10 At least 30 days prior to demolition (Barn Owl Trust 2012) three barn owl boxes will be erected; one in a mature tree a short distance away, and two within Hylton

Bridge Farm (Stables and barn) (Figure 6). The tree selected is in the open and mature, with a fork to provide suitable secure locations for the box to be installed.

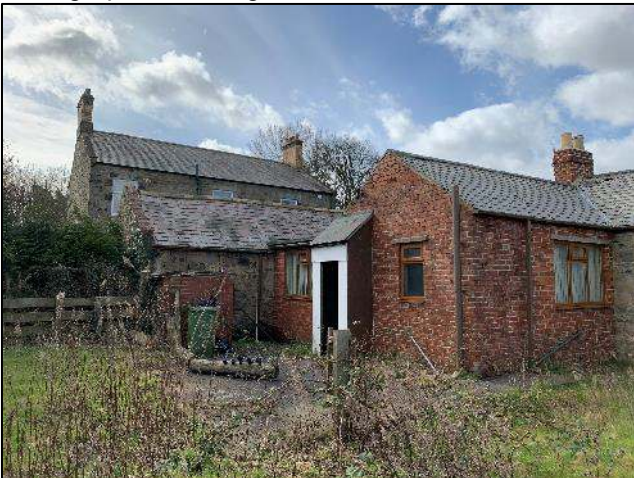
Photograph 5 Building Reference 2 & 3, showing gaps in the roof of 2.

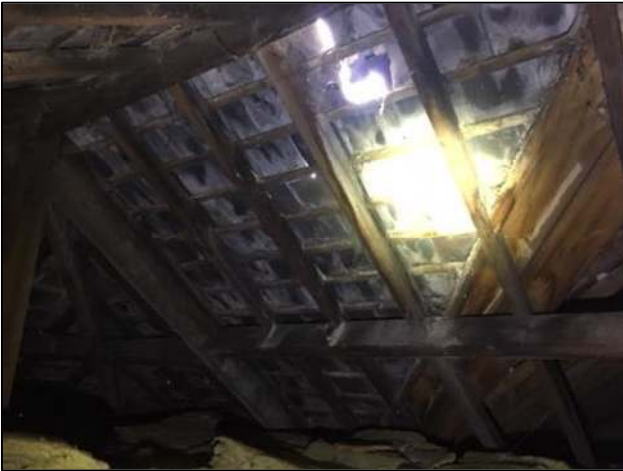
Photograph 7 Loft void of Building Reference 3, showing holes in roof.

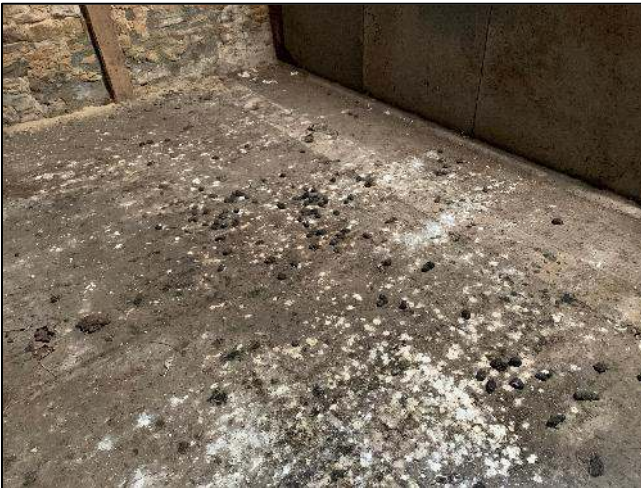
- 1.0.5 In 2021, Barn owl pellets were present within building reference 8, on the floor at the southern end, and on a plank above a series of grain stores in the upper storey of the building. There was a large number of fresh pellets present in both February and March 2021, with a barn owl seen here during the February visit. Smaller owl pellets were also present in the adjacent upper storey room, with a little owl *Athene noctua* seen in February 2021. Barn owl pellets were also present above beams in Building 7 at the northern end. Old pellets were present in the upper section of barn 5. Overall building 8 was deemed to be a Potential Nesting Sites (PNS), with

Photograph 15 Building Reference 8, internal – large accumulation of barn owl pellets

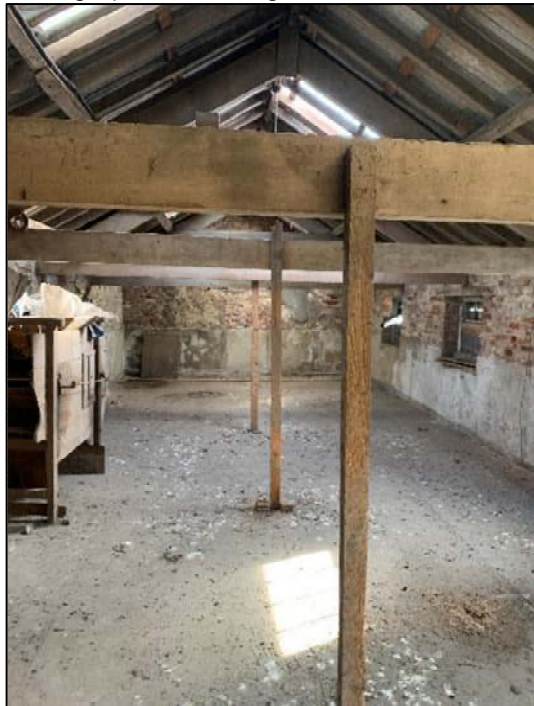
Photograph 16 Building Reference 8, internal – upper room with little owl pellets

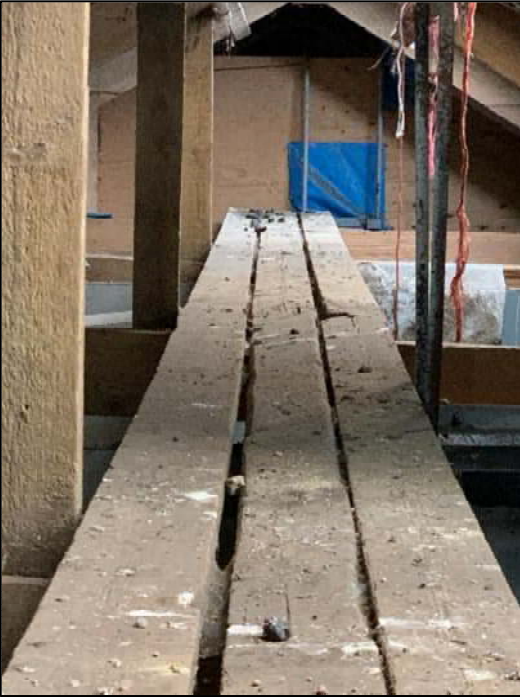
Photograph 17 Building Reference 8, internal – barn owl pellets along upper walkway of grain store.

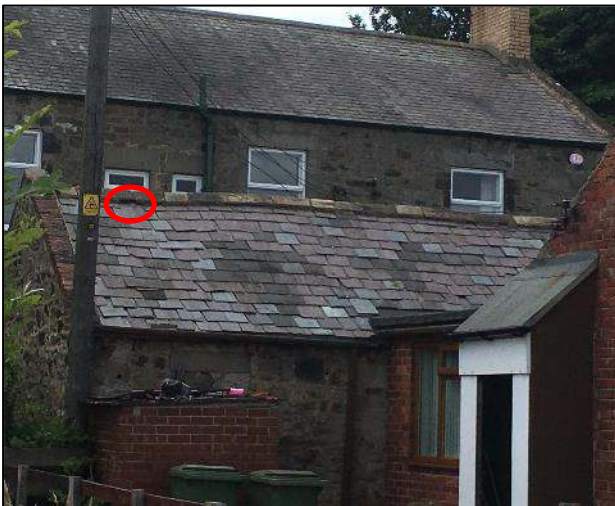
Photograph 23 West Moor Farm, Building 2, Common Pipistrelle roost under ridge tiles.

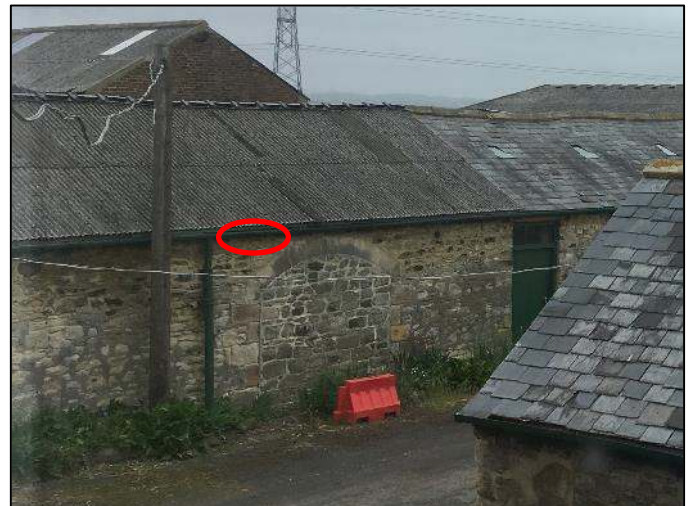
Photograph 24 West Moor Farm, Building 5, Common Pipistrelle roost eastern elevation of the barn, under the guttering.
