North Moor Farm Bat and Barn Owl Survey Report

IAMP LLP

October 2022

Ecological Impact Assessment
North Moor Farm, Washington, NE36 0BB

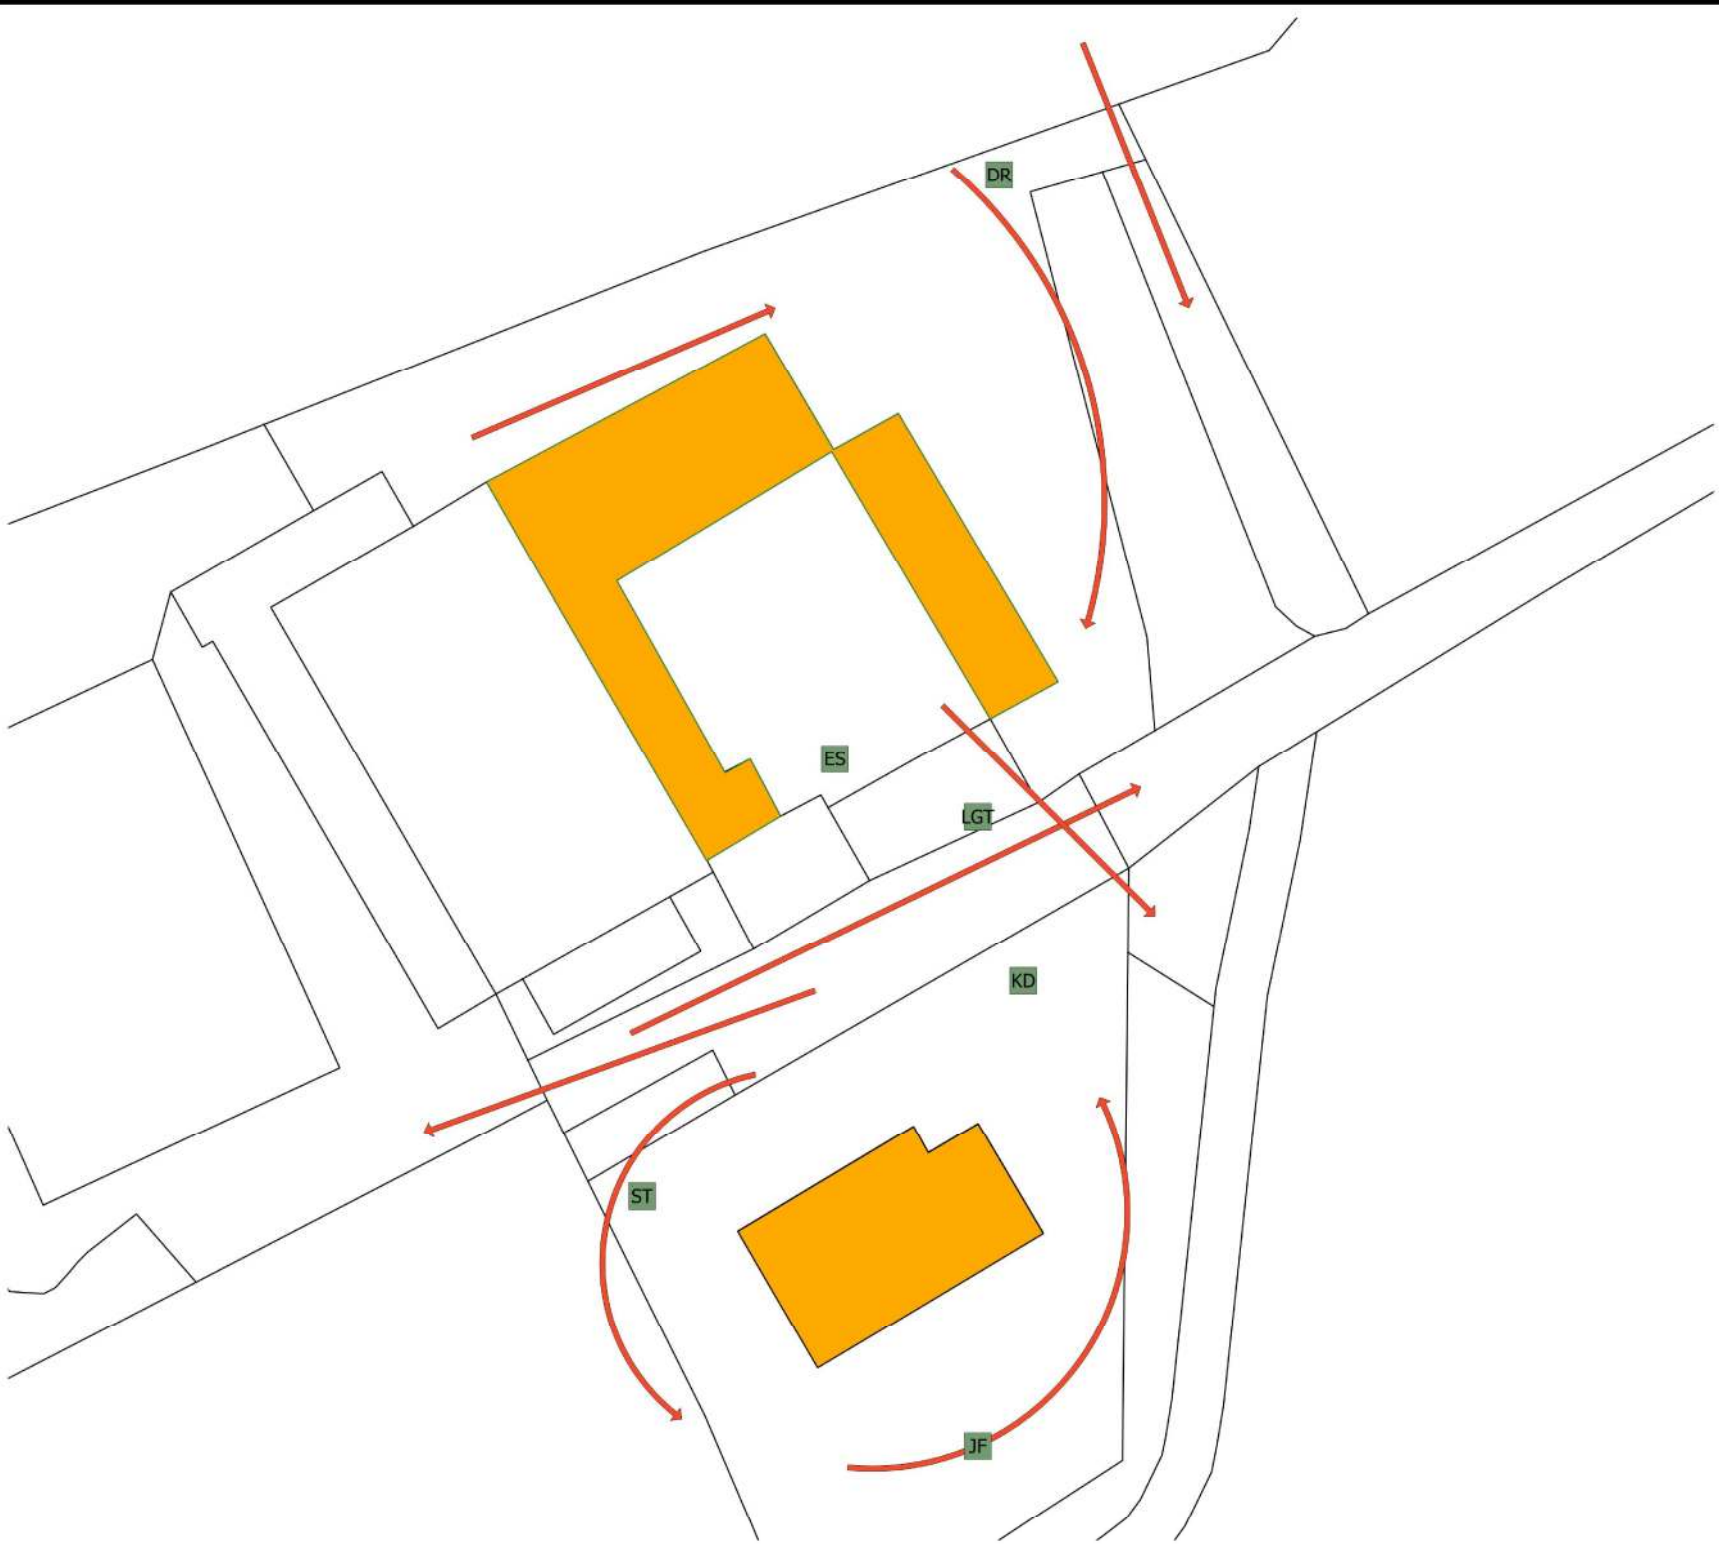
Project	North Moor Farm
Title	Survey Results 13/06/2022 Dusk DWS
Client	IAMP LLP
Date	25/10/2022
Ref	Figure 4e

Low levels of activity were recorded during this survey, with slightly higher levels from the surveyor positioned outside of the farm complex near a defunct hedgerow to the northeast. Much less foraging activity was observed, with nearly all bats recorded as just commuting through the survey area. Nearly all activity could be attributed to common pipistrelles, with one noctule pass and one soprano pipistrelle pass also recorded. No bat roosts were recorded in any of the buildings on site.

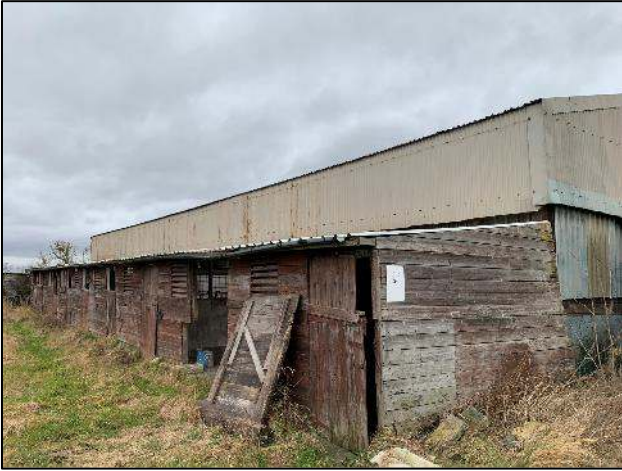
Photograph 1 Building reference 1, Wooden Stables, and Building reference 2 metal barn indoor arena.

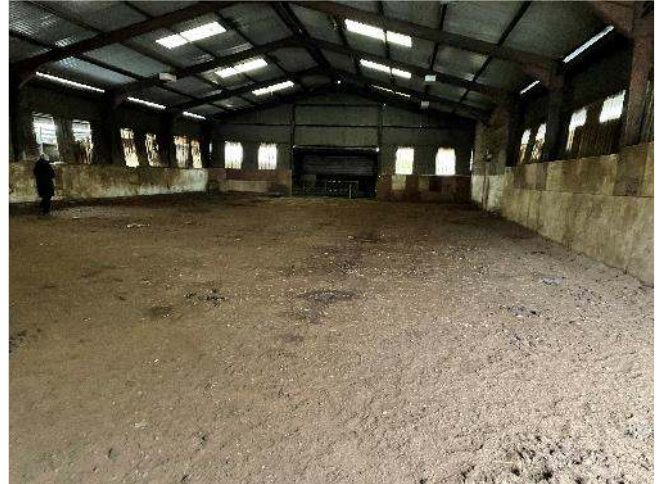
4.3.4 Overall, the buildings had deteriorated since the 2018 surveys due to the farm becoming unoccupied, and a number of storms had caused some damage. Over the summer of 2022 arson in Building 2 resulted in the loss of some of the wall panels on this barn.

Photograph 2 Building reference 2, internal.

7.1.3 Arson in the summer of 2022 has reduced the suitability of Building 2 for barn owls due to damage to some of the walls and door. Buildings 1, 4 and 6-10 were all demolished/removed from site after the May 2022 survey. Part of Building 3 was also demolished. Only the farmhouse (Building 5), Building 2 and most of Building 3 remain on site.

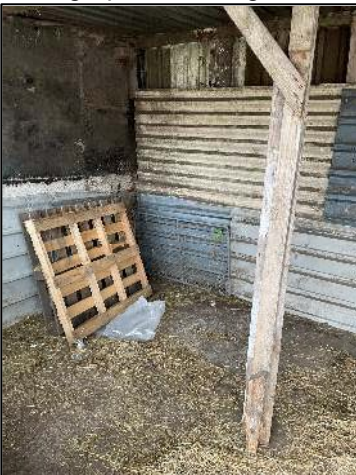
Photograph 5 Building Reference 3 internal where barn owl pellets were found.

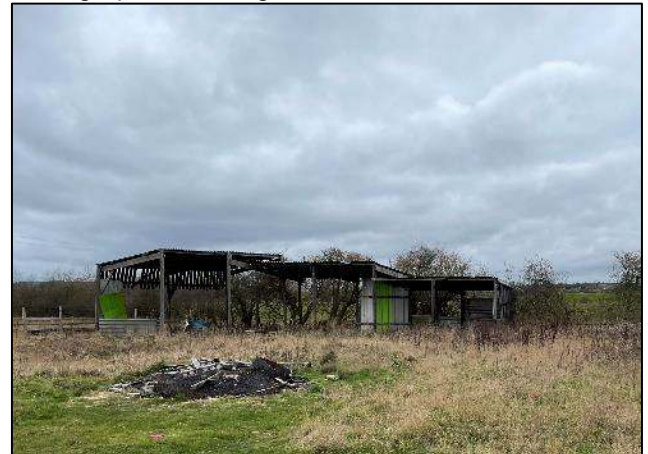
4 Photograph 6, Appendix B	Open front barn. Most walls are missing. Corrugated metal. Much smaller in size compared with 2018.	X	X	X	X	X	X	None.	None noted.	None.	Negligible

Photograph 6 Building Reference 4.

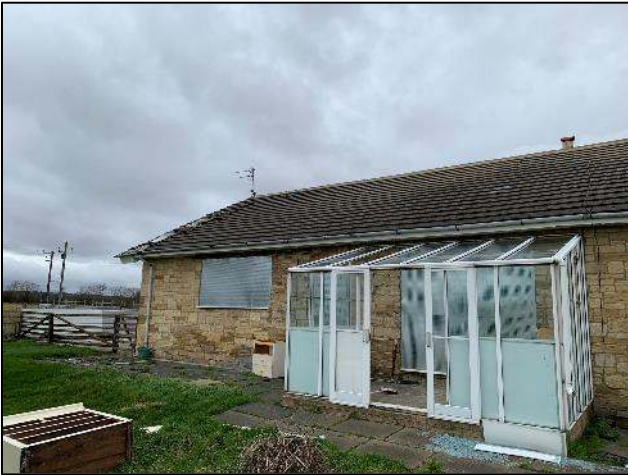
Photograph 7 Building Reference 5, farmhouse.

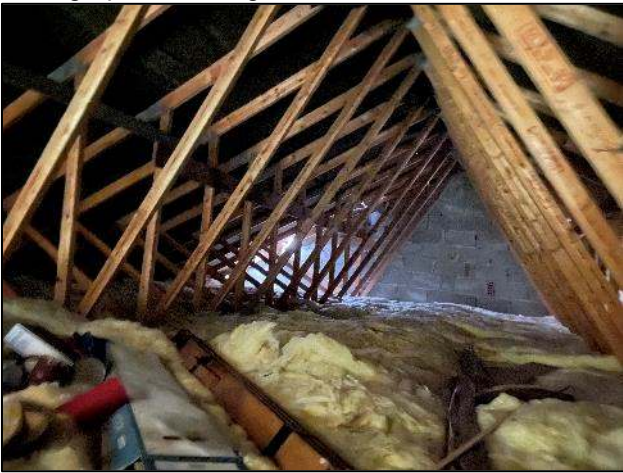
Photograph 9 Building Reference 5 loft void.

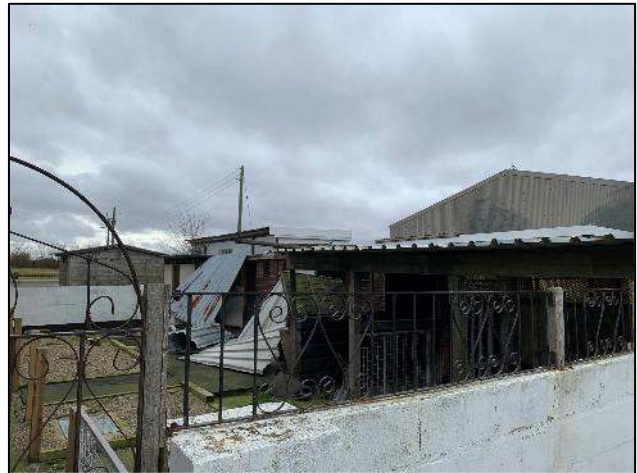
portacabins. The kennels (Building References 6) onsite were of wood construction and also negligible. A large corrugated metal barn (Building Reference 2) on site was an indoor area. The adjacent stables to the west were wooden (Building Reference 1), with a second barn (Building Reference 4) constructed of corrugated metal and open fronted, with some walls/roof missing. All of these were also assessed as negligible. A second set of brick/breezeblock stables (Building Reference 3) is present to the east of the farm complex. Gaps were present along the wall top of these stables, which were assessed as having low potential for bats. The farmhouse (Building Reference 5) itself was assessed as moderate potential. It is a single storey stone building with flat concrete tiles on the roof. Gaps were present in the ridge, in the soffits and at the gable. Table 5 below provides guidance on assigning a risk level to a building (BCT 2016).

Photograph 10 Building Reference 6, kennels.

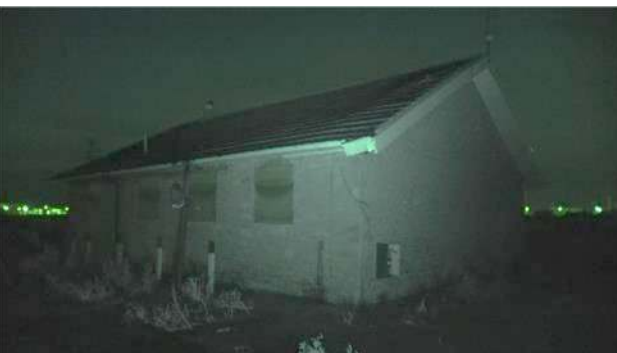
The nocturnal surveys were conducted by surveyors equipped with Echo Meter 3 and EM Touch bat detectors. Three infrared cameras were also used (Nightfox Swift) adjacent to each surveyor on the farmhouse. The emergence survey commenced 15 minutes before sunset and continued until all bats were considered to have emerged in accordance with the Bat Conservation Trust Guidelines (BCT, 2016). Following the BCT (2022) interim guidance note, only dusk surveys were carried out, with infrared cameras, because research has found that dusk surveys with night vision aids are far more effective at finding roosts than dawn survey. All video footage was reviewed afterwards using VLC Media Player. An image from the video camera can be found in Appendix B (Photograph 17).

Photograph 17 Example of camera footage from the end of the June 2022 survey.
