New Wear Footbridge Sunderland Tyne and Wear

Archaeological Watching Brief
Report No. 4414

Archaeological Watching Brief

Report No. 4414

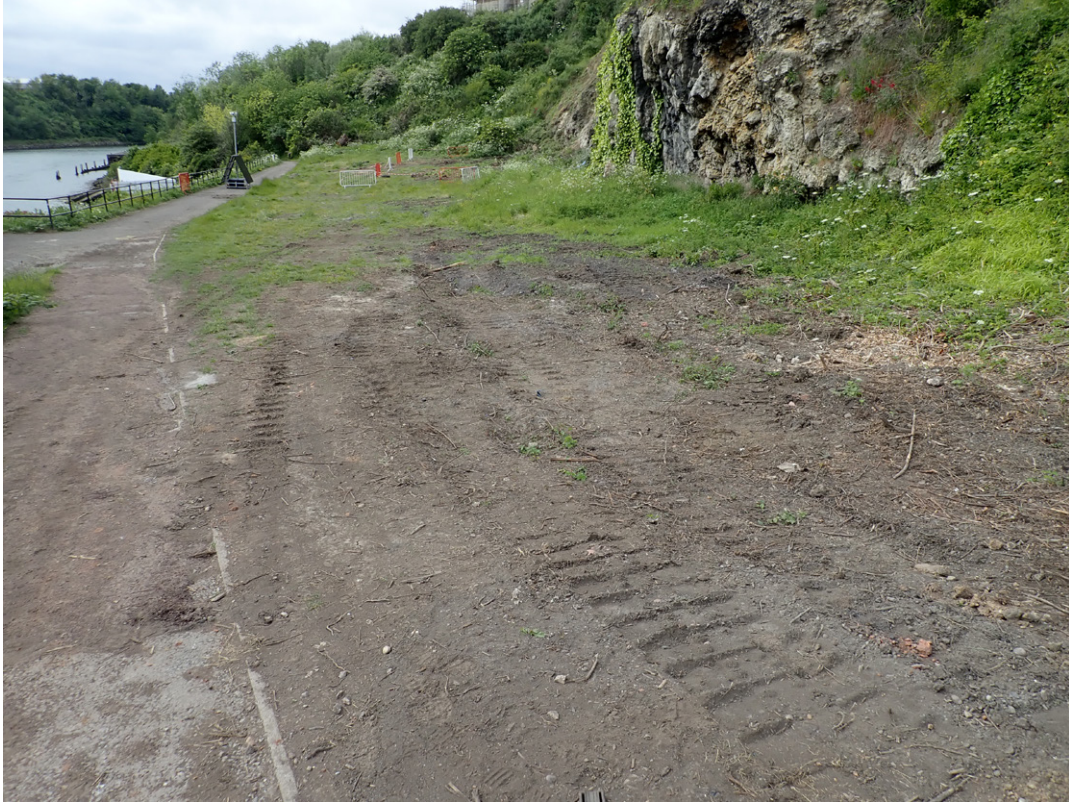
Area 1 (Figs. 2.1 and 3.1) corresponds to the location of the heavy lifting and general working platforms on the north embankment of the river. Prior to the full excavation of the area, four trial pits were excavated by the groundworks' contractors to determine ground conditions. The pits were 4m long by 2m wide and to depths varying between 0.4m to 0.75m, and none of them uncovered archaeological remains or exposed the natural geology (Fig. 3.2).

Fig. 3.1: Area 1 before excavation, facing west

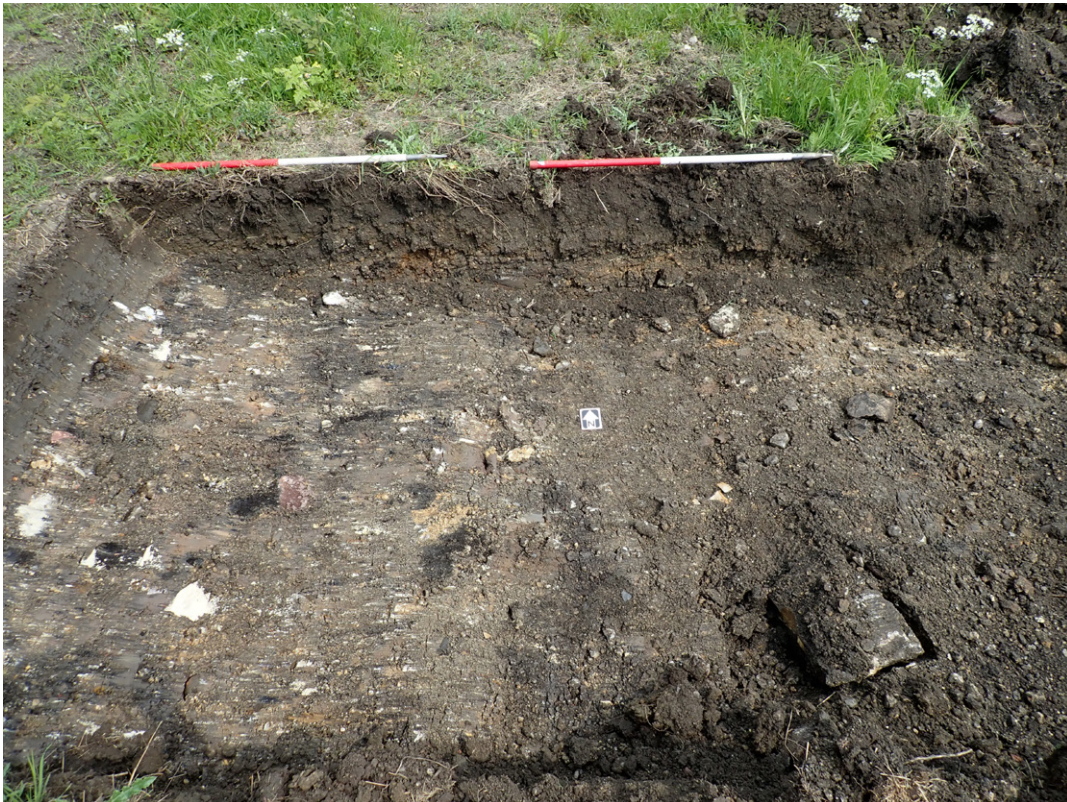
Fig. 3.2: Trial pit 3 in Area 1

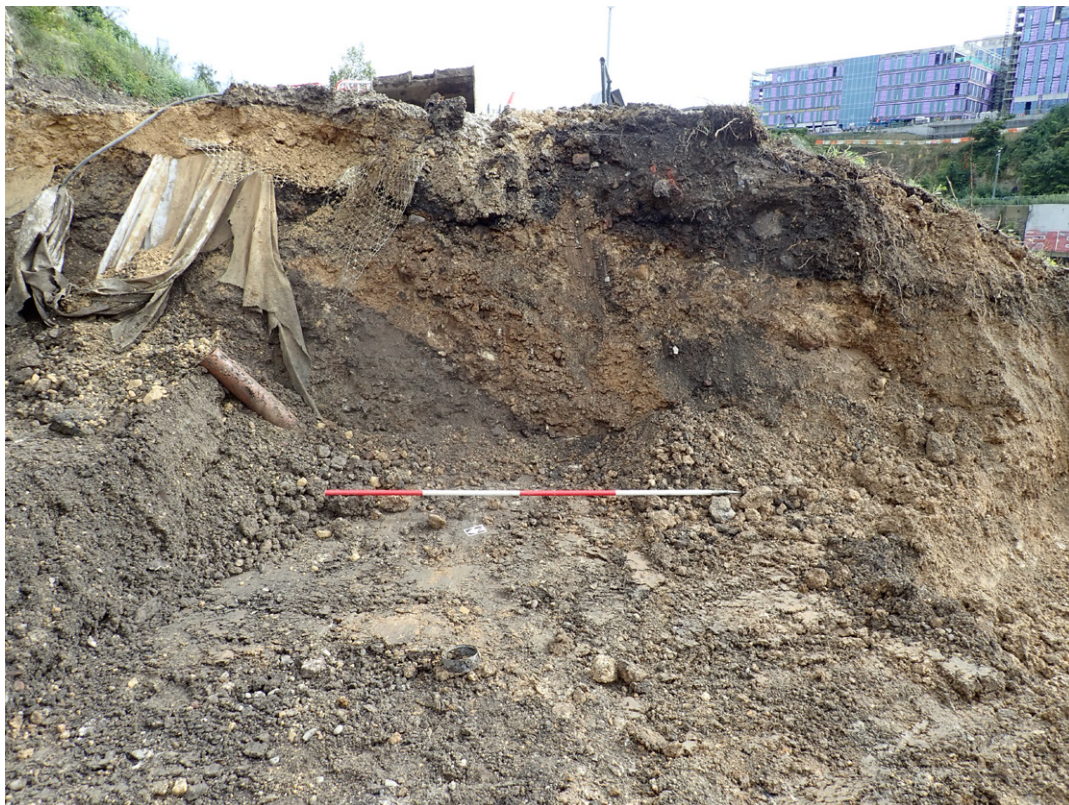
A west to east tarmac path and foundation layer of gravels were removed near the northern edge of Area 1, remains of which were still visible on the west facing section of Area 1 (Figs. 3.3-3.6).

Fig. 3.6: West facing representative section in Area 1, showing Made Grounds 102, 103 and 104

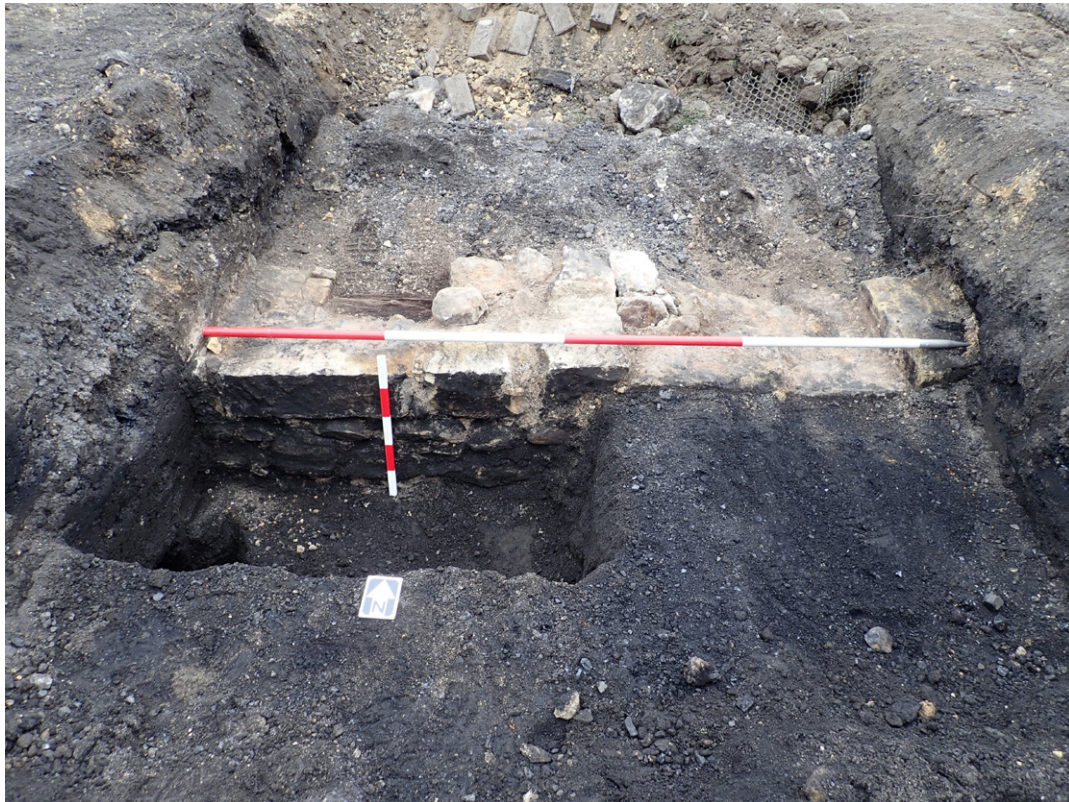
further damage during full excavation. These features include Walls **204** (Fig. 3.10), **206** and **207**, commented below. The full excavation of the heavy lifting platform covered an area of approximately 38m by 22m, and to a maximum depth of 0.80m, exposing the majority of the archaeological features recorded in Area 2.

Fig. 3.10: Hand-excavated test slot on south elevation of Wall 204 after initial exposure

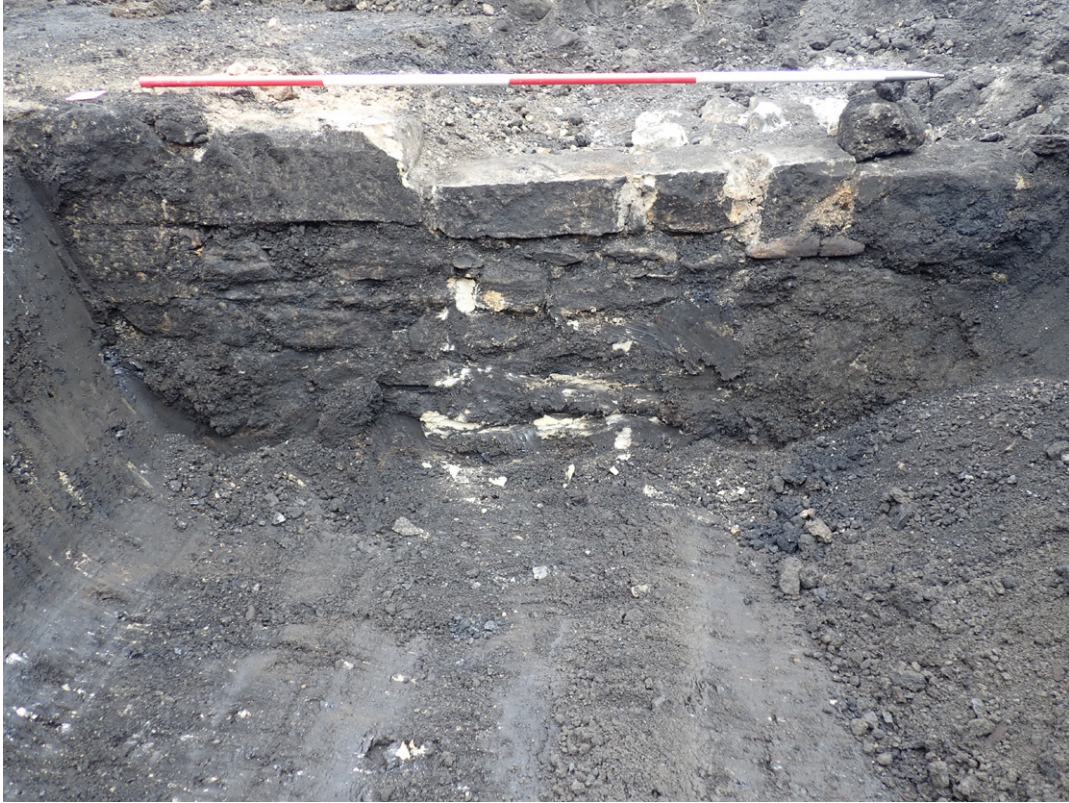
Wall **204** (Figs. 3.14 and 3.15) was part of an east to west orientated structure which measured 35m in length, 0.60m in width, and was exposed to a maximum height of 1.2m (Fig. 3.13). It was composed of perfectly squared limestone blocks, sizes varying from 0.25m long by 0.2m wide by 0.1m deep to 0.85m long by 0.6m wide by 0.28m deep. Smaller and irregularly shaped limestones were visible between the larger blocks filling the gaps in between the courses, bonded by a very degraded pinkish yellow lime mortar. Due to the project depth level requirements, most of Wall **204** was only uncovered to a maximum depth of 0.45m. But two trial pits to the south of the wall exposed the structure to a height of 1.2m where up to eight courses were identified. The south elevation of the wall revealed a perfectly squared face that would likely be replicated on the uncovered north elevation, and the remains of a pale grey lime render that probably covered the whole extension of the wall were still visible.

Fig. 3.13: South elevation of Wall 204

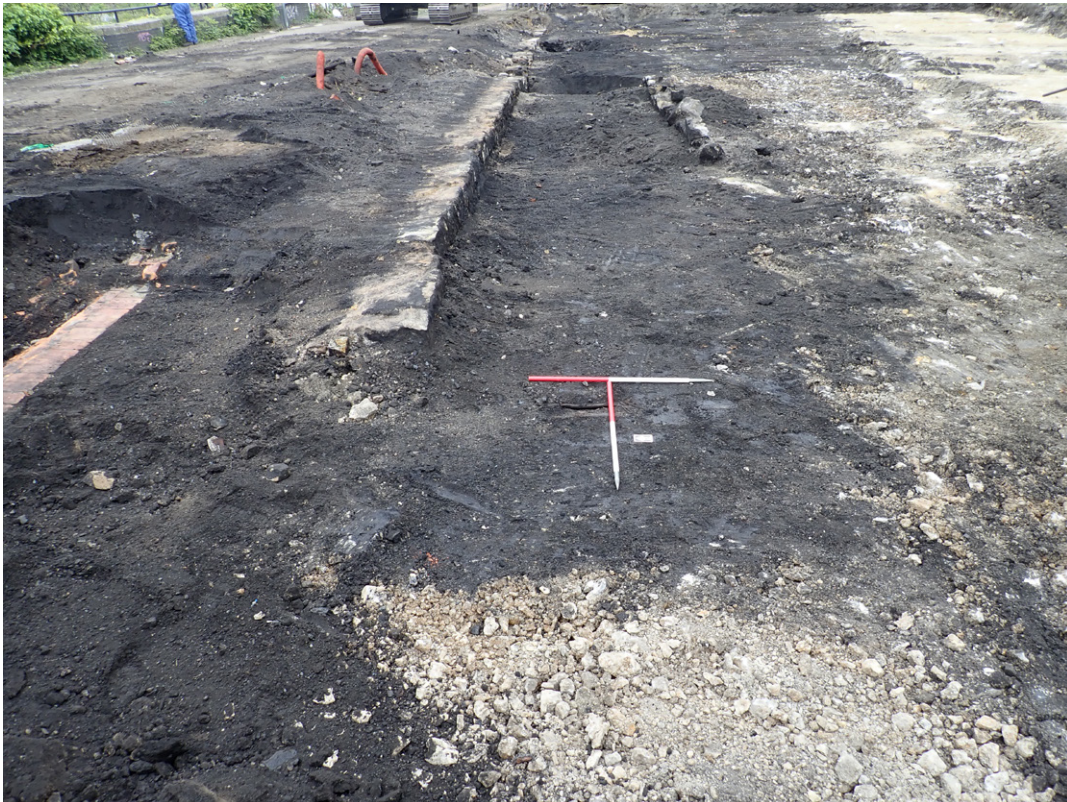
Approximately 2.5m to the south and parallel to it was Wall **206** (Figs. 3.14 and 3.15), very similar to **204** but in a more degraded condition. They seemed to belong to the same structure or have served to a common purpose. Wall **206** followed the same east to west orientation and measured 10m in length by 0.45m in width. It was exposed to a maximum height of 0.3m where only two courses were identified. It was composed of limestone blocks which appeared fragmented and damaged, sizes varying from 0.25m long by 0.2m wide by 0.1m deep to 0.65m long by 0.35m wide by 0.3m deep. Smaller and irregularly shaped limestones were visible between the larger blocks filling gaps in between the courses, bonded by a very degraded pinkish yellow lime mortar. The remains of a pale grey lime render were still visible at the top of some of the stones. The preservation condition of the wall was particularly compromised on the eastern end where the last three metres of the structure only survived in rubble form.

Fig. 3.14: Parallel Walls 204 and 206, facing east

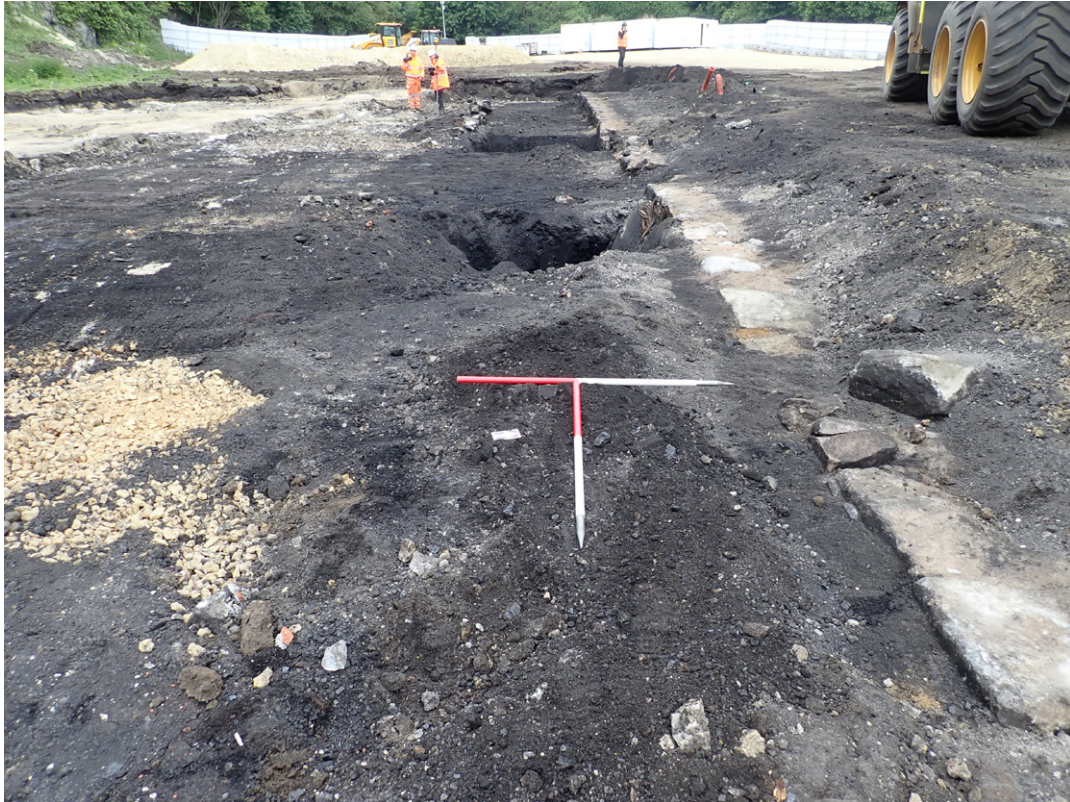
Fig. 3.15: Parallel Walls 204 and 206, facing west

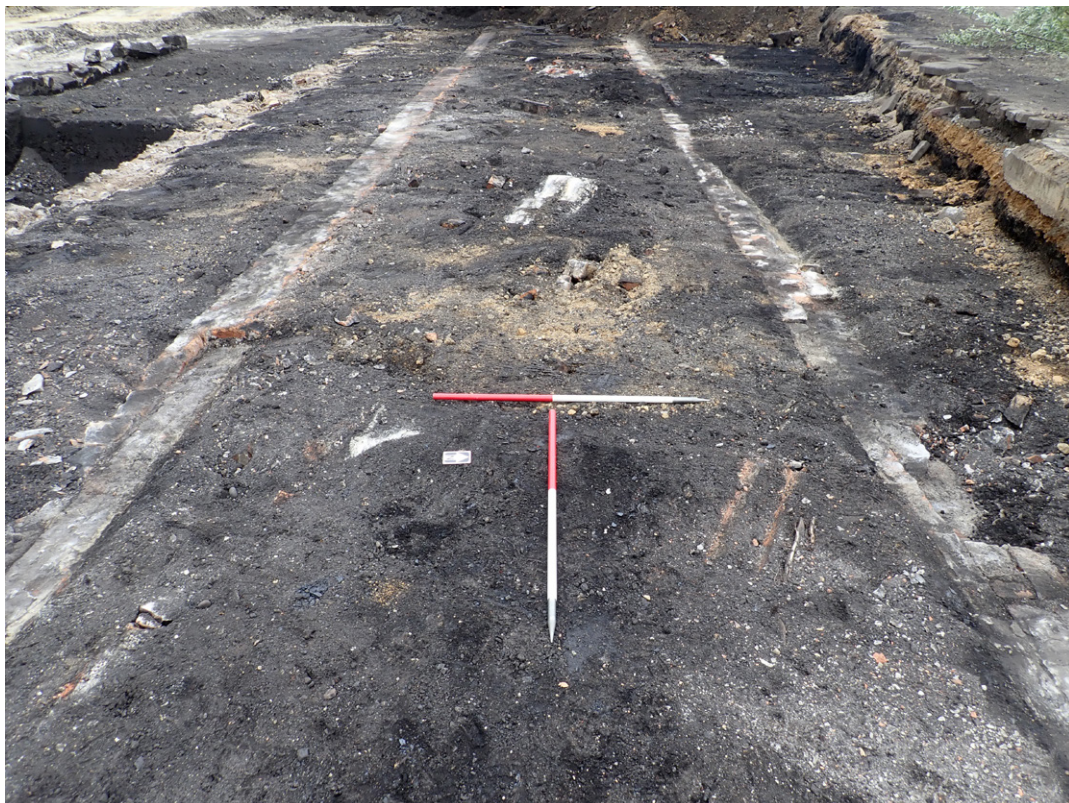
Brick Wall **207** (Figs. 3.16-3.17, 3.19 and 3.21) was found approximately 1.70m north of **204**, parallel to it on an east to west orientation. It measured 41m in length by 0.4m in width and was exposed to a maximum height of 0.33m, where up to four courses were identified. The bricks conformed to imperial measurements, 9in (235mm) length by 4.5in (115mm) width by 3in (80mm) depth and carried the inscription 'Lambton Fence House' in the frog. All bricks were laid on bed in a combination of stretcher and header, showing different bonding techniques along the extension of the wall, depending on the course or with changes sometimes occurring even within the same course. The bonding material was a pale yellow-grey lime mortar. Wall **207** continued to the east beyond the northern edge of Area 2.

Fig. 3.16: Parallel Walls 207 and 208, facing west

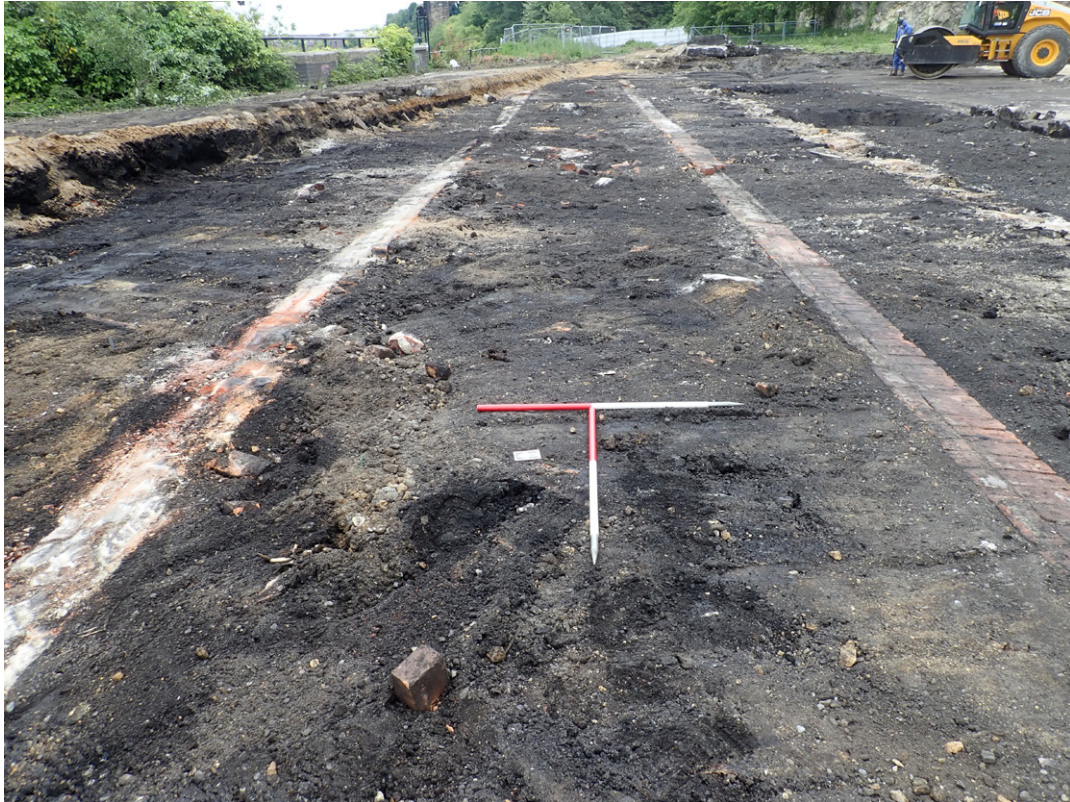
Fig. 3.17: Parallel Walls 207 and 208, facing east

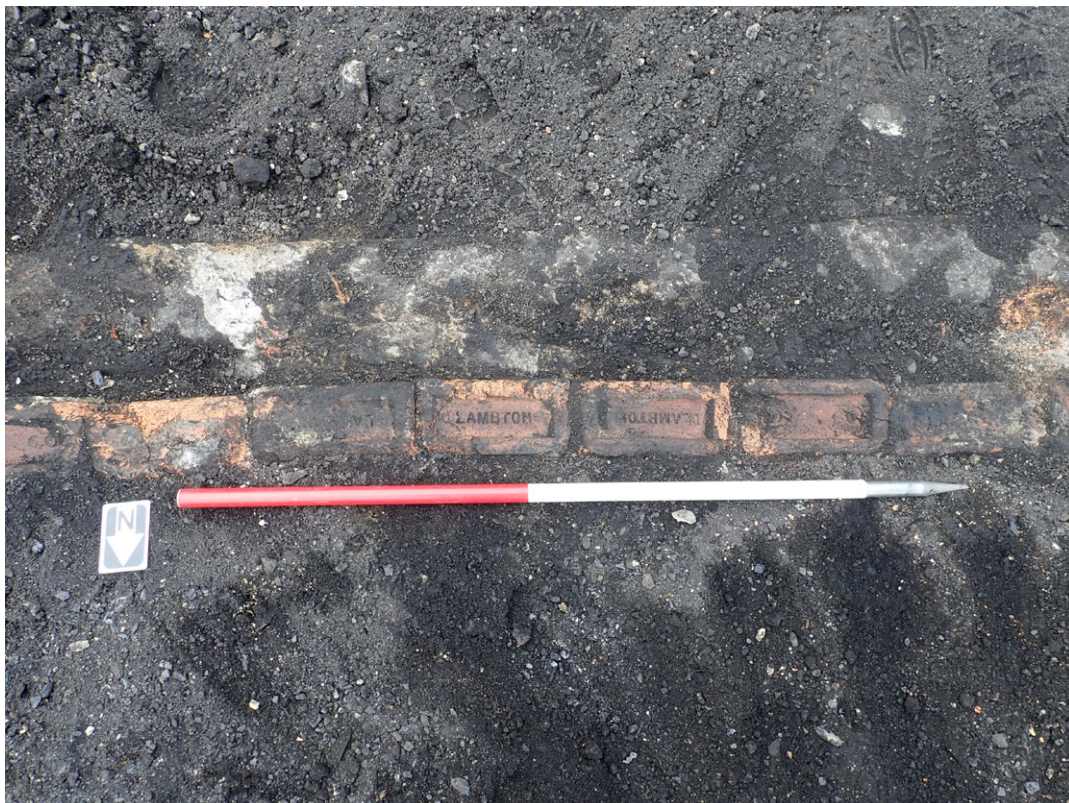
Fig. 3.18: Plan of Wall 208 showing bricks with 'Lambton' inscription

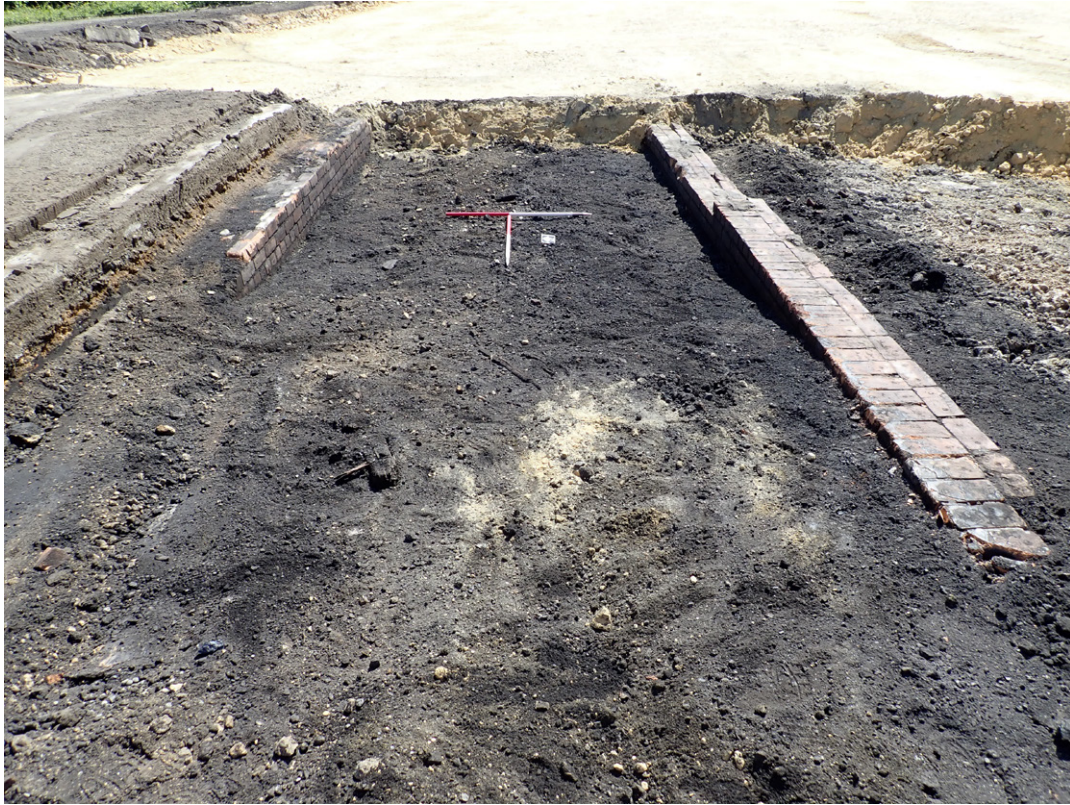
Fig. 3.19: Parallel Walls 207 and 208 in western general working platform, Area 2, facing east

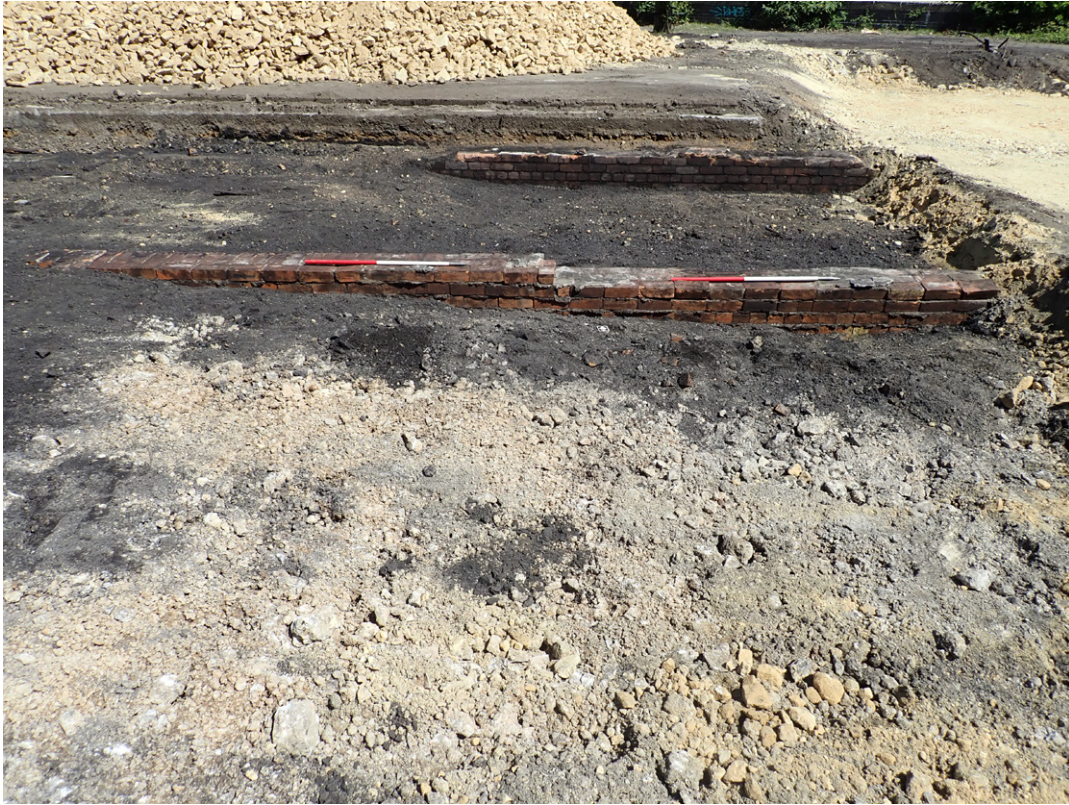
Fig. 3.21: South elevation of Wall 207

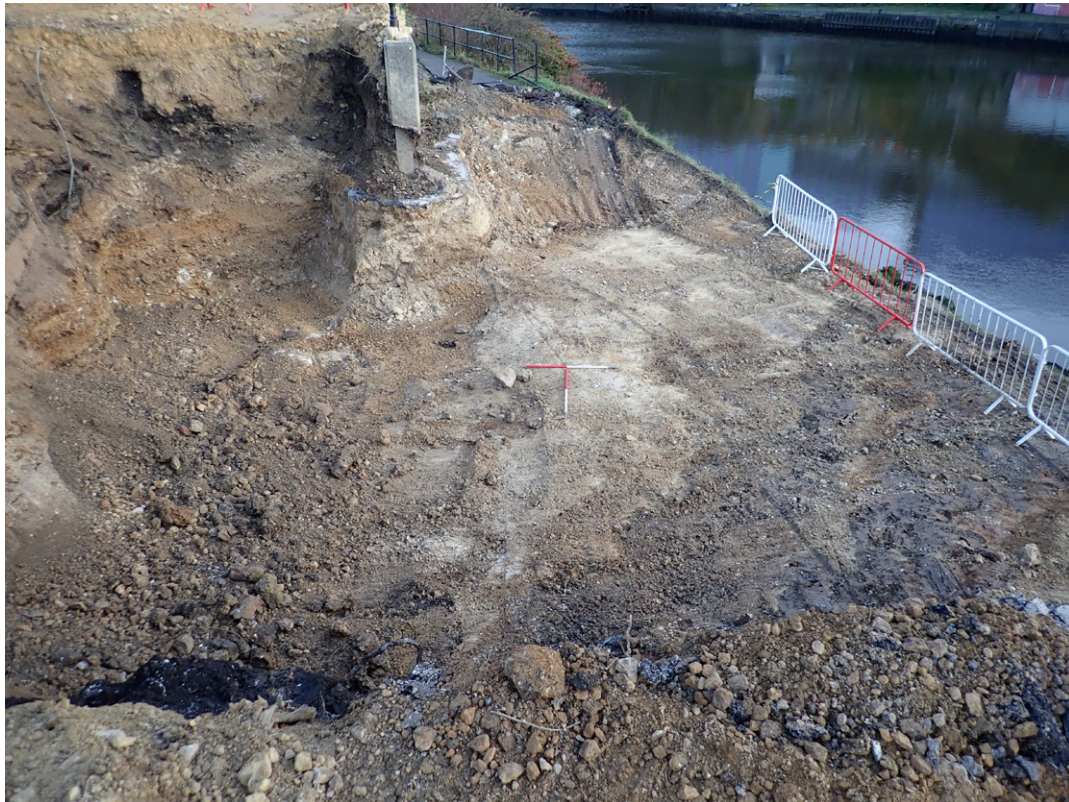
The North Pier excavation (Figs. 1 and 3.24) covered an area of approximately 20m by 8m and was archaeologically monitored to a total depth of 4m, when the excavation levels were already deep into natural geology. To achieve the area extension requirements, several modern structures were removed before or during the excavation works, including: several handrails, a west to east orientated path or narrow road composed of tarmac overlaying a foundation layer of gravels, and a north to south orientated concrete staircase that led from the upper terrace of the embankment to the river level, overlaying a foundation layer of chalk (Fig. 3.25).

Fig. 3.24: Excavation to required depth in North Pier, facing south-east

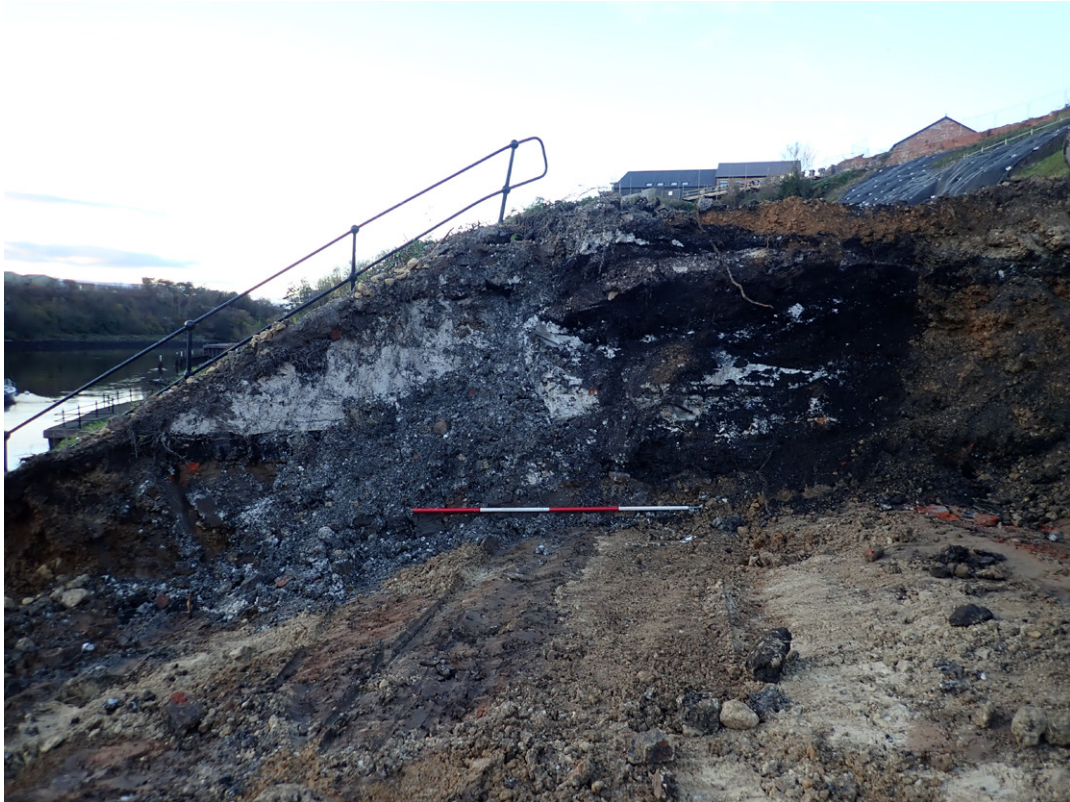
Fig. 3.25: East facing representative section in North Pier, showing Made Ground 502 and modern staircase with foundation layer of chalk

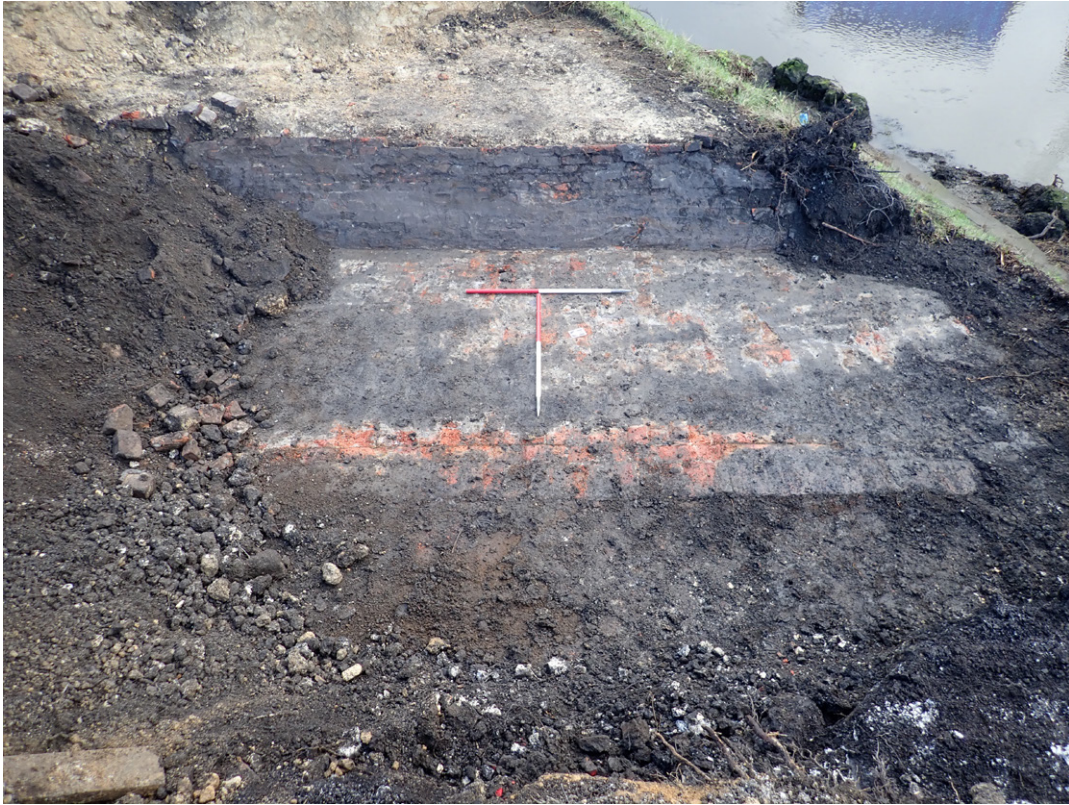
Brick Floor **505** (Figs. 3.27-3.30) was north-east to south-west orientated and measured 4.1m in length, 1.95m in width, and 0.08m in height as it was only one course high with the bricks laid on bed and as stretchers. The unfroged bricks conformed to imperial measurements, 9in (235mm) length by 4.5in (115mm) width by 2.5in (60mm) depth, and the bonding material was a pale grey concrete mortar. The floor surface presented the remains of a pale greyish-yellow lime render. Floor **505** overlaid foundation Layer **507** and abutted side walls **504** and **506**.

Fig. 3.27: North-east to south-west orientated brickwork structure in North Pier, including Walls 504 and 506, and Floor 505. Facing south-east

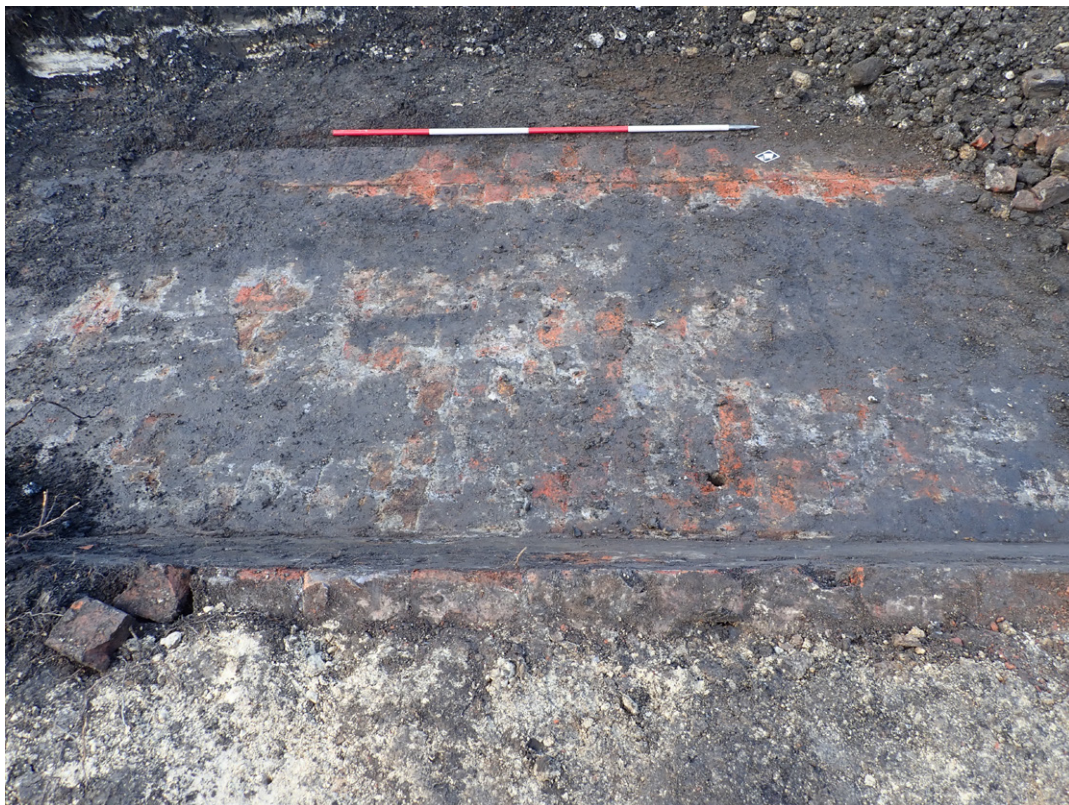
Fig. 3.28: North-east to south-west orientated brickwork structure in North Pier, including Walls 504 and 506, and Floor 505. Facing north-west

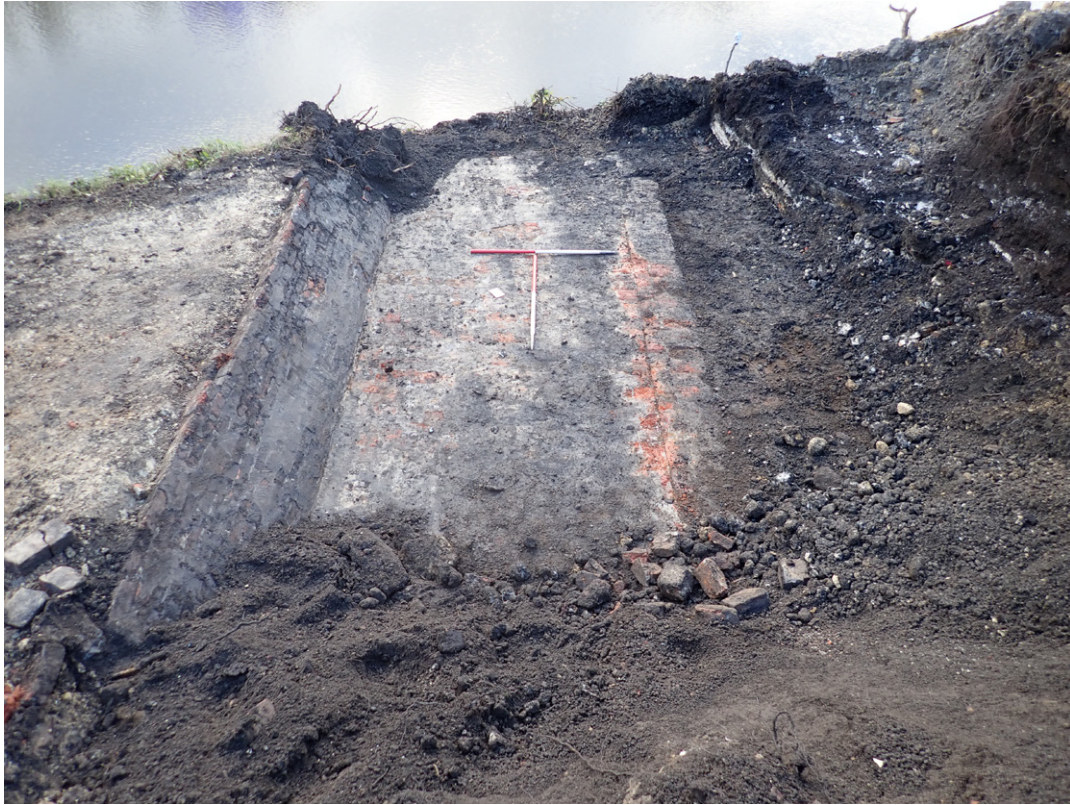
Fig. 3.29: North-east to south-west orientated brickwork structure in North Pier, including Walls 504 and 506, and Floor 505. Facing south-west

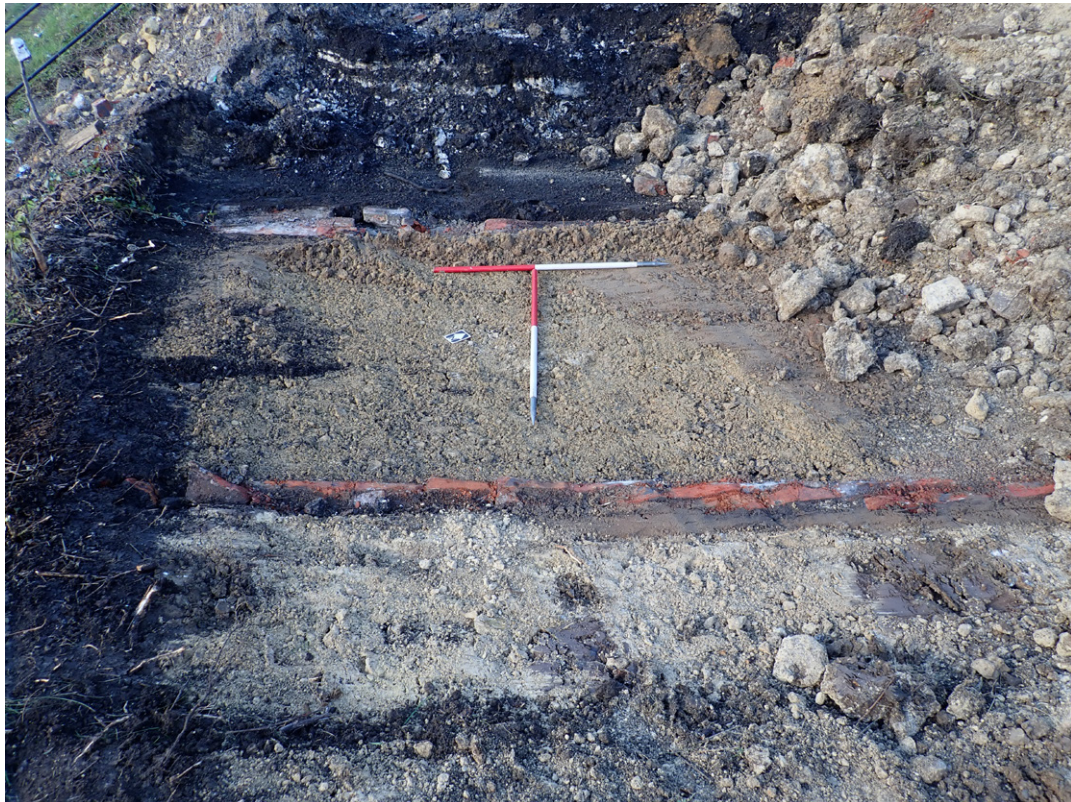
Foundation Layer **507** (Fig. 3.30) was overlaid by brick Wall **506**, measuring 4.1m in length, 1.95m in width, and 0.2m in thickness. It was composed of light brownish yellow loose silty sand with frequent small inclusions of subangular limestones. Foundation Layer **507** overlaid Natural geology **503** and abutted side walls **504** and **506**.

Fig. 3.30: Foundation Layer 507 under Floor 505, facing north-west

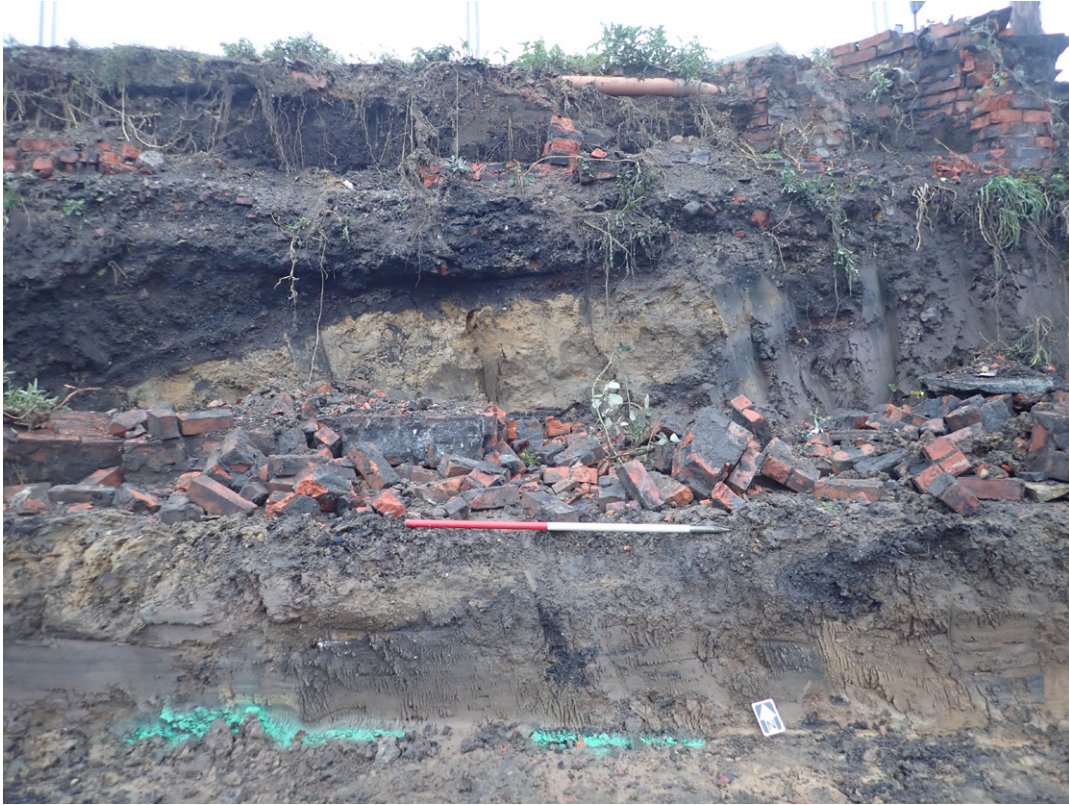
Topsoil **601** consisted of dark greyish brown sandy silt, loose, with a heavily rooted grass cover and inclusions of modern refuse, metal and building waste. It had a depth between 0.1-0.15m and overlaid Made Ground layers **602** and **603**. Made Ground **602** consisted of dark grey-black sandy silt, friable, with frequent inclusions of coal and ashes. It also contained a high volume of construction waste, metal and modern refuse. Its thickness varied from 0.4m at the top of the slope to 0.1m at the bottom and was only present on the north-eastern corner of the North Abutment area, overlaying Made Ground **603**. This consisted of mid-yellowish/orangey brown silty clay, friable, with occasional inclusions of construction waste (Fig. 3.35).

Fig. 3.35: South facing representative section in North Abutment, showing concrete Structure 605, and Made Grounds 602 and 603

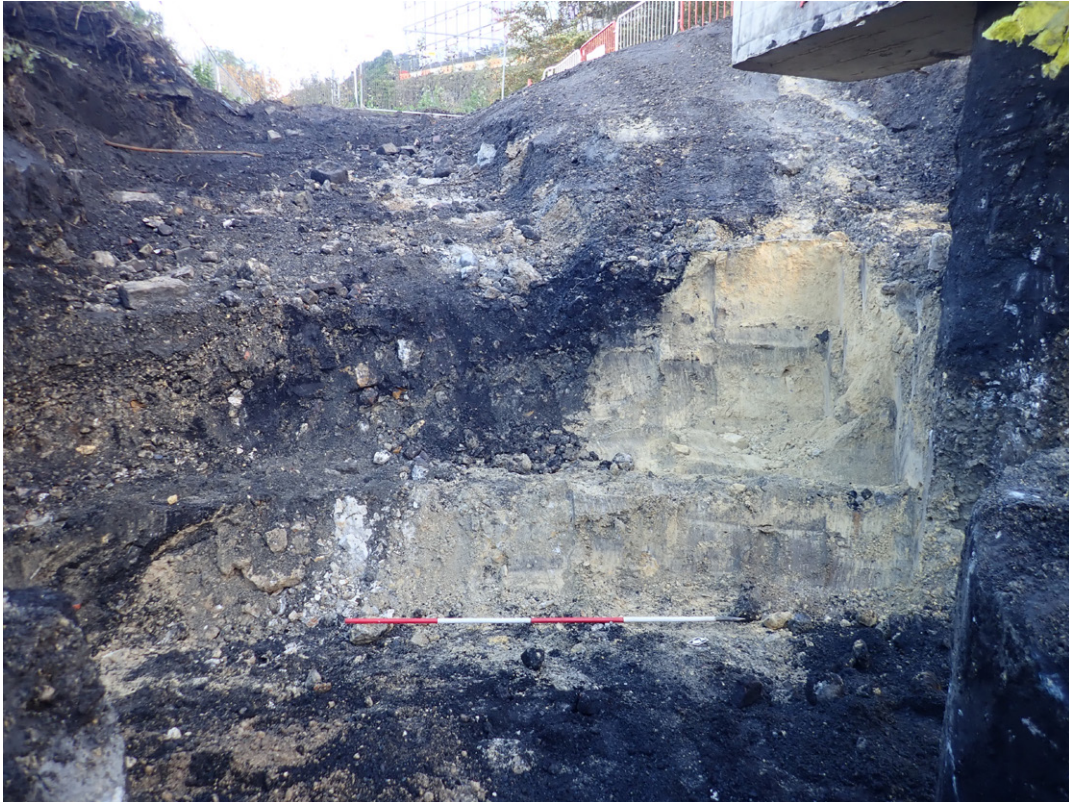
Fig. 3.41: West facing representative section in South Pier pit showing Made Grounds 402 and 403, approximately 5.5m below ground level

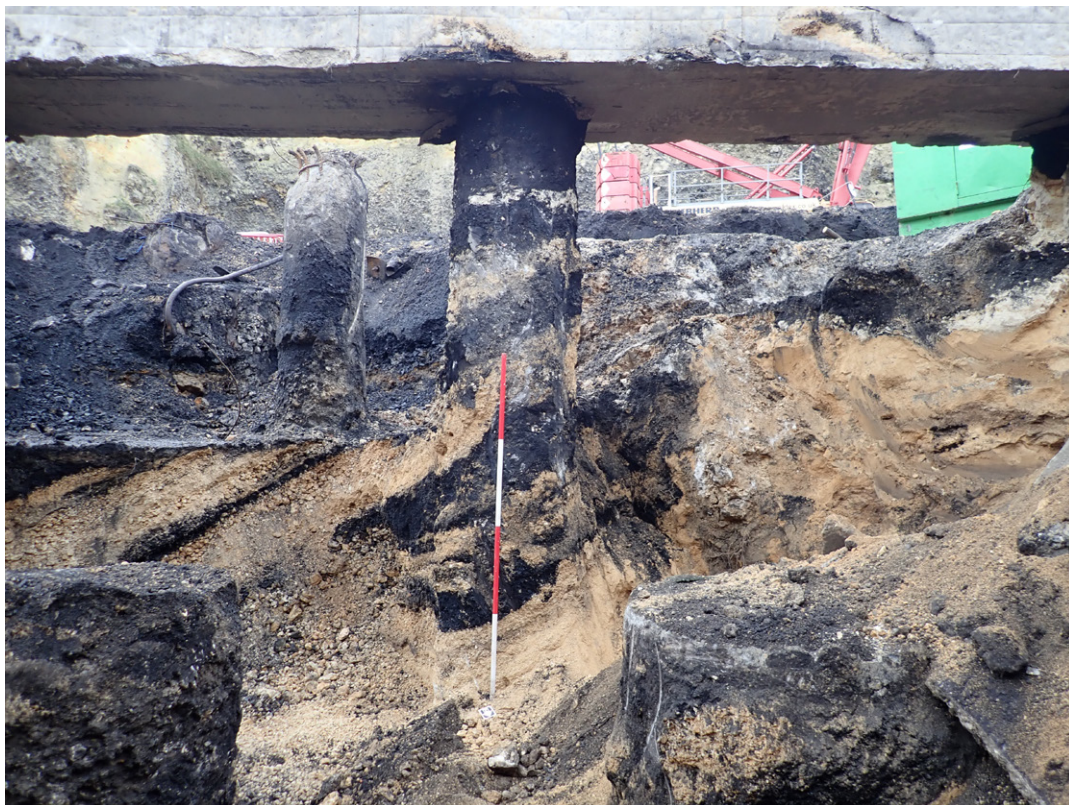
Fig. 3.42: North facing representative section in South Pier pit, showing Made Grounds 402 and 403, approximately 5.5m below ground level

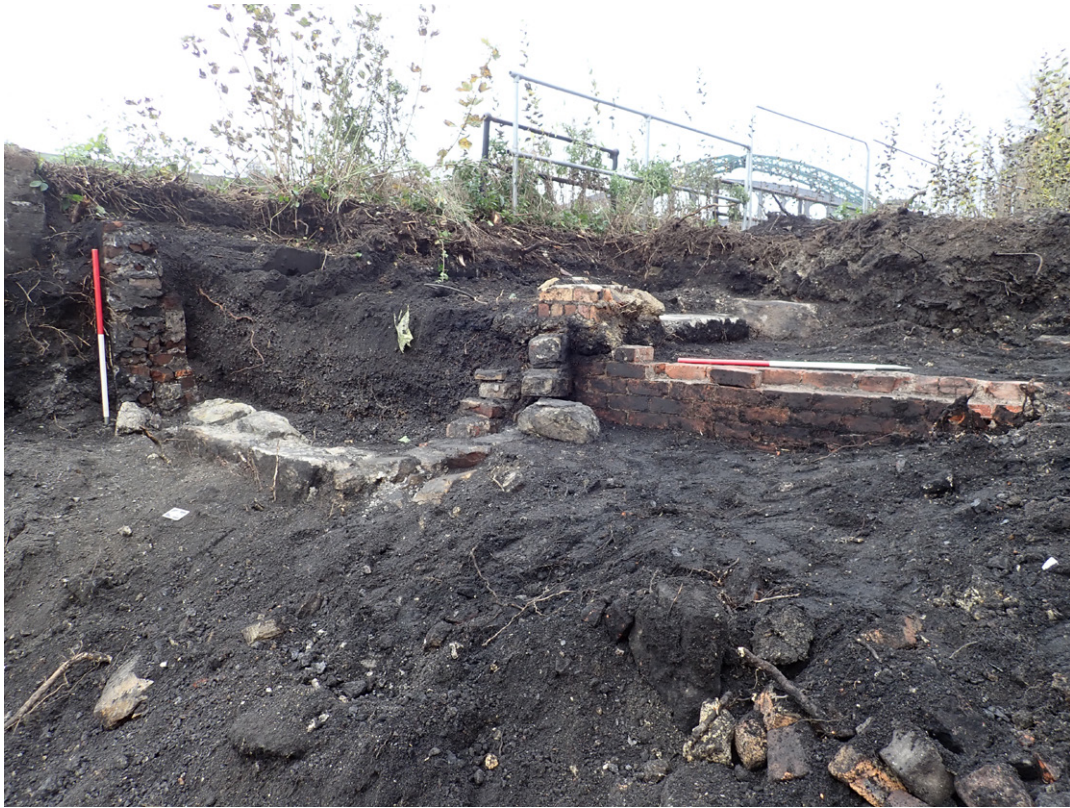
A likely similar purpose had the wall structures uncovered in the north-eastern access ramp of the South Pier (**404, 405, 406, 407, 408** and **409**), although there was no possible identification of any of these structures in the historical maps and photography. The remains exposed at lower depths on the north-western access ramp of the South Pier (Wall **410**) and in particular on the north-eastern corner of the South Pier pit area (Walls **415** and **416**) suggest earlier industrial activity, perhaps relating these substantial structures to the stone foundations of the coal drops, already active in the early 19th century.

Fig. 3.43: Structures 404, 405, 406, 407, 408 and 409, facing north-east

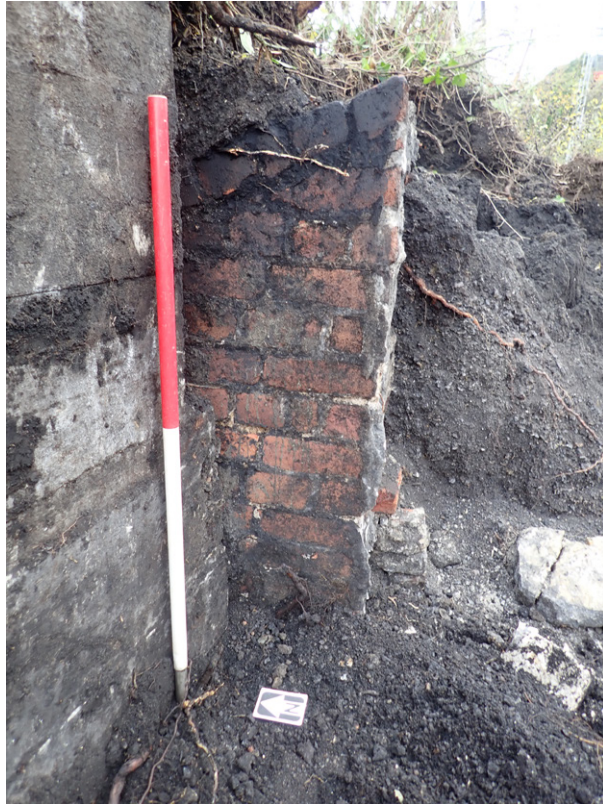
Fig. 3.45: West elevation of Wall 404

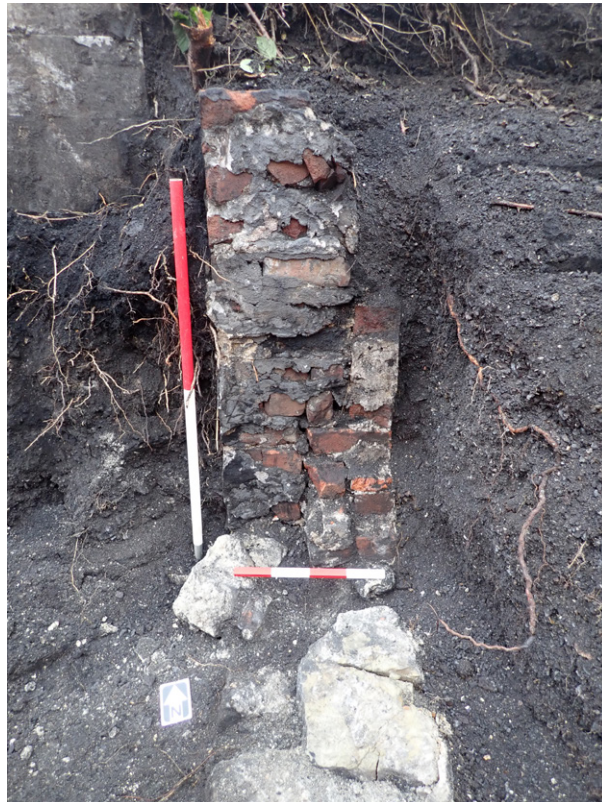
Fig. 3.46: Profile of Wall 404
