New Wear Footbridge Sunderland Tyne and Wear

Archaeological Watching Brief
Report No. 4414

Archaeological Watching Brief

Report No. 4414

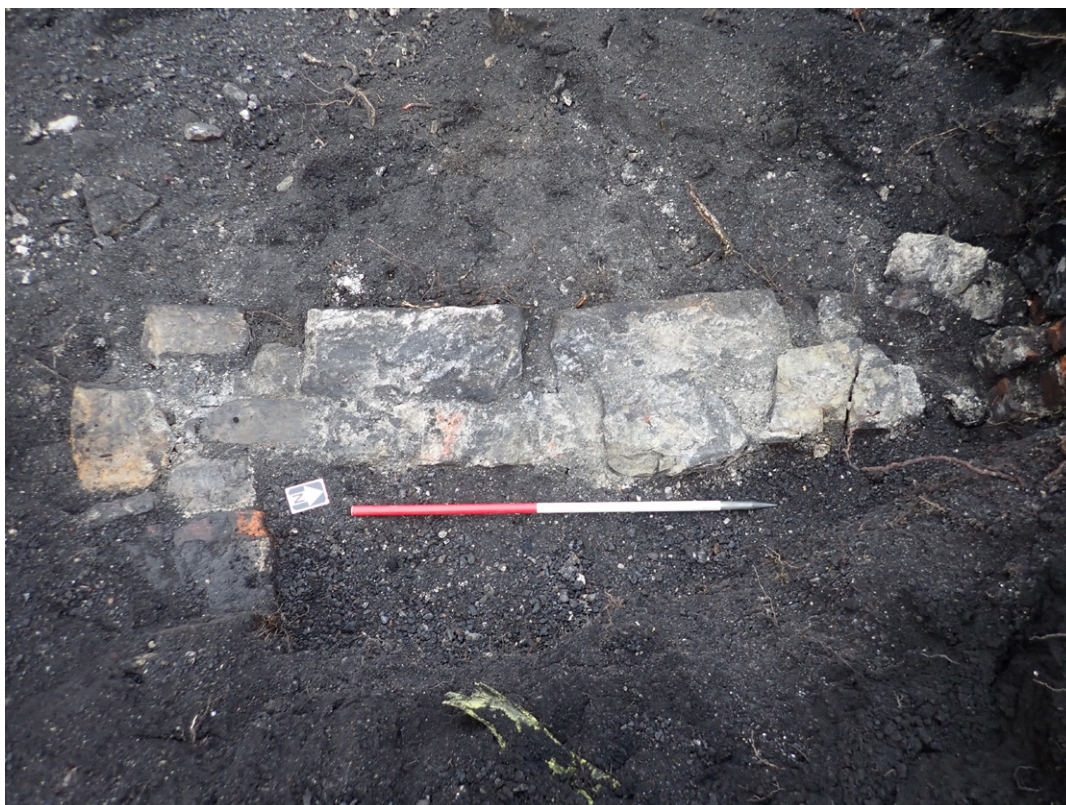
Fig. 3.48: Plan of Wall 405 and 406
