HERITAGE, DESIGN AND ACCESS STATEMENT FOR WORKS TO GREAT BRAGMANS FARM HOUSE, BRAGMANS LANE, BELSIZE, SARRATT (PHASE 2)

JOB NO: 158-74

15 FEBRUARY 2024

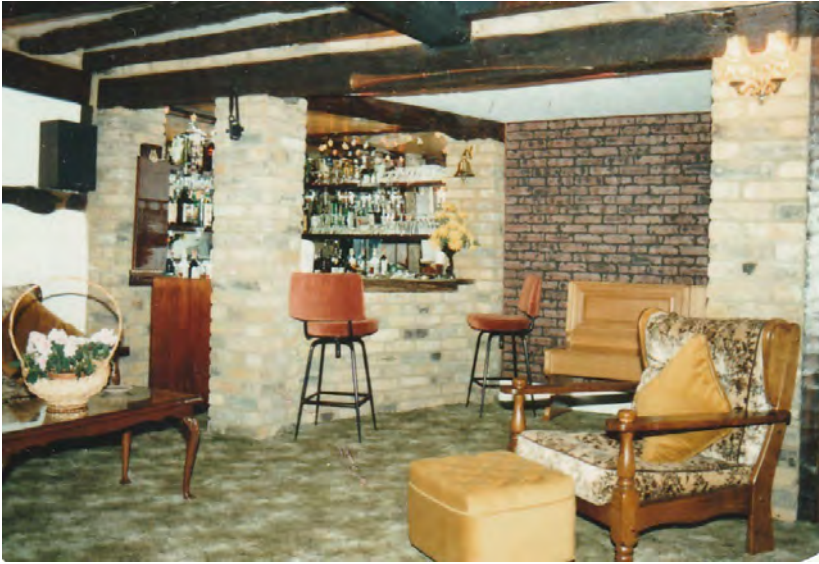
Fig 9:

Mid 20th century (between 1959-1986), showing Room G2 after the barn to the west end had been converted to residential accommodation and this space became a living area. It has been subject to further alteration since as the bar has been removed and brick piers replaced by a timber post. (Photograph from private collection)

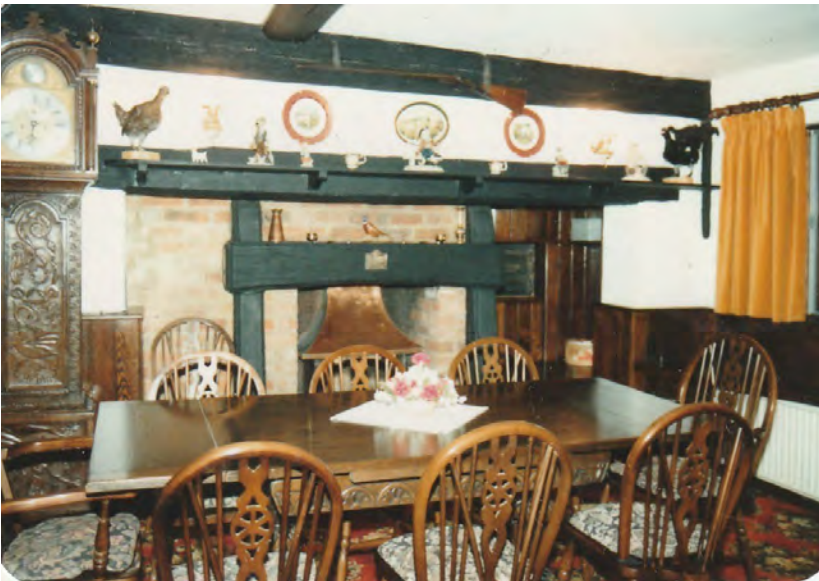
Fig 10:

Mid 20th century (between 1959-1986), showing Room G4 with the brickwork infill within the fireplace already in-situ. (Photograph from private collection)

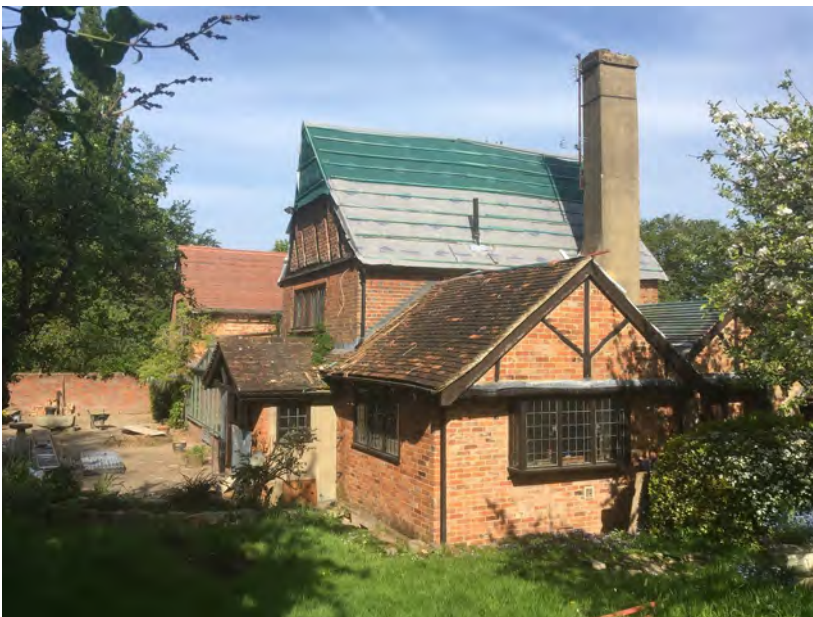
Fig 2:

Great Bragmans Farm House, Side (east) elevation, showing two storey historic cross wing with mid 20th century porch to south gable end and c.1986 extension to side.

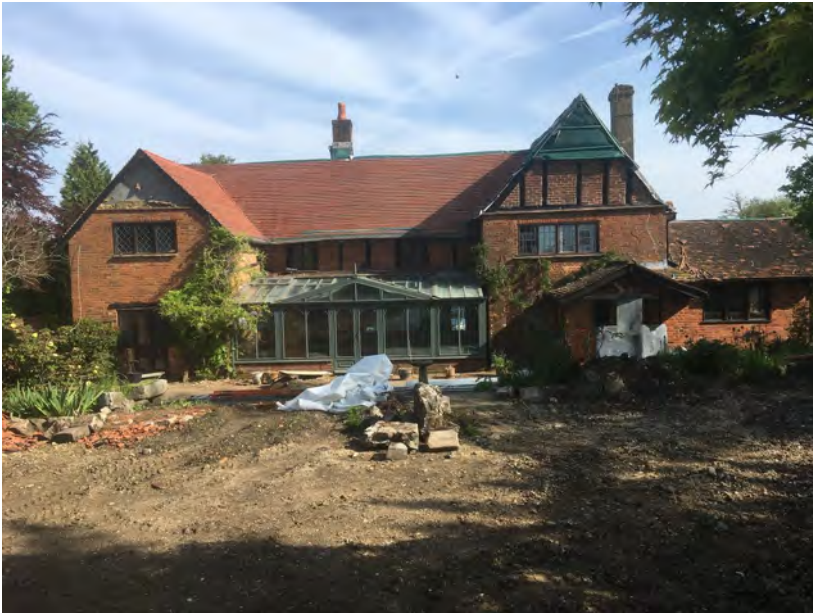
Fig 3:

Great Bragmans Farm House, showing rear (south) elevation with historic hall as central two storey element with two storey historic cross wing to east (right hand side of photograph) and two storey c.1988 extension to west (left hand side of photograph). The conservatory in the middle was added c.2001.

- The proposal is to replace the conservatory with a new conservatory designed in oak with a flat solid roof containing 3 no. rooflights. The change in roof pitch and having a largely solid roof will be critical to keeping the space warmer in winter and reducing heat build-up from solar gain in summer. It is intended that the simple form of the conservatory will not compete with the gabled ends of the original cross wing and c.1988 extension and will provide better balance to the composition of the rear elevation

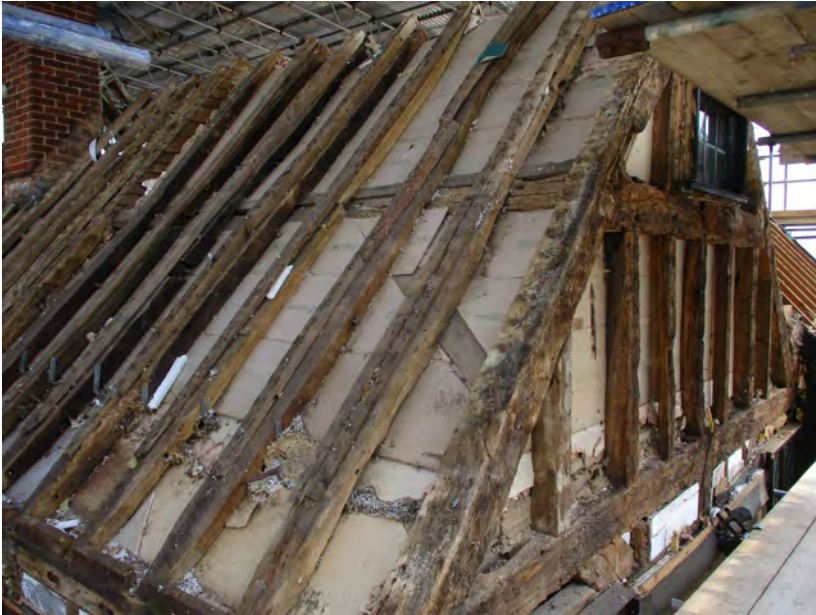
Fig 7:

North roof slope of historic hall looking along historic roof structure from west gable end.

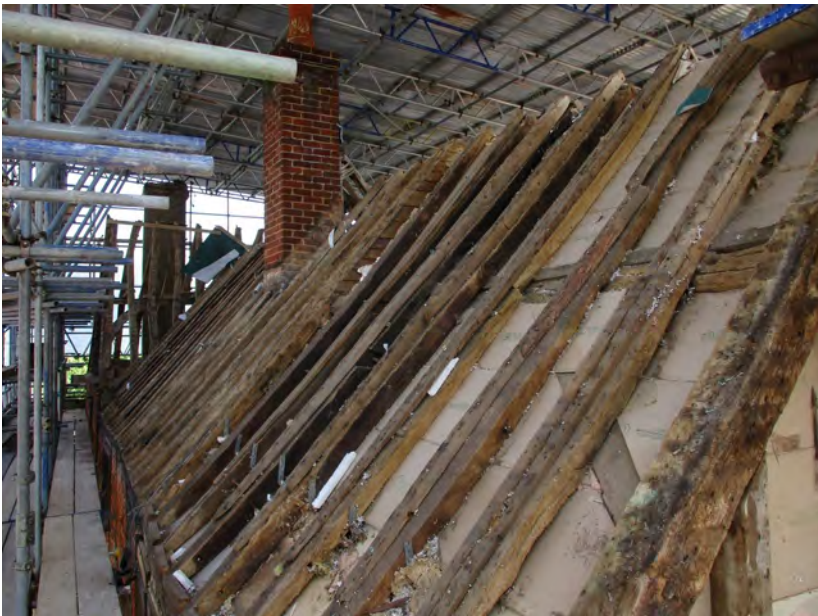
Fig 8:

North roof slope of historic hall looking east along historic roof structure from west end.

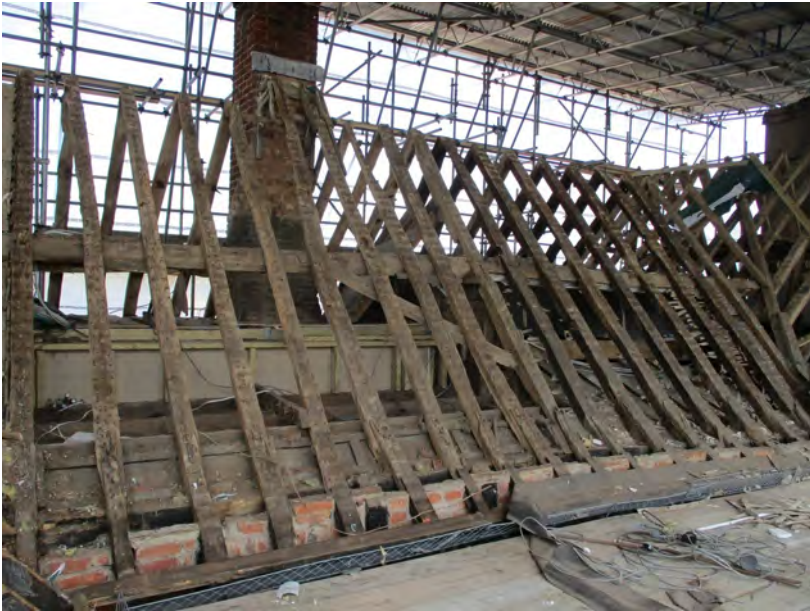
Fig 9:

South roof slope of historic hall, showing historic roof structure.

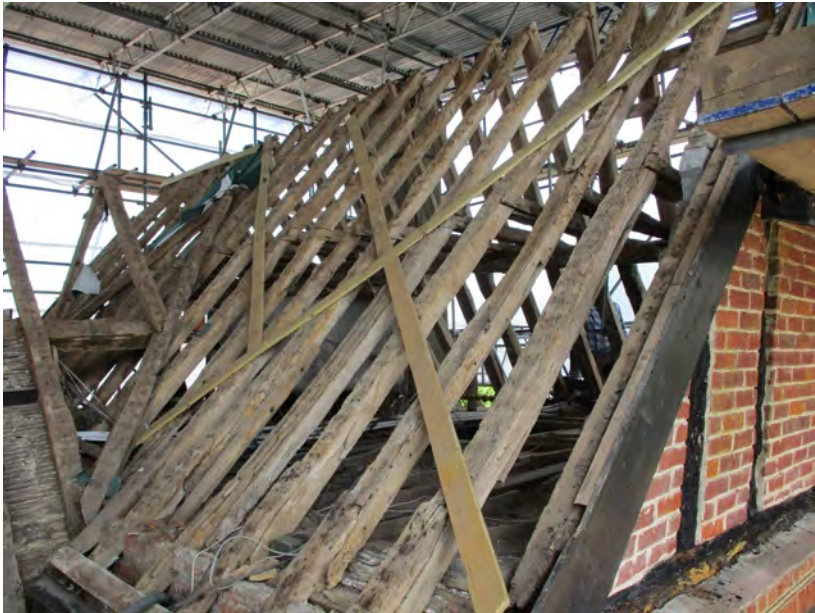
Fig 11:

West roof slope to cross wing showing historic roof structure.

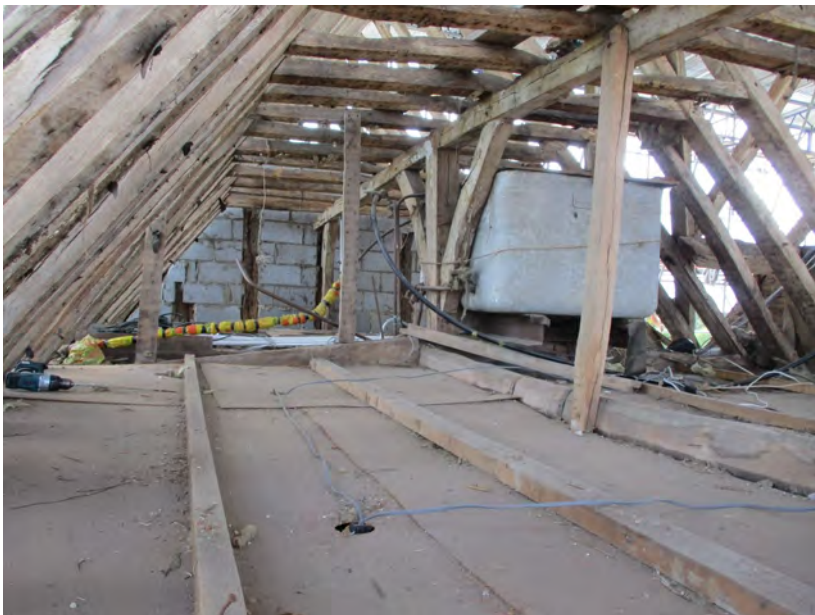
Fig 12:

Roof structure of cross wing looking south through the roof structure.

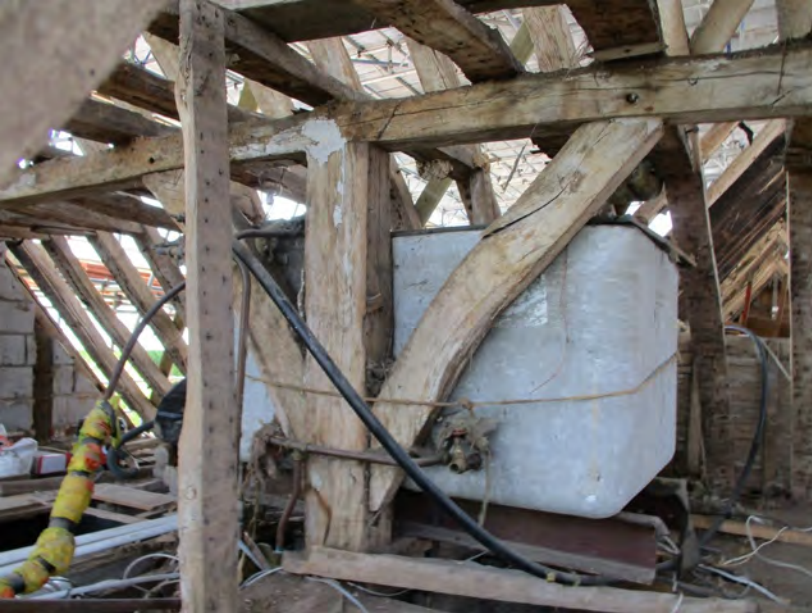
Fig 13:

Roof structure of cross wing showing crown post.

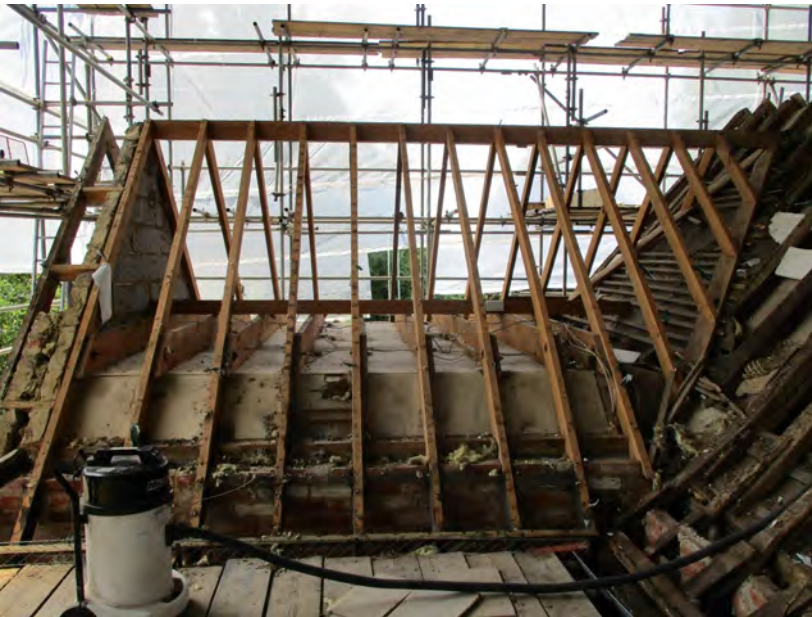
Fig 14:

Roof structure of c.1988 two storey extension for comparison.

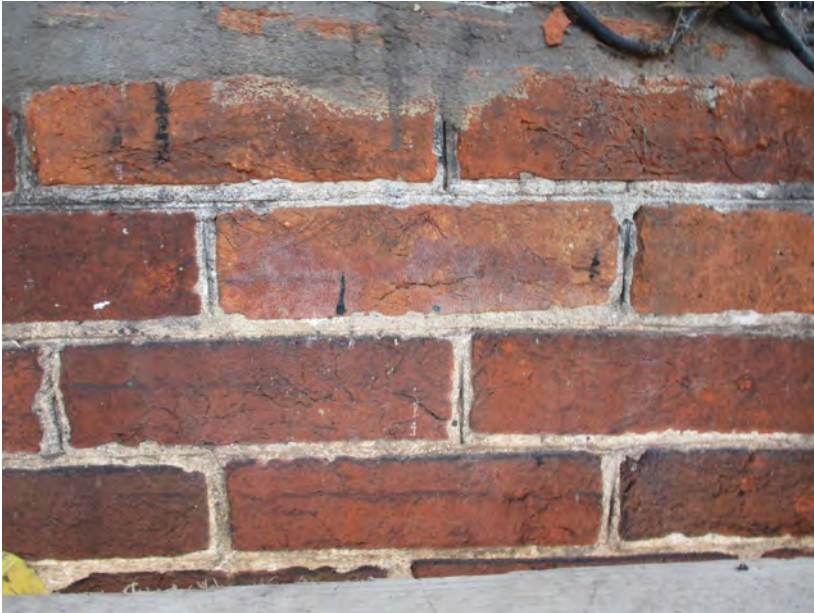
Fig 15:

North elevation of historic hall, brickwork to upper part of wall, showing one type of brickwork and mortar found in the construction of the building.

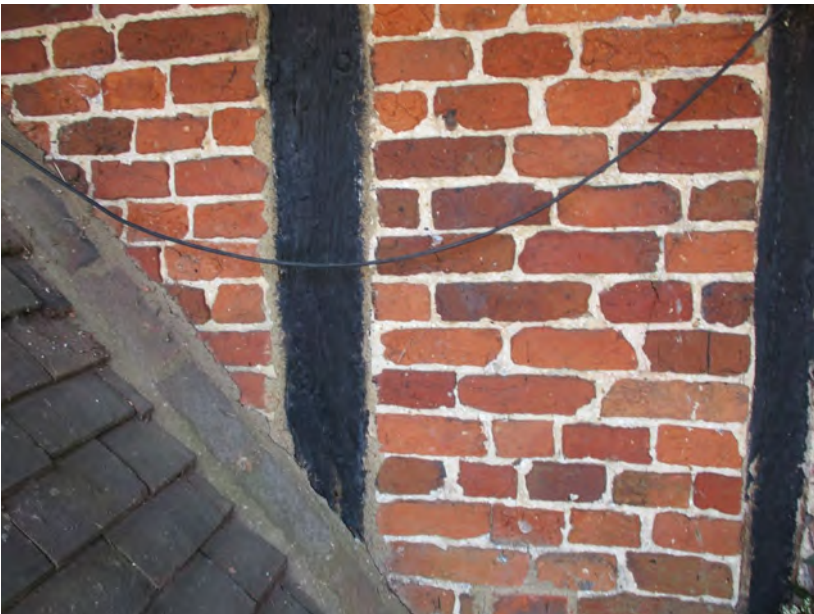
Fig 16:

North elevation of historic hall, brickwork and mortar to upper part of wall between studwork adjacent to the porch, showing one type of brickwork found in the construction of the building.

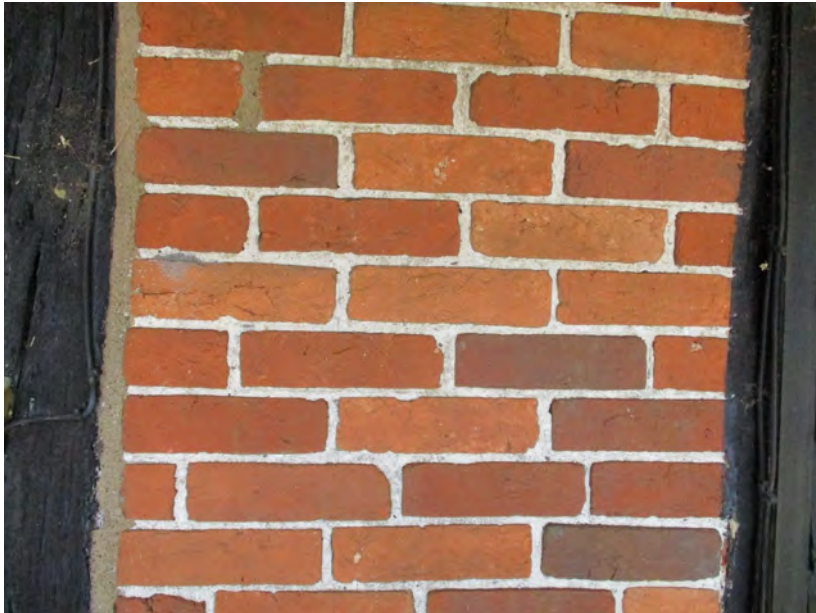
Fig 17:

North elevation of historic hall, brickwork and mortar to upper part of wall between studwork, showing one type of brickwork found in the construction of the building.

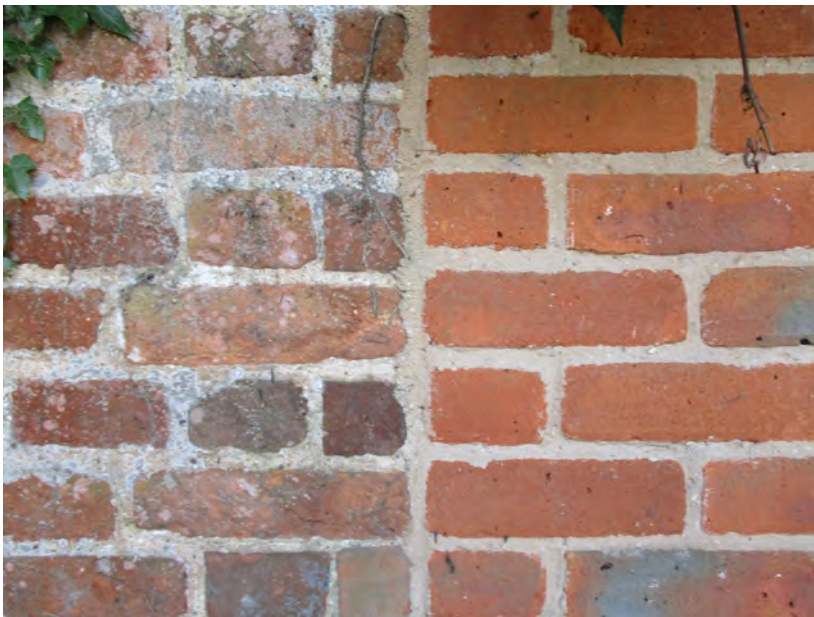
Fig 18:

North elevation of historic hall, brickwork and mortar to lower part of wall showing one type of brickwork found in the construction of the building.

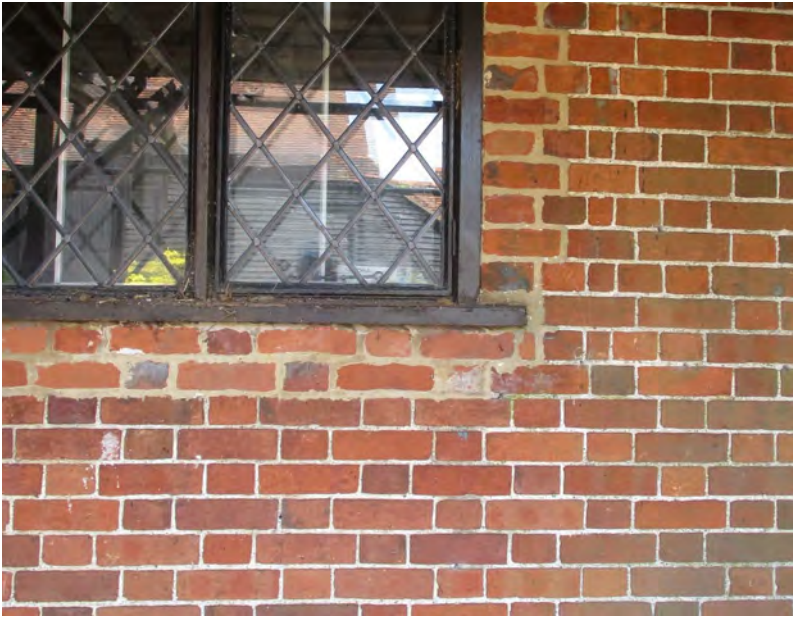
Fig 19:

North elevation of historic cross wing, brickwork and mortar to casing brickwork, showing one type of brickwork found in the construction of the building.

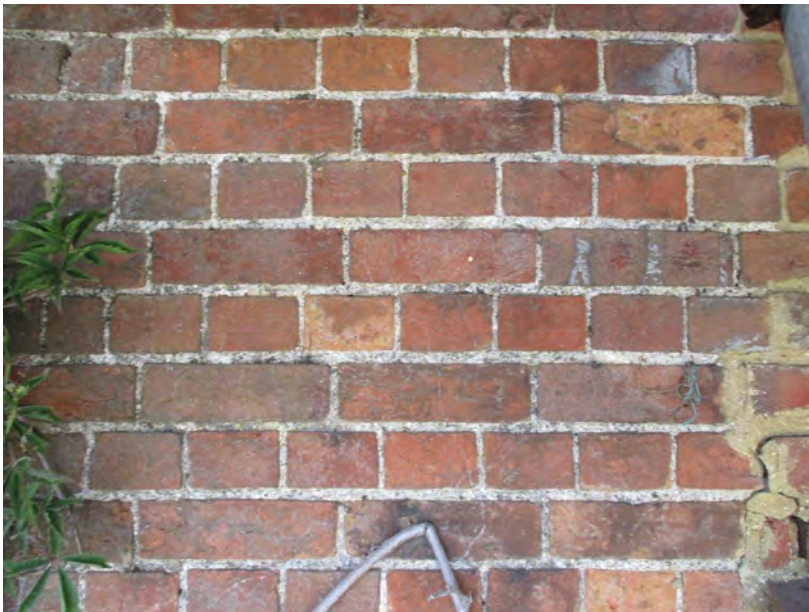
Fig 20:

South elevation of historic cross wing, brickwork and mortar to casing brickwork, showing one type of brickwork found in the construction of the building.

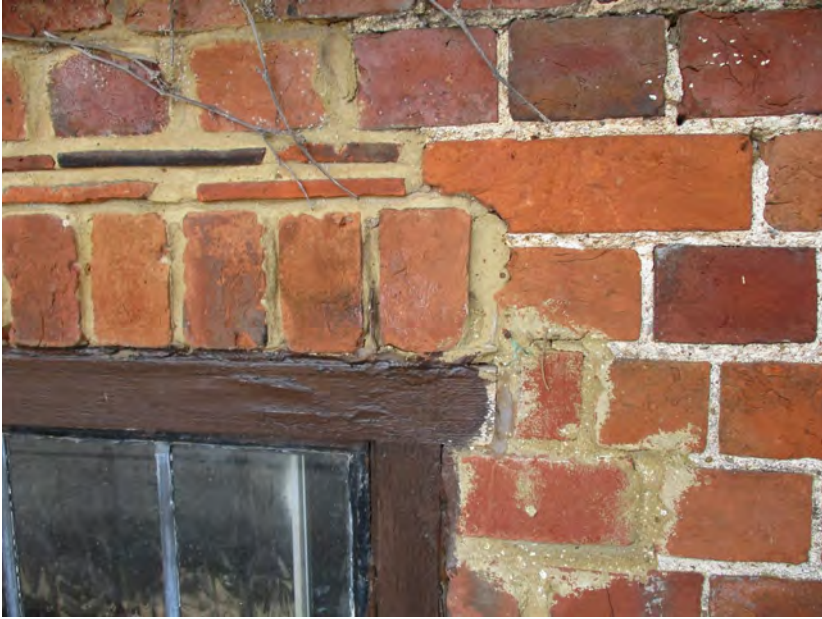
Fig 21:

South elevation of historic cross wing, brickwork and mortar to casing brickwork, showing an example of how brickwork detailing was impacted by the insertion of “new” windows in the mid 20th century.

- Replace existing mid-20th century single glazed leaded light windows with double glazed timber casements presenting central horizontal glazing bar

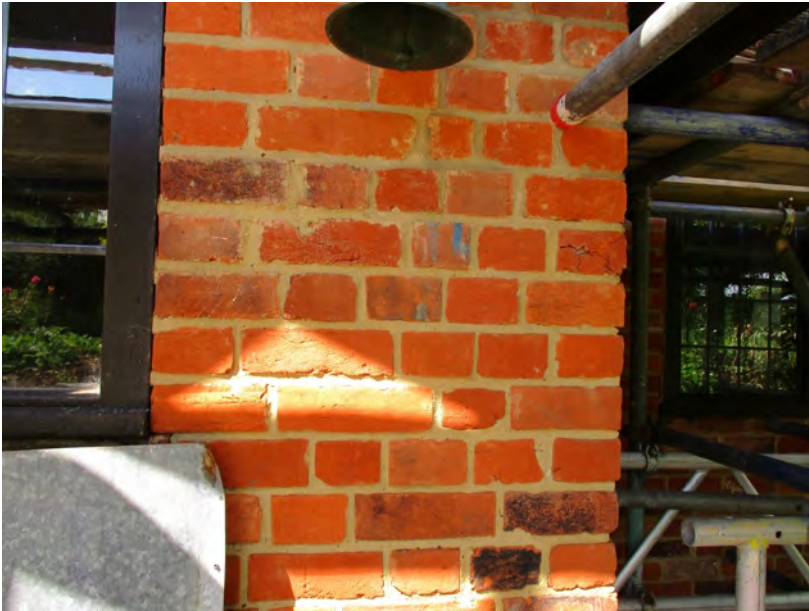
Fig 23:

South elevation mid 20th century porch, showing modern brickwork.

- The existing porch will be taken down to facilitate landscaping and the creation of level access into the building and to facilitate repairs to the historic timber frame behind. Some of the historic timber frame behind the porch is decayed and is being repaired and this could only be undertaken following partial taking down of the porch. The timber frame repairs were approved under listed building consent 23/1926/LBC and specifically identified in the approved timber frame repair schedule

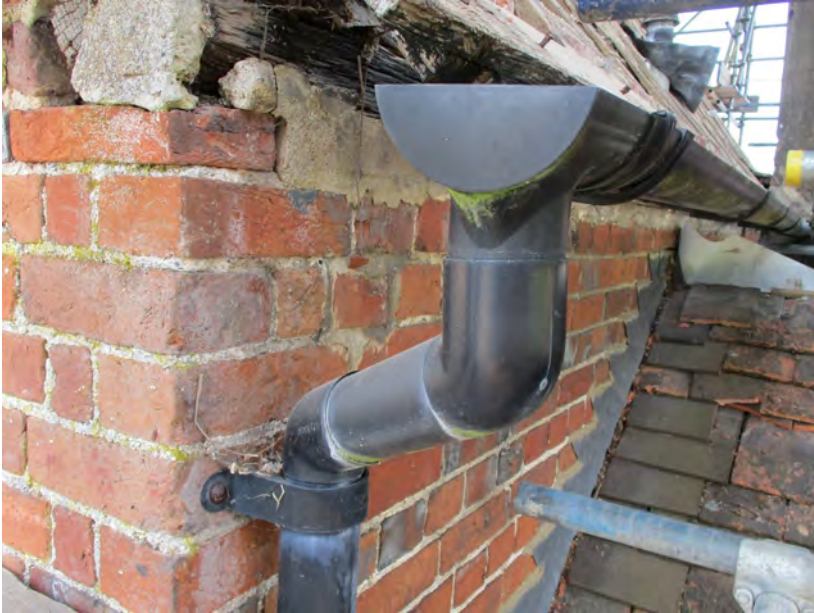
Fig 25:

Cross wing, east elevation showing an example of extant plastic guttering found on the building.

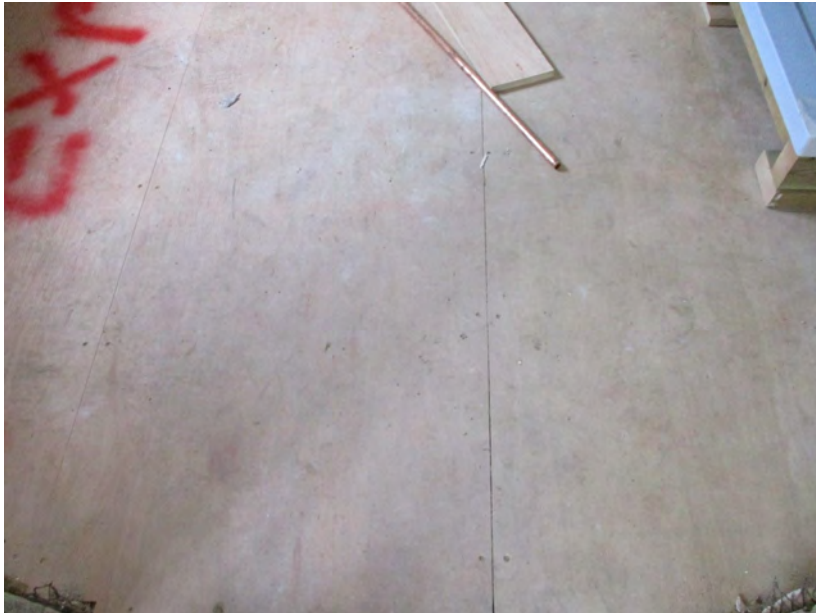
Fig 31:

Room F3, showing floor plyboarding floor finish as an example of extant flooring which is found in room F2 and F3.

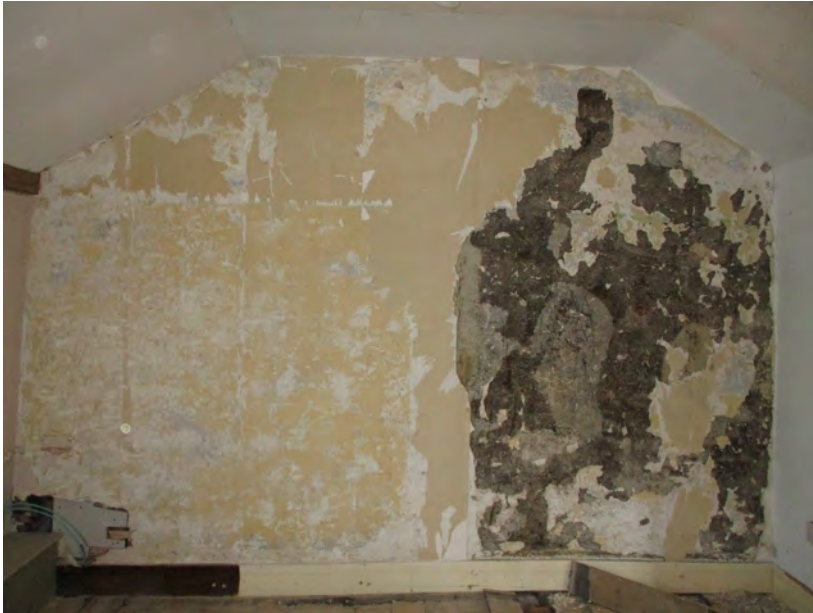
Fig 35:

Room F5, showing the east wall where historic earthen plaster/daub survives behind a later plaster finish.

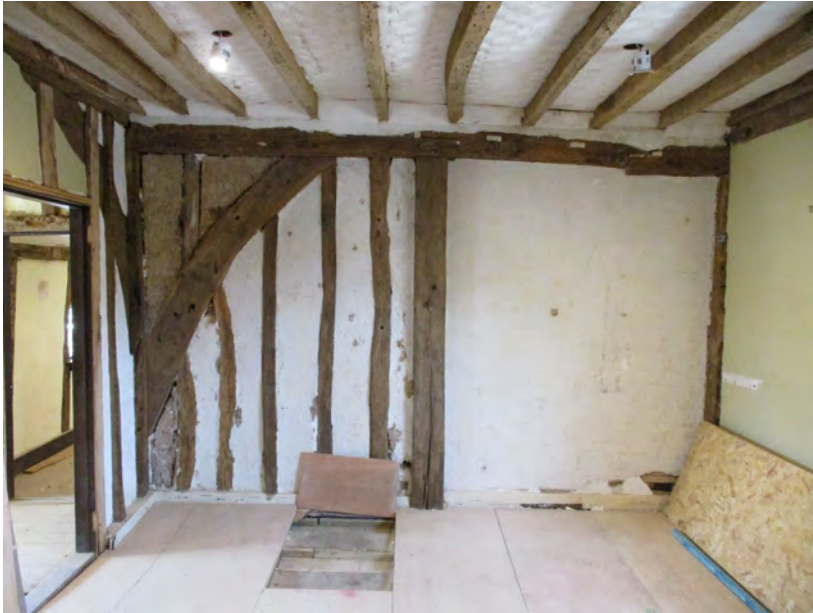
Fig 39:

Room F6, showing the west internal wall which contains historic timber frame and wattle & daub infill.

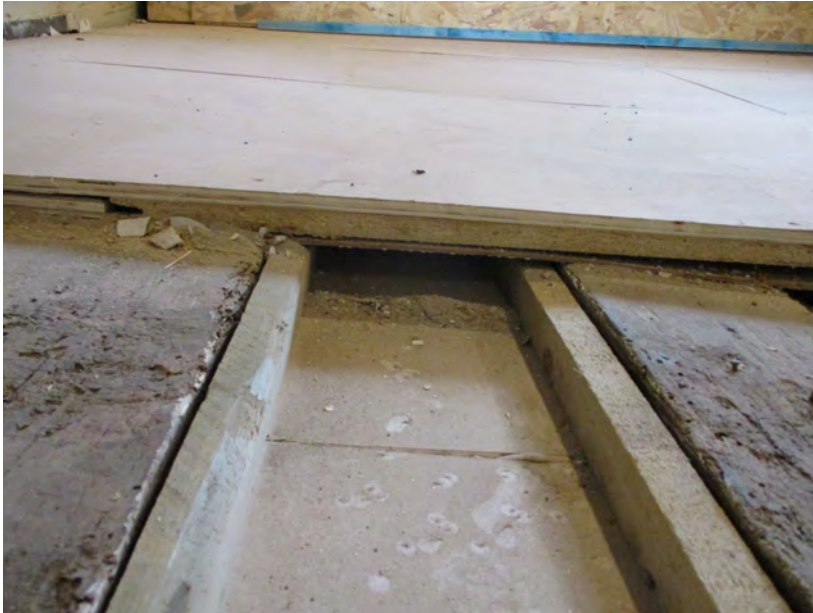
Fig 41:

Room F6, showing the extant floor construction which is formed of layers of chipboard and wood board and it is not historic. The underside of ceiling below can also be seen and this shows the extant ceiling as a plasterboard material.

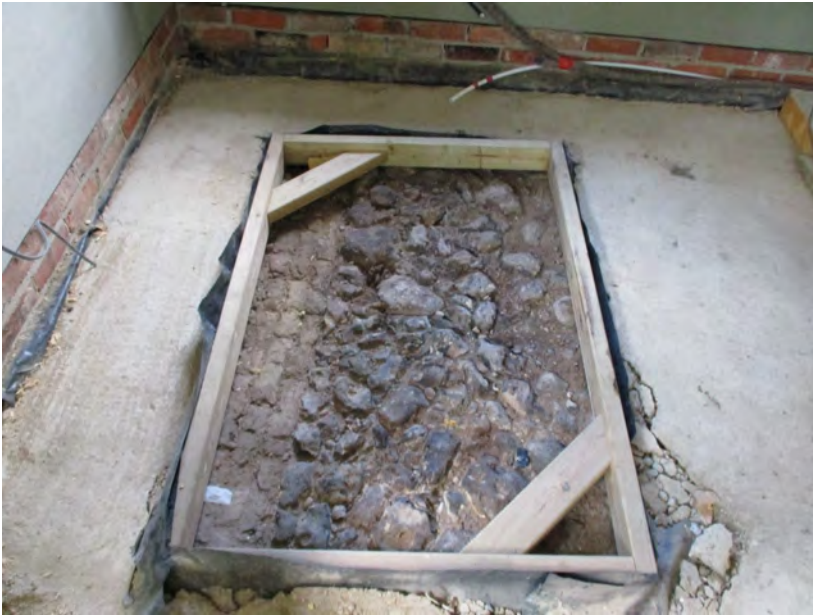
Fig 49:

Room G2, showing a section of "original" barn flooring which survives beneath the extant later concrete floor finishes.

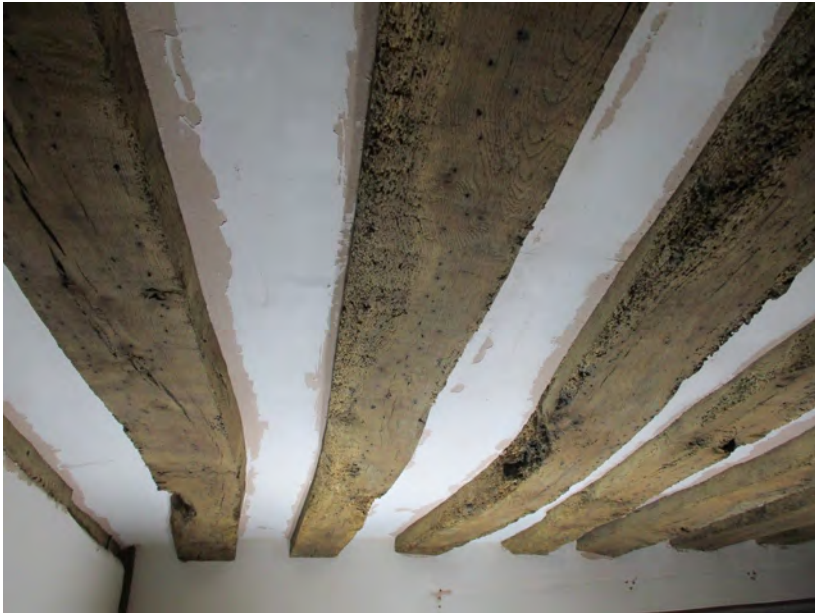
Fig 55:

Room G6, showing the ceiling joists which are a surviving original feature of this cross wing. The extant ceiling finish between the joists is plasterboard which exists in many ceilings throughout this building.

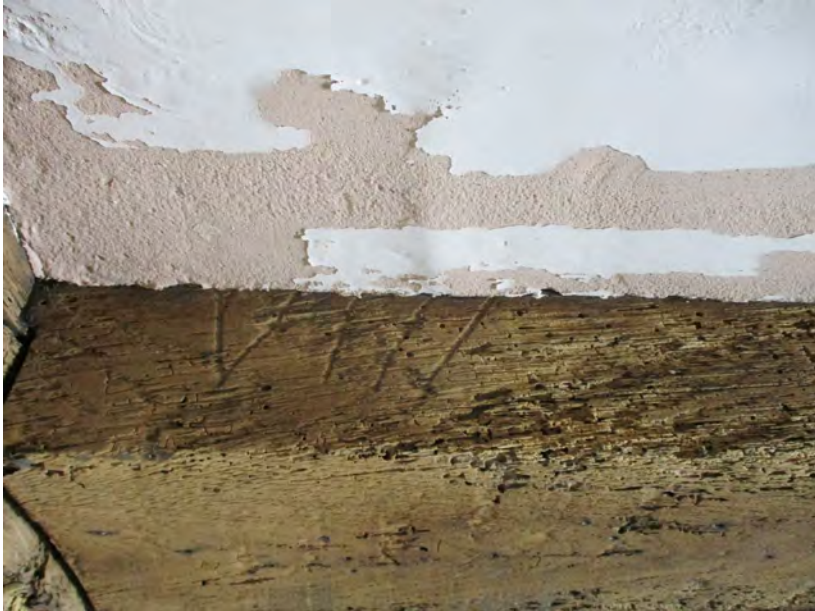
Fig 57:

Room G6, showing the carpenters markings which can be found on ceiling joists. These markings are a significant feature of the building.

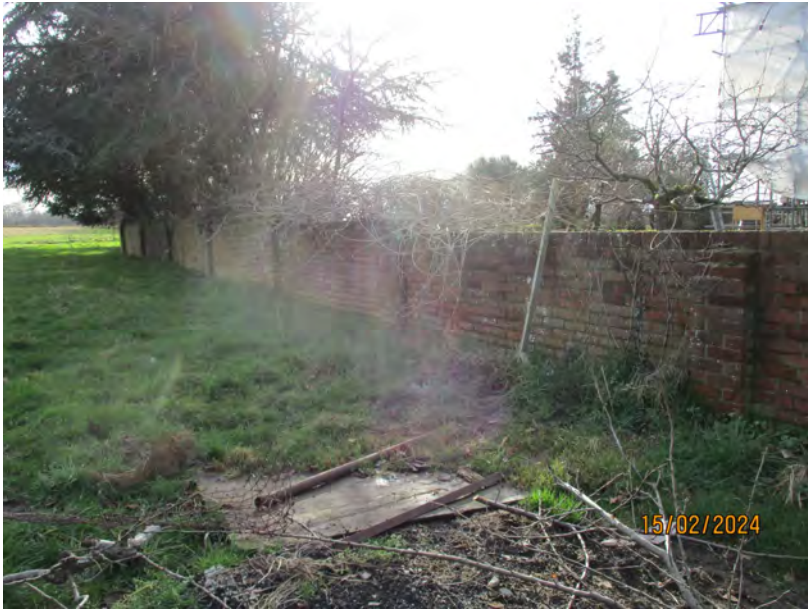
Fig 69:

Garden boundary: East boundary wall to rear garden. Built mid-late 20th century.

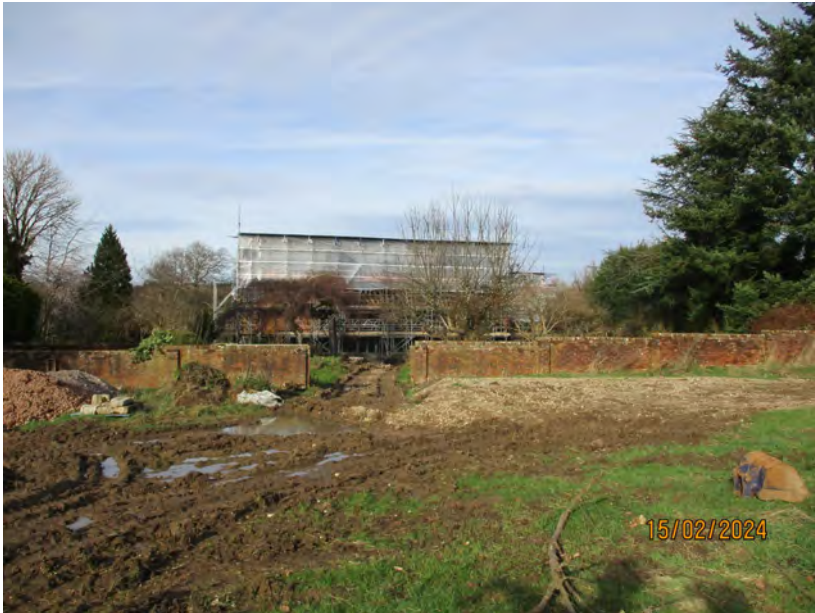
Fig 71:

Garden boundary: South boundary wall to rear garden. Built mid-late 20th century.

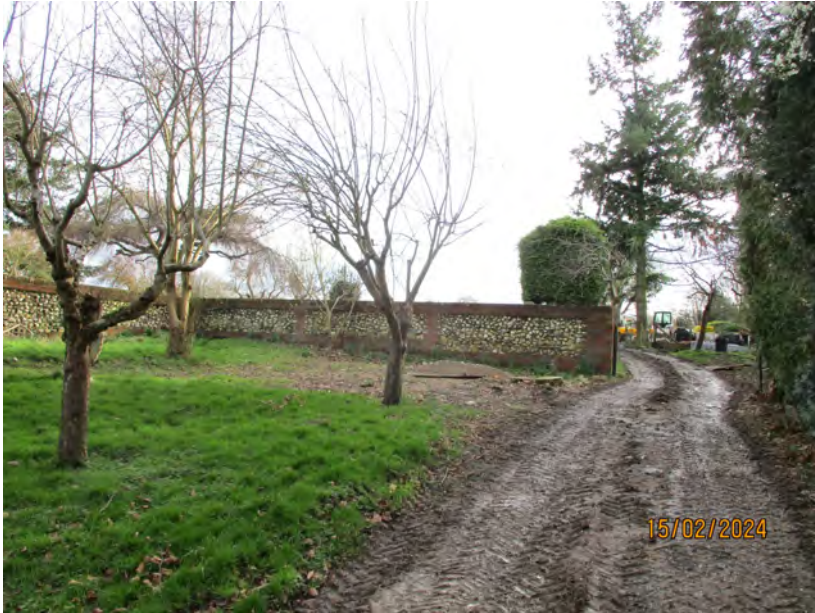
Fig 73:

Garden boundary: West garden boundaries. Built mid-late 20th century.
