Current Layout alterations

Original Layout before

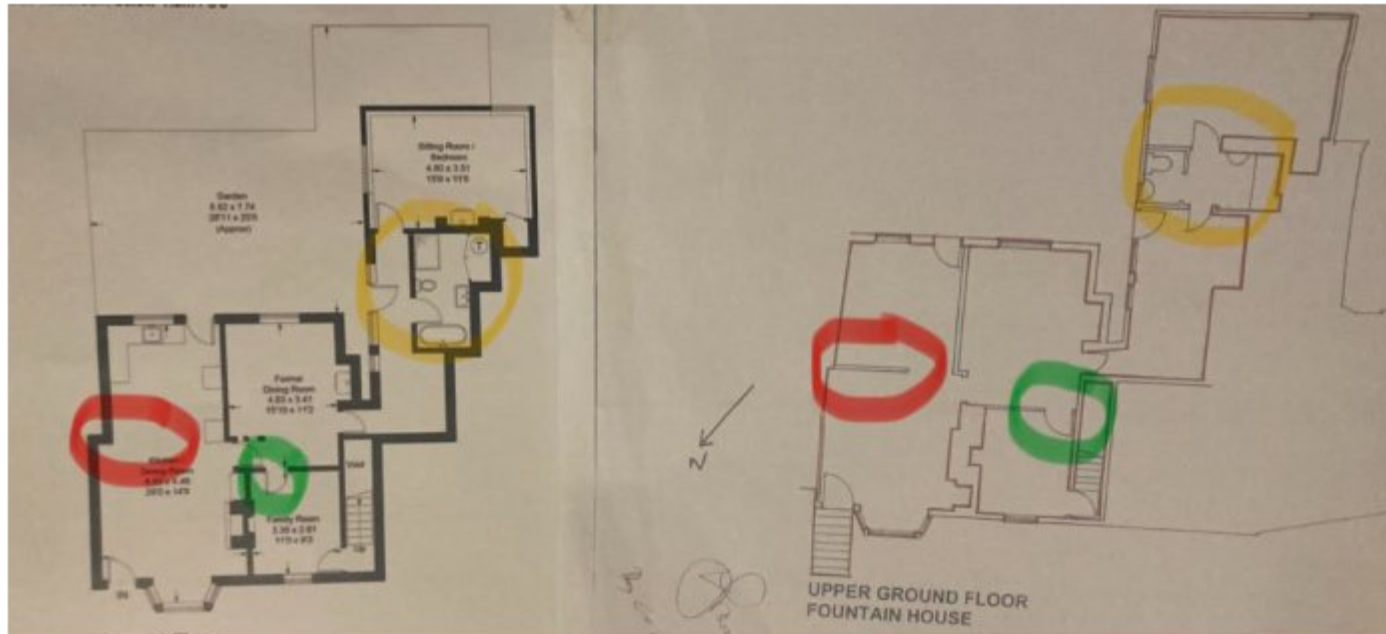
Kitchen Breakfast Room - Original layout, room was divided by hardboard partition with arch. This has been removed to open the area to form a kitchen breakfast room.

(shown marked in Red).

Door between Dining Room and Snug - moved to a new position

(shown marked in Green)

Bathroom – Relocation of bathroom from east-west to north-south orientation to give easier access to the toilet and remove the requirement to walk through the bathroom to access the lounge. New walls to give access via hallway to lounge constructed of plasterboard with oak door frame and new oak door to bathroom.

(shown marked in Yellow)
