Cottage of Clunie Bat Survey

June 2023

Prior to proposed demolition works, bat survey work was carried out on the garage of Cottage of Clunie. No roosting bats were recorded in the garage, only 3 roosting common pipistrelles in the house which will be unaffected by the work. There are therefore no ecological constraints to the proposed demolition works.

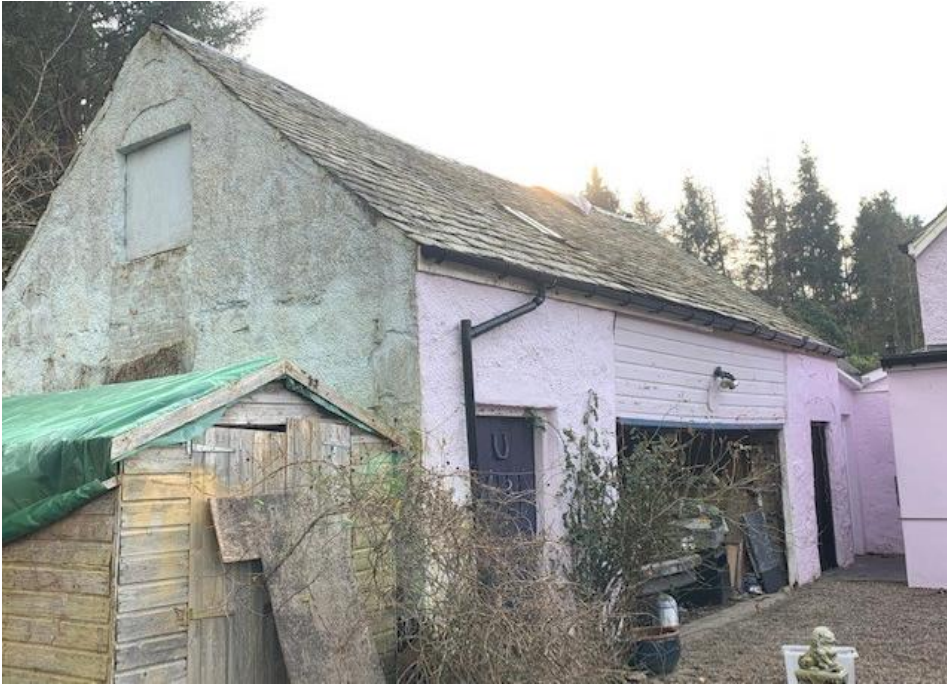
Photo 1. The south and west side of the garage.

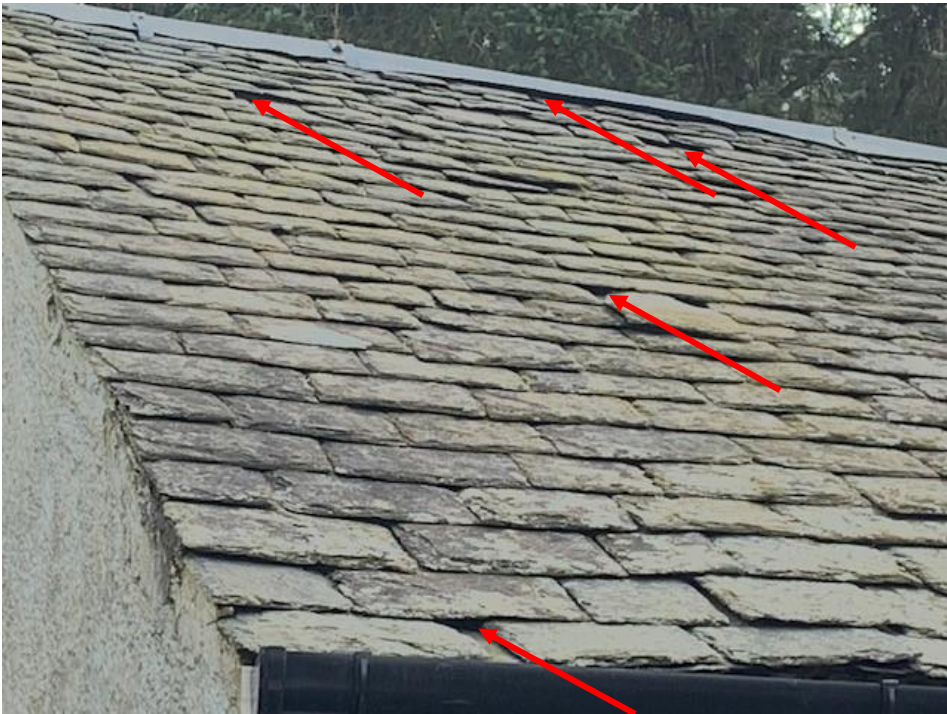
The garage is stone built with wooden roof beams, wooden sarking board and a slate covered roof. Areas with potential for bat roosts include gaps under roof slates and roof flashing (Photos 2 & 4).

Photo 2. The roof of the south side of the garage with example gaps under roof slates and ridge flashing which provide bat roost potential indicated by red arrows.

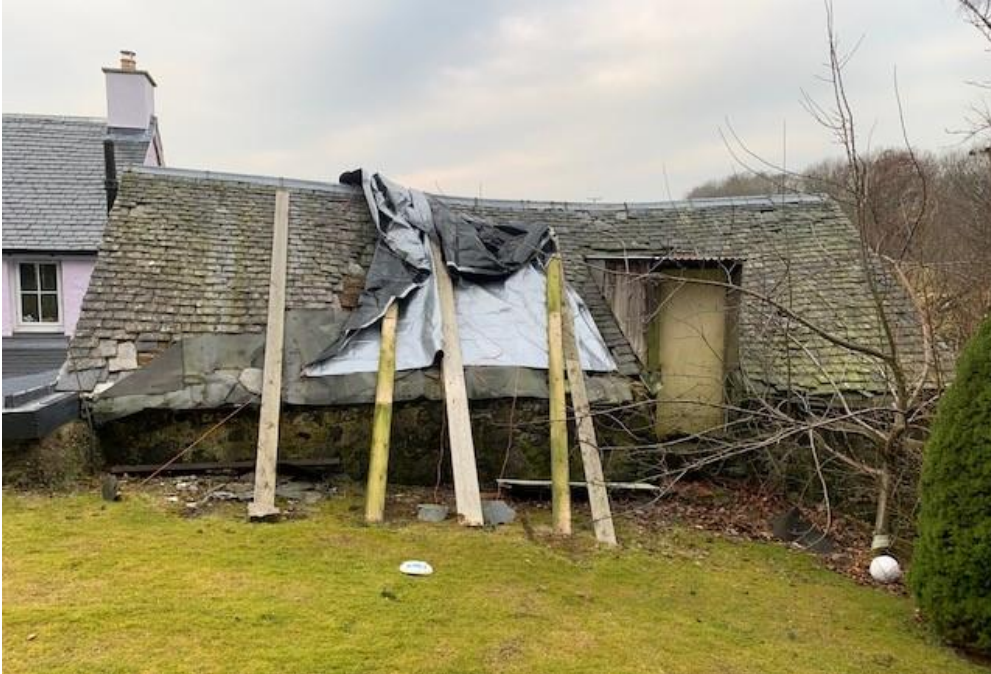
Cottage of Clunie, Forneth, Blairgowrie, PH10 6SG (grid ref.: NO 12967 44903) is located 4.4.km west of Blairgowrie. The garage is stone built with a slate covered roof. At the time of survey, the north side of the garage roof has collapsed in the middle section (Photo 3).

Photo 3. The northern side of the garage.

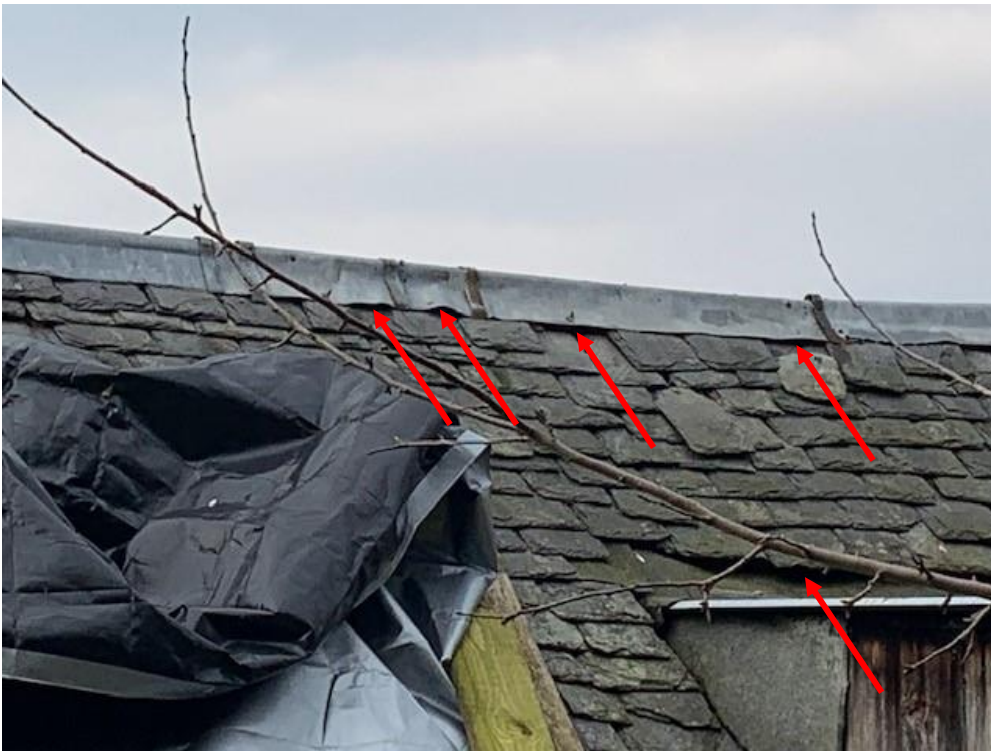
Photo 4. The north side of the garage. Example gaps under ridge flashing and roof slates which provide bat roosting potential are indicated by red arrows.
