CATHEDRAL BUSINESS PARK

SITE B - SELF STORAGE

Surface Water Drainage

CATHEDRAL PARK, CHICHESTER Factual report on winter groundwater levels and infiltration testing

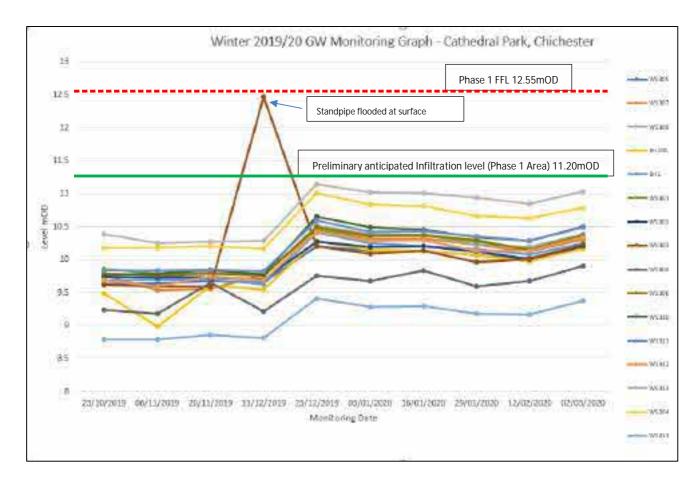
Plate 1. Winter groundwater levels compared to key development levels

The water levels can be compared to the proposed development levels and the proposed infiltration level for the Phase 1 area of 11.2mOD as shown in Plate 1 below.

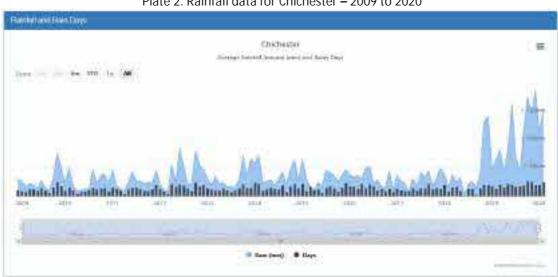
Plate 2. Rainfall data for Chichester - 2009 to 2020

The winter of 2019/20 has seen a series of significant storms and greater than average monthly rainfall for the last decade as shown in Plate 2 below.

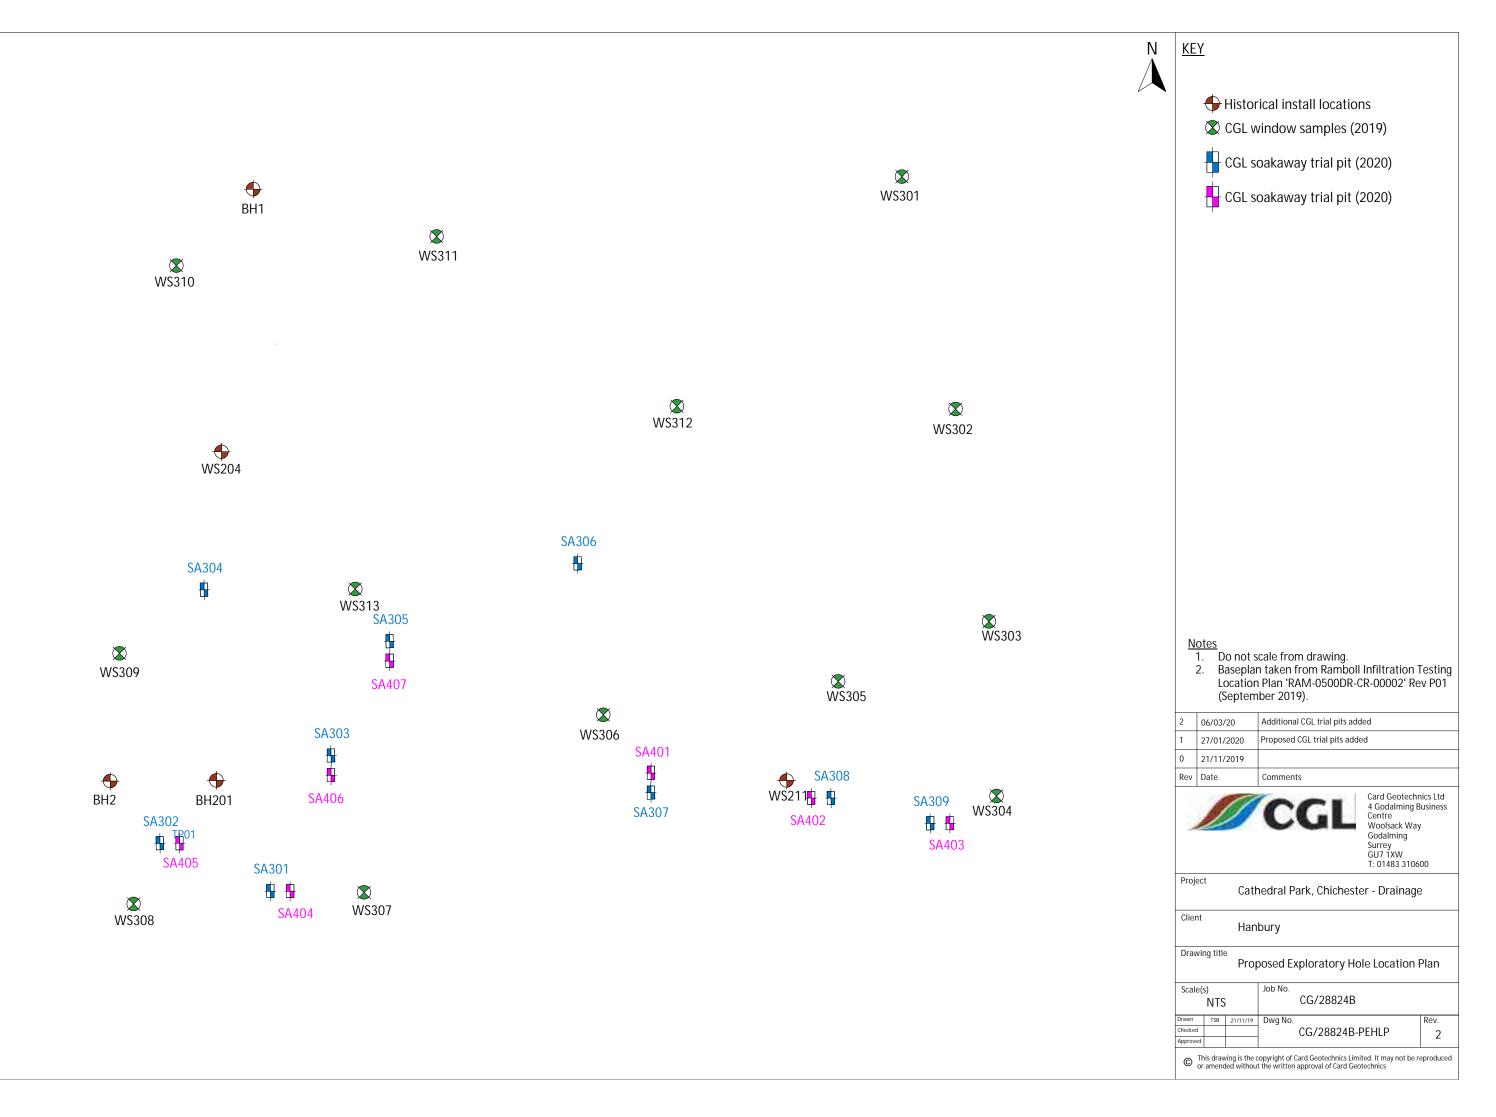
Figure 2 Site layout and exploratory hole location plan

The location of these monitoring points is shown on Figure 2. Borehole records are included in Appendix A.

Two series of infiltration tests were undertaken, broadly in line with BRE365 as conditions allowed in January and March 2020. Two levels for infiltration testing were targeted, approximately 11.2mOD and deeper at approximately 10.5mOD. The locations of the tests are shown on Figure 2.

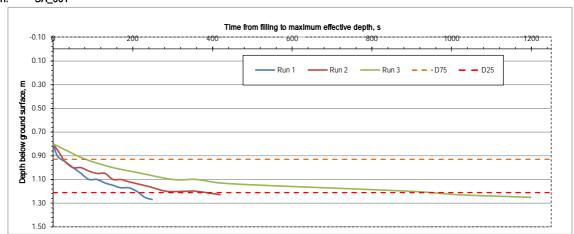
Location: SA_301

| t ₇₅ (s) | 18.333333 |
|---|---|
| Infiltration Rate (m/s): | 7.14E-0 |

| t ₇₅ (s) | 28 |
|---|---|
| Infiltration Rate (m/s) | : 3.66E-0 |

| t ₇₅ (s) | 88 |
|---|---|
| Infiltration Rate (m/s): | 1.52E-0 |

| Location | Level of test | Run 1 | Run 2 | Run 3 | Average |
|---|---|---|---|---|---|
| SA_301 | 10.70 | 7.14E-04 | 3.66E-04 | 1.52E-04 | 4.11E-04 |

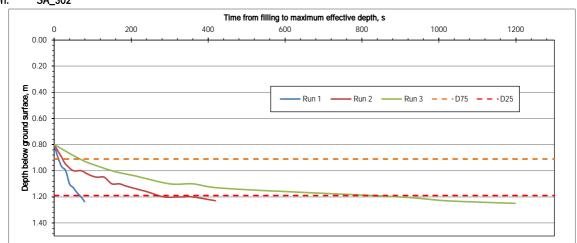
Location: SA_302

| V _{p75-25} (m³) | | 0.54 |
|---|--|---|
| Infiltration Rate (m/s) | | 1.66F-0 |

| ₅ (s) | | 68.785714 | t ₇₅ (s) |
|---|---|---|---|
| filtration Rat | e (m/s): | -1.94E-0 | Infiltra |

| t ₇₅ (s) | 18 |
|---|---|
| Infiltration Rate (m/s) | : <u>1.45E-0</u> |

| Location | Level of test | Run 1 | Run 2 | Run 3 | Average |
|---|---|---|---|---|---|
| SA_302 | 10.75 | 1.94E-02 | 1.66E-03 | 1.45E-03 | 7.51E-03 |

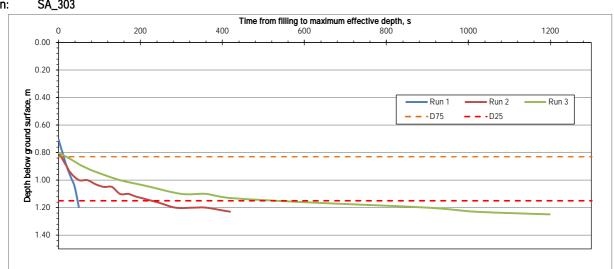
Location: SA_303

| t ₇₅ (s) | | <i>12.15</i> |
|--|--|---|
| Infiltration Rate (m/s): | | 4.74E-0 |

| t ₇₅ (s) | | 20 |
|---|--|---|
| Infiltration Rate (m/s): | | <u>1.29E-0:</u> |

| t ₇₅ (s) | | 21 |
|---|--|---|
| Infiltration Rate (m/s): | | 2.33E-0 |

| Location | Level of test | Run 1 | Run 2 | Run 3 | Average |
|---|---|---|---|---|---|
| SA_303 | 10.45 | 4.74E-03 | 1.29E-03 | 2.33E-03 | 2.79E-03 |

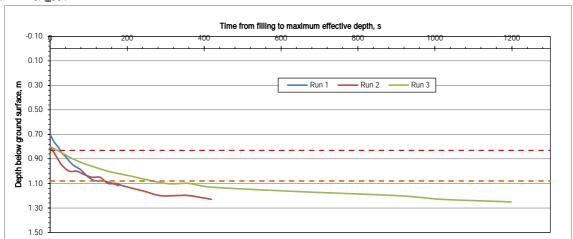
Location: SA_304

| t ₇₅ (s) | | 22 |
|---|--|---|
| Infiltration Rate (m/s): | | 5.34E-0 |

| t ₇₅ (s) | | 40 |
|---|---|---|
| Infiltration R | ate (m/s): | 2.32E-0 |

| Location | Level of test | Run 1 | Run 2 | Run 3 | Average |
|---|---|---|---|---|---|
| SA_304 | 10.65 | 1.44E-03 | 5.34E-04 | 2.32E-04 | 7.34E-04 |

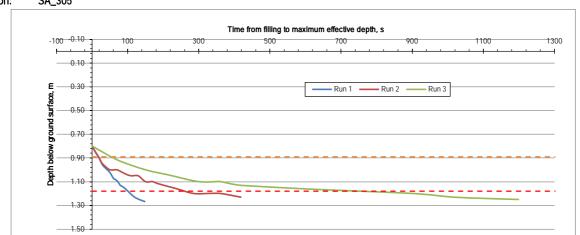
Location: SA_305

| 0.49 | V _{p75-25} (m ⁻) | | |
|---|---|---|--|
| 1.75E-0 | Infiltration F | Rate (m/s): | |

| | 28.0875 | t ₇₅ (s) | 35.6 |
|---|---|---|---|
| (m/s): | 1.38E-0; | Infiltration Rate (m/s): | <u>1.10E-0</u> ; |

| Location | Level of test | Run 1 | Run 2 | Run 3 | Average |
|---|---|---|---|---|---|
| SA_305 | 10.30 | 1.75E-03 | 1.38E-03 | 1.10E-03 | 1.41E-03 |

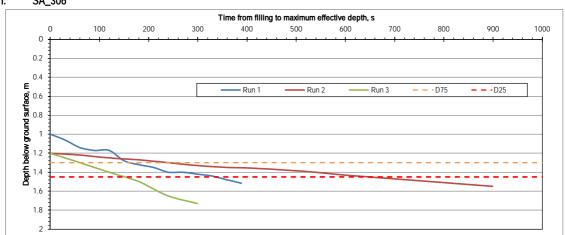
Location: SA_306

| t ₇₅ (s) | | 217.5 |
|---|---|---|
| Infiltration Rat | e (m/s): | 4.23E-0 |

| t ₇₅ (s) | 240 |
|---|---|
| Infiltration Rate (m/s): | 2.16E-0 |

| t ₇₅ (s) | | 128 |
|---|---|---|
| Infiltration Rat | e (m/s): | 7.89E-0 |

| Location | Level of test | Run 1 | Run 2 | Run 3 | Average |
|---|---|---|---|---|---|
| SA_306 | 11.05 | 4.23E-04 | 2.16E-04 | 7.89E-04 | 4.76E-04 |

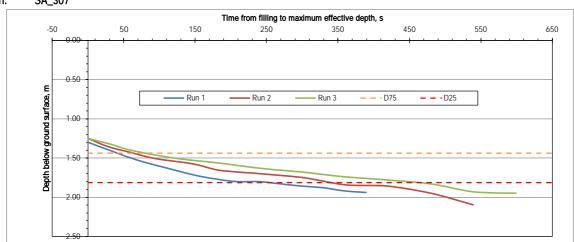
Location: SA_307

| t ₇₅ (s) | | 60 |
|---|--|---|
| Infiltration Rate (m/s): | | 5.70E-0 |

| t ₇₅ (s) | | 74 |
|---|---|---|
| Infiltration F | Rate (m/s): | 4.57E-0 |

| t ₇₅ (s) | | 83 |
|---|---|---|
| Infiltration F | Rate (m/s): | 4.20E-0 |

| Location | Level of test | Run 1 | Run 2 | Run 3 | Average |
|---|---|---|---|---|---|
| SA_307 | 9.90 | 5.70E-04 | 4.57E-04 | 4.20E-04 | 4.82E-04 |

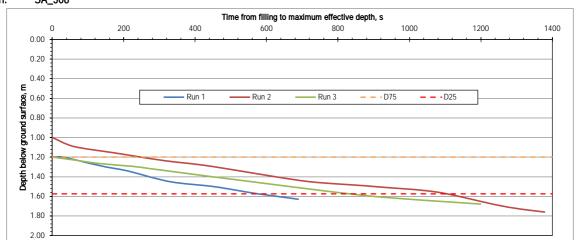
Location: SA_308

| t ₇₅ (s) | | 206.25 |
|---|---|---|
| Infiltration Rat | te (m/s): | 2.88E-0 |

| V _{p75-25} (m ³) | 0.64 |
|---|---|
| Infiltration Rate (r | n/s): <u>1.82E-0</u> |

| t ₇₅ (s) | | 290 |
|---|---|---|
| Infiltration F | Rate (m/s): | 2.34E-0 |

| Location | Level of test | Run 1 | Run 2 | Run 3 | Average |
|---|---|---|---|---|---|
| SA_308 | 10.35 | 2.88E-04 | 1.82E-04 | 2.34E-04 | 2.35E-04 |

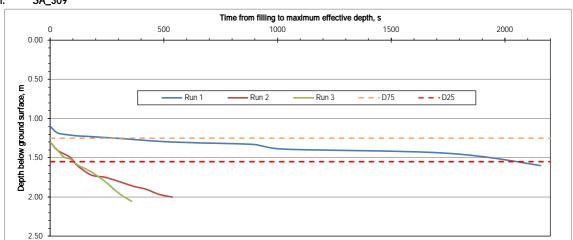
Location: SA_309

| t ₇₅ (s) | 288 |
|---|---|
| Infiltration Rate (m/s): | 8.22E-0 |

| t ₇₅ (s) | | <i>75</i> |
|---|--|---|
| Infiltration Rate (m/s): | | 6.14E-0 |

| t ₇₅ (s) | | 70 |
|---|---|---|
| Infiltration R | ate (m/s): | 7.73E-0 |

| Location | Level of test | Run 1 | Run 2 | Run 3 | Average |
|---|---|---|---|---|---|
| SA_309 | 9.95 | 8.22E-05 | 6.14E-04 | 7.73E-04 | 4.90E-04 |

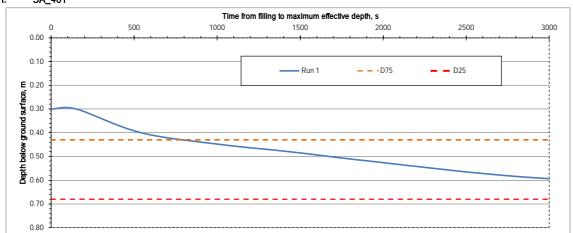
Location: SA_401

| t ₇₅ (s) | 780 |
|---|---|
| Infiltration Rate (m/s): | 3.25E-0! |

| Site Address: | Land off Bognor Road, Chichester –Plot B, Self Storage |
|---|---|
| | Infiltration rate used from test pit SA401 3.25x10-5m/s |

| Location | Level of test | Run 1 | Run 2 | Run 3 | Average |
|---|---|---|---|---|---|
| SA-401 | 11.30 | 3.25E-05 | | | 3.25E-05 |

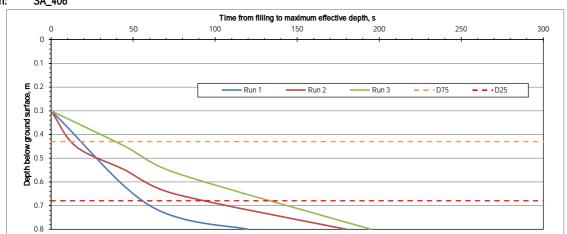
Location: SA_406

| Infiltration Rat | e (m/s): | 3.50E-0 |

| t ₇₅ (s) | | 13 |
|---|---|---|
| Infiltration F | Rate (m/s): | 1.64E-0 |

| t ₇₅ (s) | | 38 |
|---|--|---|
| Infiltration Rate (m/s): | | 1.38E-0 |

| Location | Level of test | Run 1 | Run 2 | Run 3 | Average |
|---|---|---|---|---|---|
| SA-406 | 10.85 | 3.50E-03 | 1.64E-03 | 1.38E-03 | 2.17E-03 |

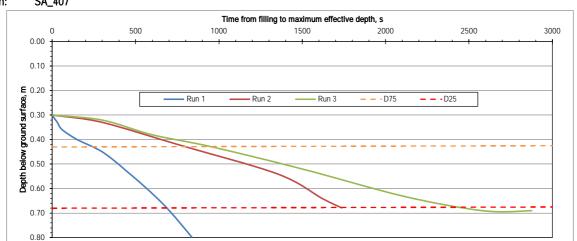
Location: SA_407

| t ₇₅ (s) | | <i>225</i> |
|---|--|---|
| Infiltration Rate (m/s): | | 3.03E-0 |

| ▼p75-25 (**** / | | 0.02 |
|---|---|---|
| Infiltration Rate | e (m/s): | 1.45E-0 |

| υ ₇₅ (m) | 0.425 |
|---|---|
| Infiltration Rate (m/s): | 8.95E-0 |

| Location | Level of test | Run 1 | Run 2 | Run 3 | Average |
|---|---|---|---|---|---|
| SA-407 | 11.10 | 3.03E-04 | 1.45E-04 | 8.95E-05 | 1.79E-04 |
