## Phase 2: Site Investigation

Stockton Riverside College

S230207/SI

# PHASE 2 SITE INVESTIGATION REPORT

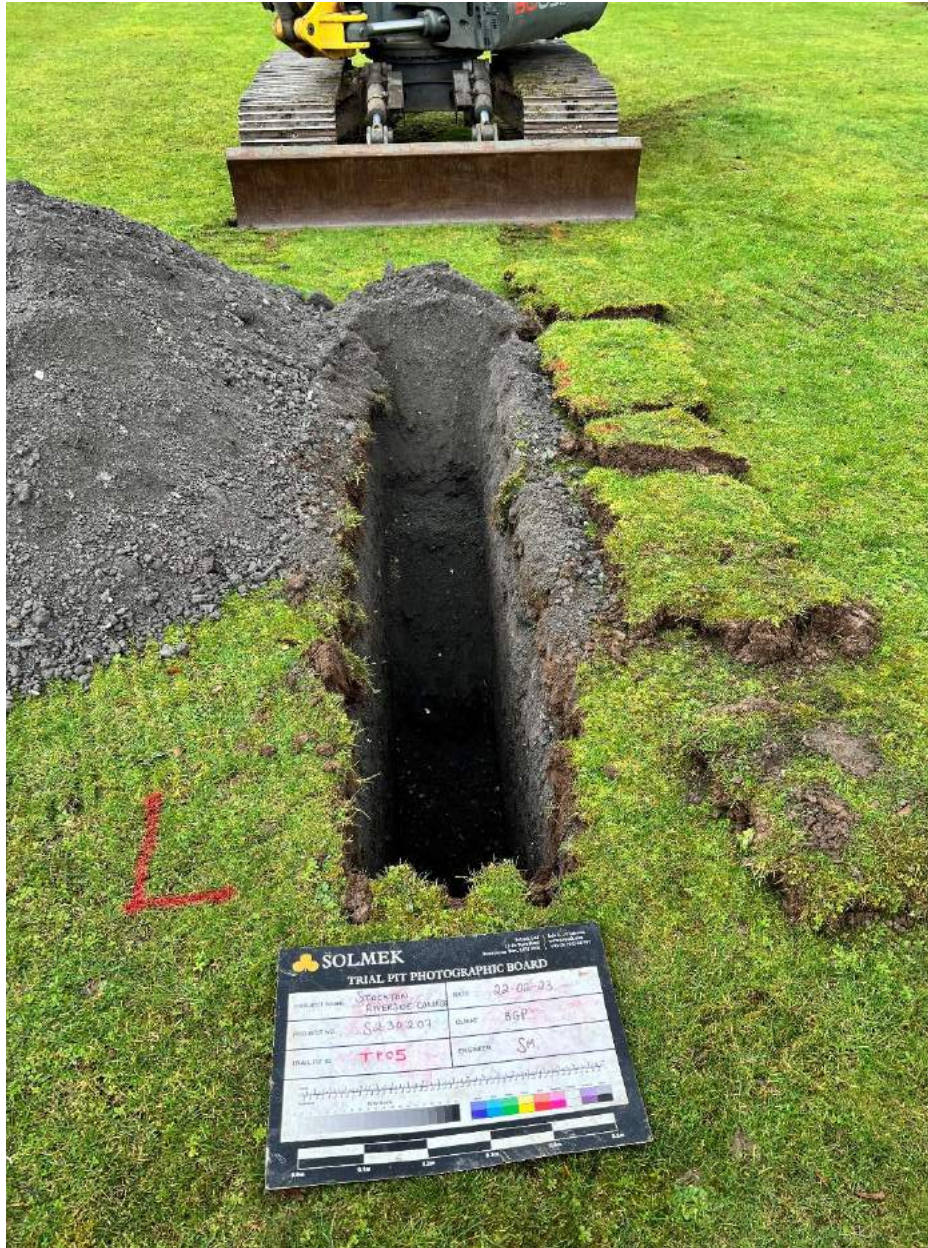
**Figure 7:** Photo showing TP05

In terms of metals, semi-metals, non-metals and inorganic determinants generally none of the eight samples subject to testing returned any values above relevant threshold values considered to cause long term harm to human health apart from elevated concentrations of lead in TP03 (0.50-0.60m) and in TP05 (0.50-0.60m), in the proposed car park area of the site.

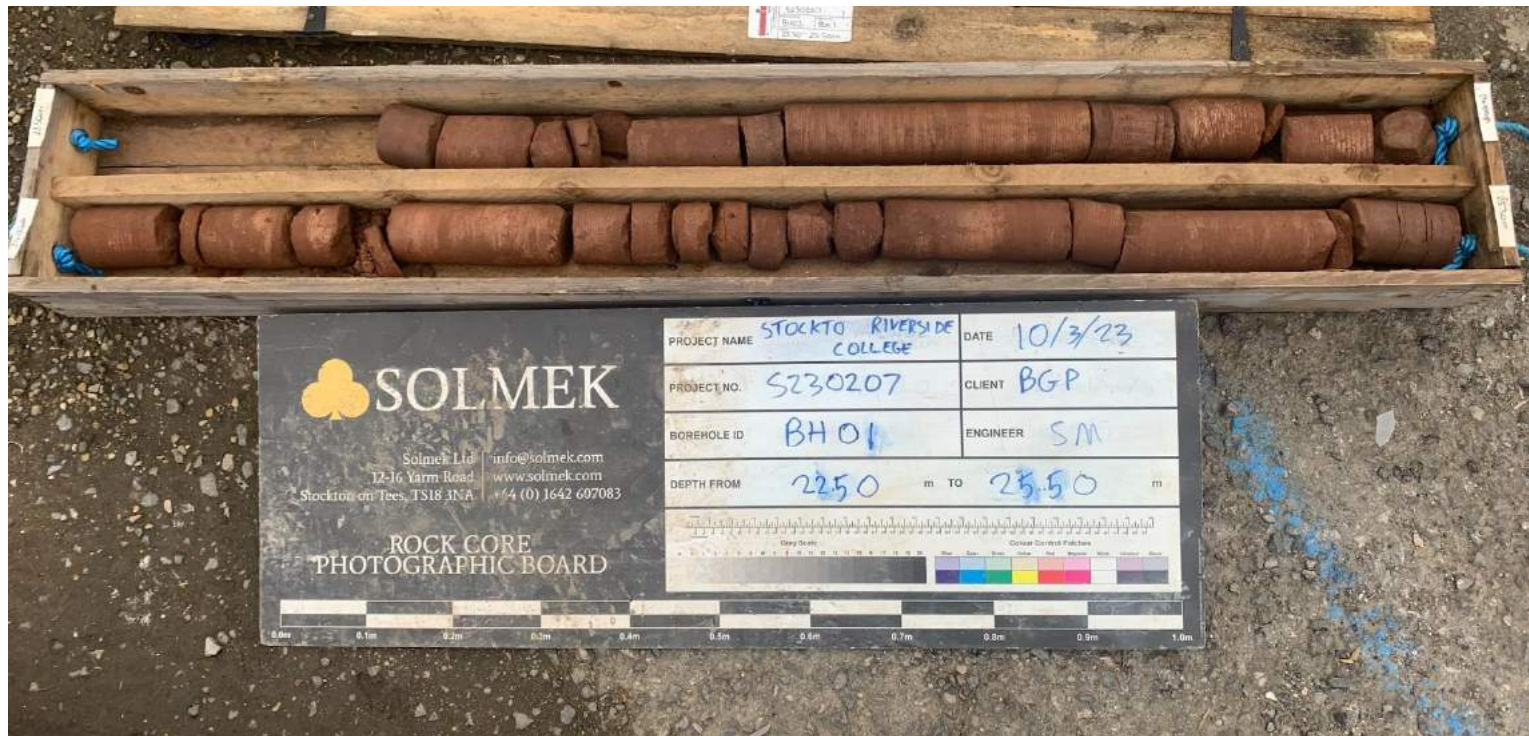
**Figure 10: BH01, 22.50-25.50m**

All the samples exhibited an axial cleavage failure mode and produced UCS results between 16.8 and 28.5MPa.

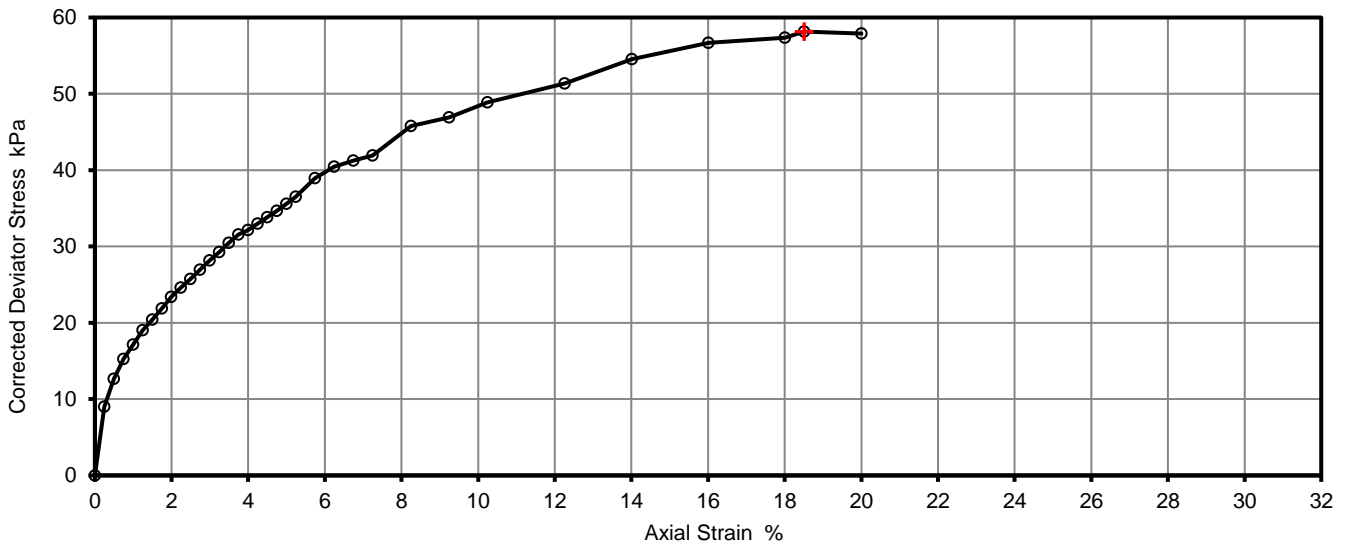
Rate of Strain	1.0	%/min
Cell Pressure	210	kPa
At failure	18.5	%
Axial Strain	58	kPa
Deviator Stress, $(\sigma_1 - \sigma_3)_f$	29	kPa $\frac{1}{2}(\sigma_1 - \sigma_3)_f$
Undrained Shear Strength, $c_u$	Plastic	
Mode of Failure

Deviator stress corrected for area change and membrane effects

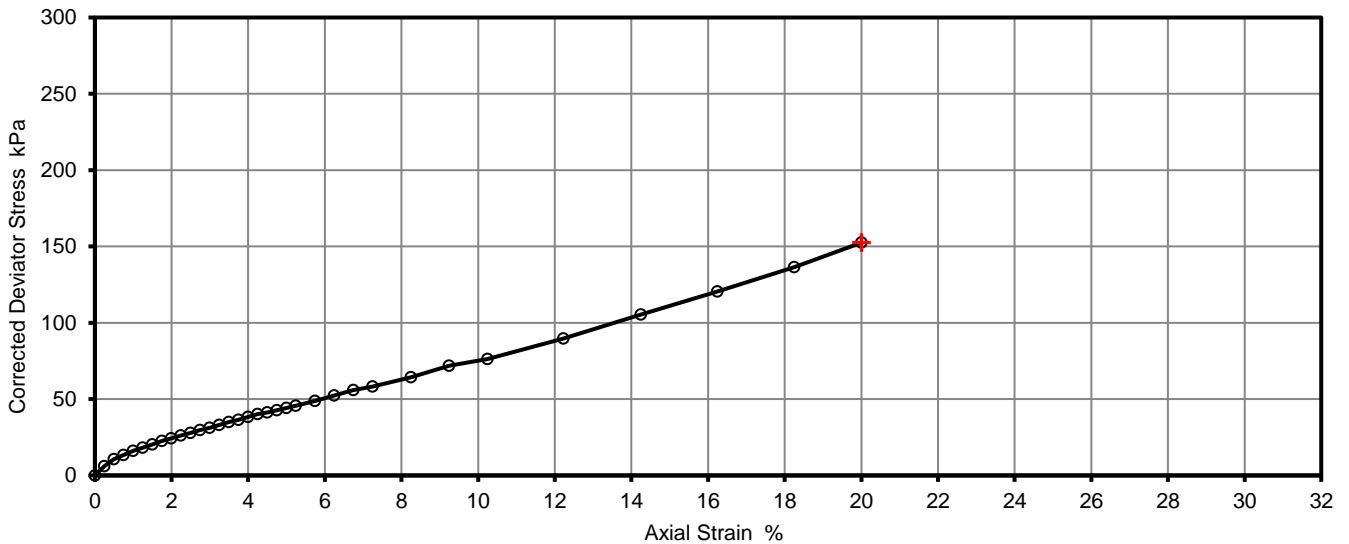
Rate of Strain	1.0 %/min
Cell Pressure	330 kPa
Axial Strain	20.0 %
At failure Deviator Stress, $(\sigma_1 - \sigma_3)_f$	152 kPa
Undrained Shear Strength, $c_u$	76 kPa $\frac{1}{2}(\sigma_1 - \sigma_3)_f$
Mode of Failure	Plastic

Deviator stress corrected for area change and membrane effects
