The White Hart, South Mimms

Bat Survey Report

Report Ref: CSA/6115/02

October 2023

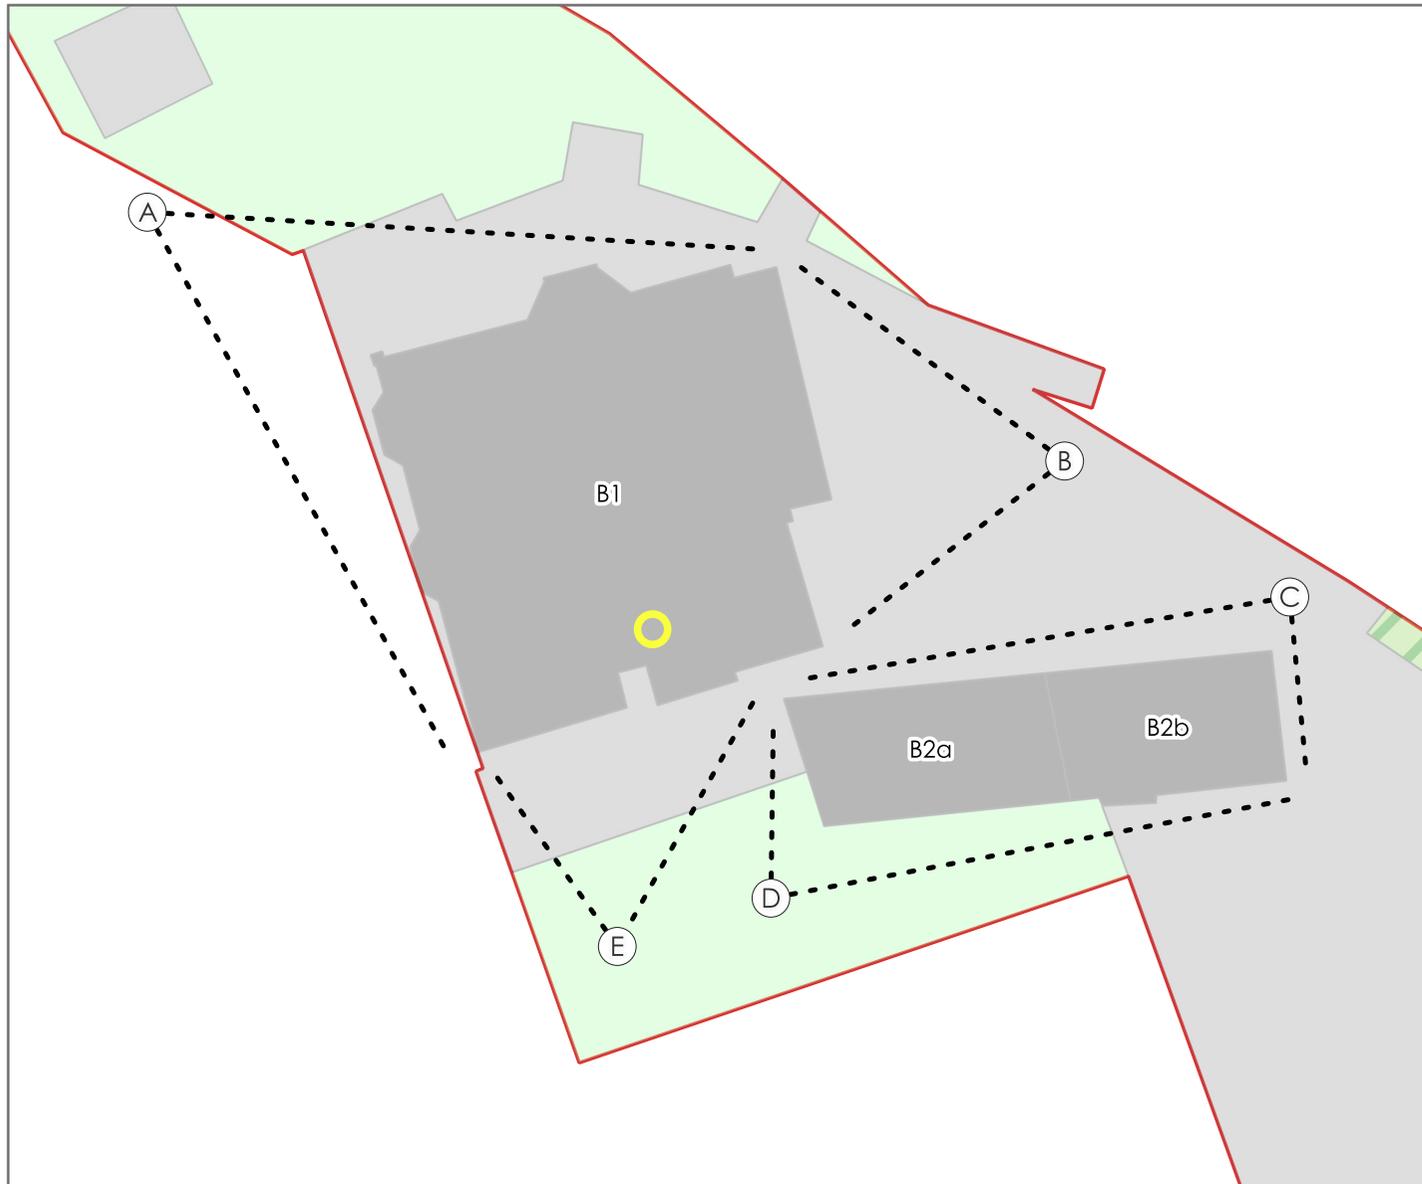
- 4.2 A detailed account of the bat activity recorded during the surveys is presented in the Bat Survey Plan (Appendix A) and Bat Survey Results Tables (Appendix B). Surveyor locations were Surveyor A (B1) – north-west of the Site, adjacent to Blanche Lane; Surveyor B (B1) and C (B2) – north-east of the Site, adjacent to St Albans Road; Surveyor D (B2) and E (B1) – south of B1 in the former public house garden (see Bat Survey Plan Appendix A).

Emergence Location
1 no. common pipistrelle (06/06/2023)
1 no. common pipistrelle (27/06/2023)
-

Surveyor Locations
11/05/2023: A, B, C, D, E
06/06/2023: A, B, C, D, E
27/06/2023: A, B, E
-

Surveyor Field of View
