West Pier, Scarborough, North Yorkshire

Bat Survey, May 2023.

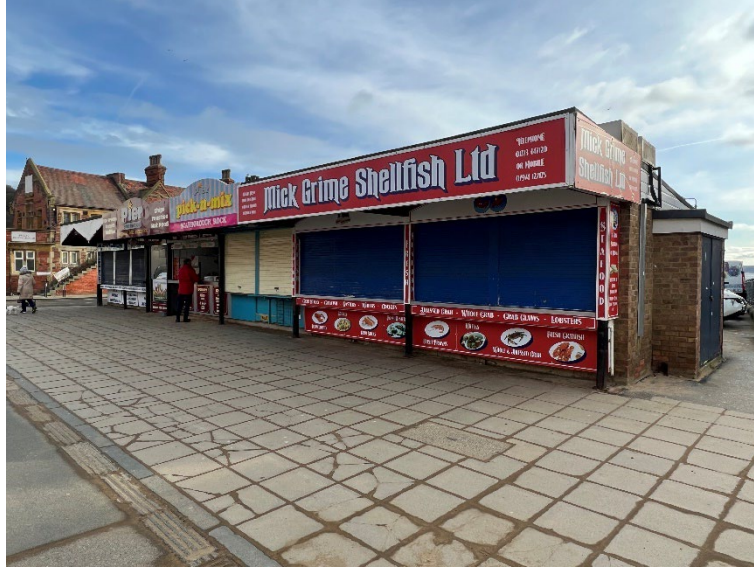
Plate 1 – Kiosks (Building 6), north and west elevation.

<i>Building 6</i> There were no signs of roosting bats or bat activity, and the building has no features to support roosting bats. Consequently, the building has a NEGLIGIBLE SUITABILITY to support roosting bats (see 5.3 plate 1).
02/02/23	Hibernation.	No hibernating bats were observed during the endoscope survey.
02/05/23	Emergence	No roosting bats were observed emerging from the buildings.
