2135 - Scarborough Harbour West Pier  
Redevelopment

Heritage Impact Assessment

11 April 2024

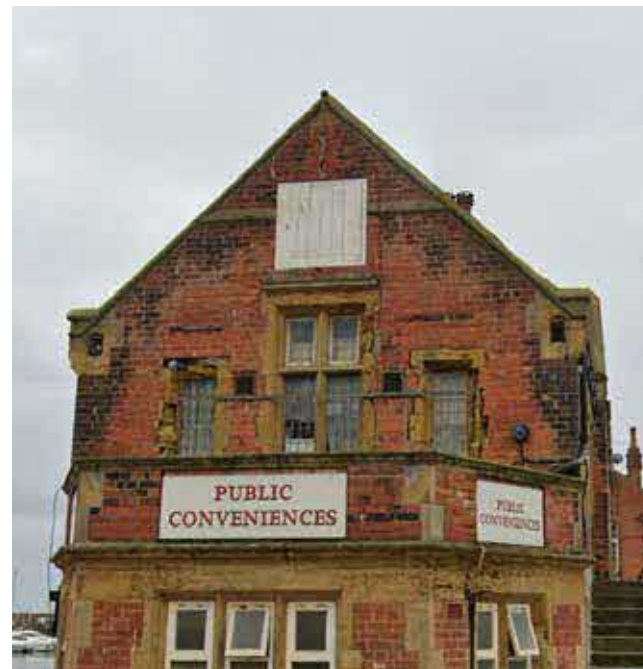
At the first floor level the stone reveals and windows, which are proposed to be repaired and replaced where necessary to match the existing to maintain and re-enhance the character of Building 1, would be obscured and even removed in order to allow for an extension in this location.

Building 1 North West Elevation 1st floor

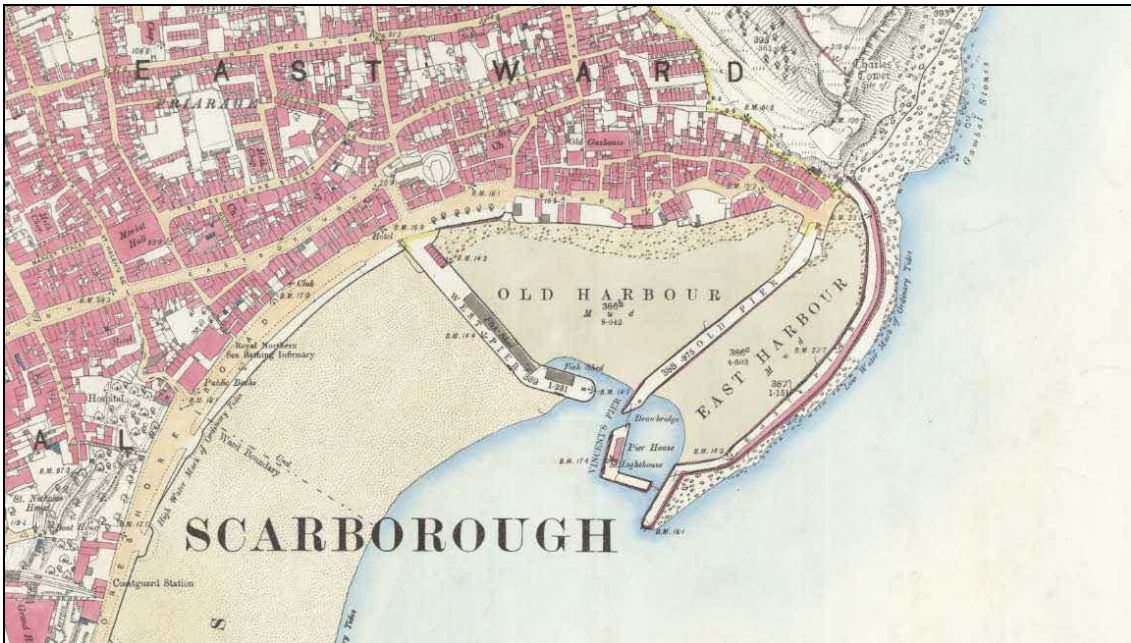
1890 – West Pier widened and Harbour Office and fish sheds constructed.

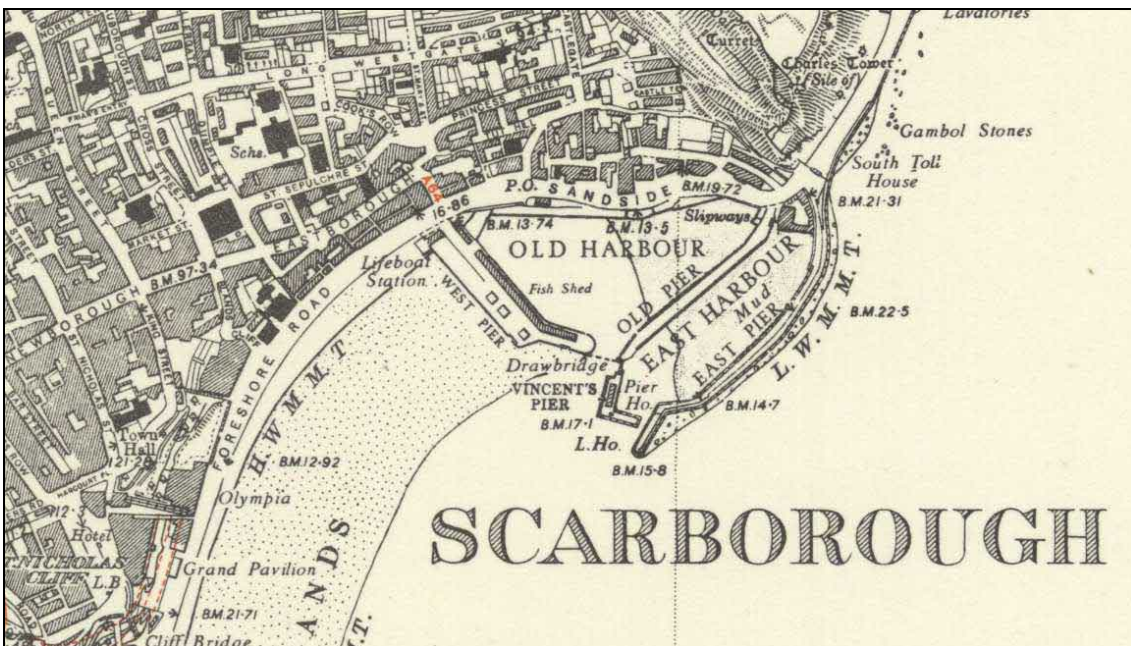
1950 – Building 5 constructed.
