Details of repair & restoration works to Kitchen floor

This information has been supplied to discharge condition 3 of Listed Building Consent DC/22/05516.

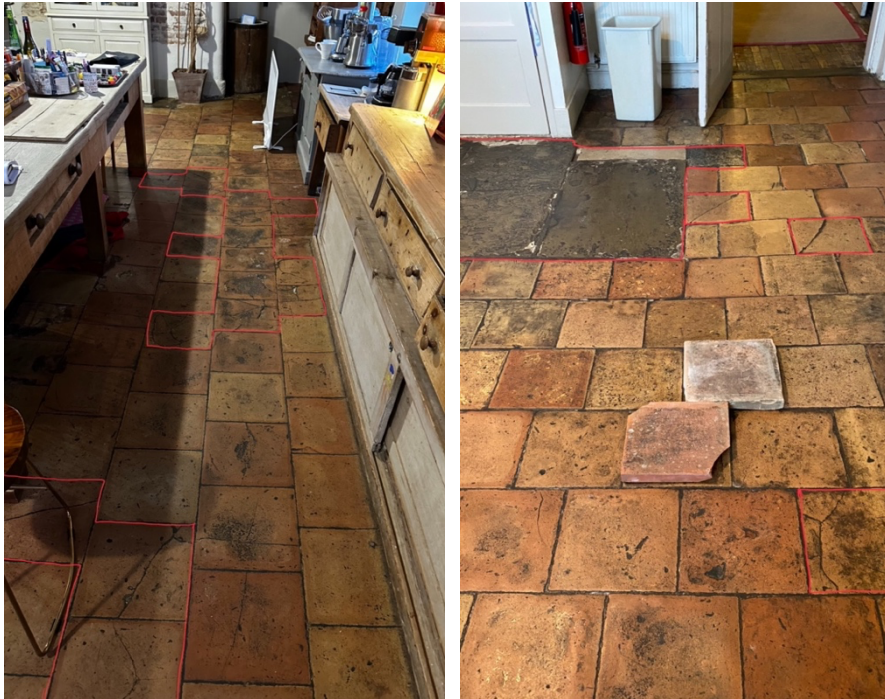
These photographs highlight the typical condition of existing kitchen pammments that would be considered for replacement (with red line boundary). The random placement of flagstones (partly visible in the left-hand photo) will be rationalised and focused to an area in front of the range. Areas of cement flooring (to the left-hand side of the range) will be removed, and replaced with reclaimed pammments.

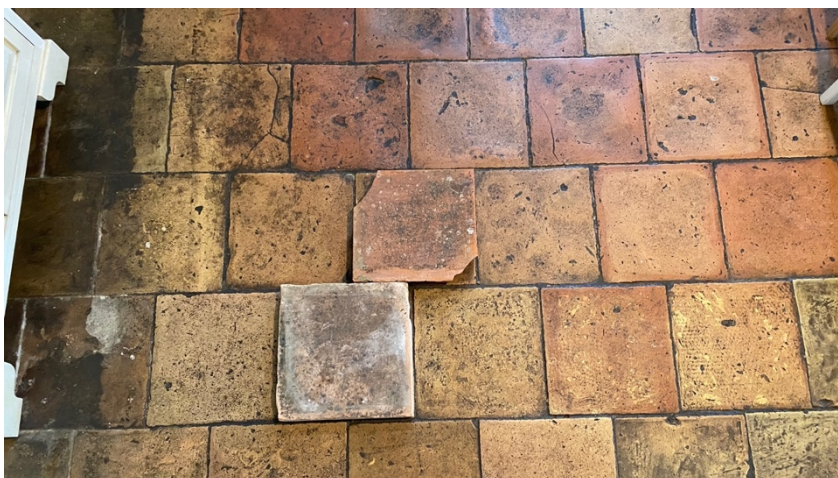
The proposed replacement pammments will be reclaimed – samples in photo above. These will be sourced from Mongers of Hingham, a Norfolk-based reclamation specialist. Light terracotta, pink and buff tones will be sourced to match the existing floor as best as possible. The existing pammments being retained, will be gently cleaned.
