## Assessment of Significance and Heritage Statement

Site: Town Street Farmhouse, Church Street, Ropley, Hampshire, SO24 0DP

Client: Mr & Dr Pinder

Date: 8<sup>th</sup> March 2024

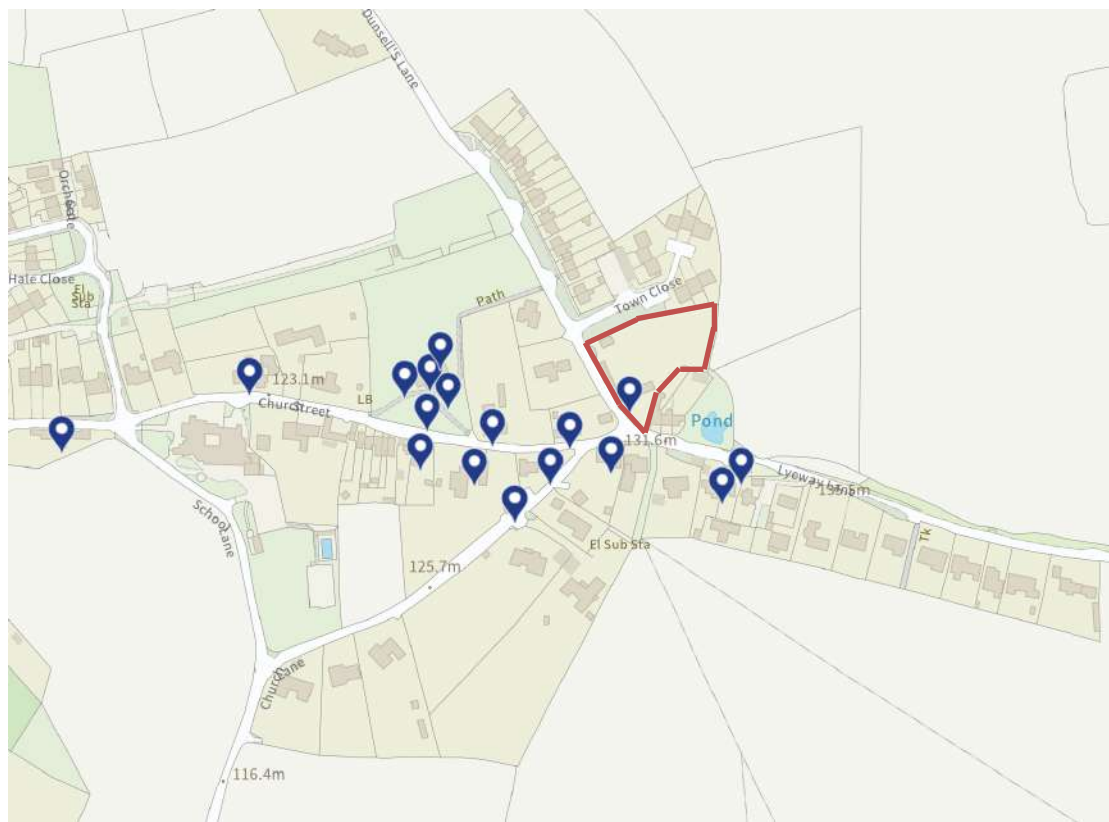
Figure 2; Illustration of the proximity of designated heritage assets, taken from Historic England's mapping. Red boundary added to application site for identification purposes.

As shown in figure 2, there are a large number of designated heritage assets in the centre of the village, although these are all located to the South, East, and West of Town Street Farmhouse, with the properties to the North along Dunsell's Lane and into Town Close being post-WW2 social housing, bungalows, and a garage block. Views of these together with views of Town Street Farmhouse from Church Street and its access from Dunsell's Lane are provided in figures 3-6.

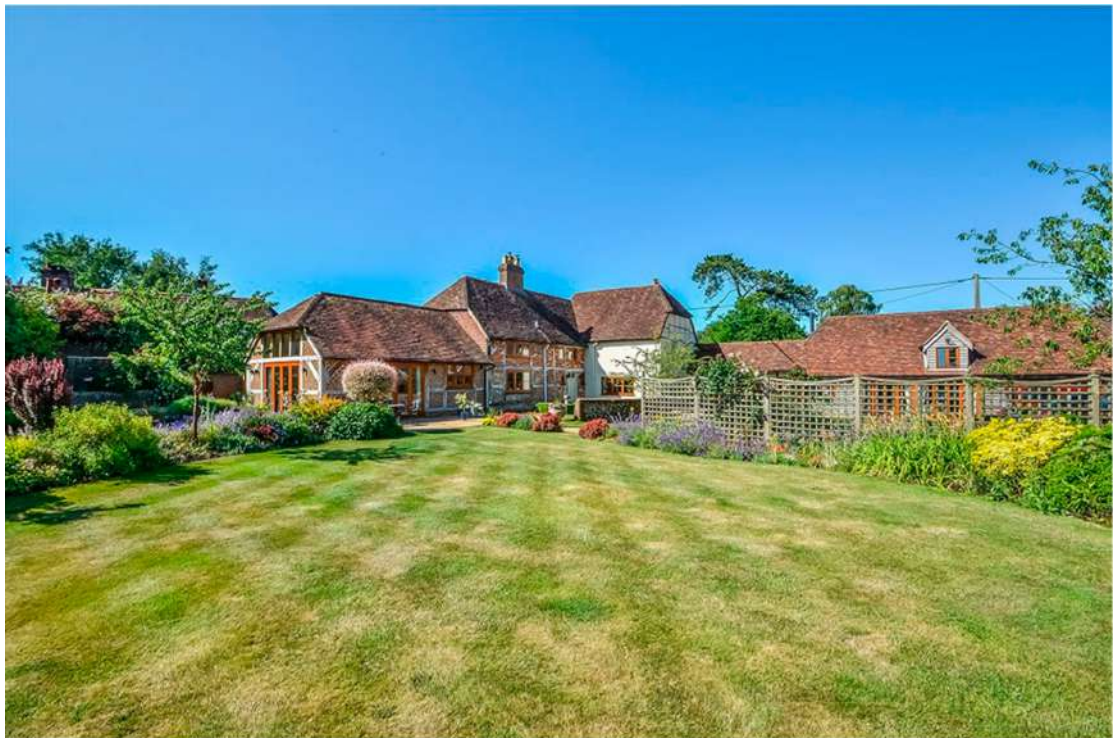
Figure 8; View of the rear (North) elevation of the Farmhouse and the Eastern elevation of the former cart shed, as viewed from the garden. Prominently visible in the left foreground is the kitchen extension, consented in 2011. Image by Knight Frank.

In August of 2011 planning permission and listed building consent were received for the demolition of the existing kitchen and conservatory, and their replacement with a new timber-framed kitchen extension to the Eastern end of the original farmhouse. As this does not affect our current proposals, we have not included drawings of this, although as it was constructed, it does appear in the photographs and plans for context.

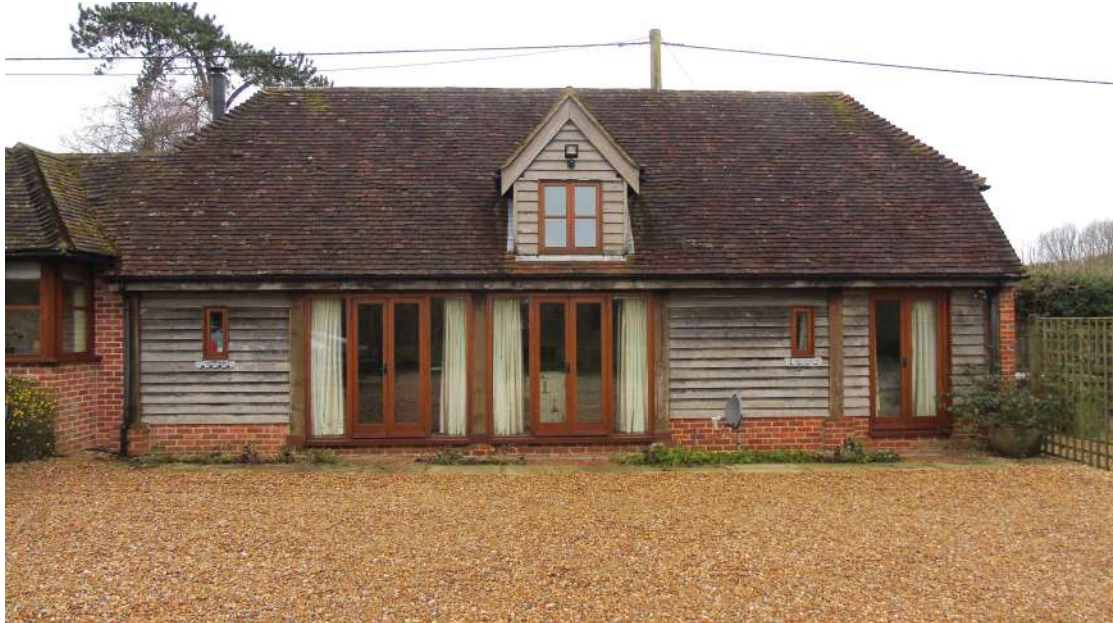
Figure 9; View of the courtyard (East) elevation of the former cart shed.

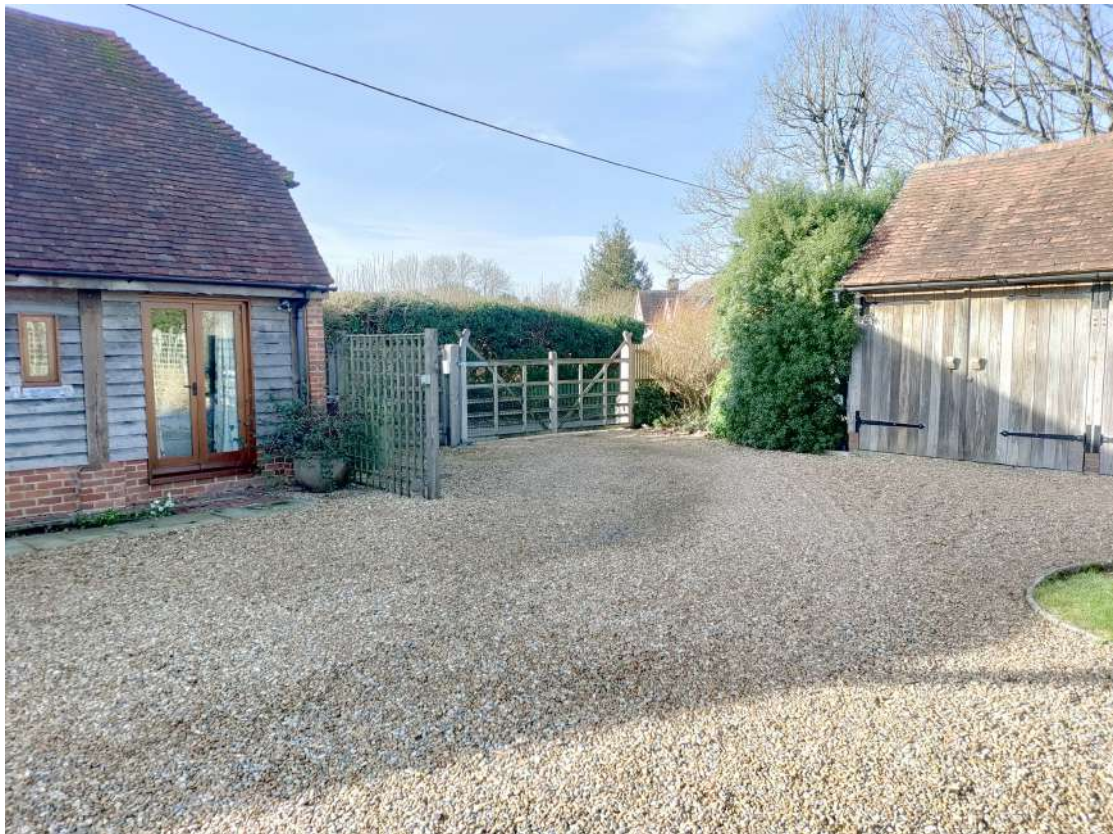
Figure 10; View of the Northern end of the courtyard, showing the end of the former cart shed, drive entrance, and the existing modern garage.

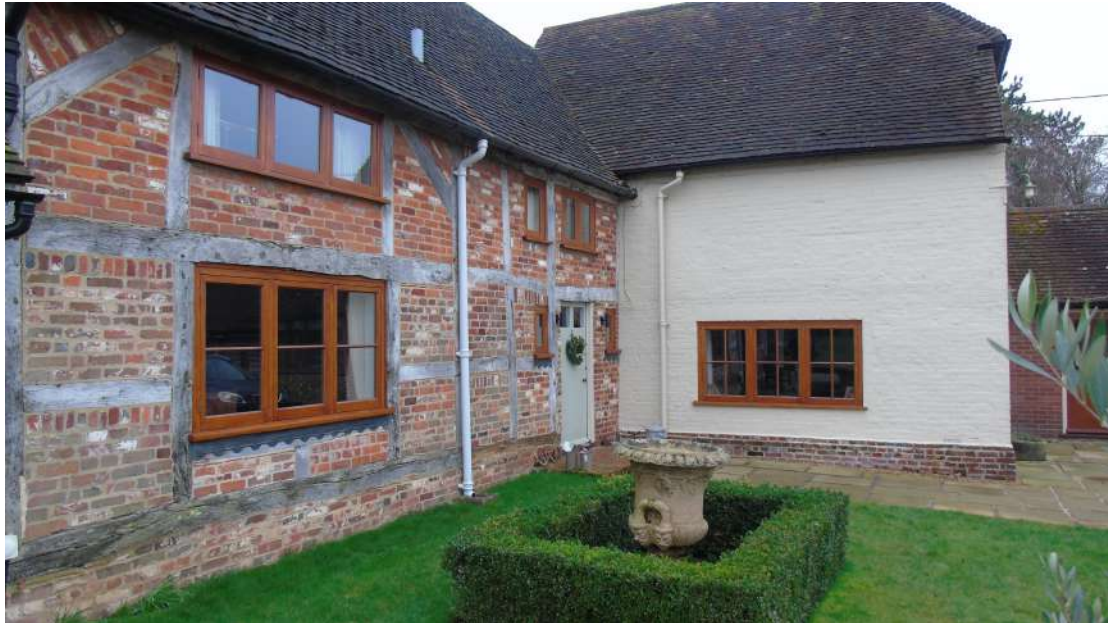
Figure 11; View of the rear of the original core of the house and the rear of the C18 extension with its painted brickwork, as seen from the garden.

A two-storey brick-built C18 wing was later added as a range to the Western end of the original frame.

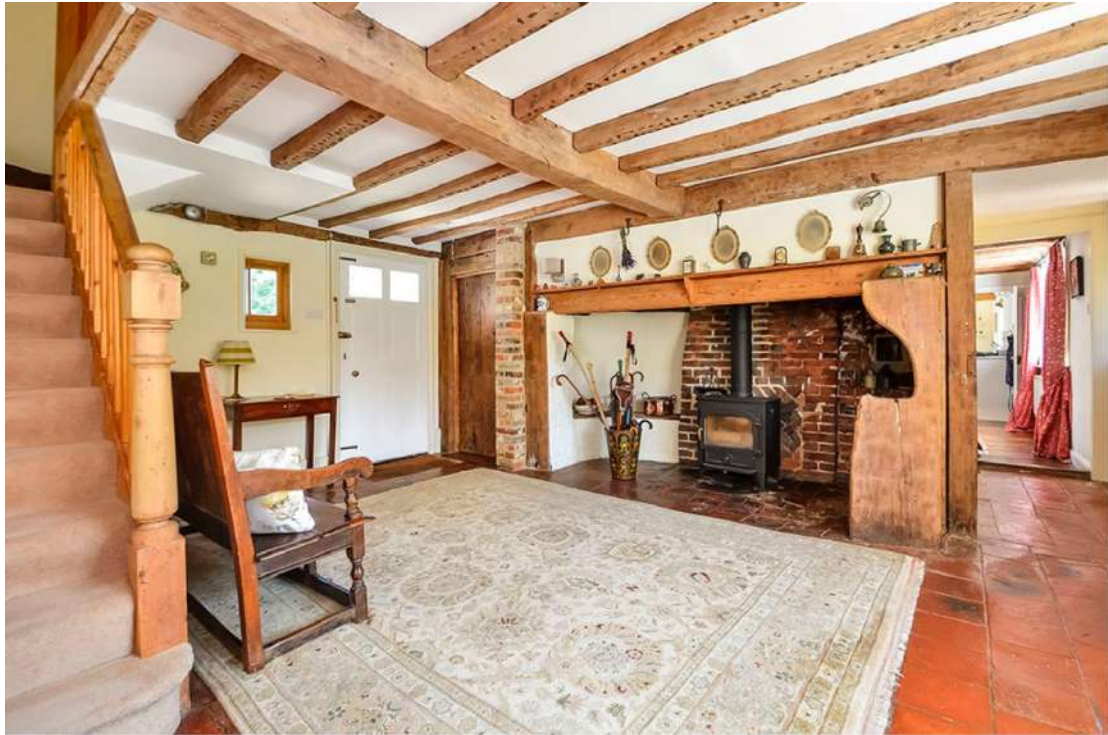
Figure 13; View of the Westernmost of the ground floor rooms in the original core of the house, showing the smoke bay and the later first floor. The modern softwood staircase is visible on the left. Image by Knight Frank.

The core of the house is a late-C16 timber-framed hall house of 3 bays, which included a smoke bay into which a chimney was later inserted. The creation of the first floor is likely to be a C17 alteration, and the nature and height of the building's original construction as an open hall house has created some significant compromises to the first floor. The available height has meant that once the first floor had been inserted the principal tie beams had to be heavily cut at the bottom to try and allow adequate height for occupants to pass between bays at the first-floor level. Even with this drastic alteration, the heights below the remaining sections of the tie beams are extremely low.

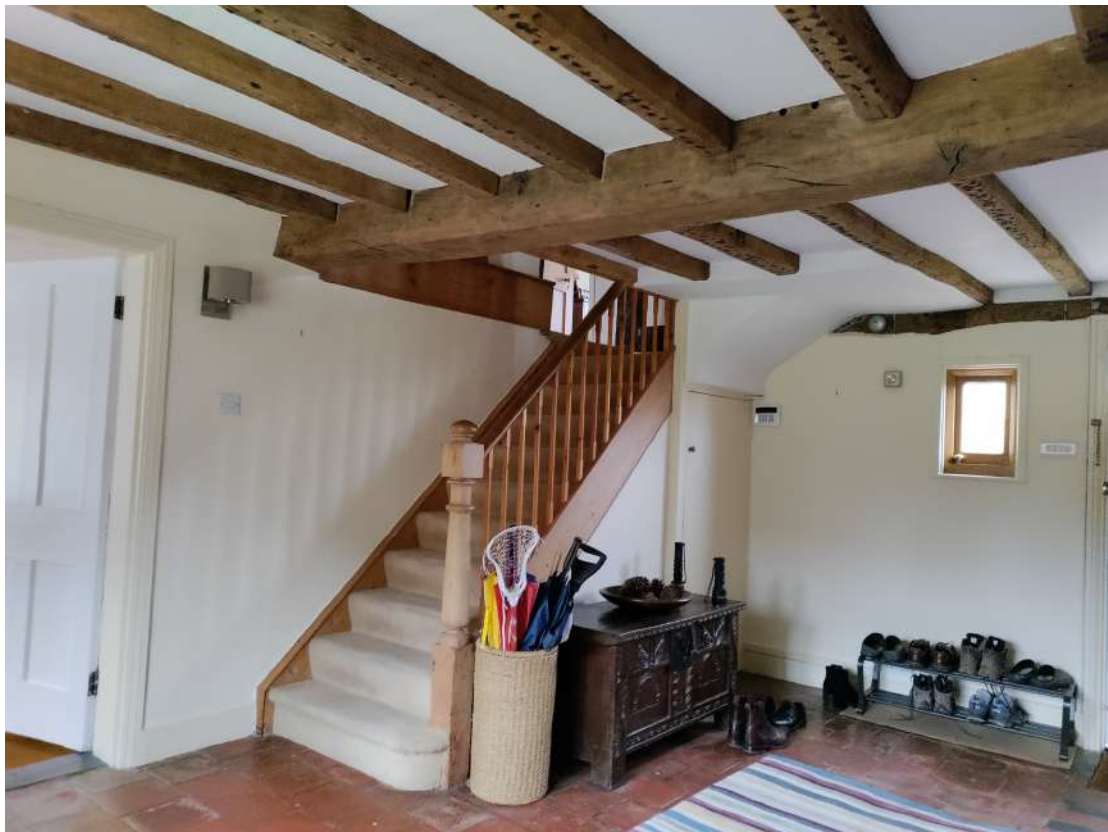
Figure 14; View of the existing staircase in the hall, showing the poor quality twentieth century softwood stair, newel post, and balustrade.

The proposals within the historic core of the farmhouse have been limited to the C18 part of the house, with no changes proposed to the C16 and C17 fabric or spaces beyond the replacement of the poor-quality softwood staircase and balustrade, and re-glazing of the existing single-glazed windows in the existing frames with new thin double glazing, such as Histoglass, or similar.

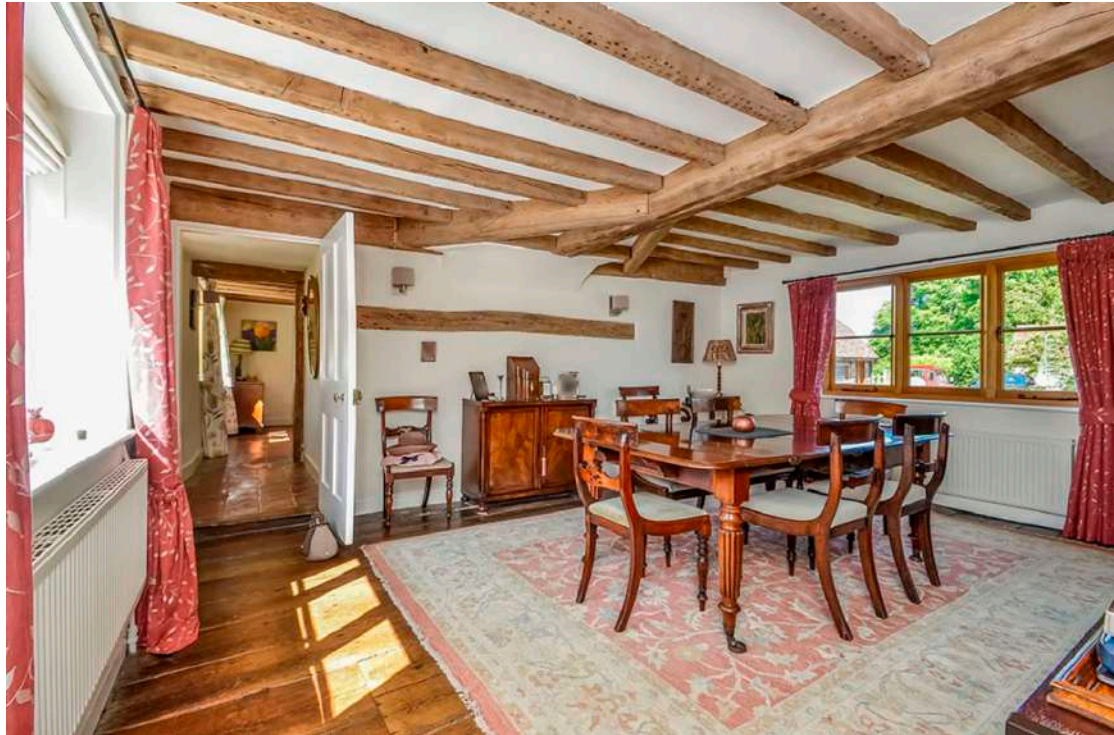
Figure 15; View of the Easternmost ground floor room in the historic core of the farmhouse, with the later first floor visible. Image by Knight Frank.

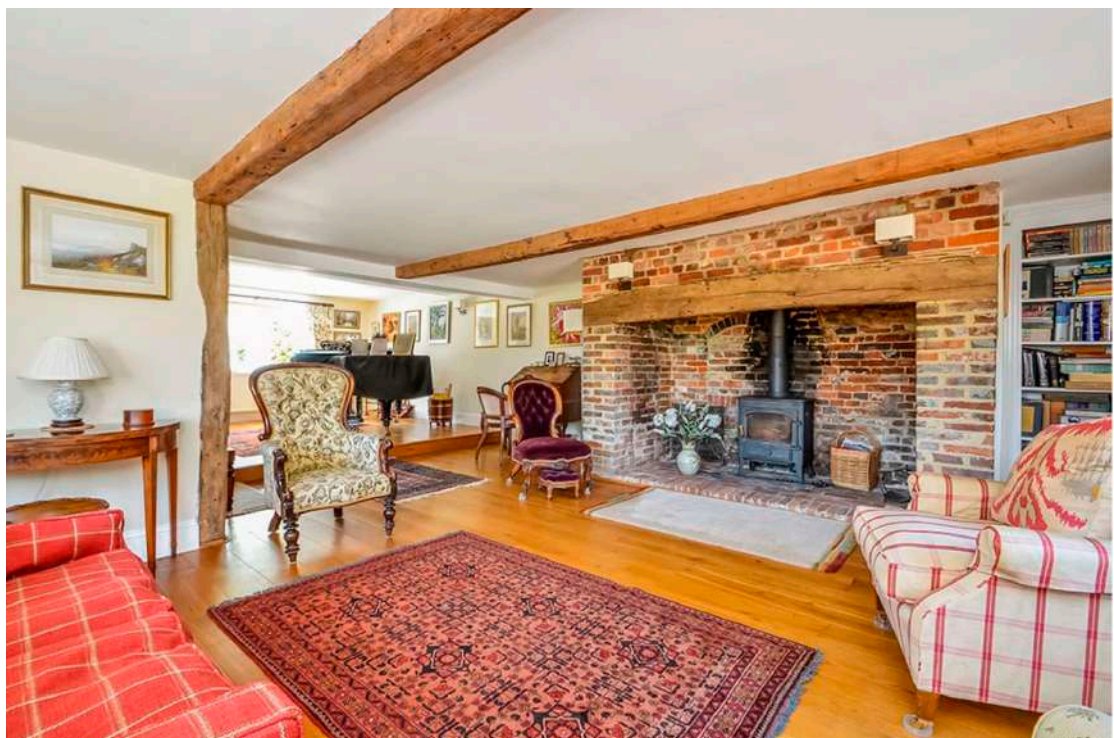
Figure 16; View of the fireplace and living room on the ground floor of the C18 extension to the Western end of the original farmhouse. Image by Knight Frank.

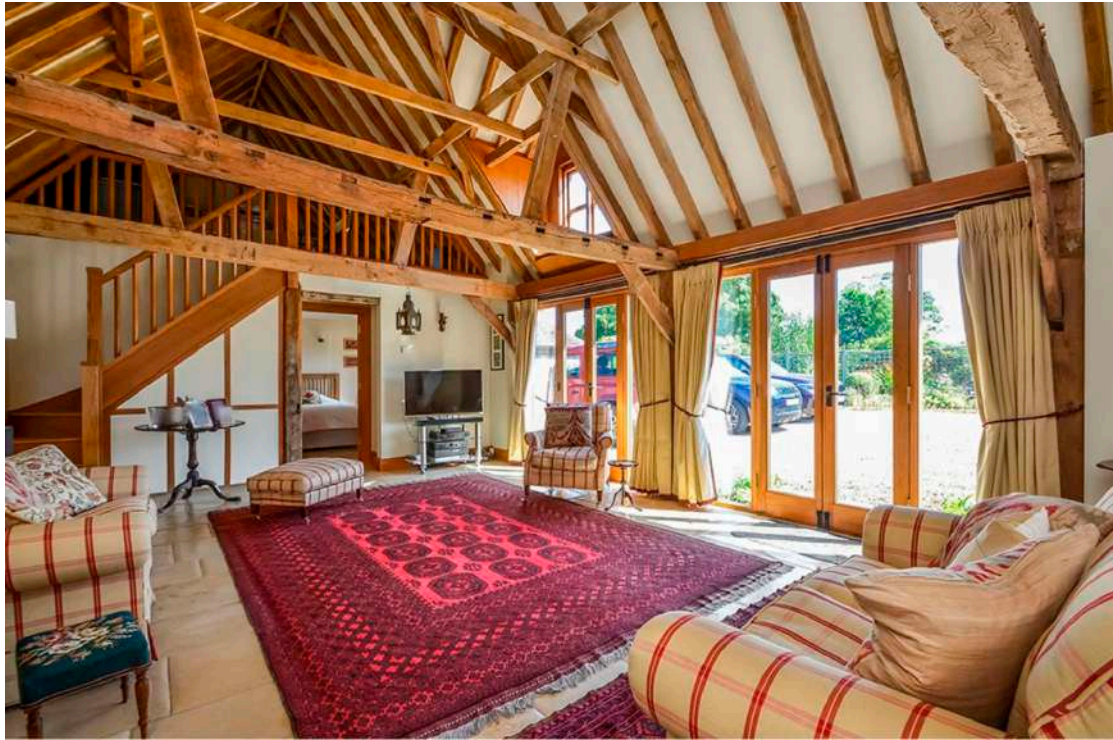
Figure 17; View of the interior of the former cart shed, illustrating the conversion to living accommodation. Note the door to the back of the photo, where the bedroom is visible and accessed directly from this primary living space. Image by Knight Frank.

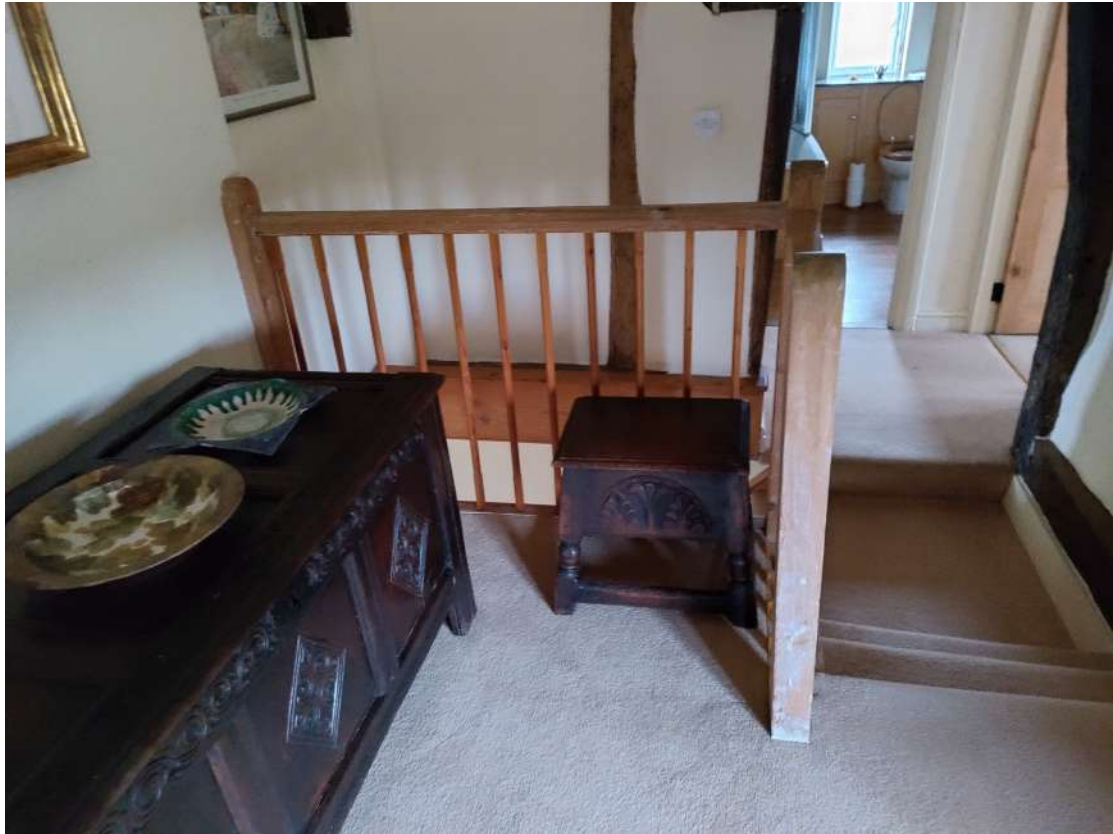
Figure 19; View of the first-floor landing showing the balustrade from the landing side.

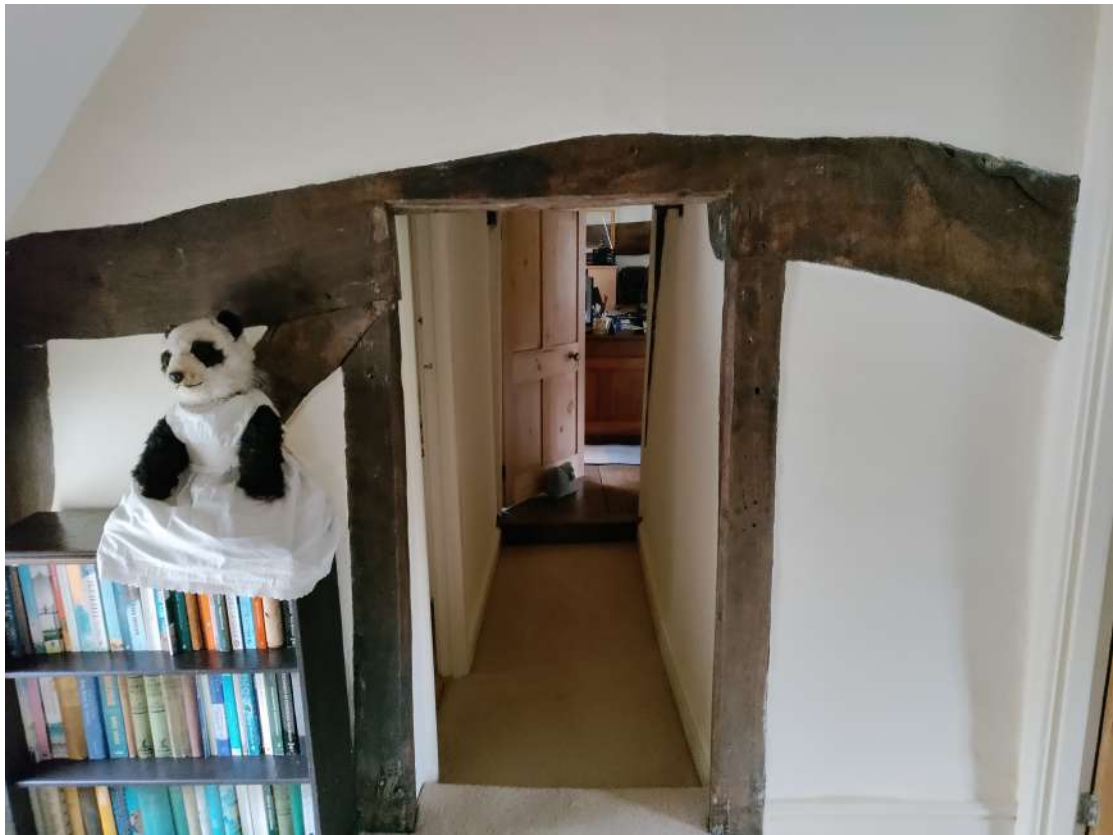
Figure 20; View of the tie beam leading through to the Easternmost bedroom, illustrating how low it is, even with the underside cut out.

The first of these is the extremely compromised door height (only 1.58m) to the largest first floor bedroom, and other areas of restricted access caused by the low height of the tie beams forming the original frame from the first floor. As discussed above, this is a result of the original hall-house design, where no first floor originally existed. When the floor was subsequently added the tie beams naturally remained at their set heights, which are so low that in earlier times their lower sections have been imprudently cut away. The 1.58m height of the access to the bedroom includes the additional height gained by cutting away the lower part of the beam.

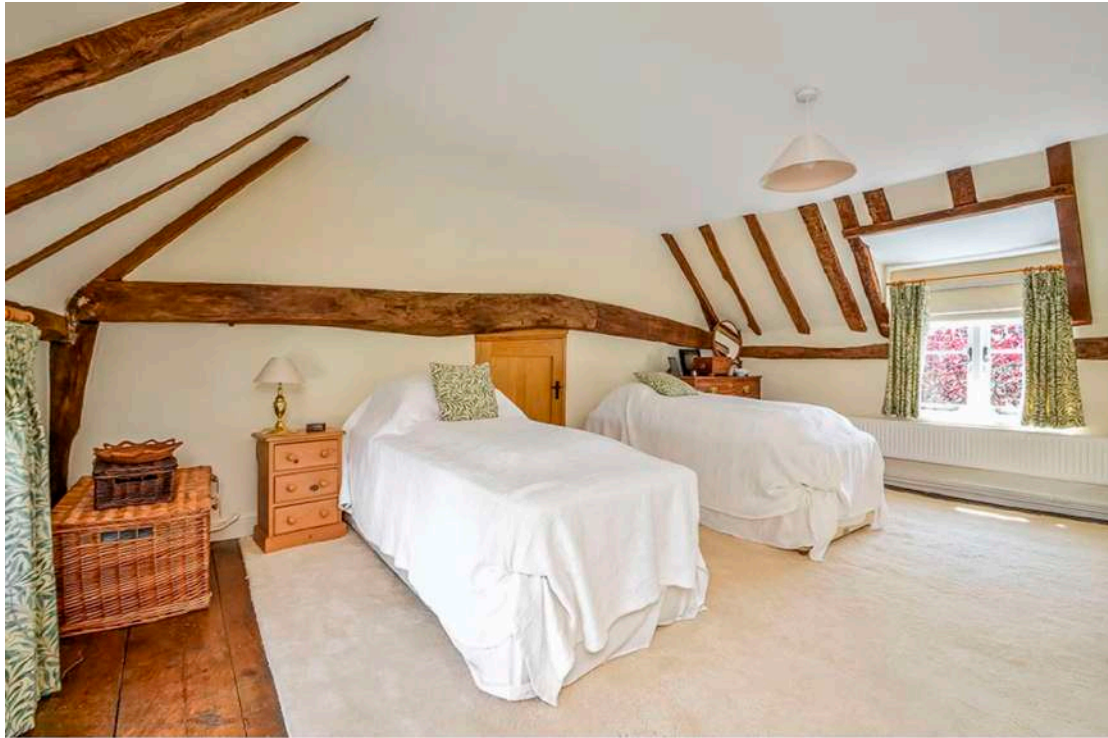
Figure 21; View of the Easternmost bedroom in the historic core of the property. An example of the low accesses and tie beam heights is put into scale by the adjacent beds. Image by Knight Frank.

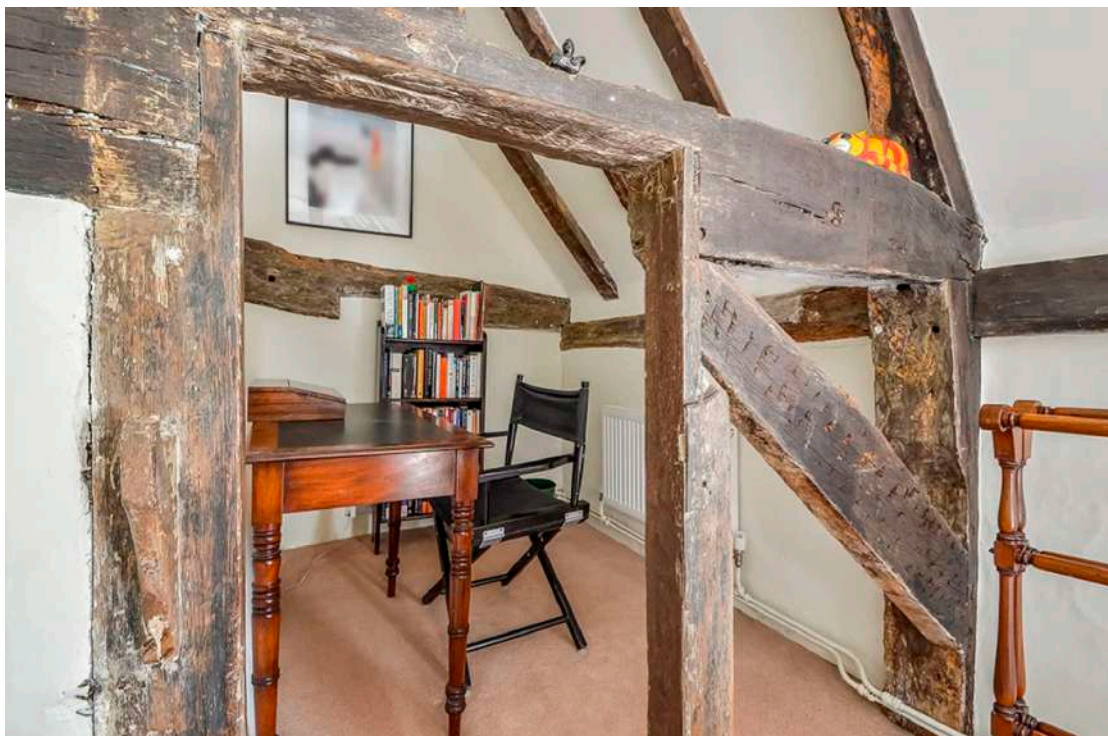
Figure 22; View of the section of the Western bedroom in the historic core of the property, showing the section 'cut-off' between two tie beams and the chimney stack. The furniture illustrates the very low heights of the beams. Image by Knight Frank.

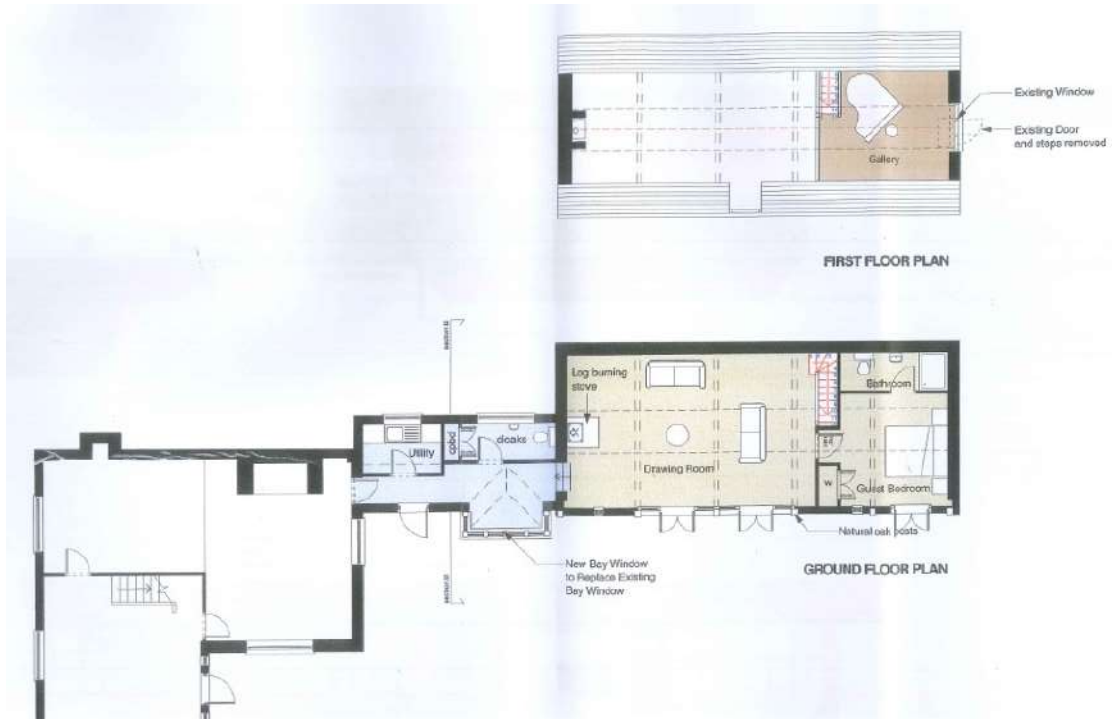
Figure 27; Reduced plans illustrating the works consented under 21921/009 and 21921/010 for the conversion of the former cart shed.

Consents under application numbers 21921/009 and 21921/010 granted permission for the conversion of the former cart shed, which had formerly been used for garaging, in 2002. A completion certificate under building regulations records that this work was finished on site in 2003. This work essentially rebuilt this dilapidated former agricultural building to form living accommodation including a large open living room, an en-suite bedroom, and gallery space over. It is illustrated in the drawings below from that application.

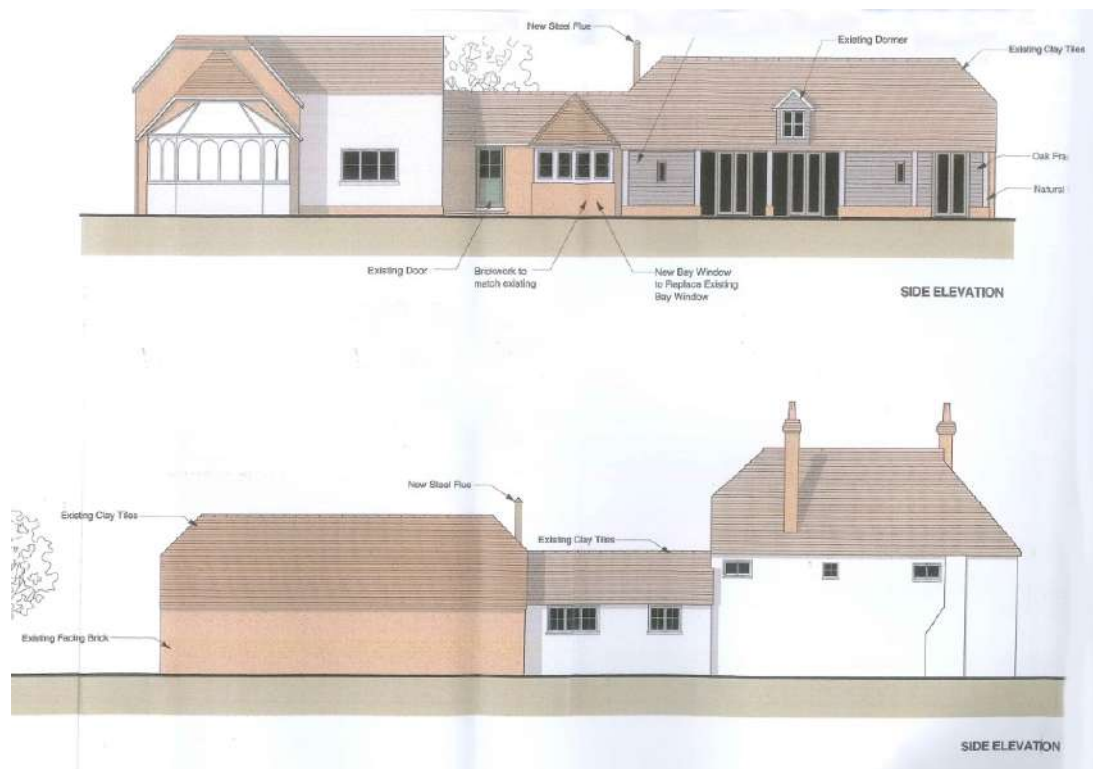
Figure 28; Reduced elevations illustrating the works consented under 21921/009 and 21921/010 for the conversion of the former cart shed.

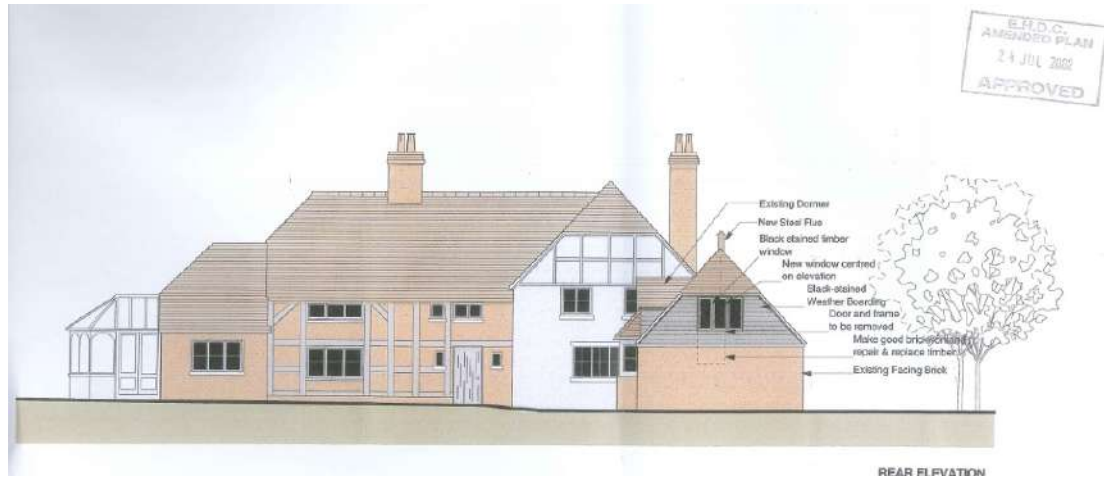
Figure 29; Reduced elevations illustrating the works consented under 21921/009 and 21921/010 for the conversion of the former cart shed.

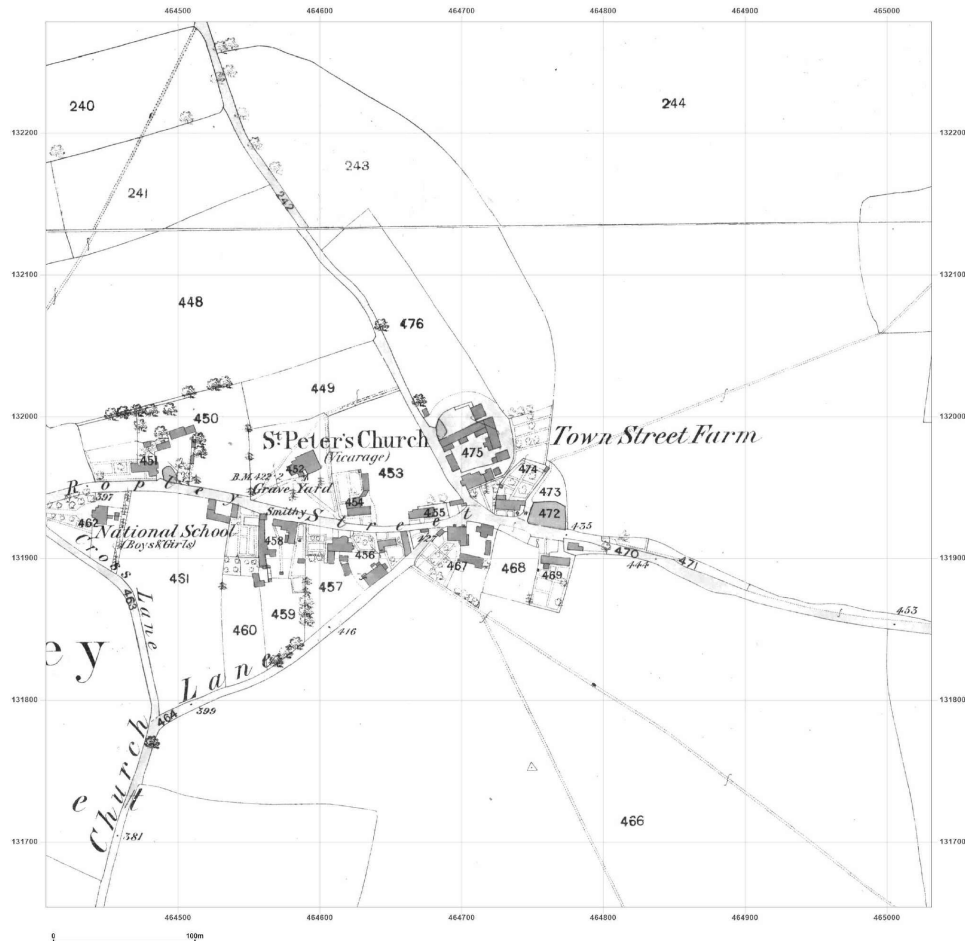
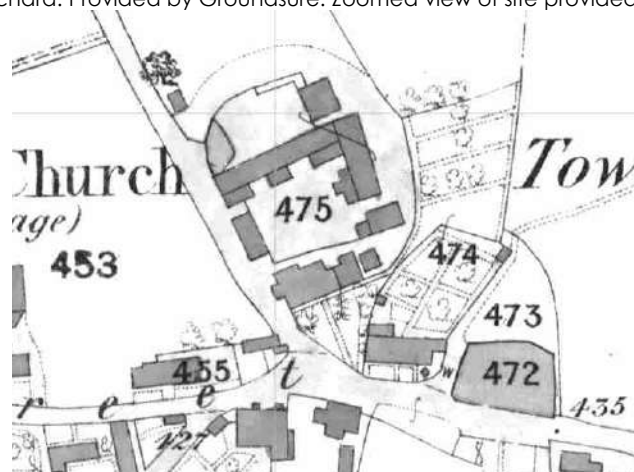
Figure 32; Ordnance Survey of 1870, illustrating Town Street Farm (annotated as 475, at the centre of the plan). The farmhouse is at the Southern end of the site, with a large quadrangle of buildings to the North, running along Dunsell's Lane and then back into the East. A very large building is shown running along the Northern boundary, beyond which is a pond. The ground to the East of the courtyard is likely to have been an orchard. Provided by Groundsure. Zoomed view of site provided below.

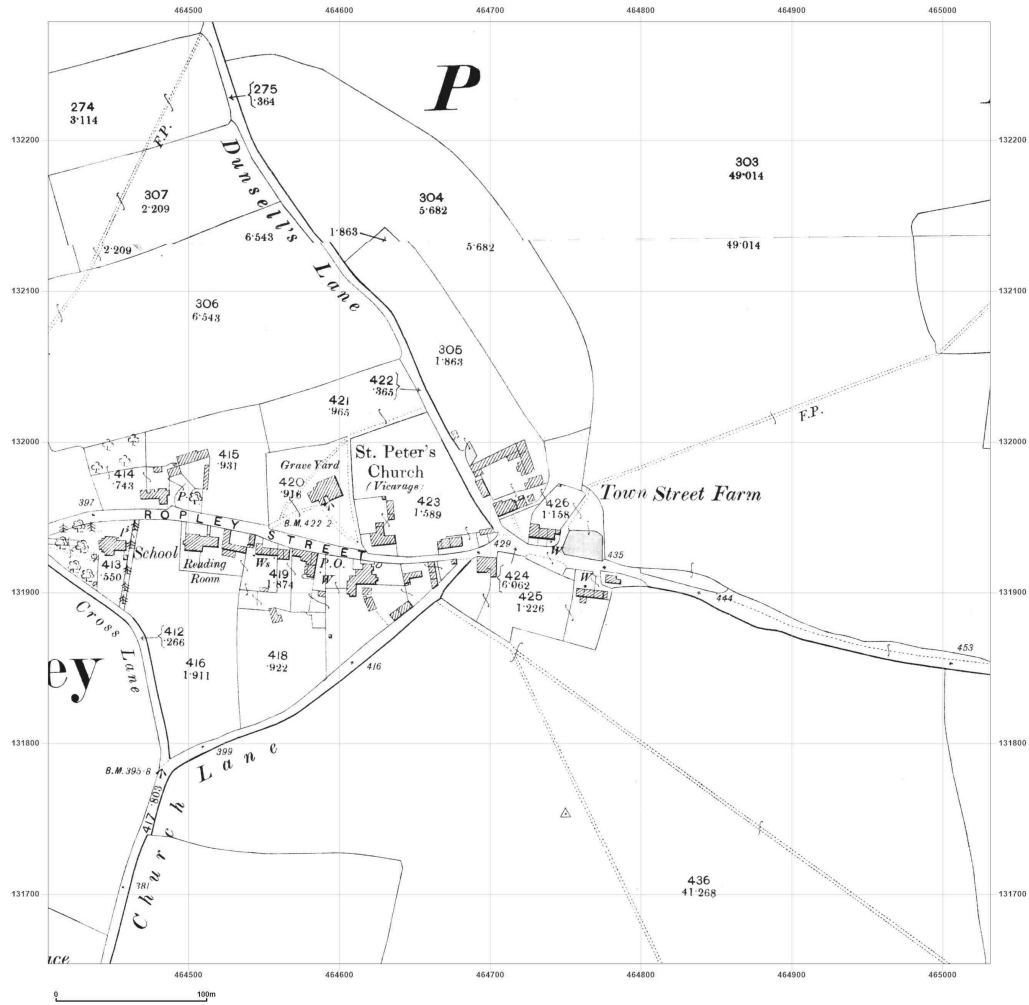
Figure 33; Ordnance Survey of 1896. This shows that the site has barely changed since the preceding survey. The only changes being the removal of the structure to the North, beyond the courtyard, and the removal of the small projecting section of building in the centre of the Northern courtyard range. Provided by Groundsure. Zoomed view of site provided below.

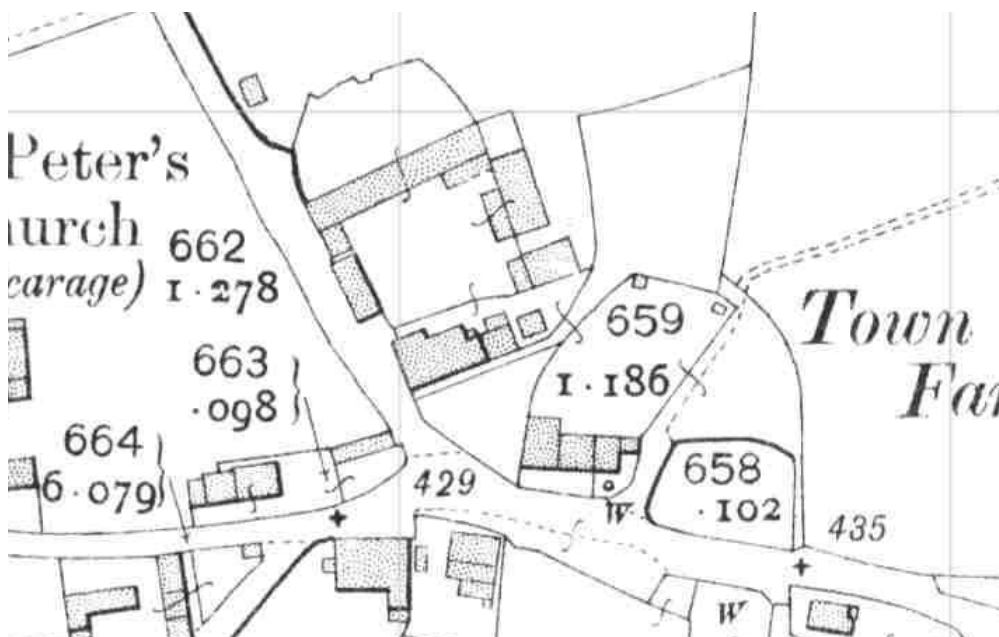
Figure 34; Ordnance Survey of 1909. The buildings remain broadly similar to the preceding survey, with the buildings along Dunsell's Lane and the Northern range now almost contiguous. The pond to the North now appears to have gone. Provided by Groundsure. Zoomed view of site provided below.

The available Ordnance Survey mapping for Town Street Farmhouse leaves a significant gap between the 1909 map and the 1957 map, the latter being from the 1:10,560 scale series, rather than the 1:2,500 scales available for the other dates.

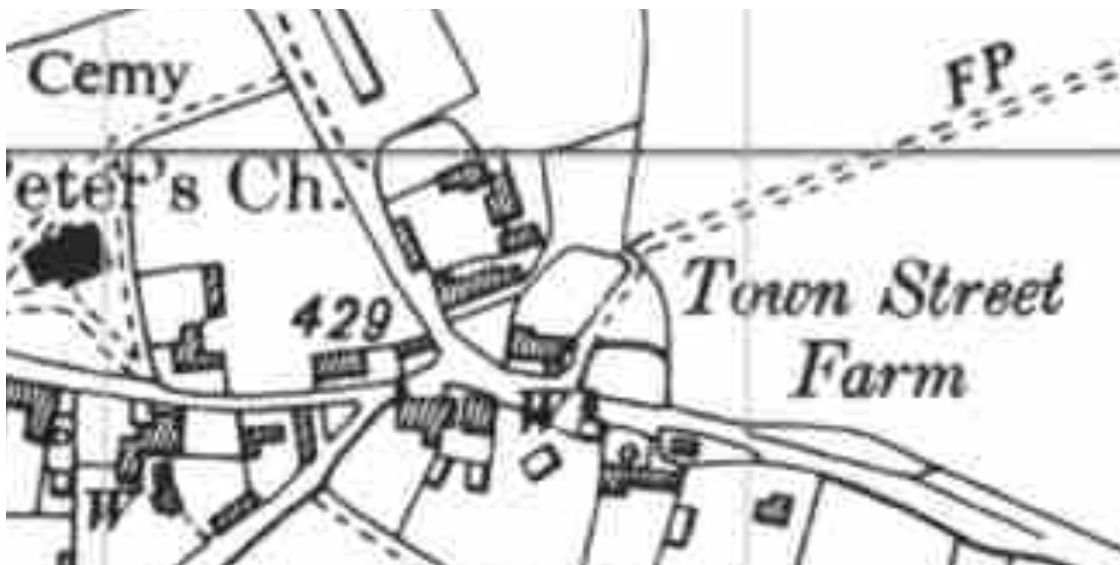
Figure 35; Ordnance Survey of 1957. The farmstead retains its courtyard, with the only substantial change being the removal of the section of building to the North-West corner. Provided by Groundsure. Zoomed view of site provided below.

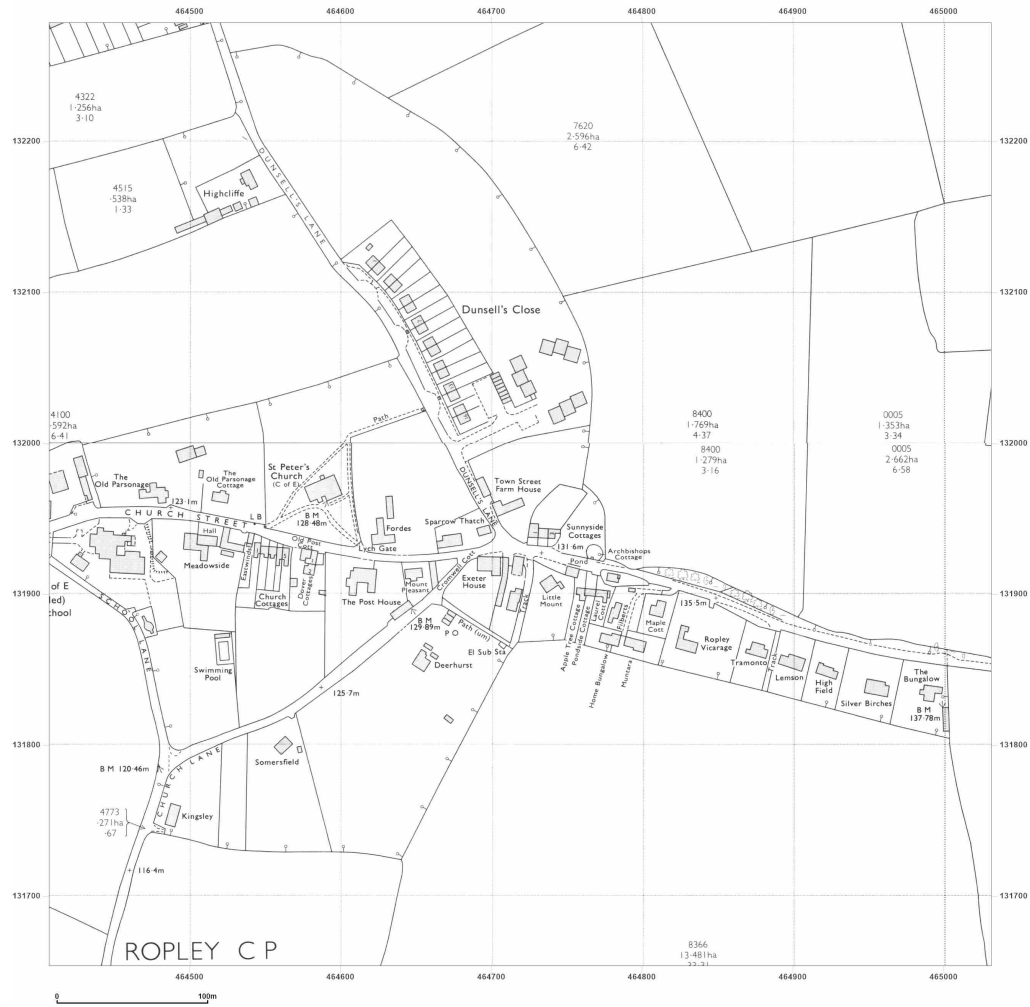
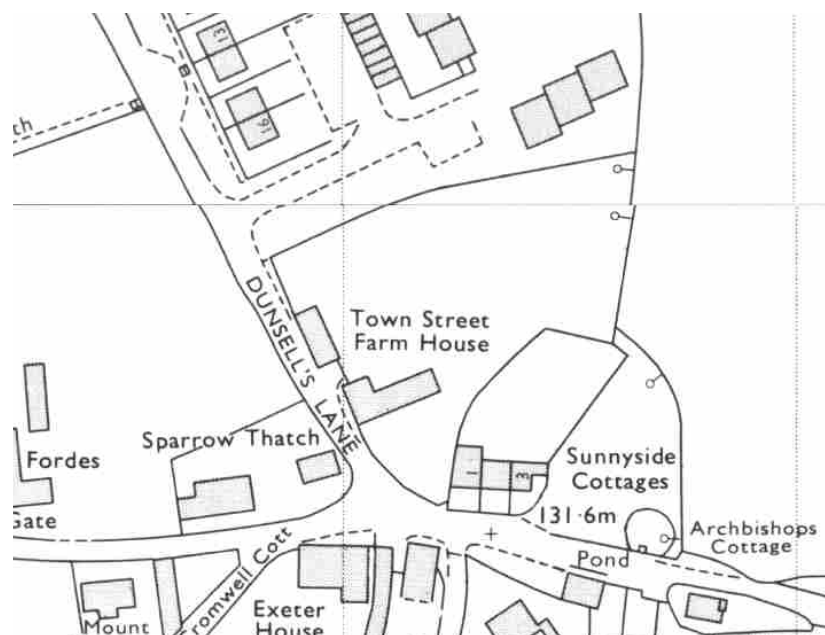
Figure 36; Ordnance Survey of 1974. By the time of this survey the site had reached close to its current form with regard to the surviving historic buildings, with only the farmhouse and cart shed remaining. The post-war housing on Dunsell's Lane and Town Close are now shown for the first time. Provided by Groundsure. Zoomed view of site provided below.

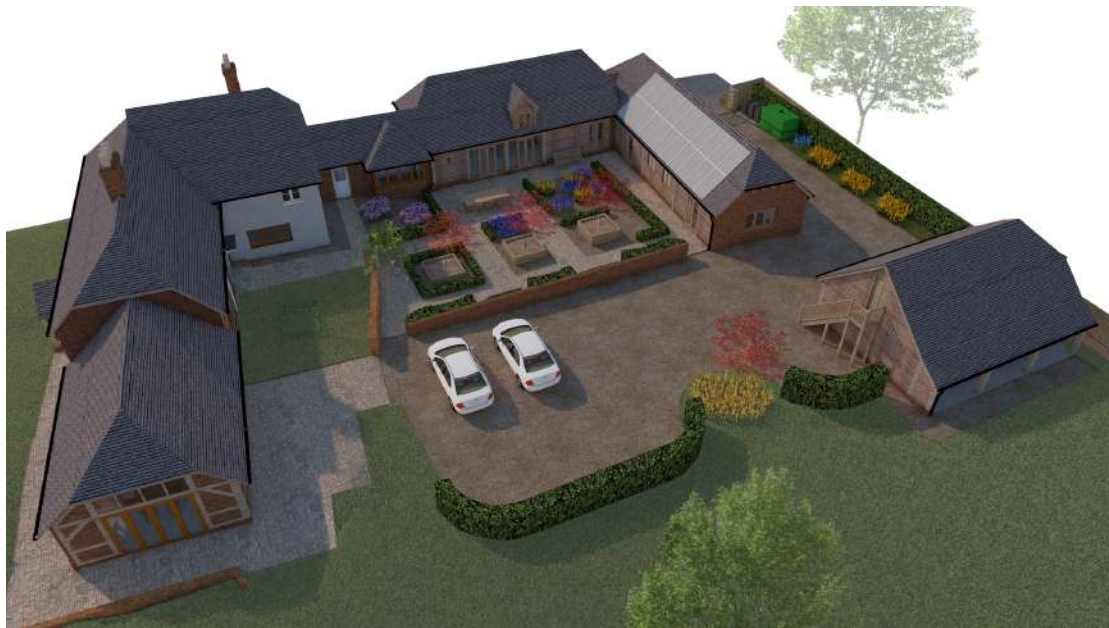
Figure 43; Aerial rendered view showing the site from the East. This shows the relative positions of the ground floor extension to the right of the cart shed, and the garage and store building. The sense of the courtyard garden and revised parking area is also shown.

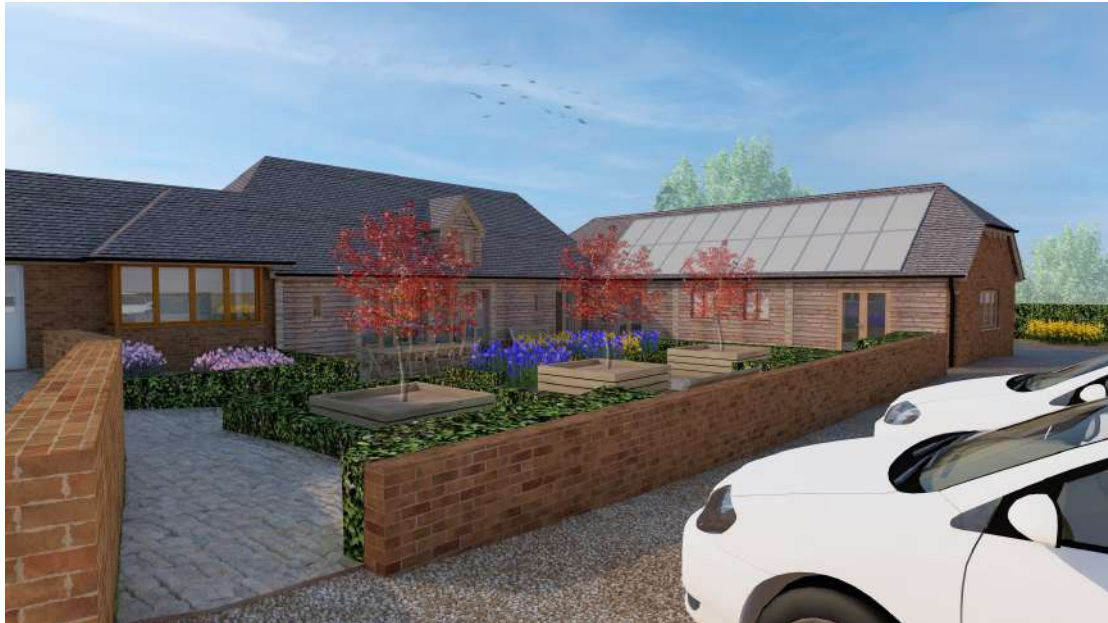
Figure 44; Rendered view looking to the North-West from the parking area toward the new single-storey wing across the courtyard garden. The lower ridge height and traditional materials are clearly visible.
