## Assessment of Significance and Heritage Statement

Site: Town Street Farmhouse, Church Street, Ropley, Hampshire, SO24 0DP

Client: Mr & Dr Pinder

Date: 8<sup>th</sup> March 2024

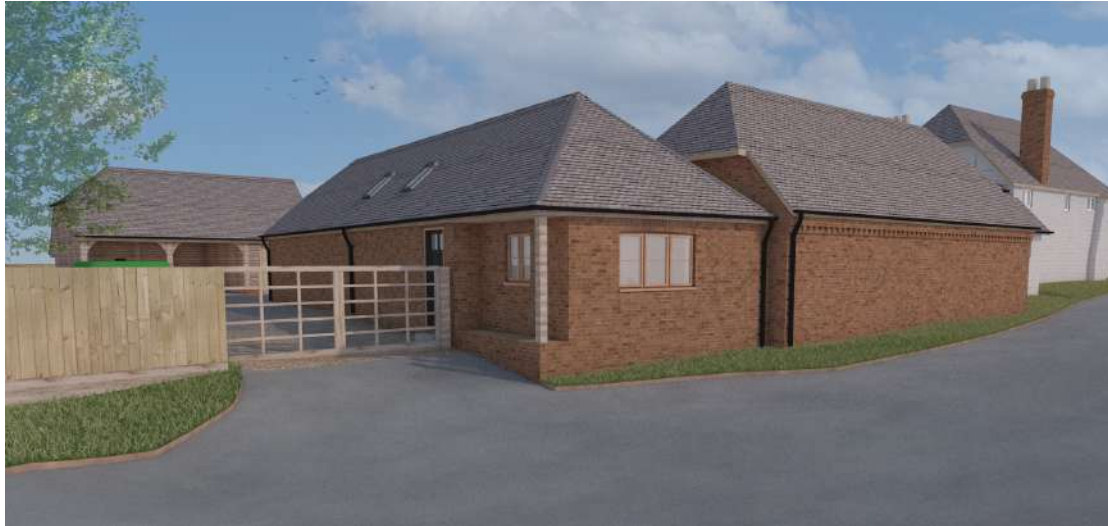
Figure 46; View of the new wing and garage as seen from Dunsell's Lane.
