Nile and Villiers, Sunderland

Ground Investigation Interpretive Report

Town Development Limited

October 2023

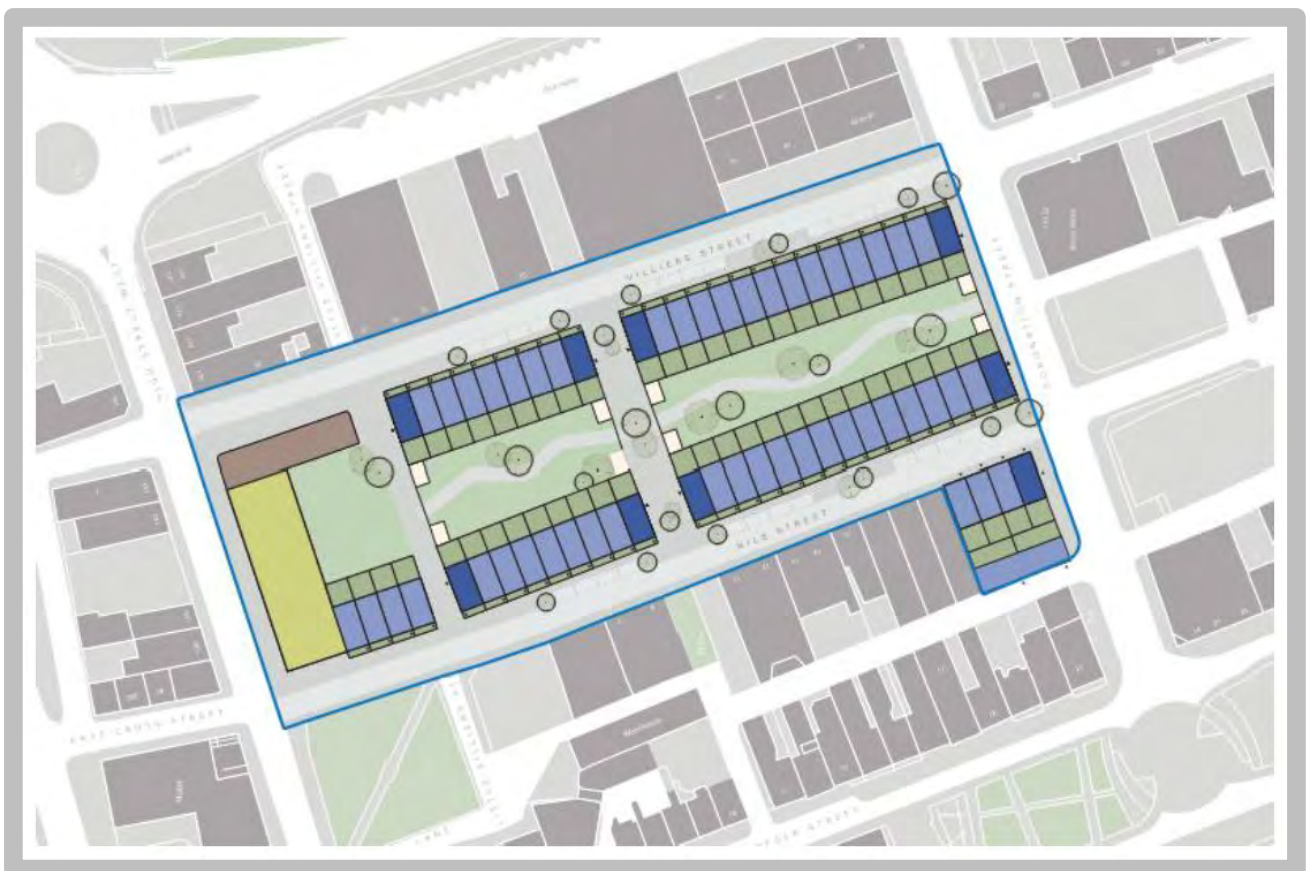
Indicative Development Layout

At this stage it is understood that the final development will comprise residential properties with areas of private gardens and public open spaces and associated infrastructure across much of the site with a large commercial unit on the northern boundary. An indicative Plan of Proposals as supplied by the Client's civil engineer is shown below for information. The plan is orientated with North to the left.

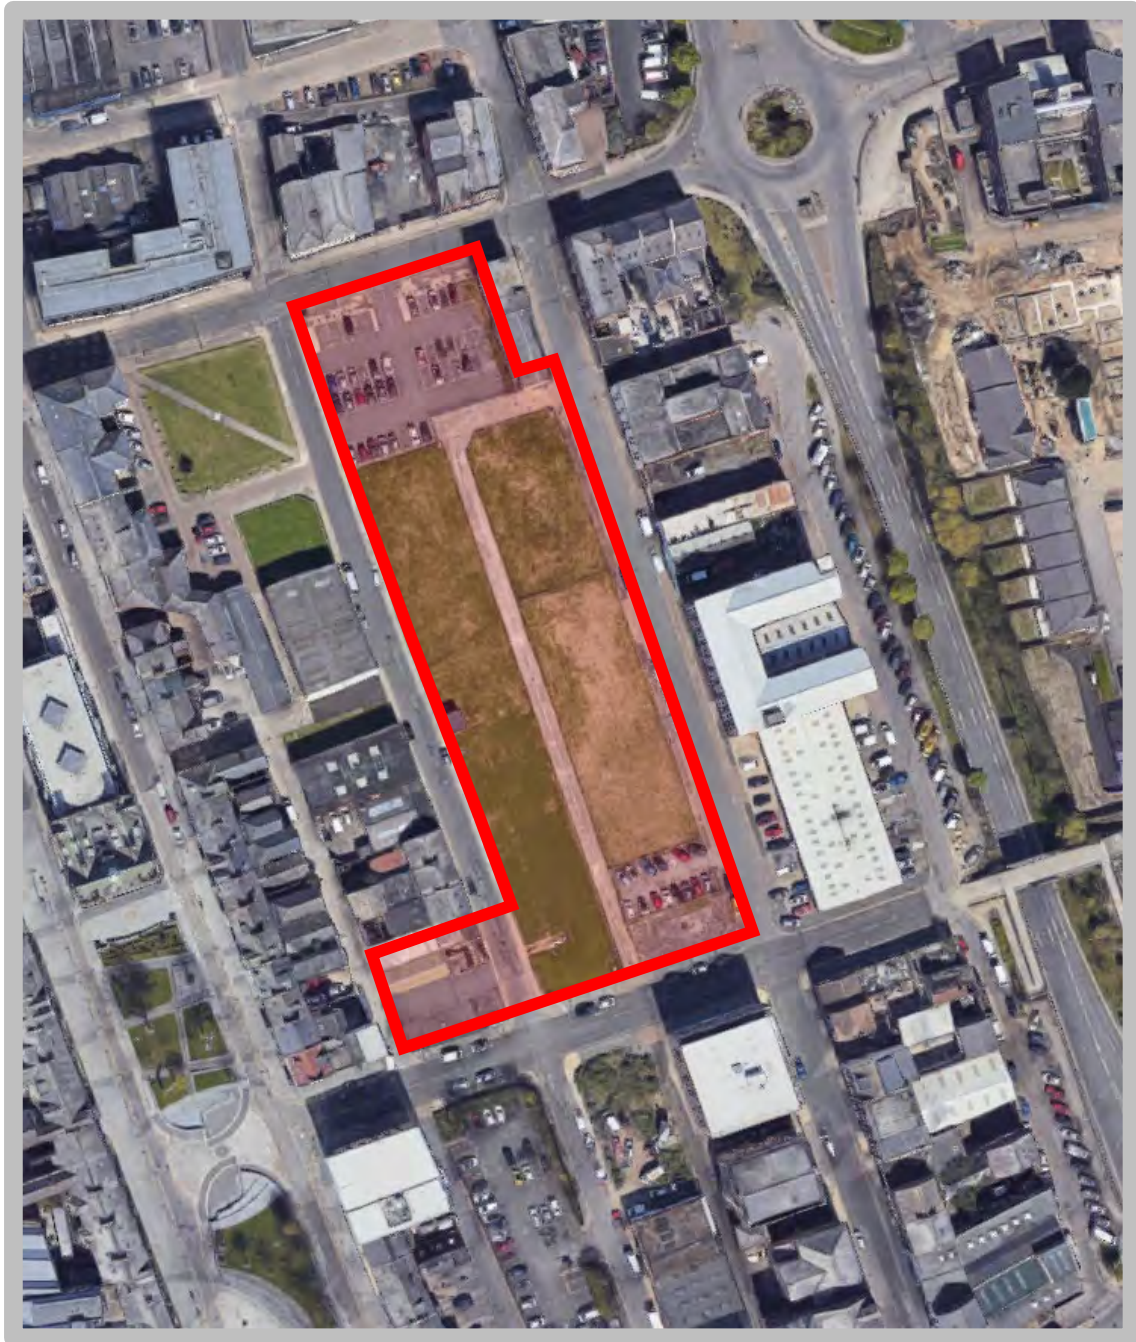
Figure 2 – Aerial Photograph Showing the Site's Red Line Boundary.

A general site location plan of the site is presented as Figure 1 and an aerial photograph as Figure 2.

The site is a rectangular plot of open land, previously commercial properties, and derelict land, covered with scrub grass with hardstanding and tarmacadam car parking in the north and south of the site. An electricity substation is located within the site adjacent to the Nile Street site boundary. The site is generally flat with a slight dip to the south adjacent to Villiers Street. The site is bisected by Little Villiers Street, which appears to be a former narrow lane between Nile Street and Villiers Street. The area surrounding the site is predominately commercial properties with some open public land and residential properties to the west of Nile Street beyond which is the bulk of Sunderland City Centre. To the east of Villiers Street is the A1018, beyond which is the area of Sunderland Docks. To the north of the site is High Street West beyond which there are commercial properties with the River Wear approximately 300m to the north. To the south of the site is Coronation Street beyond which are commercial properties.

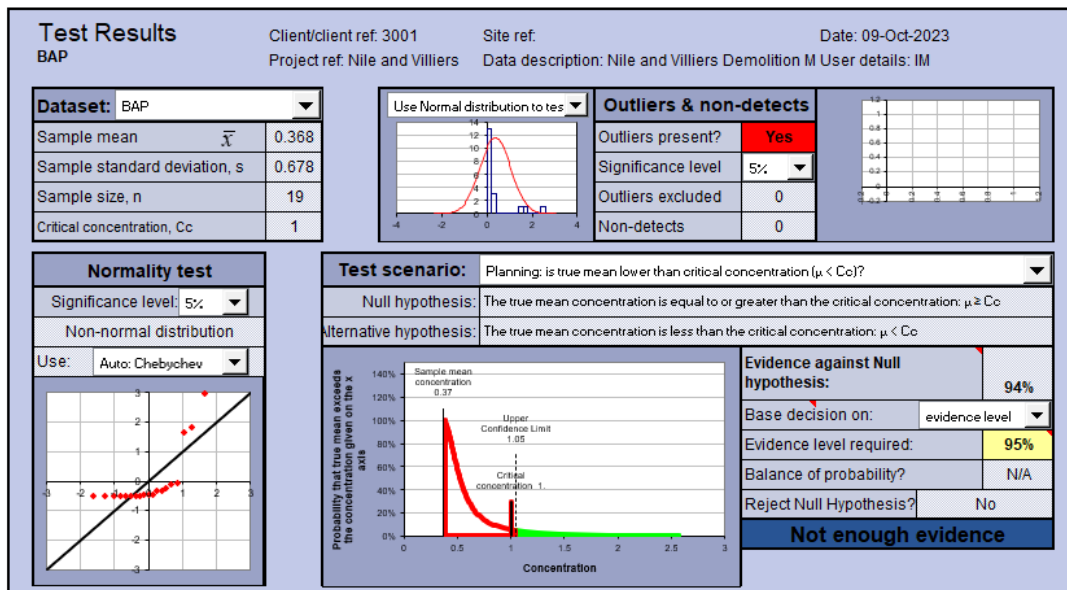
Benzo(a)pyrene, UCL95% 1.05mg/kg

The statistical analysis of the Benzo(a)pyrene (BaP) concentration in the Granular Made Ground indicates a statistical upper confidence limit (U95) of 1.05mg/kg which marginally exceeds the SGV of 1.00mg/kg with statistical outliers noted.

The lower SGV of 1.00mg/kg utilising the surrogate marker approach is considered appropriate based on the PAH profile (LQM Profiling Tool) indicating the potential presence of coal tar or coal tar derivatives such as creosote, however, the profile also fits that of a combustion (soot) source suggesting a coal fire or coal fired boiler is likely and is considered appropriate on review of the site's history.

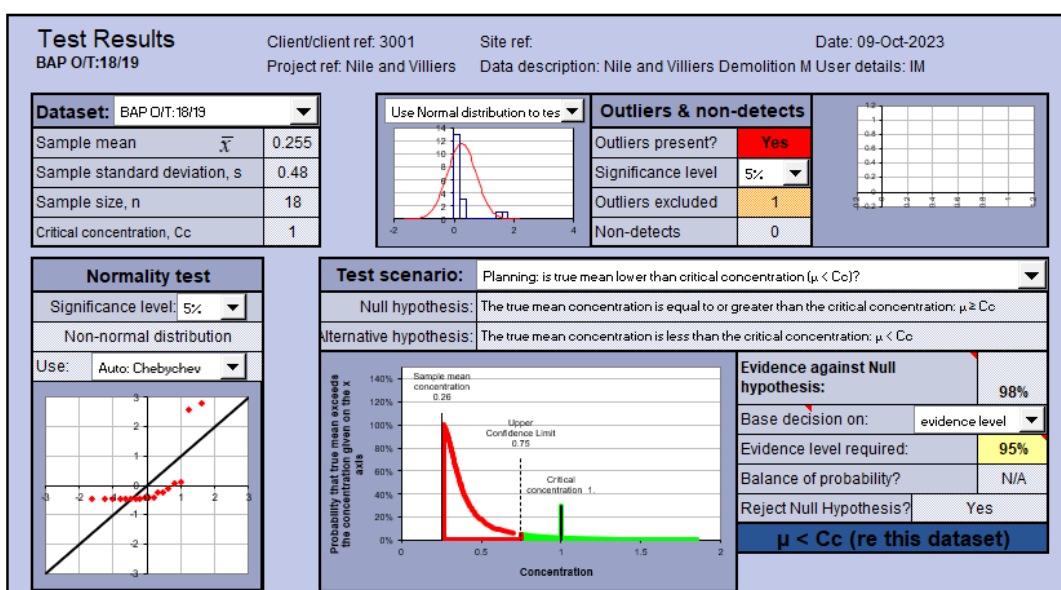
Benzo(a)pyrene, 1st outlier removed, UCL95% 0.75mg/kg

With the highest statistical outlier (hotspot) removed from the dataset, 2.40mg/kg reported in TP-01 at 0.40m, the upper confidence limit (U95) is 0.75mg/kg which is within the SGV of 1.00mg/kg.

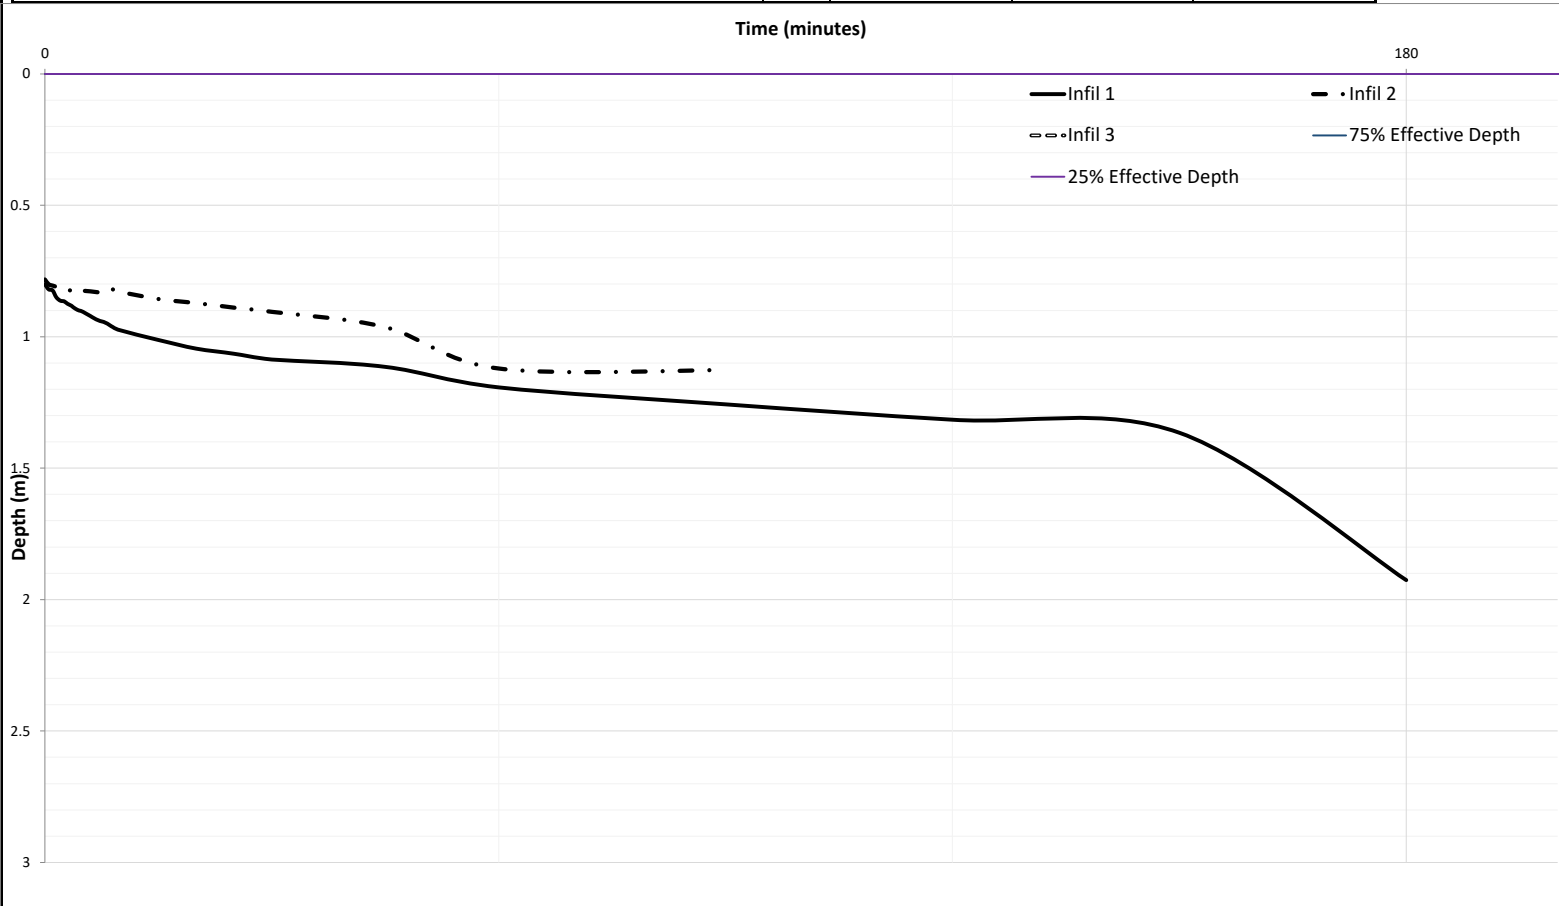
SOAKAWAY TEST RESULTS

Water level did not fall to below the 25% full level within 24 hrs for fills 2 and 3 - Soil infiltration rate based on effective drainage only

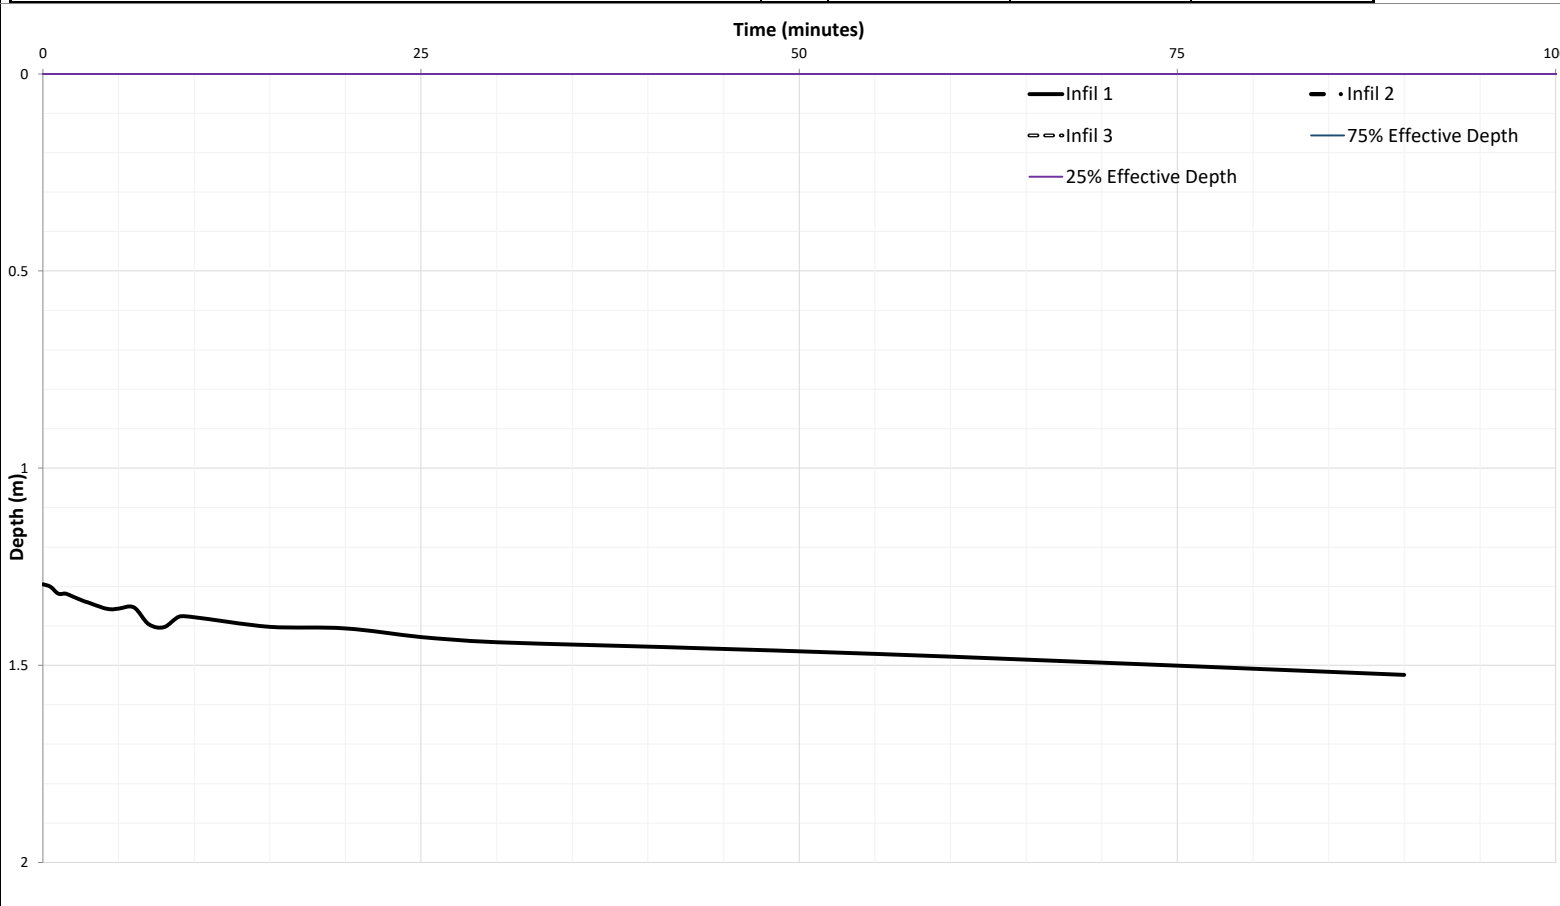
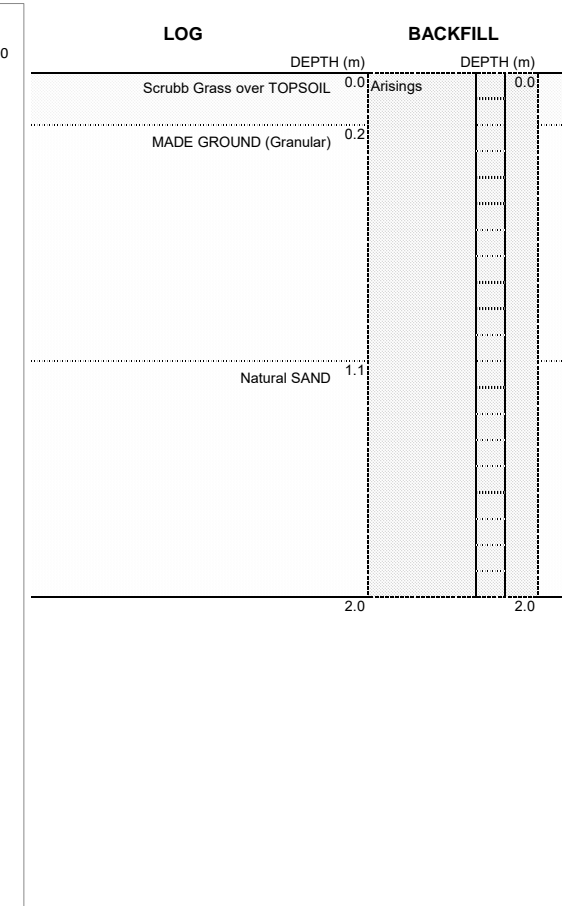
SOAKAWAY TEST RESULTS

Water level did not fall to below the 25% full level within 24 hrs for fills 1, 2 and 3 - Soil infiltration rate based on effective drainage only

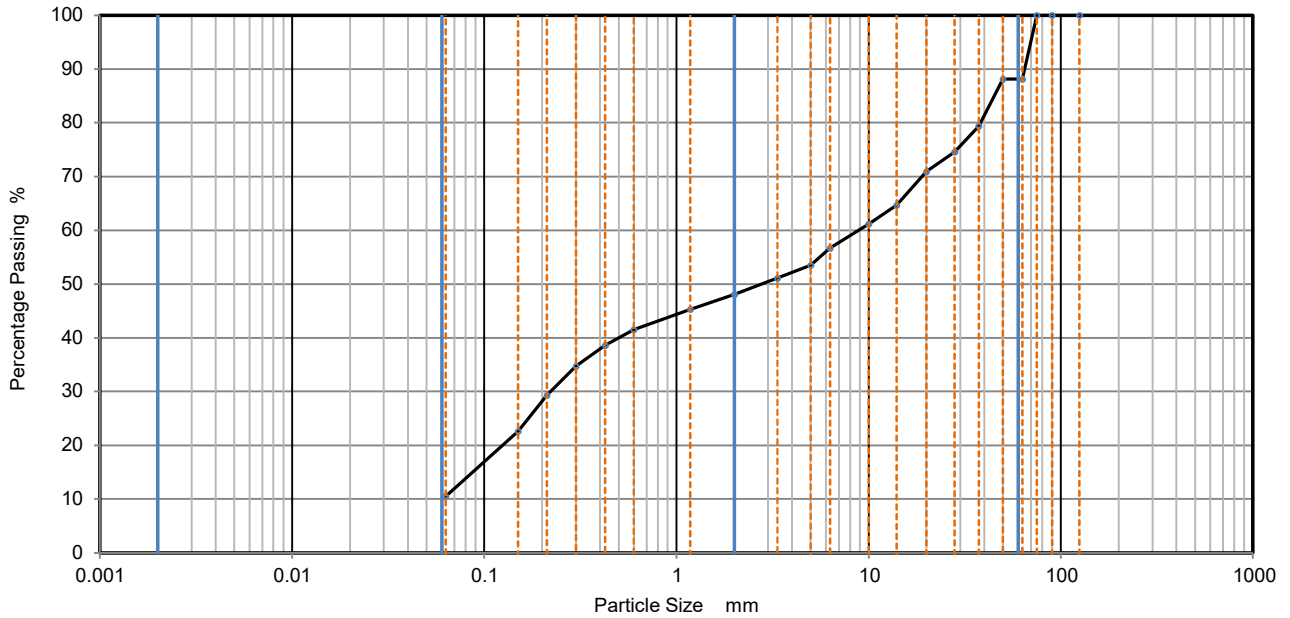
PARTICLE SIZE DISTRIBUTION

Job Ref	D11093	
			Borehole/Pit No.	TP-02	
Site Name	3001 Nile and Villiers		Sample No.	6	
Soil Description	MG (Brown Slightly Clayey Gravelly Sand. Gravel Includes Brick & Concrete)		Depth, m	0.30	
Specimen Reference		Specimen Depth	m	Sample Type	B
Test Method	BS 1377-2:1990, Washing and Drying, Clauses 9.2		KeyLAB ID	EAT_2023100323

Sieving		Sedimentation	
Particle Size mm	% Passing	Particle Size mm	% Passing
125	100		
90	100		
75	100		
63	88		
50	88		
37.5	79		
28	75		
20	71		
14	65		
10	61		
6.3	57		
5	54		
3.35	51		
2	48		
1.18	45		
0.6	42		
0.425	39		
0.3	35		
0.212	29		
0.15	23		
0.063	11

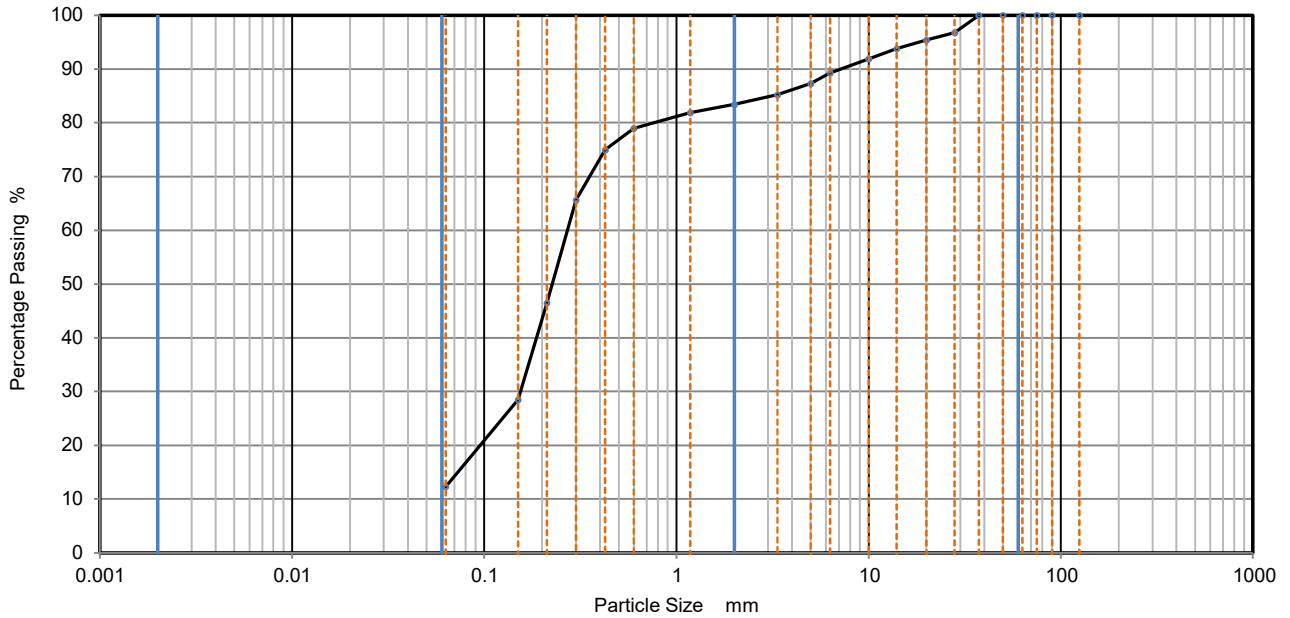
PARTICLE SIZE DISTRIBUTION

Job Ref	D11093	
			Borehole/Pit No.	TP-07	
Site Name	3001 Nile and Villiers		Sample No.	15	
Soil Description	Brown Slightly Clayey Slightly Gravelly Sand		Depth, m	0.40	
Specimen Reference		Specimen Depth	m	Sample Type	B
Test Method	BS 1377-2:1990, Washing and Drying, Clauses 9.2		KeyLAB ID	EAT_2023100332

Sieving		Sedimentation	
Particle Size mm	% Passing	Particle Size mm	% Passing
125	100		
90	100		
75	100		
63	100		
50	100		
37.5	100		
28	97		
20	95		
14	94		
10	92		
6.3	89		
5	87		
3.35	85		
2	83		
1.18	82		
0.6	79		
0.425	75		
0.3	66		
0.212	47		
0.15	29		
0.063	12

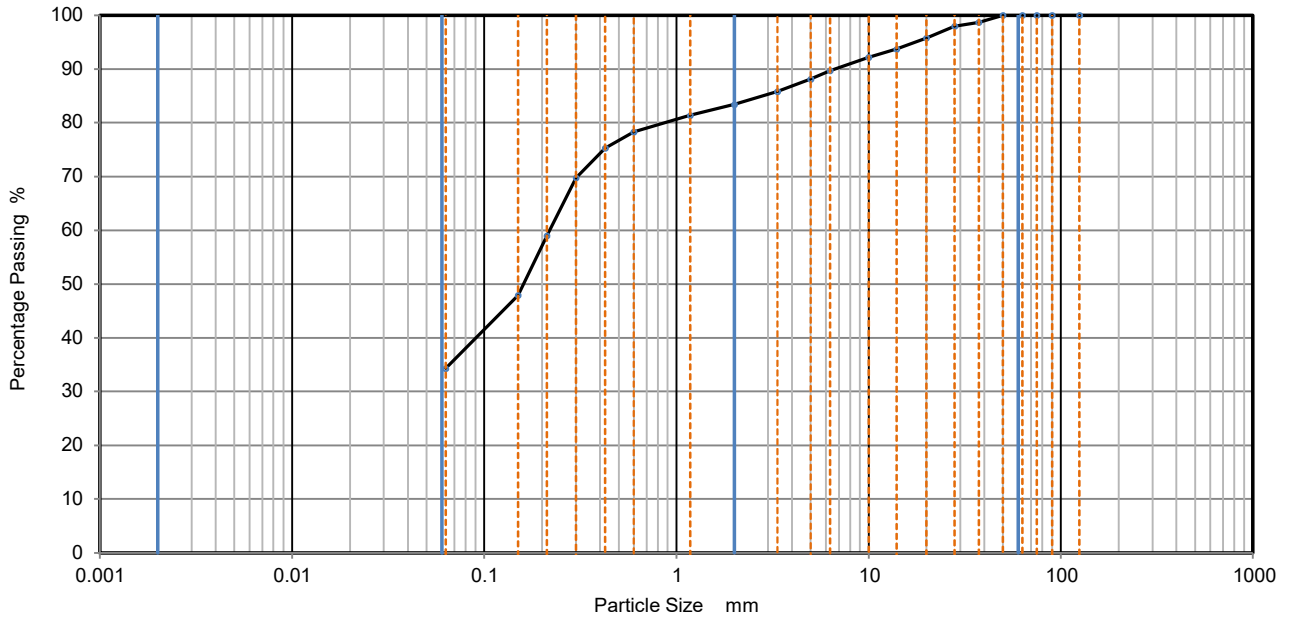
PARTICLE SIZE DISTRIBUTION

Job Ref	D11093	
			Borehole/Pit No.	TP-08	
Site Name	3001 Nile and Villiers		Sample No.	17	
Soil Description	Brown Clayey Gravelly Sand		Depth, m	0.50	
Specimen Reference		Specimen Depth	m	Sample Type	B
Test Method	BS 1377-2:1990, Washing and Drying, Clauses 9.2		KeyLAB ID	EAT_2023100334

Sieving		Sedimentation	
Particle Size mm	% Passing	Particle Size mm	% Passing
125	100		
90	100		
75	100		
63	100		
50	100		
37.5	99		
28	98		
20	96		
14	94		
10	92		
6.3	90		
5	88		
3.35	86		
2	83		
1.18	81		
0.6	78		
0.425	75		
0.3	70		
0.212	59		
0.15	48		
0.063	34

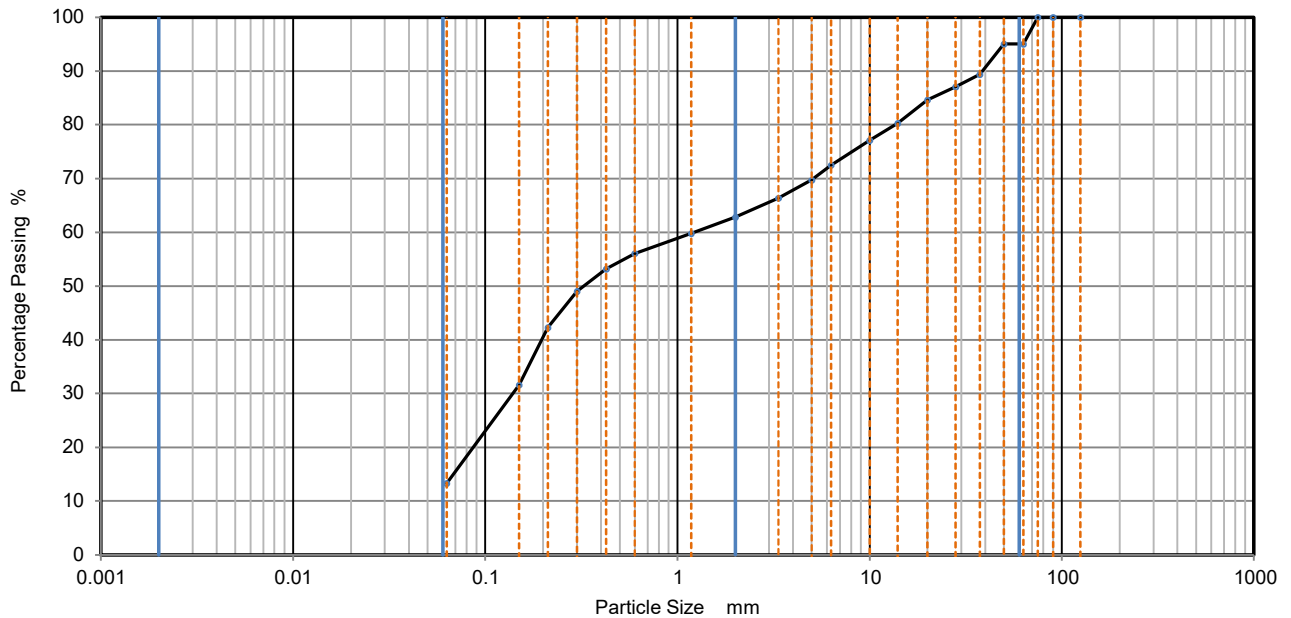
PARTICLE SIZE DISTRIBUTION

Job Ref	D11093	
			Borehole/Pit No.	TP-03	
Site Name	3001 Nile and Villiers		Sample No.	8	
Soil Description	MG (Brown Slightly Clayey Gravelly Sand. Gravel includes Brick & Concrete)		Depth, m	0.60	
Specimen Reference		Specimen Depth	m	Sample Type	B
Test Method	BS 1377-2:1990, Washing and Drying, Clauses 9.2		KeyLAB ID	EAT_2023100325

Sieving		Sedimentation	
Particle Size mm	% Passing	Particle Size mm	% Passing
125	100		
90	100		
75	100		
63	95		
50	95		
37.5	89		
28	87		
20	85		
14	80		
10	77		
6.3	73		
5	70		
3.35	66		
2	63		
1.18	60		
0.6	56		
0.425	53		
0.3	49		
0.212	42		
0.15	32		
0.063	13

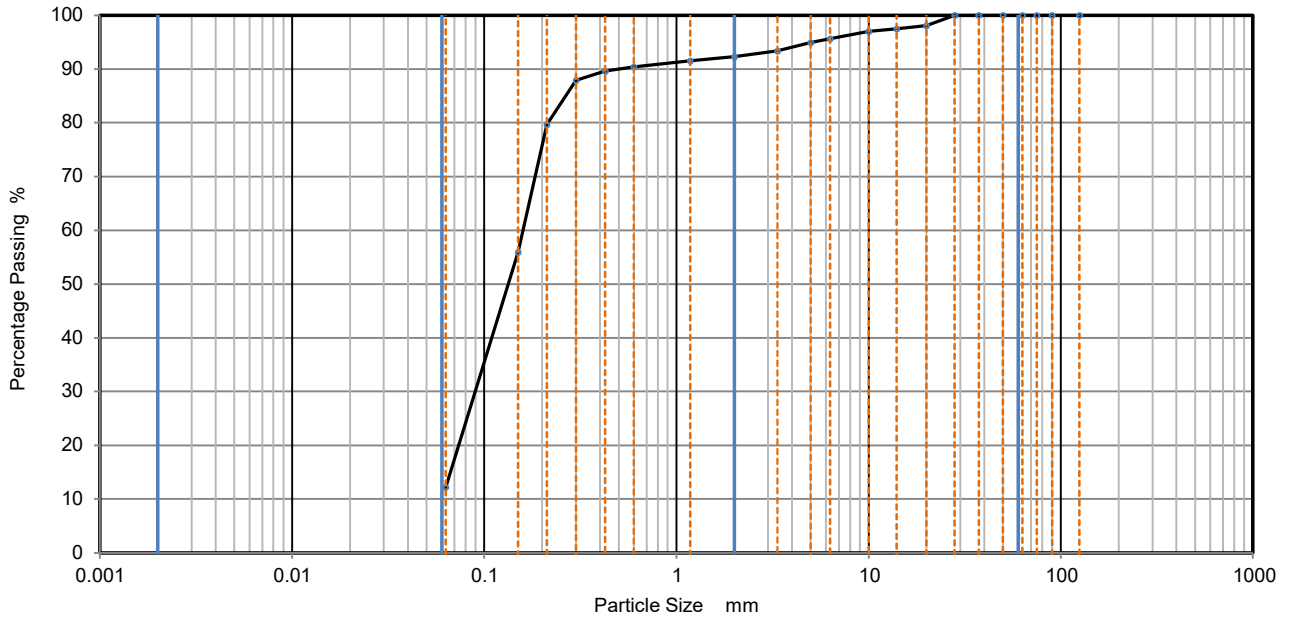
PARTICLE SIZE DISTRIBUTION

Job Ref	D11093	
			Borehole/Pit No.	TP-06	
Site Name	3001 Nile and Villiers		Sample No.	14	
Soil Description	Brown Slightly Clayey Slightly Gravelly Sand		Depth, m	1.40	
Specimen Reference		Specimen Depth	m	Sample Type	B
Test Method	BS 1377-2:1990, Washing and Drying, Clauses 9.2		KeyLAB ID	EAT_2023100331

Sieving		Sedimentation	
Particle Size mm	% Passing	Particle Size mm	% Passing
125	100		
90	100		
75	100		
63	100		
50	100		
37.5	100		
28	100		
20	98		
14	98		
10	97		
6.3	96		
5	95		
3.35	93		
2	92		
1.18	92		
0.6	90		
0.425	90		
0.3	88		
0.212	80		
0.15	56		
0.063	12

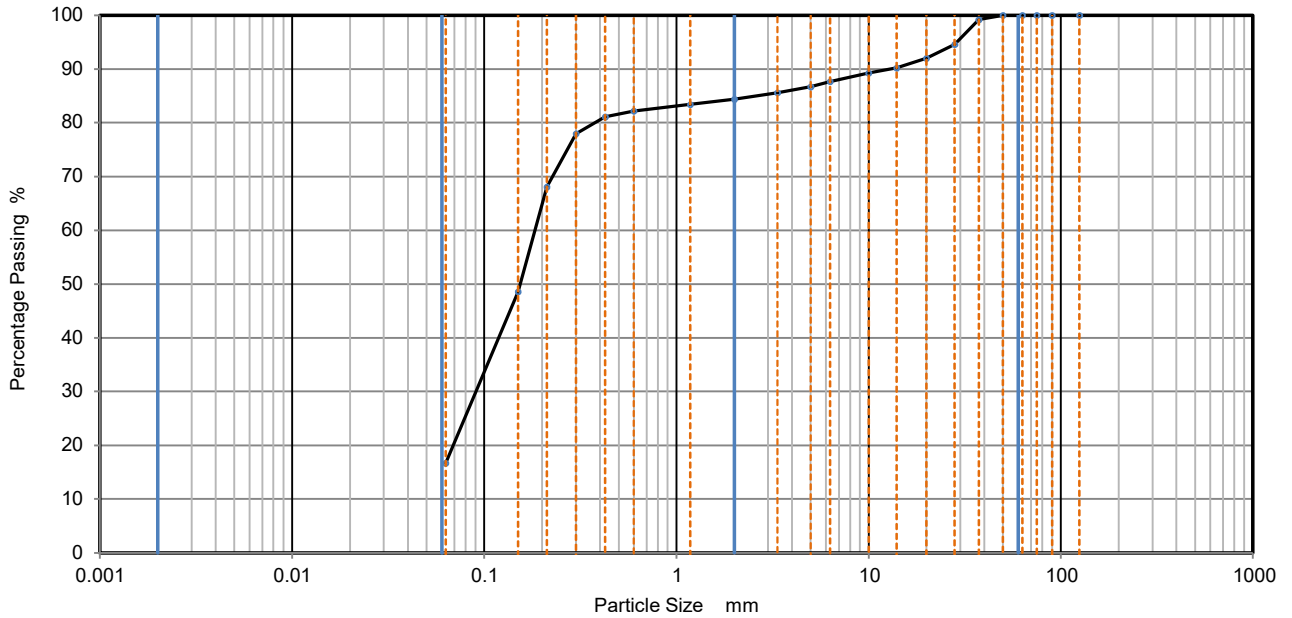
PARTICLE SIZE DISTRIBUTION

Job Ref	D11093	
			Borehole/Pit No.	TP-04	
Site Name	3001 Nile and Villiers		Sample No.	10	
Soil Description	Brown Slightly Clayey Gravelly Sand		Depth, m	2.00	
Specimen Reference		Specimen Depth	m	Sample Type	B
Test Method	BS 1377-2:1990, Washing and Drying, Clauses 9.2		KeyLAB ID	EAT_2023100327

Sieving		Sedimentation	
Particle Size mm	% Passing	Particle Size mm	% Passing
125	100		
90	100		
75	100		
63	100		
50	100		
37.5	99		
28	95		
20	92		
14	90		
10	89		
6.3	88		
5	87		
3.35	86		
2	84		
1.18	83		
0.6	82		
0.425	81		
0.3	78		
0.212	68		
0.15	49		
0.063	17

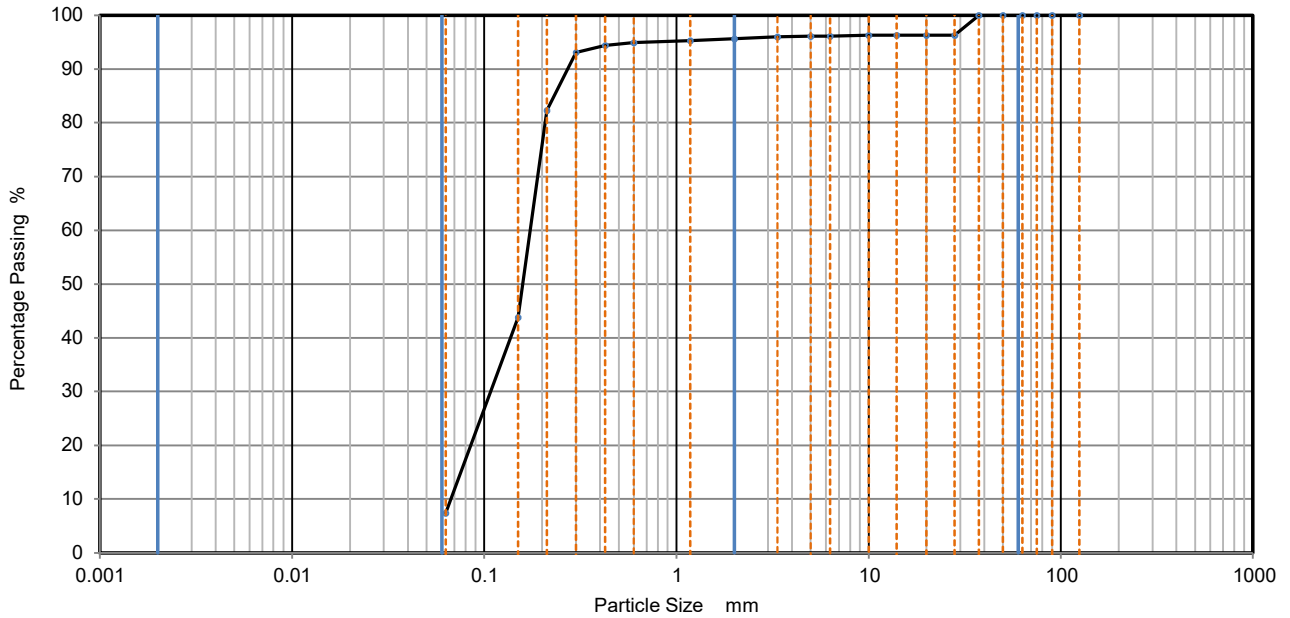
PARTICLE SIZE DISTRIBUTION

Job Ref	D11093	
			Borehole/Pit No.	TP-01	
Site Name	3001 Nile and Villiers		Sample No.	5	
Soil Description	Brown Slightly Clayey Slightly Gravelly Sand		Depth, m	2.00	
Specimen Reference		Specimen Depth	m	Sample Type	B
Test Method	BS 1377-2:1990, Washing and Drying, Clauses 9.2		KeyLAB ID	EAT_2023100322

Sieving		Sedimentation	
Particle Size mm	% Passing	Particle Size mm	% Passing
125	100		
90	100		
75	100		
63	100		
50	100		
37.5	100		
28	96		
20	96		
14	96		
10	96		
6.3	96		
5	96		
3.35	96		
2	96		
1.18	95		
0.6	95		
0.425	94		
0.3	93		
0.212	82		
0.15	44		
0.063	7

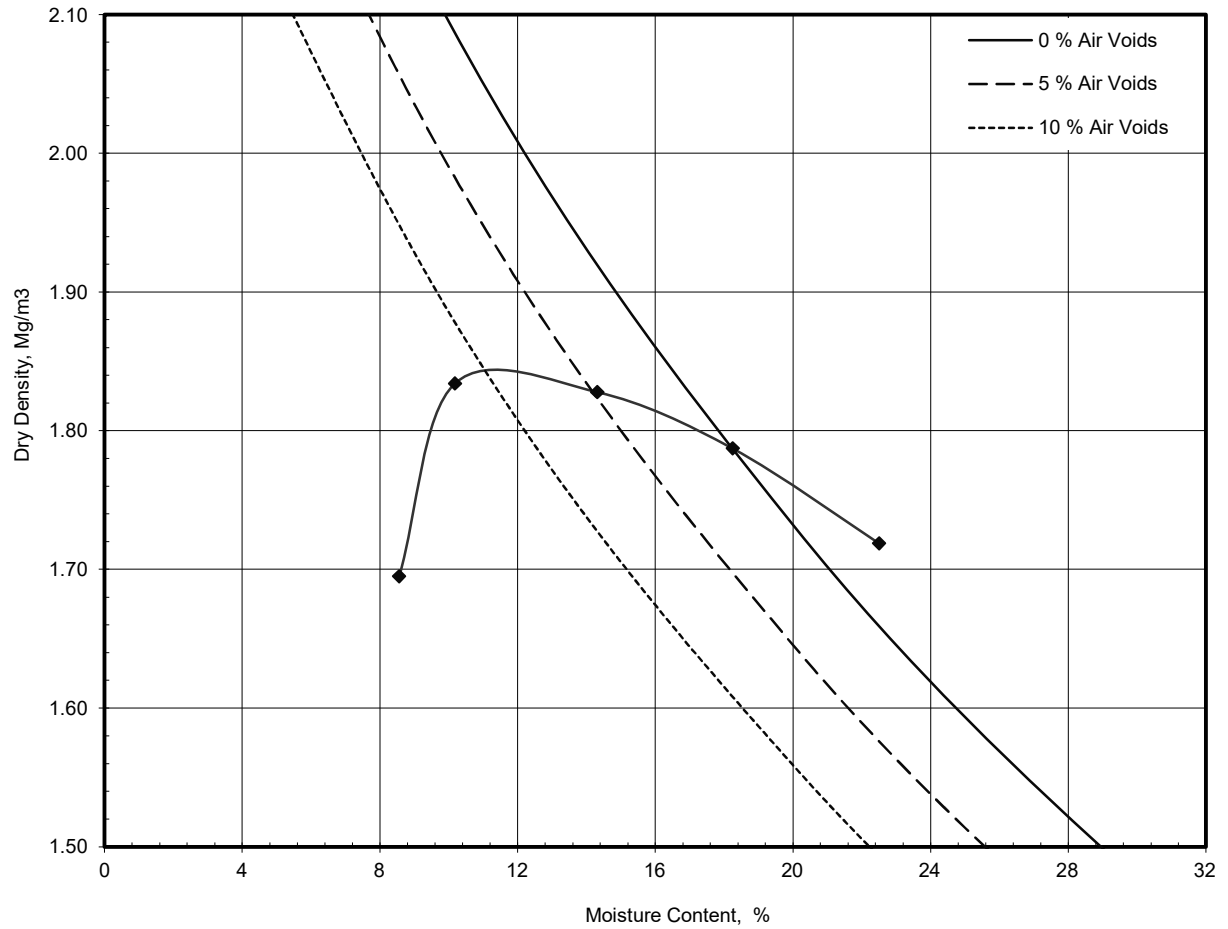
Preparation	Material used was air dried
Mould Type	One Litre
Samples Used	Separate specimens tested
Material Retained on 37.5 mm Sieve	%
Material Retained on 20.0 mm Sieve	%
Particle Density - Assumed	Mg/m ³
Grading Zone of Material	2

Maximum Dry Density	1.83
Optimum Moisture Content	10

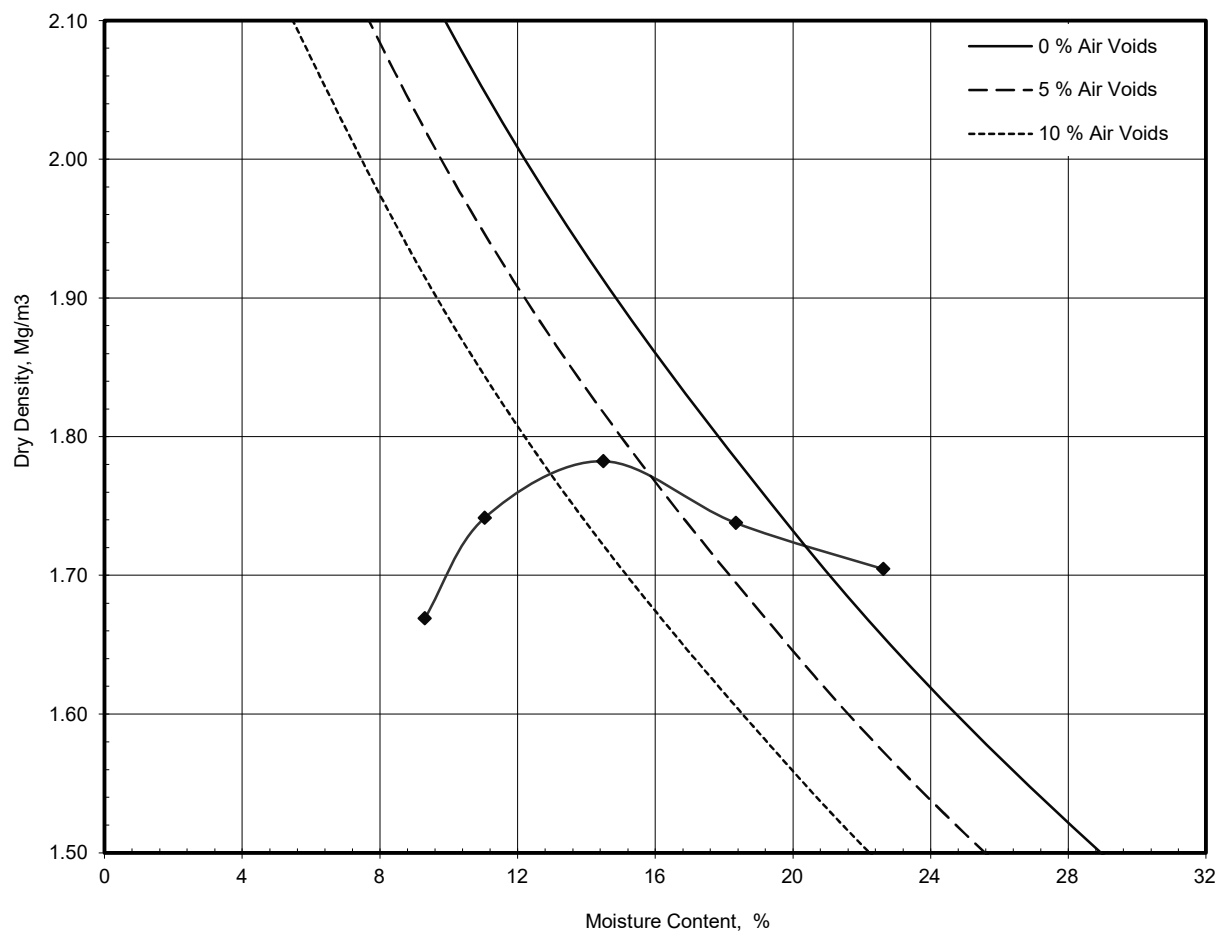
Preparation	Material used was air dried
Mould Type	One Litre
Samples Used	Separate specimens tested
Material Retained on 37.5 mm Sieve	0
Material Retained on 20.0 mm Sieve	1
Particle Density - Assumed	2.65
Grading Zone of Material	2
Maximum Dry Density	1.78
Optimum Moisture Content	14

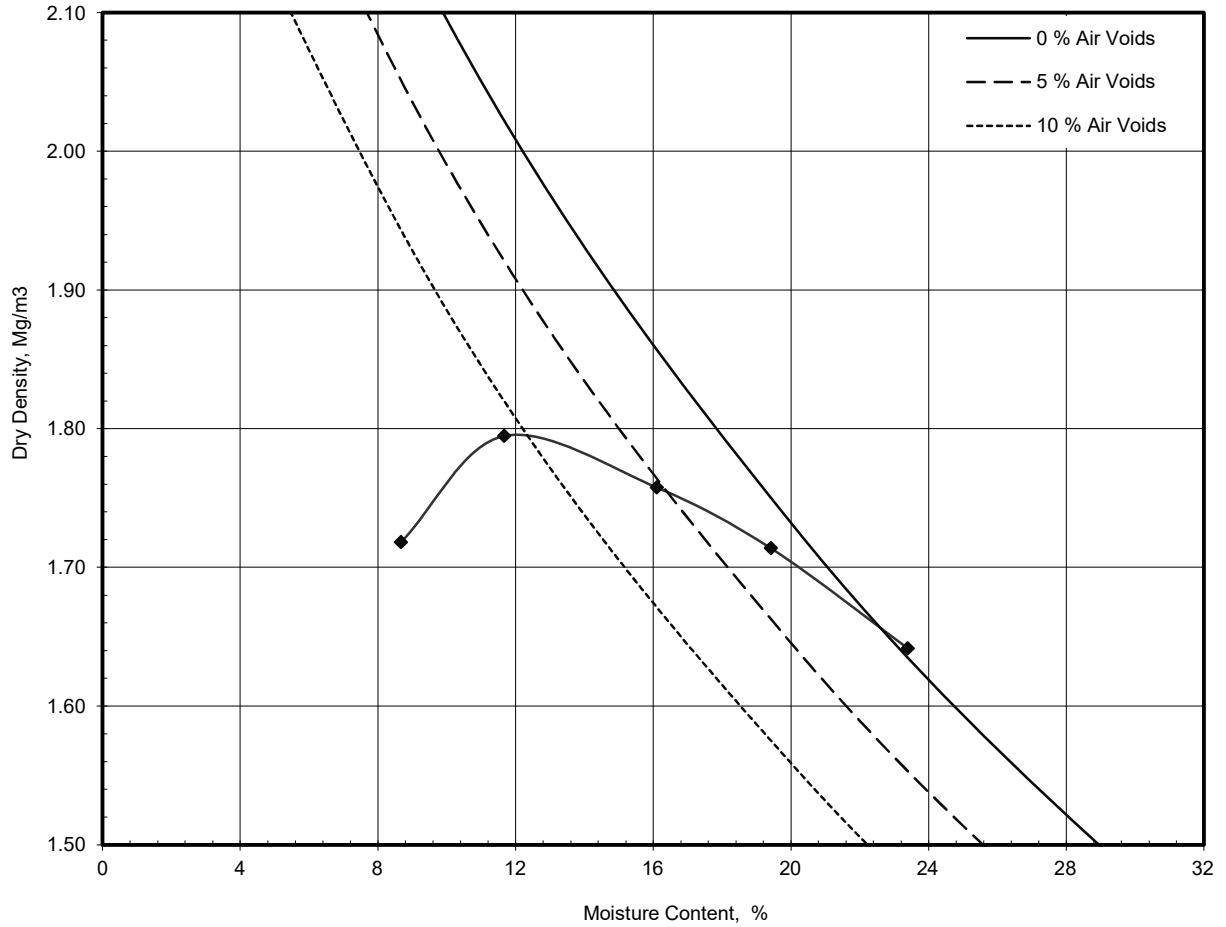
Preparation	Material used was air dried	
Mould Type	One Litre	
Samples Used	Separate specimens tested	
Material Retained on 37.5 mm Sieve	%	0
Material Retained on 20.0 mm Sieve	%	0
Particle Density - Assumed	Mg/m ³	2.65
Grading Zone of Material	1

Maximum Dry Density	Mg/m ³	1.79
Optimum Moisture Content	%	12

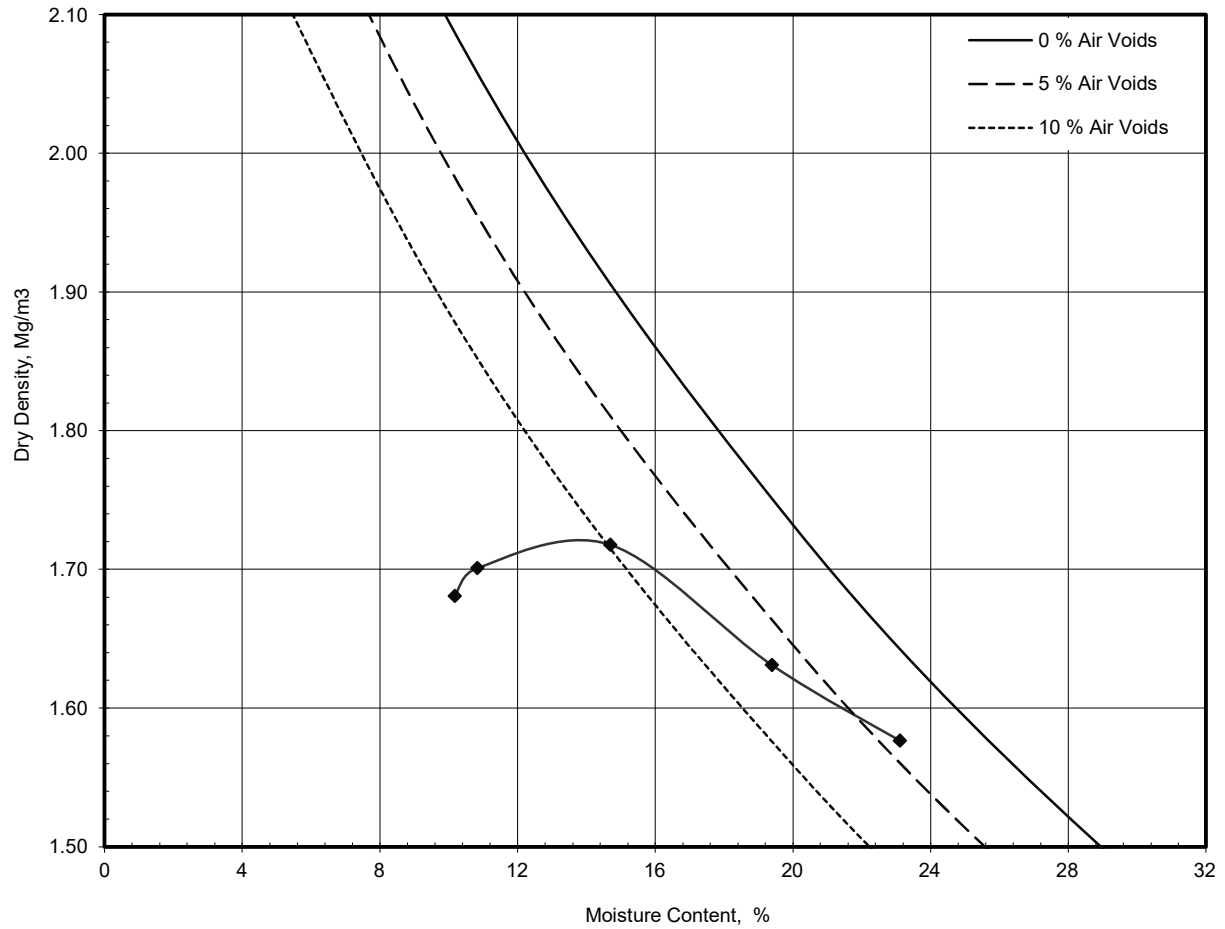
Site Name	3001 Nile and Villiers	
Soil Description	MG (Brown Slightly Clayey Gravelly Sand. Gravel includes Brick, Glass, Wood & Concrete)	
Specimen Ref.	Specimen Depth	m
Test Method	BS1377:Part 4:1990, clause 3.6, 4.5kg rammer

Preparation	Material used was air dried	
Mould Type	CBR	
Samples Used	Separate specimens tested	
Material Retained on 37.5 mm Sieve	%	8
Material Retained on 20.0 mm Sieve	%	13
Particle Density - Assumed	Mg/m³	2.65
Grading Zone of Material	5	
Maximum Dry Density	Mg/m³	1.72
Optimum Moisture Content	%	15

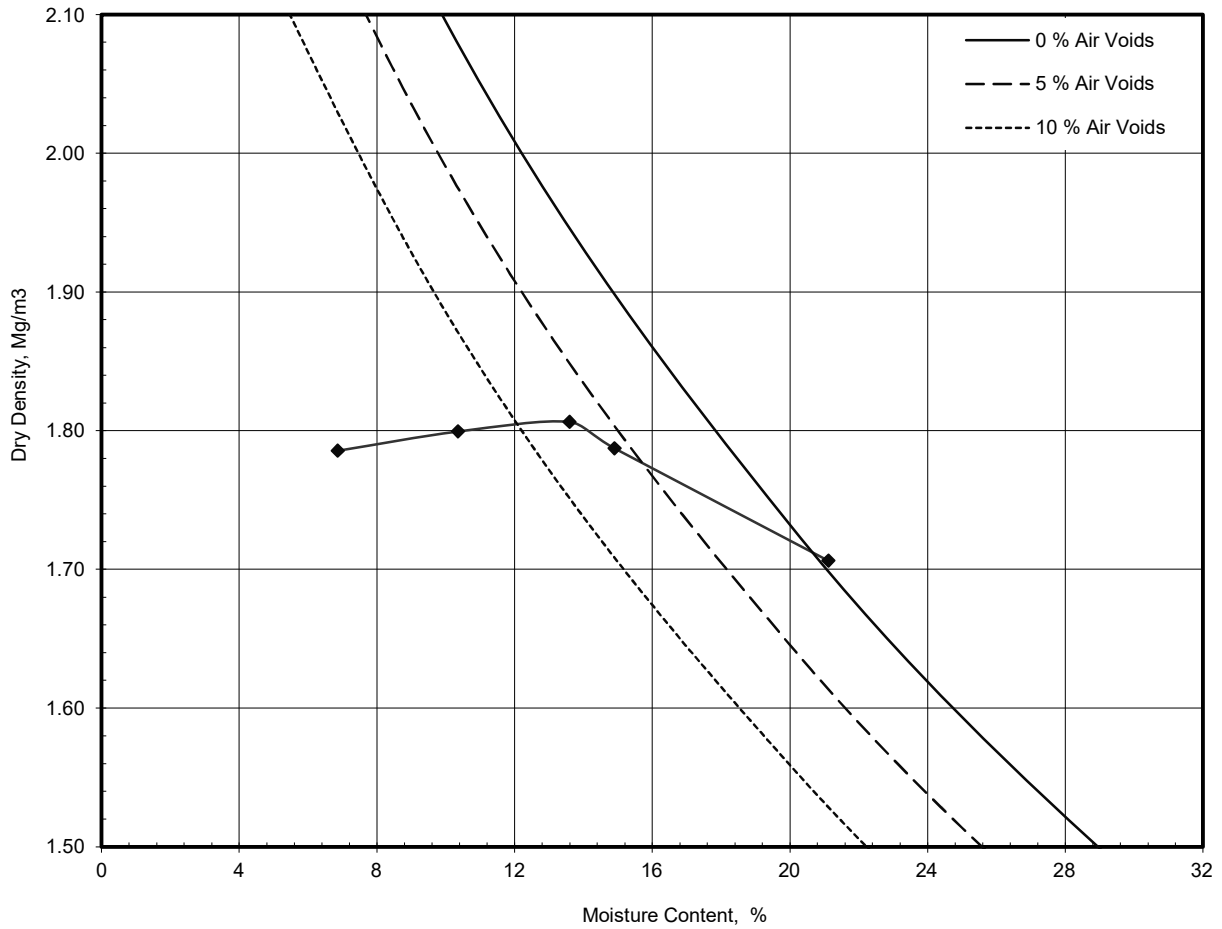
Site Name	3001 Nile and Villiers		
Soil Description	Brown Slightly Clayey Gravelly Sand		
Specimen Ref.	Specimen Depth	m	
Test Method	BS1377:Part 4:1990, clause 3.6, 4.5kg rammer		Compaction Test Reference/No.

Preparation	Material used was air dried	
Mould Type	CBR	
Samples Used	Separate specimens tested	
Material Retained on 37.5 mm Sieve	%	10
Material Retained on 20.0 mm Sieve	%	3
Particle Density - Assumed	Mg/m ³	2.65
Grading Zone of Material	X	
Maximum Dry Density	Mg/m ³	1.81
Optimum Moisture Content	%	14

Comments Testing deviates from British Standard due to amount retained on 37.5mm sieve	Date 13/10/2023 07:48	Checked	Approved	UKAS Accredited Laboratory No. 20632
		K Gargett	N. O'Brien

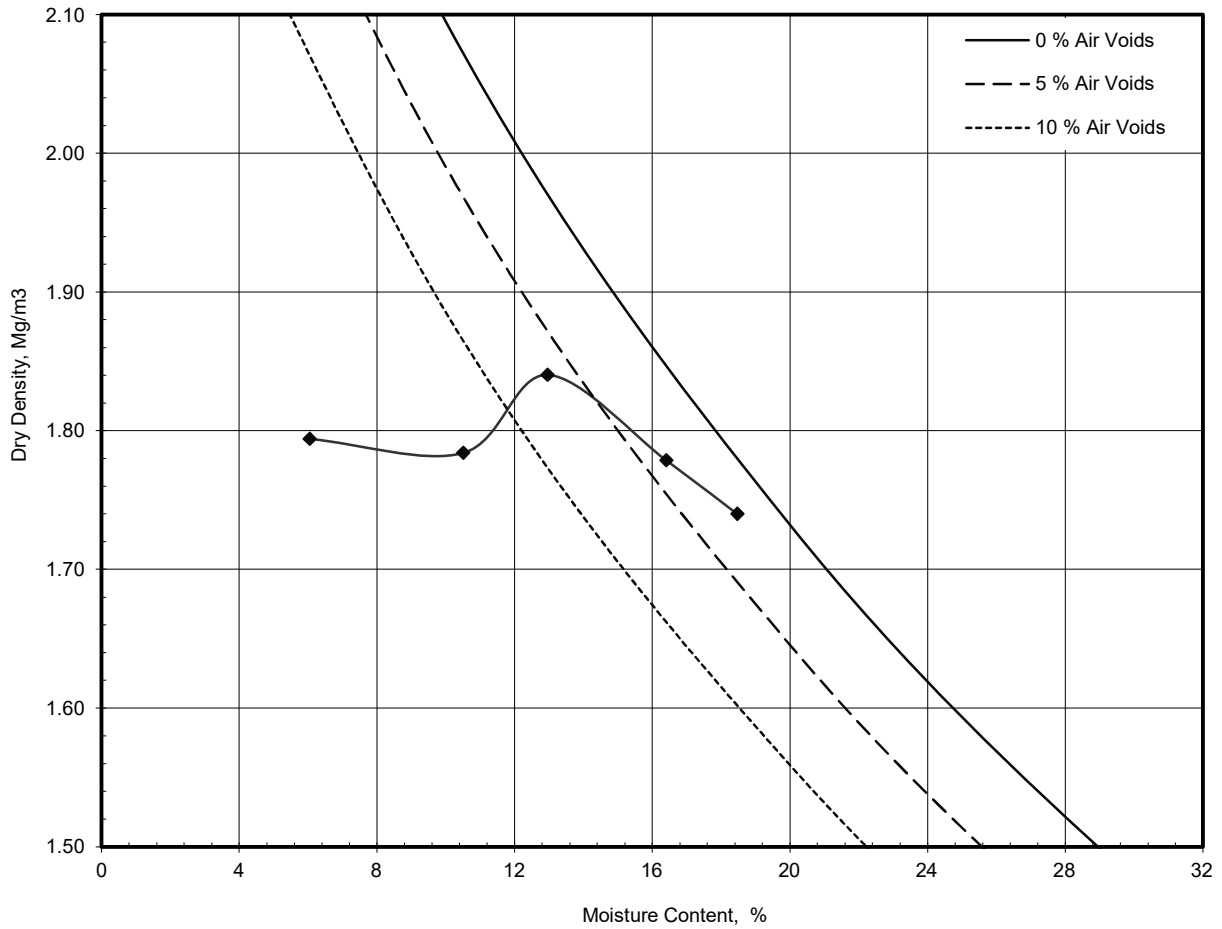
Site Name	3001 Nile and Villiers		
Soil Description	Brown Clayey Gravelly Sand		
Specimen Ref.	Specimen Depth	m	
Test Method	BS1377:Part 4:1990, clause 3.6, 4.5kg rammer

Preparation	Material used was air dried	
Mould Type	CBR	
Samples Used	Separate specimens tested	
Material Retained on 37.5 mm Sieve	%	1
Material Retained on 20.0 mm Sieve	%	3
Particle Density - Assumed	Mg/m³	2.65
Grading Zone of Material	4	
Maximum Dry Density	Mg/m³	1.84
Optimum Moisture Content	%	13
