Nile and Villiers, Sunderland

Ground Investigation Interpretive Report

Town Development Limited

October 2023

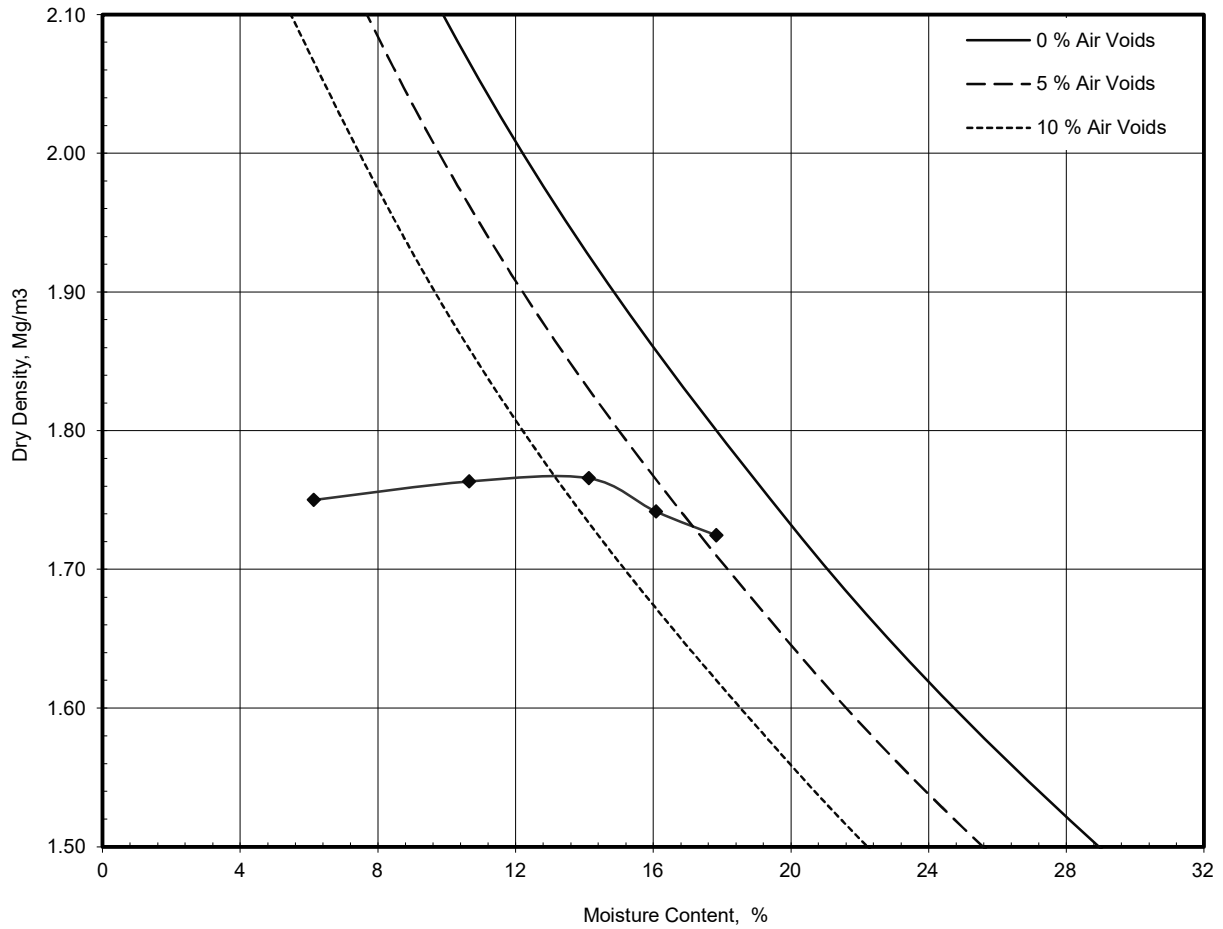
Site Name	3001 Nile and Villiers		
Soil Description	MG (Brown Slightly Clayey Gravelly Sand. Gravel includes Brick & Concrete)		
Specimen Ref.	Specimen Depth	m	
Test Method	BS1377:Part 4:1990, clause 3.6, 4.5kg rammer		Compaction Test Reference/No.

Preparation	Material used was air dried	
Mould Type	CBR	
Samples Used	Separate specimens tested	
Material Retained on 37.5 mm Sieve	%	22
Material Retained on 20.0 mm Sieve	%	10
Particle Density - Assumed	Mg/m³	2.65
Grading Zone of Material	X	
Maximum Dry Density	Mg/m³	1.77
Optimum Moisture Content	%	14

Comments Testing deviates from British Standard due to amount retained on 37.5mm sieve	Date 13/10/2023 13:00	Checked	Approved	UKAS Accredited Laboratory No. 20632
		K Gargett	N. O'Brien

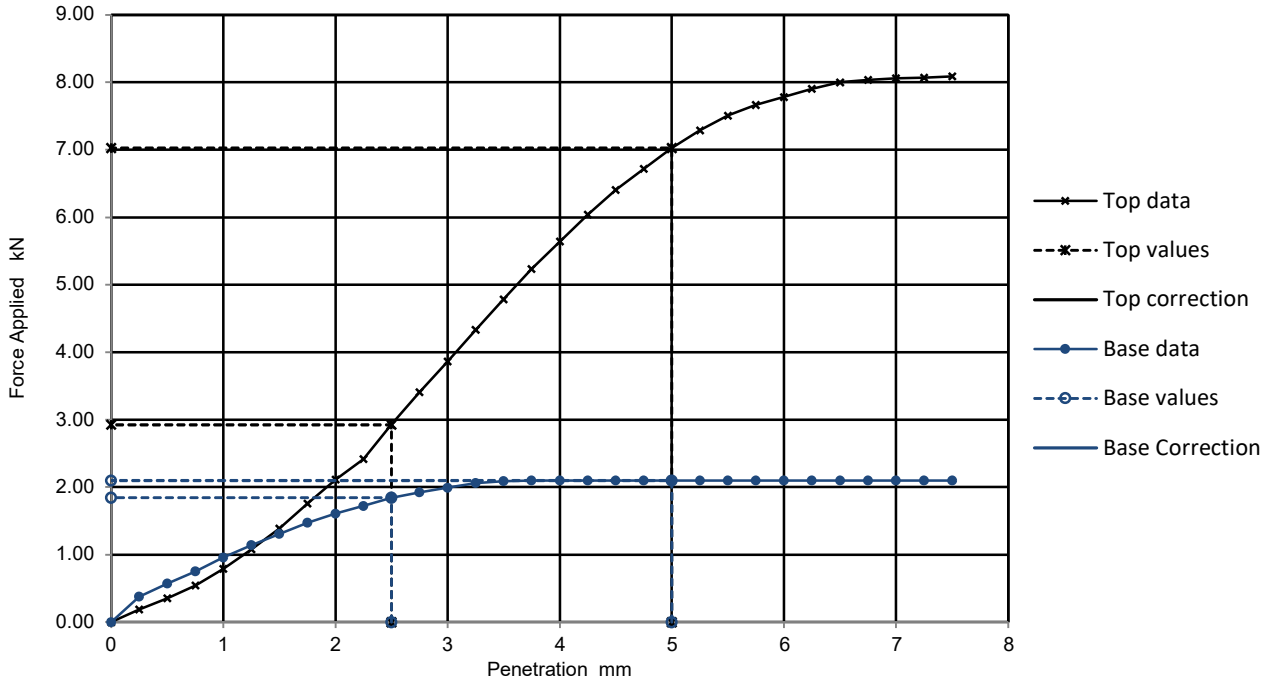
Force v Penetration Plots

Condition	REMOULDED	Soaking details	
Details	Recompacted with specified standard effort using 4.5kg rammer	Period of soaking	N/A days
		Time to surface	N/A days
		Amount of swell recorded	N/A mm
Material retained on 20mm sieve removed	0 %	Dry density after soaking	Mg/m ³
Initial Specimen details	Bulk density	1.92 Mg/m ³	Surcharge applied
	Dry density	Mg/m ³	12 kg
	Moisture content	%	7 kPa

Curve correction applied	CBR Values, %				Moisture Content %
	2.5mm	5mm	Highest	Average	
TOP	22	35	35		8.3
BASE	14	10	14		7.7

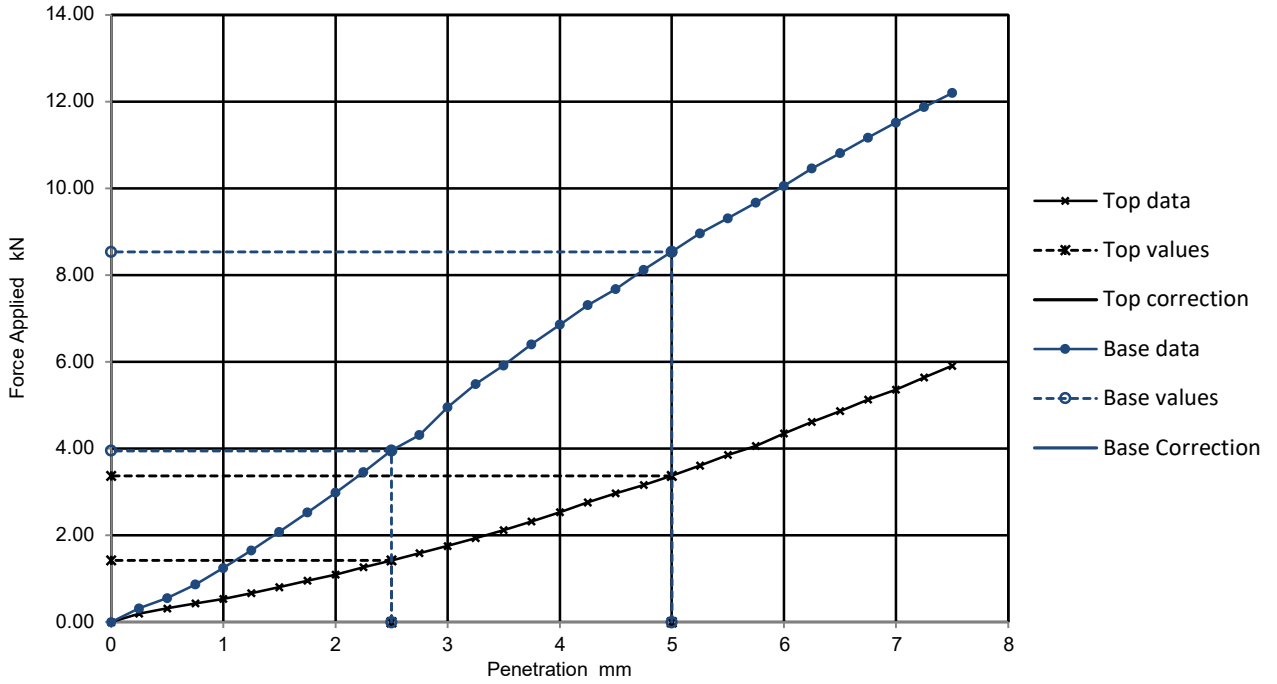
Force v Penetration Plots

Condition	REMOULDED	Soaking details	
Details	Recompacted with specified standard effort using 4.5kg rammer	Period of soaking	N/A days
		Time to surface	N/A days
		Amount of swell recorded	N/A mm
Material retained on 20mm sieve removed	4 %	Dry density after soaking	Mg/m ³
Initial Specimen details	Bulk density	2.55 Mg/m ³	Surcharge applied
	Dry density	2.26 Mg/m ³	12 kg
	Moisture content	13 %	11 kPa

Curve correction applied	CBR Values, %				Moisture Content %
	2.5mm	5mm	Highest	Average	
TOP	11	17	17		13.4
BASE	30	43	43		11.6

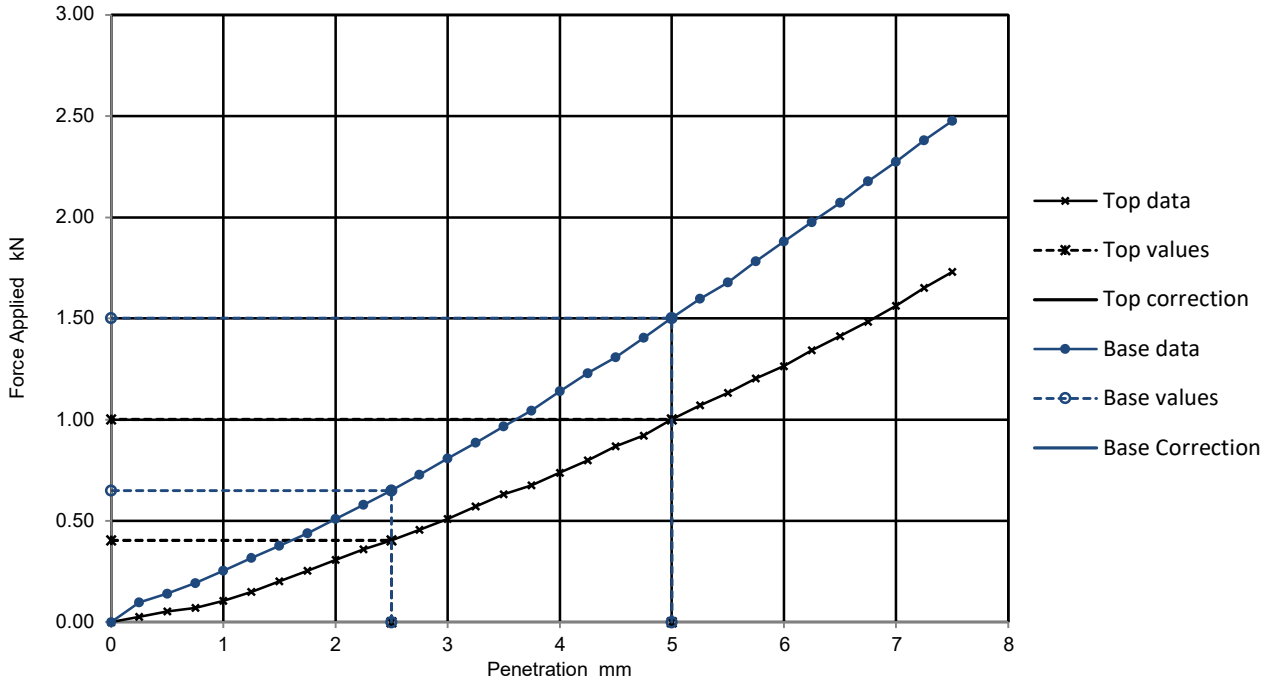
Force v Penetration Plots

Condition	REMOULDED		Soaking details	
Details	Recompacted with specified standard effort using 4.5kg rammer		Period of soaking	N/A days
			Time to surface	N/A days
			Amount of swell recorded	N/A mm
Material retained on 20mm sieve removed	8	%	Dry density after soaking	Mg/m ³
Initial Specimen details	Bulk density	2.07 Mg/m ³	Surcharge applied	12 kg
	Dry density	1.80 Mg/m ³		7 kPa
	Moisture content	15 %

Curve correction applied	CBR Values, %				Moisture Content %
	2.5mm	5mm	Highest	Average	
TOP	3.1	5.0	5.0		16.5
BASE	4.9	7.5	7.5		13.5
