Date
March 2019

Project Number
1700003663

WINDRUSH INDUSTRIAL PARK, WITNEY, OXFORDSHIRE PHASE I ENVIRONMENTAL ASSESSMENT AND GROUNDWATER SAMPLING REPORT

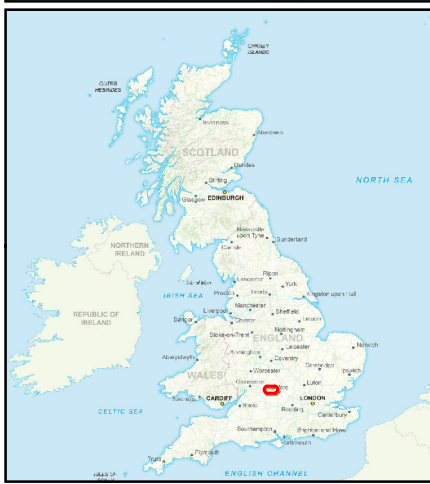
Figure Title Figure 1: Site Location	Project Name Windrush Industrial Park, Witney, Oxfordshire	Date March 2019	
		Scale As shown	
Project Number 1700003663	Client Blenheim Estate Ltd	Issue 1	Prepared By RH

The site is located approximately 2.5km west of the centre of Witney, Oxfordshire, at National Grid Reference 433290, 210370 (see Figure 1, Appendix 1). Land in the vicinity of the site slopes gently down-gradient to the south.

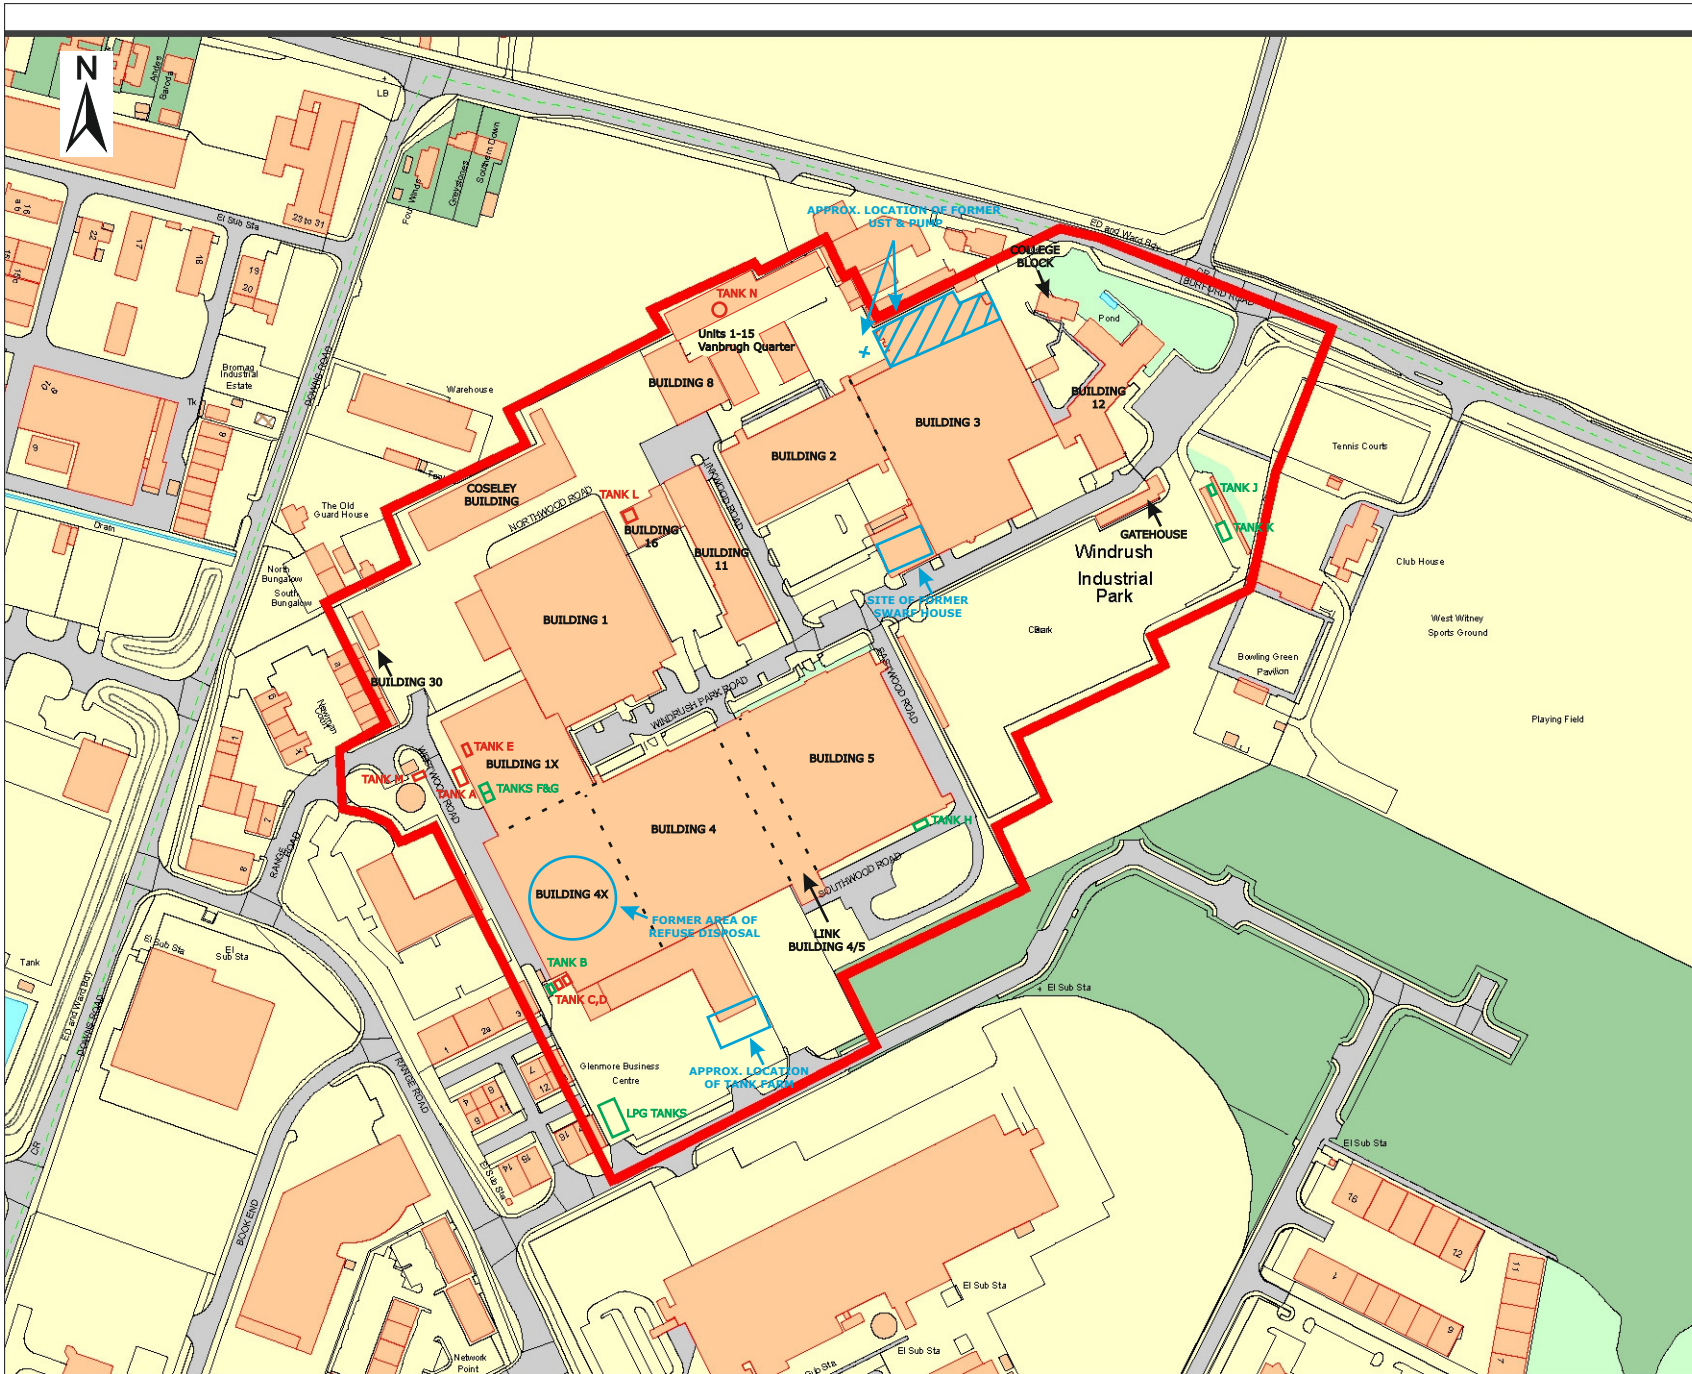
- Site Boundary
- Red Annotations - Storage identified in 2019
- Green Annotations - Storage identified in 2010
- Blue Annotations - Info from Planning

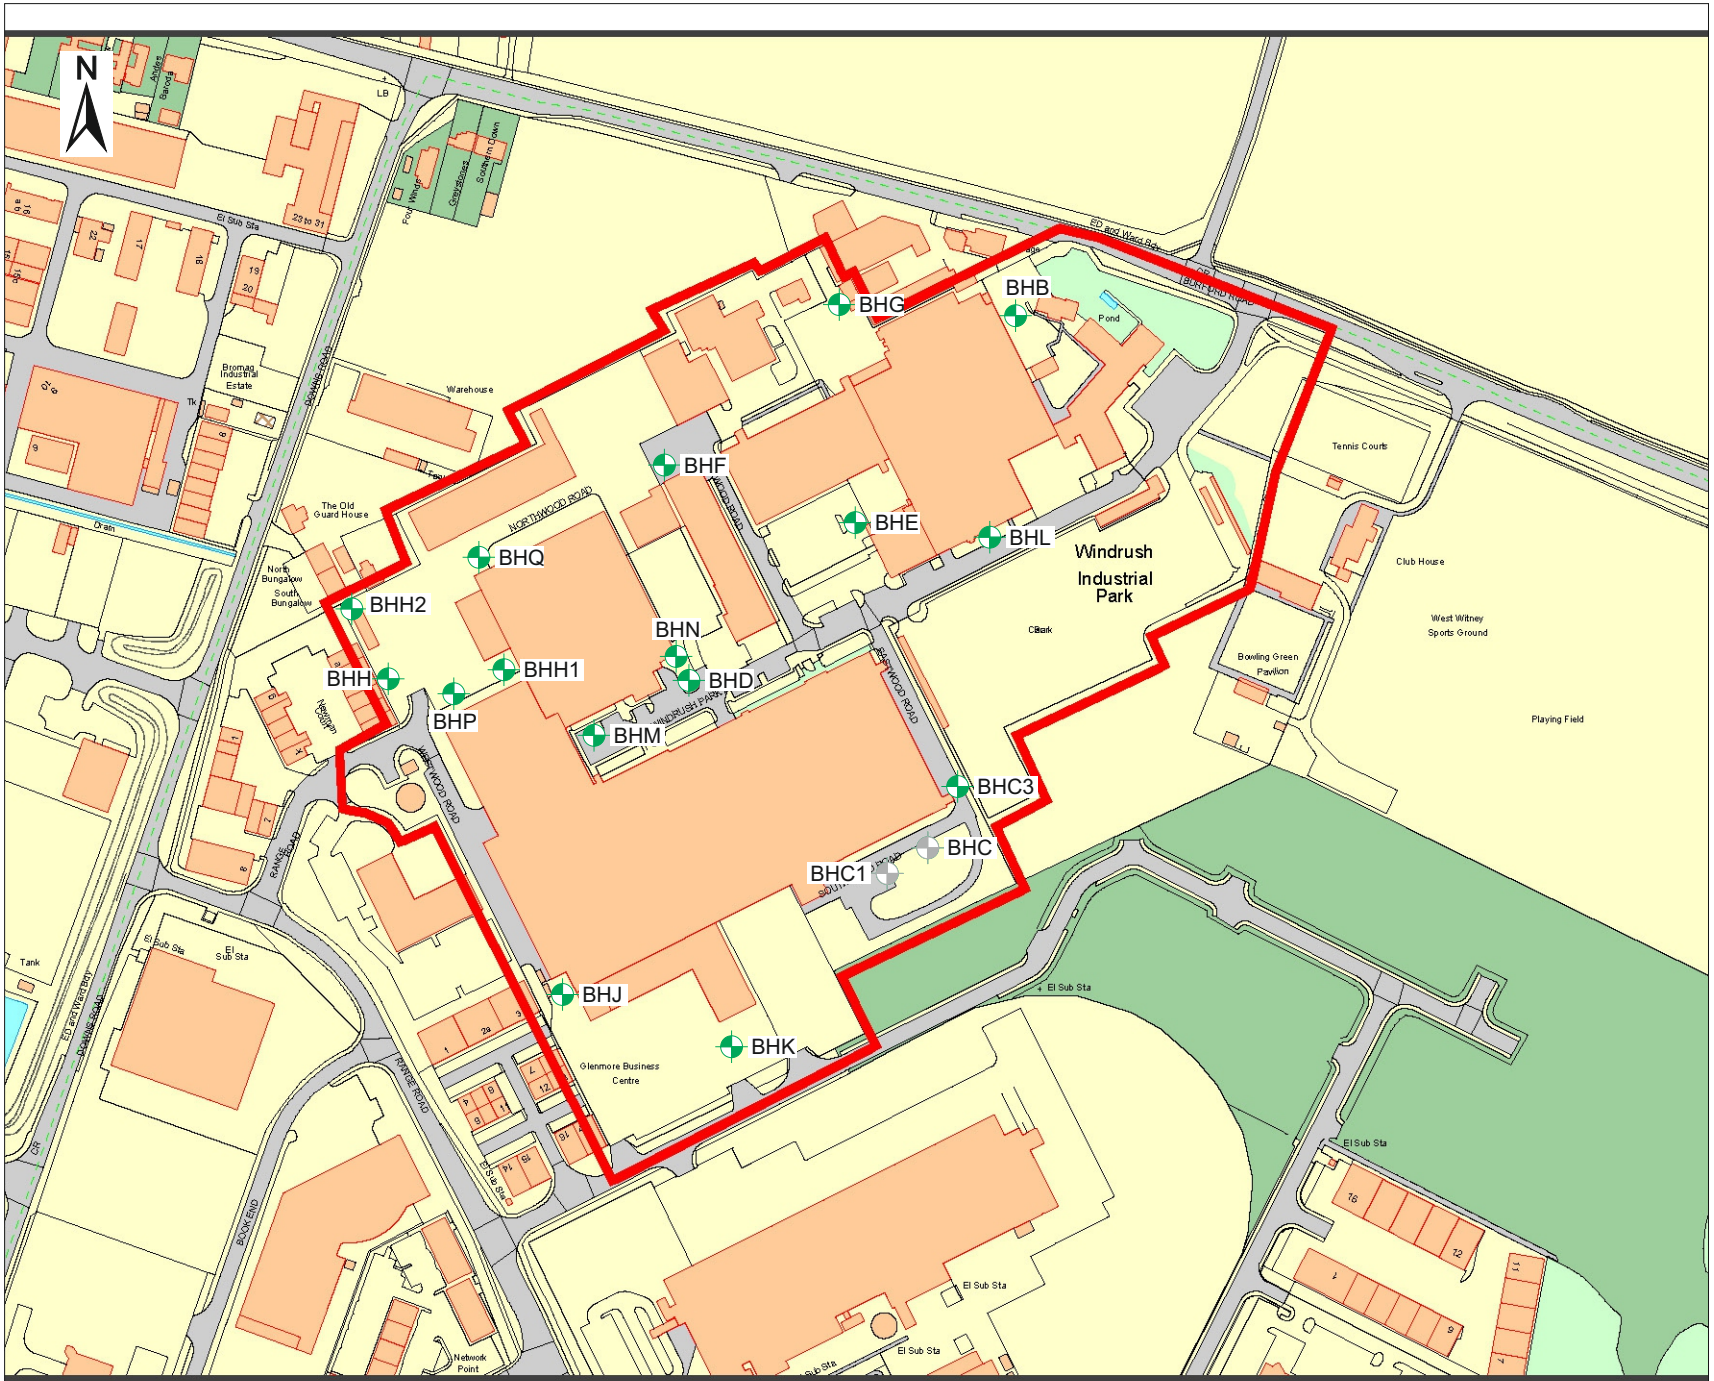
- Site Boundary
- 2019 Sampling Locations
- 2010 Sampling Locations that are no longer available

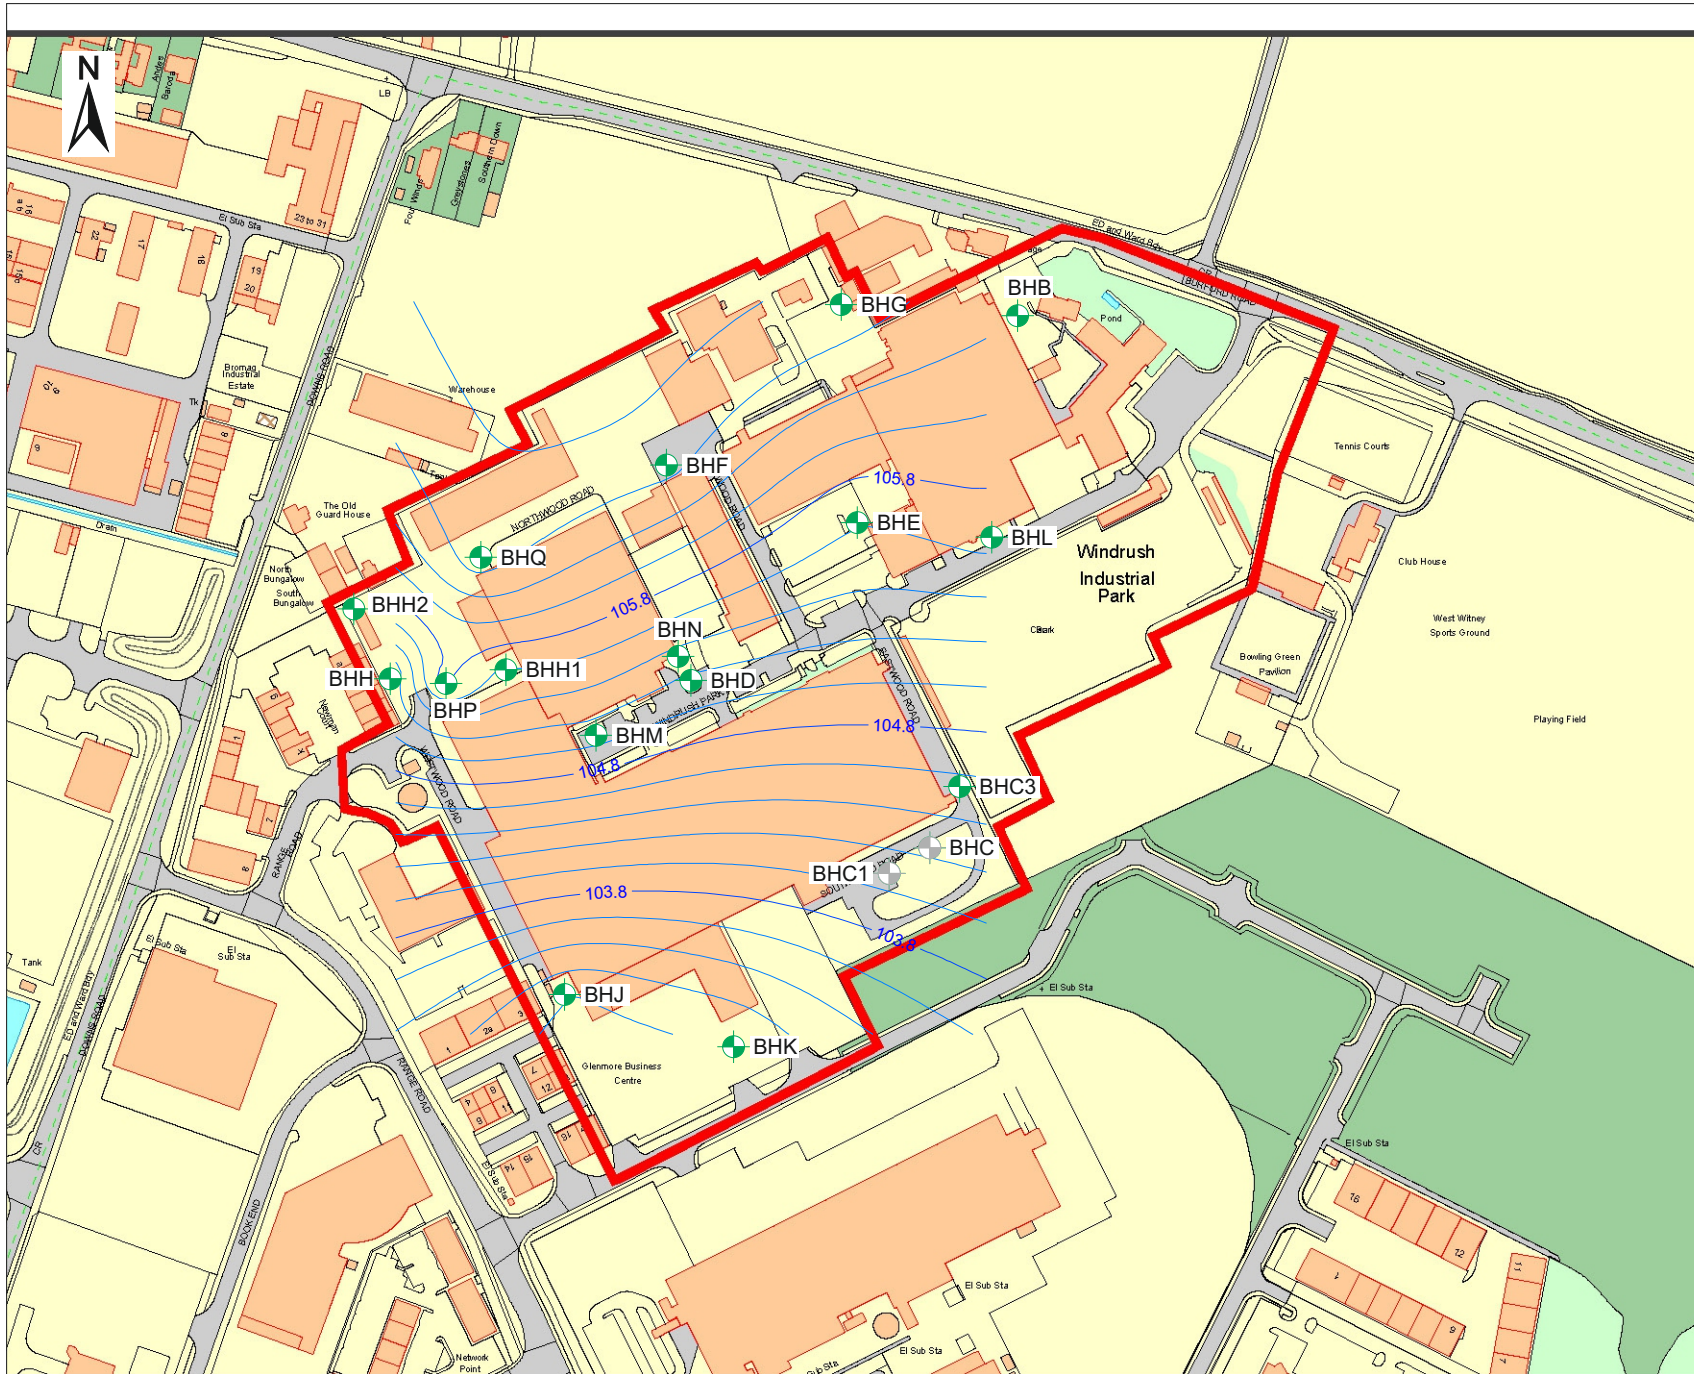
- Legend
- Site Boundary
 - 2019 Sampling Locations
 - 2010 Sampling Locations that are no longer available
 - Groundwater Level in Shallow Aquifer

Note: Groundwater levels based on 2019 data from BHE, BHF, BHG, BHH, BHH1, BHJ, BHK, BHL, BHM, BHN, BHP

The site is unusual in terms of groundwater given the different water levels. The drop in relative groundwater elevation does not appear to mimic topography to the same extent. It is possible that there may be an unidentified geological structure in the eastern section of the site, which may be influencing the groundwater. Furthermore, the Cornbrash and Forest Marble deposits, which contain mudstone bands and foundation structures in nearby buildings, also have the potential to influence the groundwater at the site. There is not enough data from the lower water table to accurately determine groundwater flow in this water body.

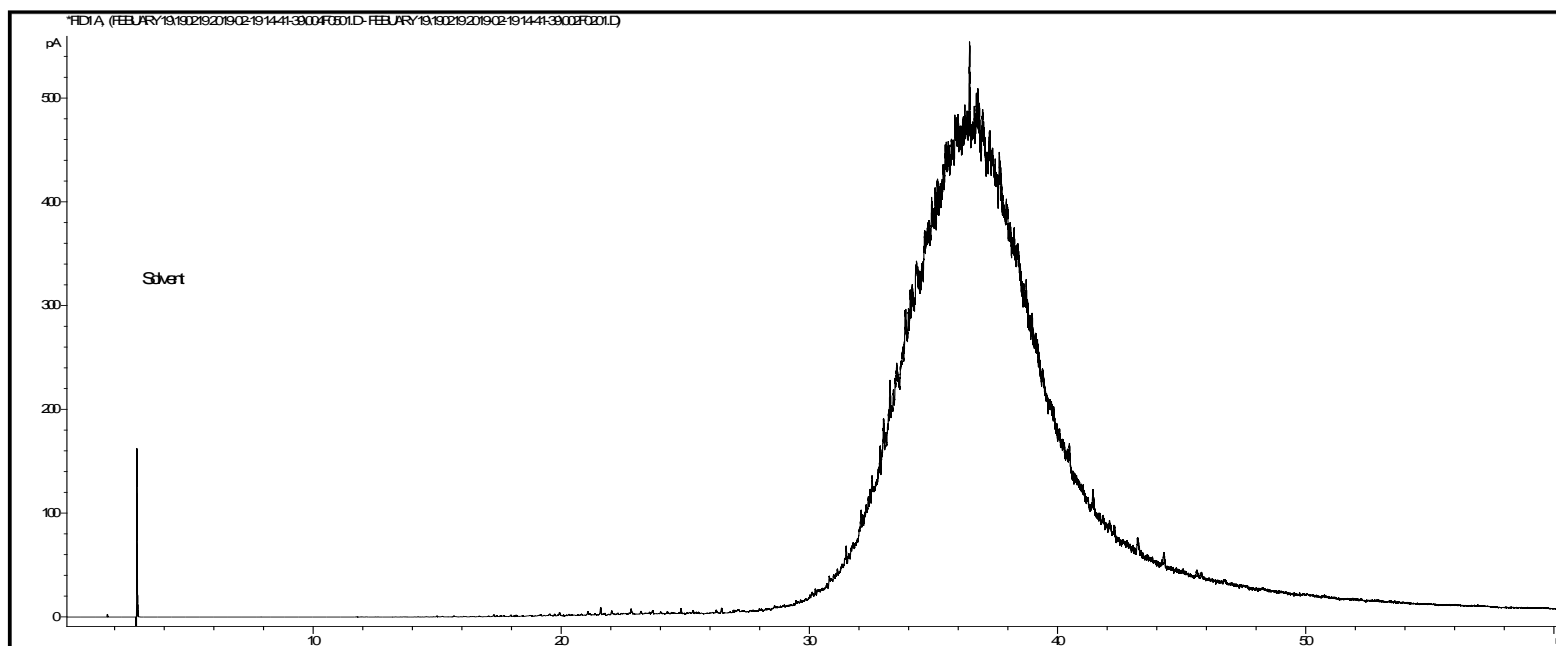
Chromatogram:

Interpretation: Possible Hydraulic Oil

*The age of release estimated in this report is based on the nC₁₇/pristane ratio only as prescribed by Christensen and Larsen (1993) and Kaplan, Galperin, Alimi et al., (1996). Age estimation should be treated with caution as it can be influenced by site specific factors that the laboratory are not aware of.

Free phase product (i.e. oil floating on groundwater) is present within borehole BHG in the north of the site. This too was found in the past, although the thickness of free phase product has increased. Total petroleum hydrocarbons (TPH) has also been detected at low levels in 2019 in some groundwater wells where it was not previously encountered. However, as with the VOCs, significant migration of hydrocarbons from the area of borehole BHG does not appear to have occurred over the last c.15 years. The free phase product has been described by the laboratory as likely to be hydraulic oil.
