**PLOTS B, WINDRUSH INDUSTRIAL ESTATE**

**ARBORICULTURAL IMPACT ASSESSMENT  
TO BS 5837:2012**

**TREE SURVEY TO BS 5837:2012**

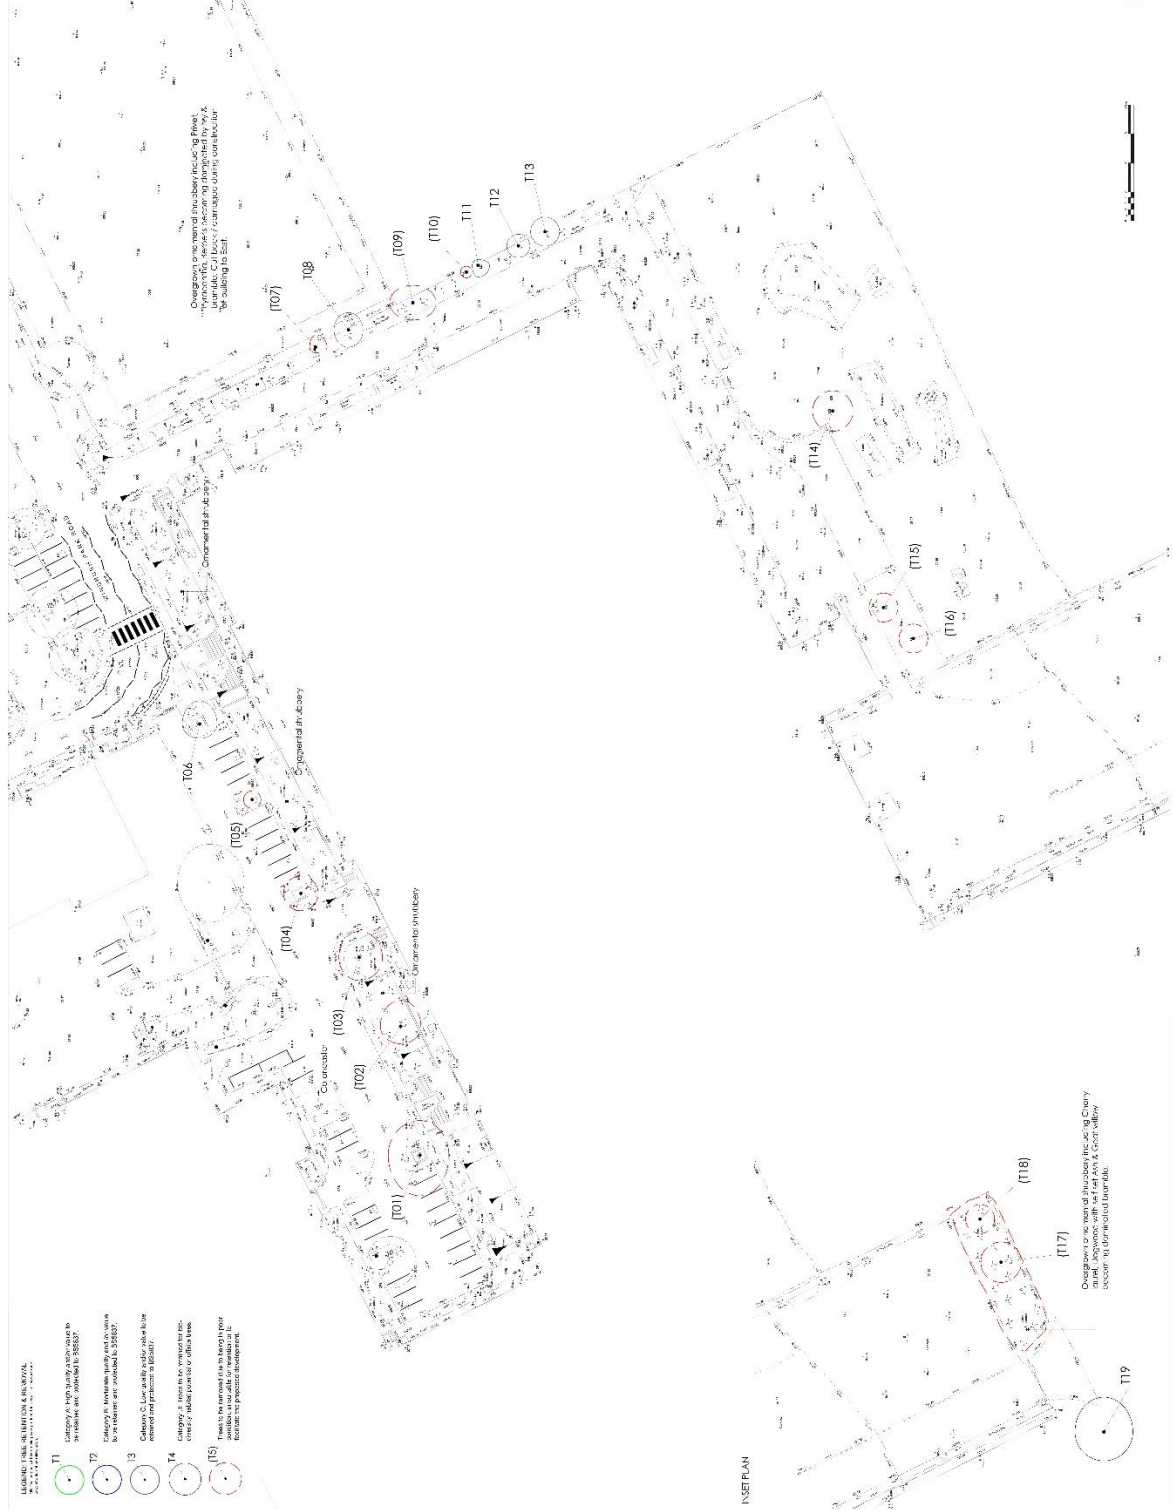
23-043-P-04 Tree Retention & Removal Plan

3.2.0 The assessment highlighted a number of trees that would need to be removed as a result of the development of the site as listed within Table 1 below and as identified within the Tree Retention & Removal Plan 23-043-P-04.

3.2.1 In summary the proposed development will mean the removal of 13 trees with 9 of those trees considered to be low quality and value and 2 of moderate quality and value. The location of these trees within the site limits the effect of their removal on the surrounding landscape and the proposed development includes for a significant tree planting within the site which will mitigate for their loss. The removal of these trees is therefore not considered to be a constraint to the proposed development of the site.

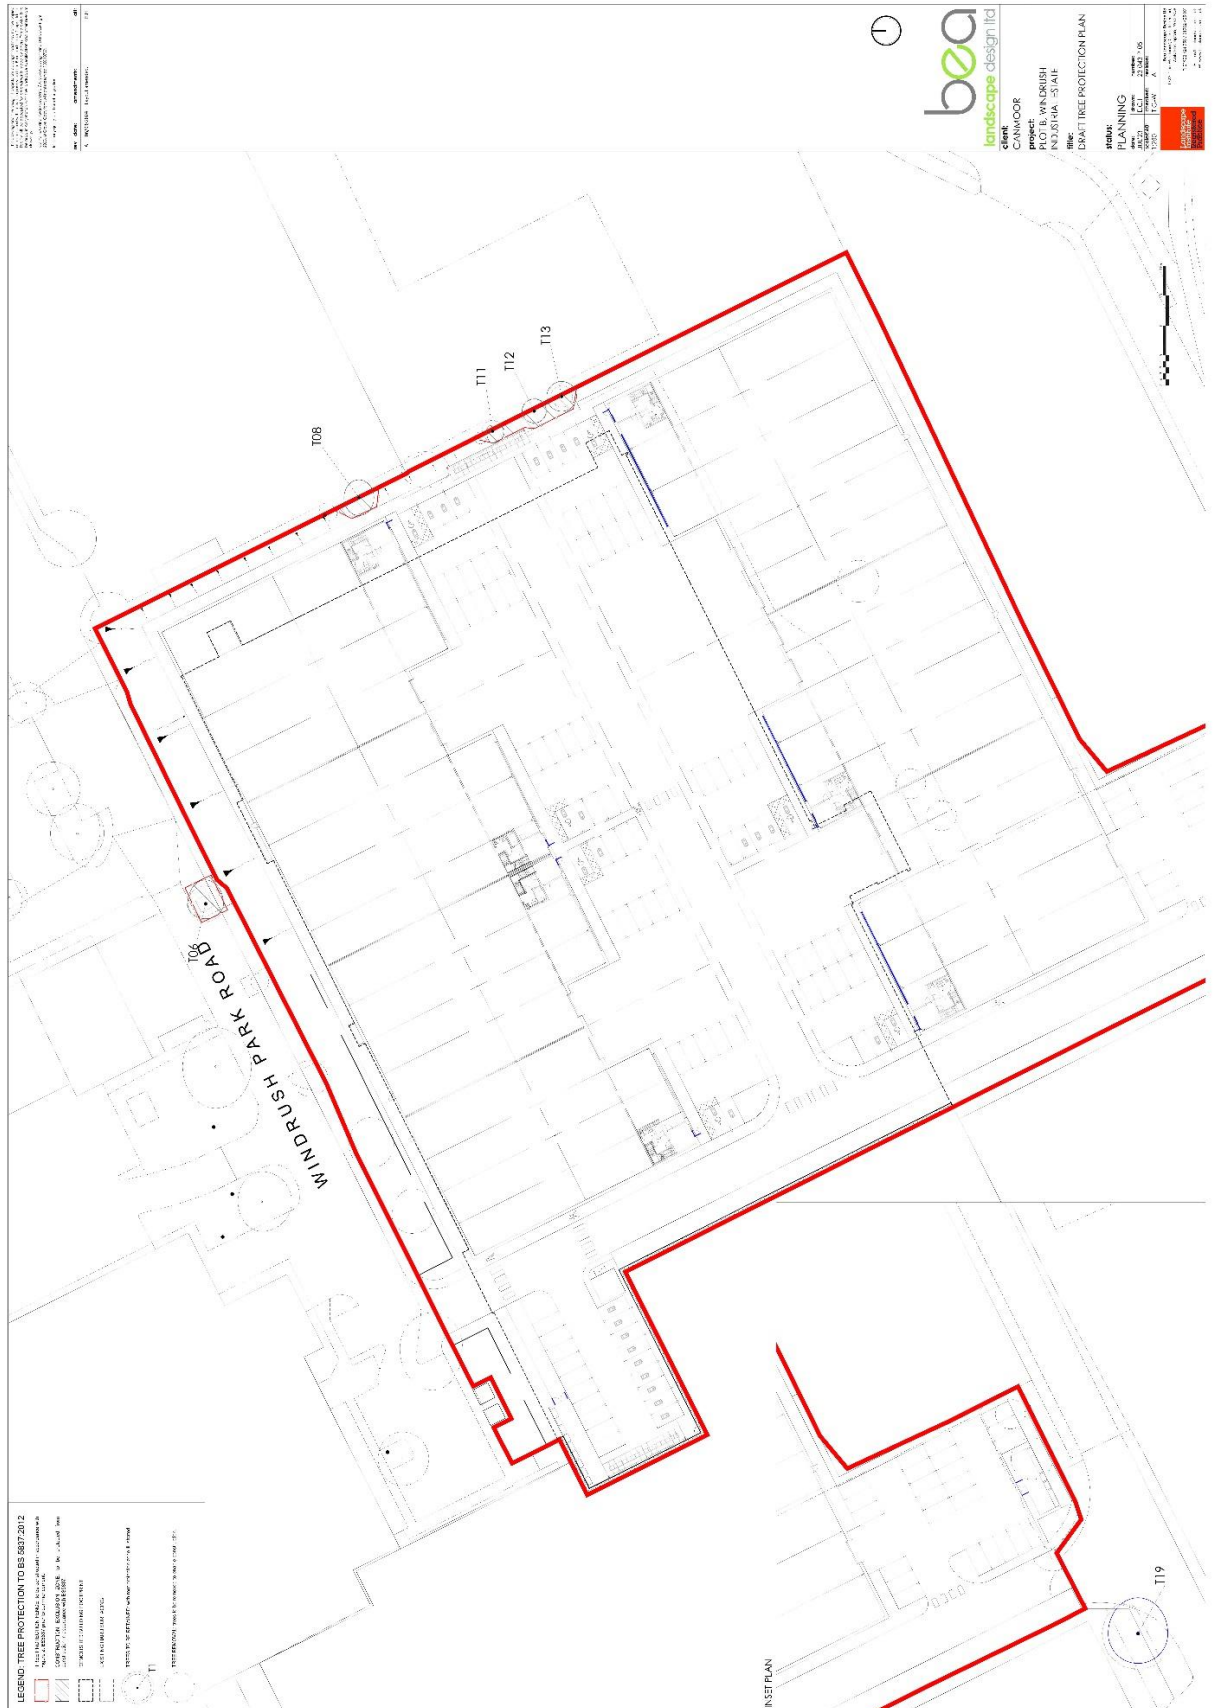
23-043-P-05 Draft Tree Protection Plan

8.2.0 The creation of the proposed access roads, pavements and hard standing at the edge of the RPA retained trees is to be mitigated through the use pedestrian operated tools / hand digging to break out the existing kerbs and install the replacements.

- 8.2.1 To minimise potential root damage during the implementation of soft landscaping no cultivation of topsoil is to be carried out within the RPA with the transplants / shrubs to be pit planted by hand.

- 8.3.0 The trees are to be protected from damage during the course of the works in accordance with the guidance of BS5837:2012.

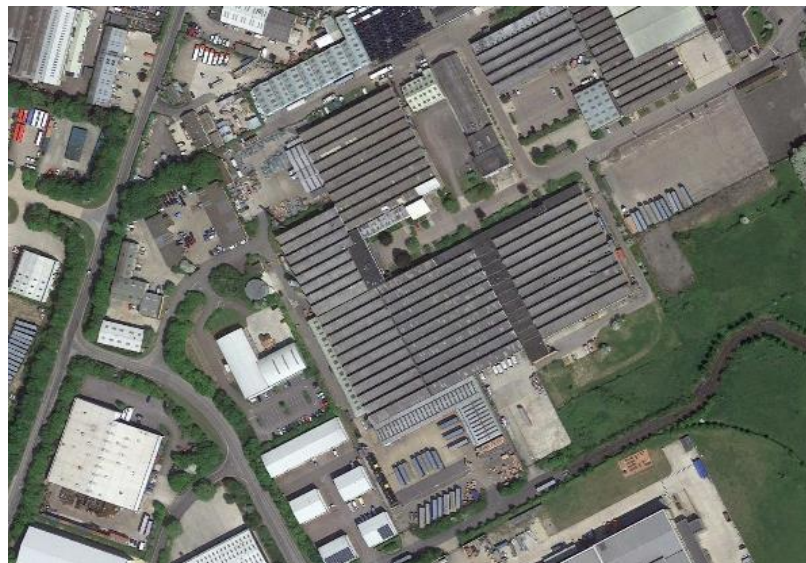
Figure 2. Aerial Photograph

2.2 The area surveyed is currently occupied by industrial buildings with associated service yard, access road and car parking (refer to Figure 02. Aerial Photograph below).

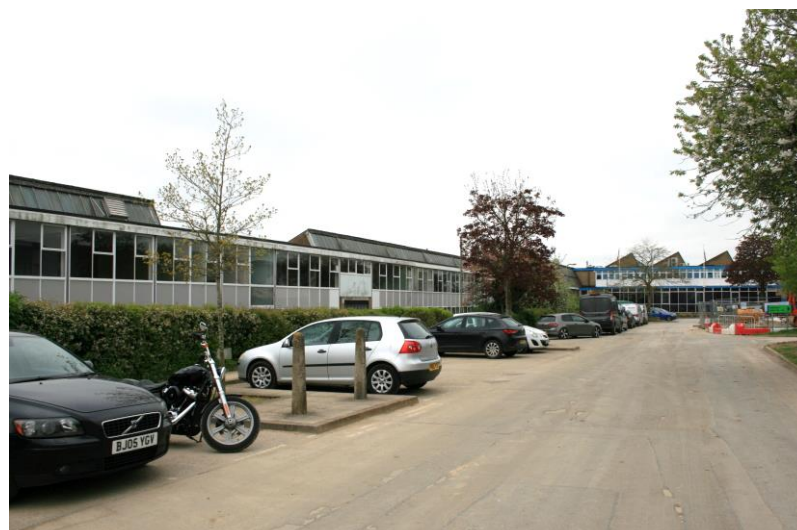
Figure 3. View Southwest towards T01-T05

3.2 Trees T01 to T06 are a number of predominantly low quality and value Purple leaved maple, False acacia and Apple trees growing within the hard and soft landscaped areas to the front of the existing buildings (refer to Figure 3 below). Trees T01, T04 and T06 are growing within raised brick planters with the estimated root protection areas shown as a radius as the size of tree indicates a greater root spread than the size of the planters would indicate.

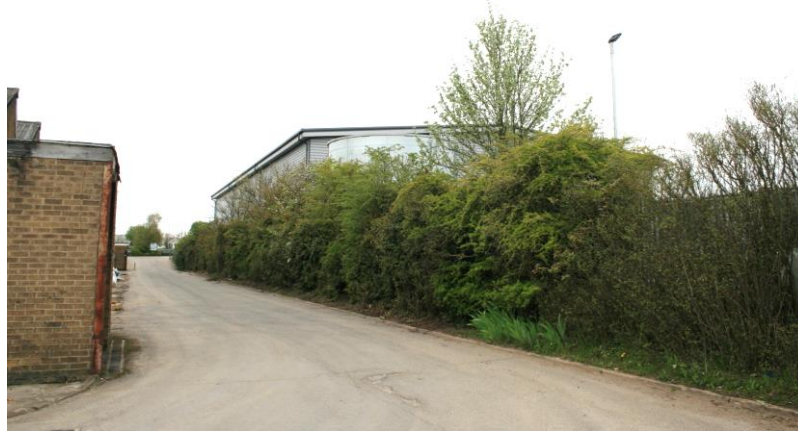
Figure 4. View North towards T07-T13

3.3 To the East of the survey area is a slope down from the adjacent site planted with ornamental shrubs and a number of young trees including Whitebeam, Rowan, Apple and Hawthorn of varying value and condition (refer to Figure 4 above).
