Harlech Court,
Cardiff

Preliminary Roost Assessment

December 2023

Acer Ecology

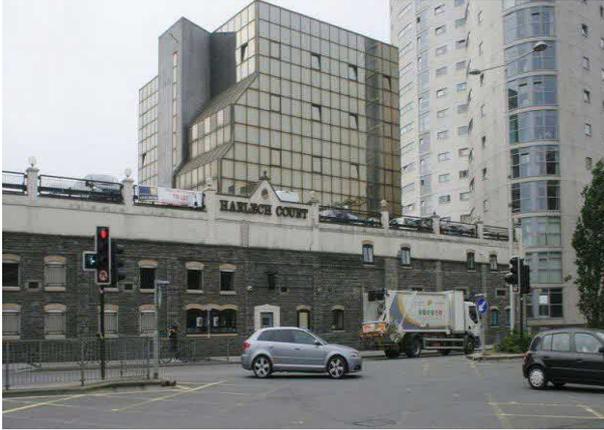
Photo 1: Northern Front of B1a

Building Number	Description	Evidence Of Bats	Potential for Bats
B1a	<p>The building is a two-storey structure with split use as a bar, car park, office space and school (see Photos 1, 2, 3, 4 and 5). The roof is flat and constructed from concrete, and is utilised as a car park.</p> <p>There are multiple metal grates on the front of the building with suitable gaps that could provide bats with access to the interior (see Photo 6).</p> <p>The front of the building is constructed from stone on the first two floors of the structure. The southern rear, eastern and western sides of the building are constructed from brick and mortar, sections of which are rendered (see Photos 3, 4 and 5). The external walls are in generally good condition on the northern front, however there is a crack in the render on the southern rear which could be utilised by roosting bats (see Photo 41). Gaps are present between a notice board and the external walls on the southern rear, providing a potential roosting place for bats (see Photo 42). Ventilation gaps on the eastern side and southern rear provide potential access points for bats to the interior (see Photo 7). Sections of the ceiling have also been netted on the northern side and southern rear.</p> <p>The doors, window frames and door frames are of timber construction (see Photo 1). Multiple windows are boarded up and so do not provide access into the interior. However, some along the northern front are open, whilst others are covered with chicken wire which is in poor condition. These features allow access into the open space beneath the car park (see Photo 1). The windows and door surrounding the Porters bar are well sealed and had no gaps surrounding the frames. However, gaps between the door frames and external walls are present on fire exits and so could be used by bats (see Photo 4).</p> <p>Due to the usage of the building and urban location, numerous security lights are present on all sides (see Photo 7).</p>	None	Moderate

There are numerous potential access points for bats to enter the interior. Bats could gain entry through the gaps in the metal grates (see Photo 1) and ventilation gaps (see Photo 7).

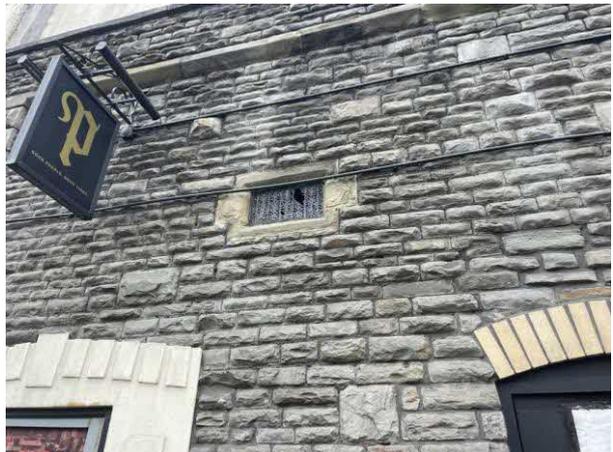
Photo 6: Metal Grate on Northern Front

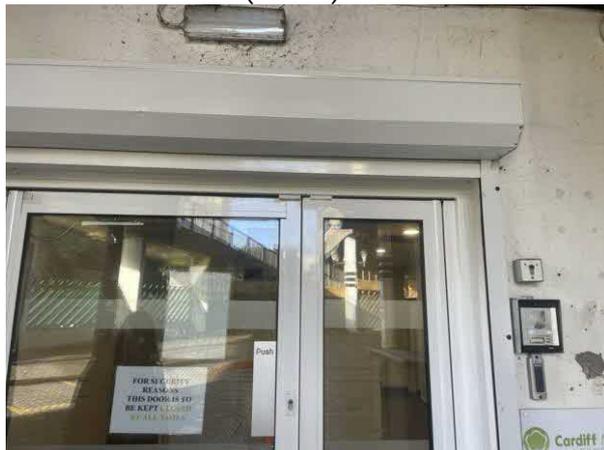
Photo 8: Security Light Above uPVC door on Eastern side of B1a (School)

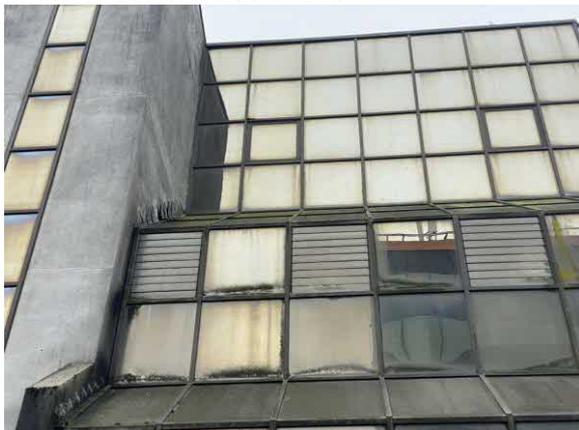
Photo 9: Eastern Side of B1b

B1b	<p>The building is a four-storey structure with split use as an office space and a school (see Photos 9, 10, 11, 12, 13 and 14). The building is constructed of brick and mortar with glass panelling on all elevations. A section of the eastern elevation sits approximately 1-2m forward from the rest of the building, with a brick-and-mortar extension to the rear of this structure.</p> <p>The roof is flat and constructed from steel corrugated sheeting with rubber flat roof matting covering the entirety (see Photos 15 and 16). The access point to the roof is always open, leaving gaps between corrugated sheeting and breezeblocks exposed which could be utilised by roosting bats (see Photo 45).</p> <p>Numerous glass panels are missing to the rear of the building and have been boarded with MDF, and one single panel is missing completely to the southern rear and western side which allows access into the space between the panel and the external wall (see Photo 14). Where the eastern side of the building adjoins B1c, raised lead flashing is present which has potential</p>	None	Moderate

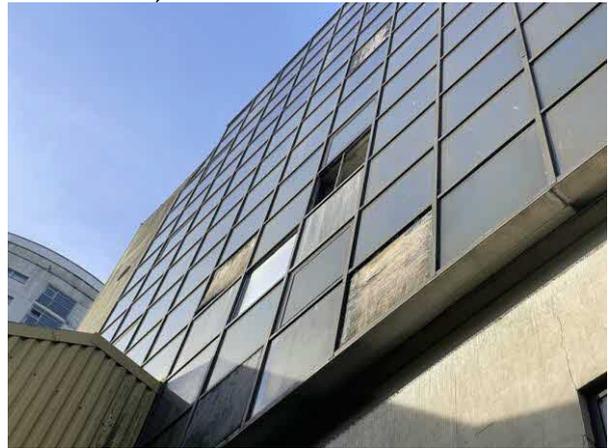
Photo 14: Southern Rear of B1b (Including Missing Glass Panels)

Not all parts of the office block could be inspected during the preliminary roost assessment. The missing glass panel to the southern rear of the building wasn't able to be accessed and therefore could not be inspected. The survey is only slightly constrained, and this is not considered to have significantly affected the accuracy of the assessment.

- PRF 1 – Exposed corrugated metal sheeting (see Photo 45);
- PRF 2 – Crevices between breezeblocks (see Photo 45);
- PRF 3 – Missing glass panels on southern rear and western side (see Photo 14);
- PRF 4 – Raised lead flashing (see Photo 46);
- PRF 5 – Torn rubber coating (see Photo 47);
- PRF 6 – Raised fascia (see Photo 47); and
- PRF 7 – Netting (see Photo 48).

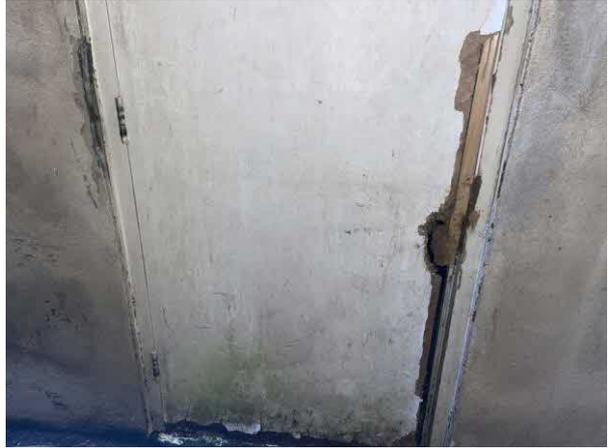
Photo 26: Timber Door on Northern Front of B2

There are two potential access points for bats to enter the interior. Bats could gain entry through the gap in the external wall (see Photo 28) and the broken timber door (see Photo 26).

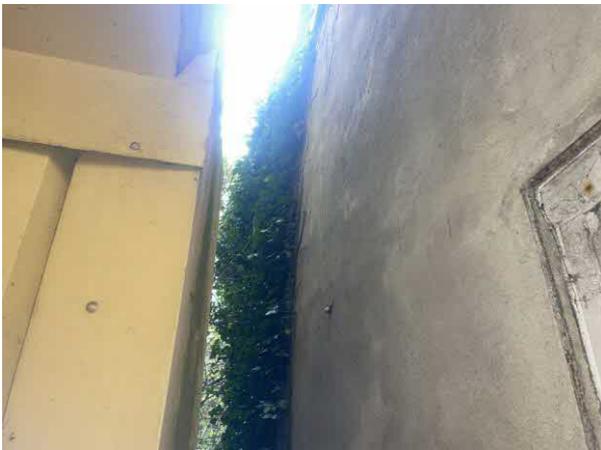
Photo 27: Eastern Front of B2, Ivy Coverage

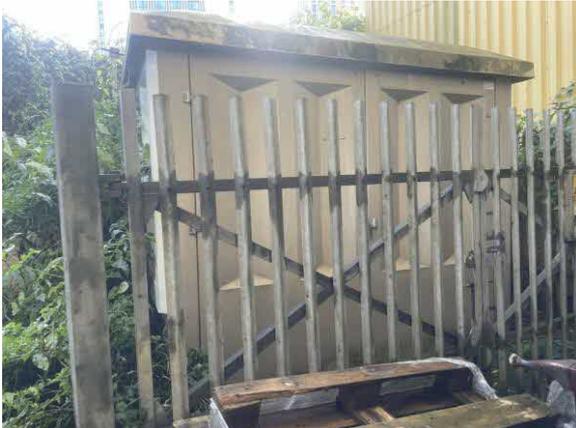
Photo 34: Northern Front of B3

B3	B3 is a substation that is surrounded by metal fencing (see Photo 34). The building comprises metal sheeting and plastic trim, with a flat roof and doors constructed of metal. The building is in generally good condition, however there is a gap in the mesh under the eaves on the northern front which bats could use to roost and potentially access the interior (see Photo 36).	None	Low

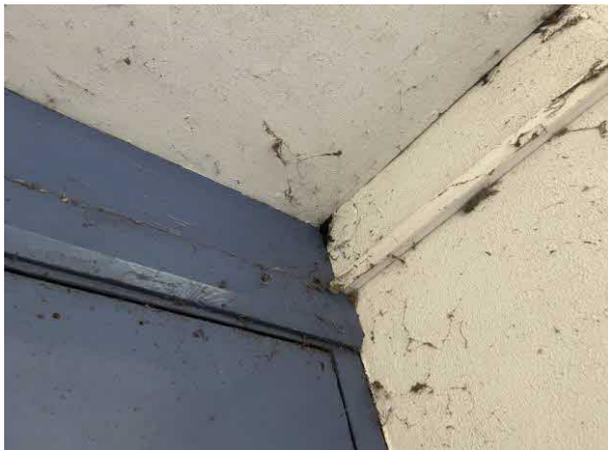
Photo 40: Gap Between External Wall and Door Frame to Southern Rear of B1a

- PRF 1 – Gaps between external walls and door frames (see Photo 40);
- PRF 2 – Crack in rendering (see Photo 41);
- PRF 3 – Gaps behind notice board (see Photo 42);
- PRF 4 – Ventilation gaps (see Photo 7);
- PRF 5 – Gap underneath window frame (see Photo 43); and
- PRF 6 – Gap in rendering underneath security light (see Photo 44);
